MARE ISLAND NAVAL SHIPYARD, FIREHOUSE  
Vallejo (Central Fire Station)(Building 99)  
Solano County  
California

HABS No. CA-1543-I

MARE ISLAND NAVAL SHIPYARD,  
FIREHOUSE (BUILDING 99)(CENTRAL FIRE STATION)

Location: Southwest corner of California Avenue and 7th Street  
Mare Island Naval Shipyard  
Vallejo  
Solano County  
California

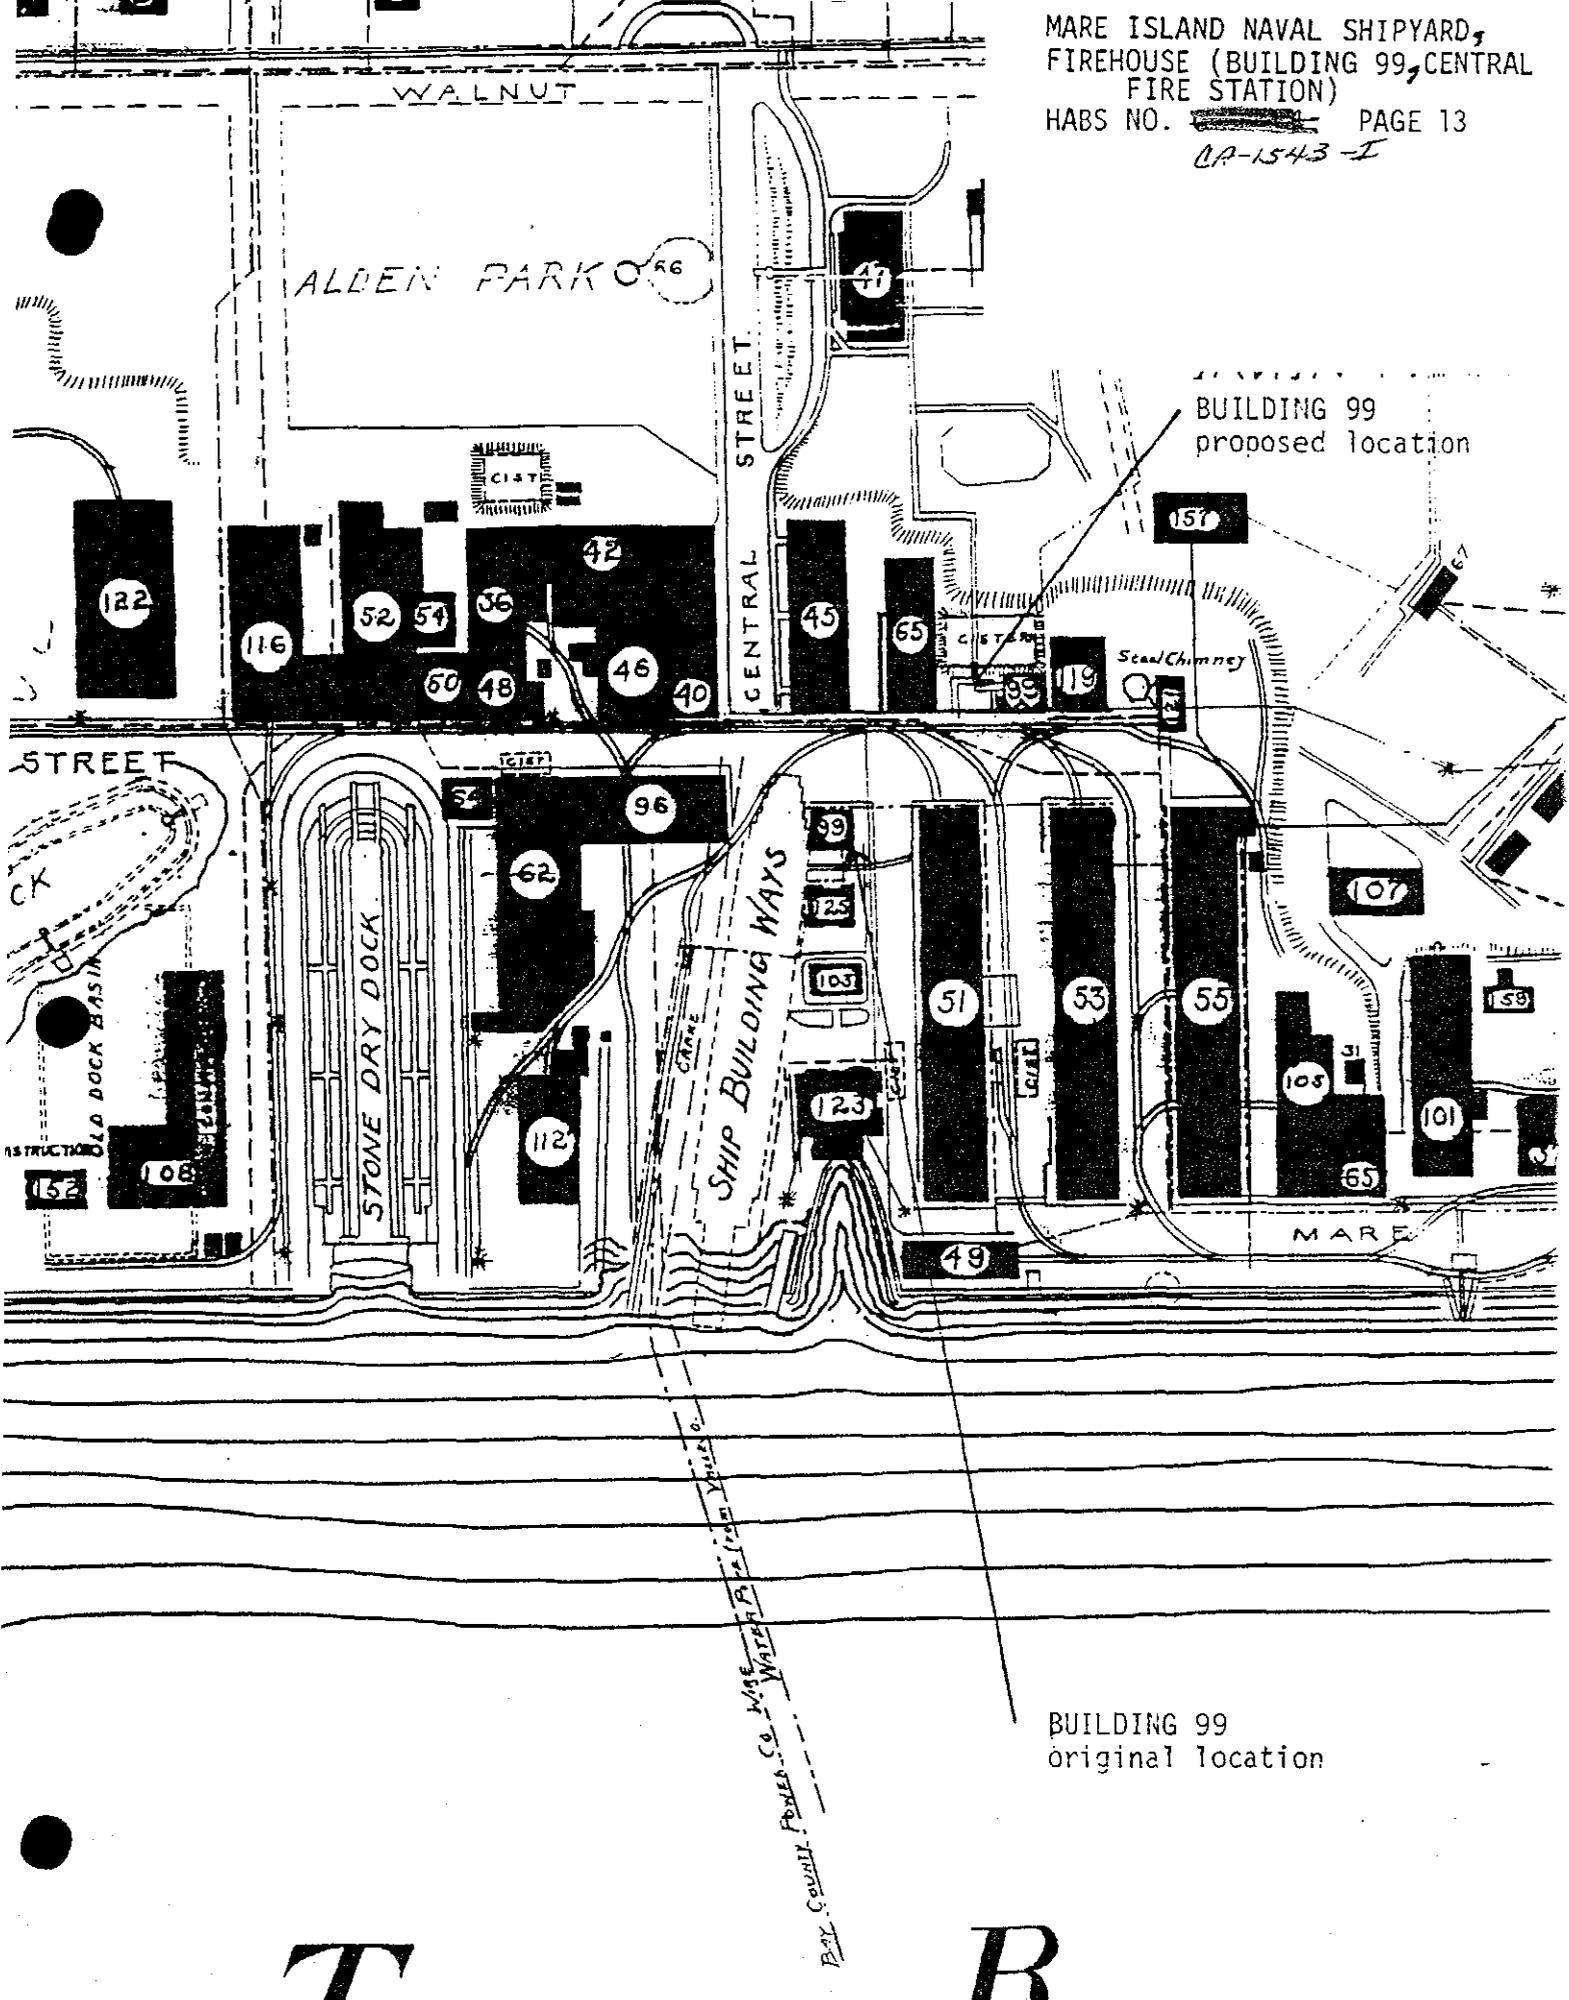
PLAN OF  
U.S. NAVY YARD  
MARE ISLAND

BUILDING 99  
proposed location

BUILDING 99  
original location

CALIFORNIA  
JULY 1948  
DESIGNED BY THE ARCHITECTS  
AND ENGINEERS  
OF THE U.S. NAVY

Statement of  
Significance: Building 99 was constructed in 1900 on the northeast corner  
of California Avenue and Central Street, was moved in 1916  
to its present location to allow extension of ship Building  
Ways No. 1 for construction of the battleship USS CALIFORNIA.  
This structure was the first building constructed on Mare  
Island utilizing steel frame construction and was also one  
of the first buildings constructed by Commander R. C.  
Hollyday, Civil Engineering Corps, United States Navy, after  
the earthquake of 1898, as part of the general reconstruction  
of the Yard. Its brick arch forms make reference to earlier  
masonry construction of a classical revival style. It is  
considered a contributing element of the Mare Island Naval  
Shipyard National Historic Landmark.

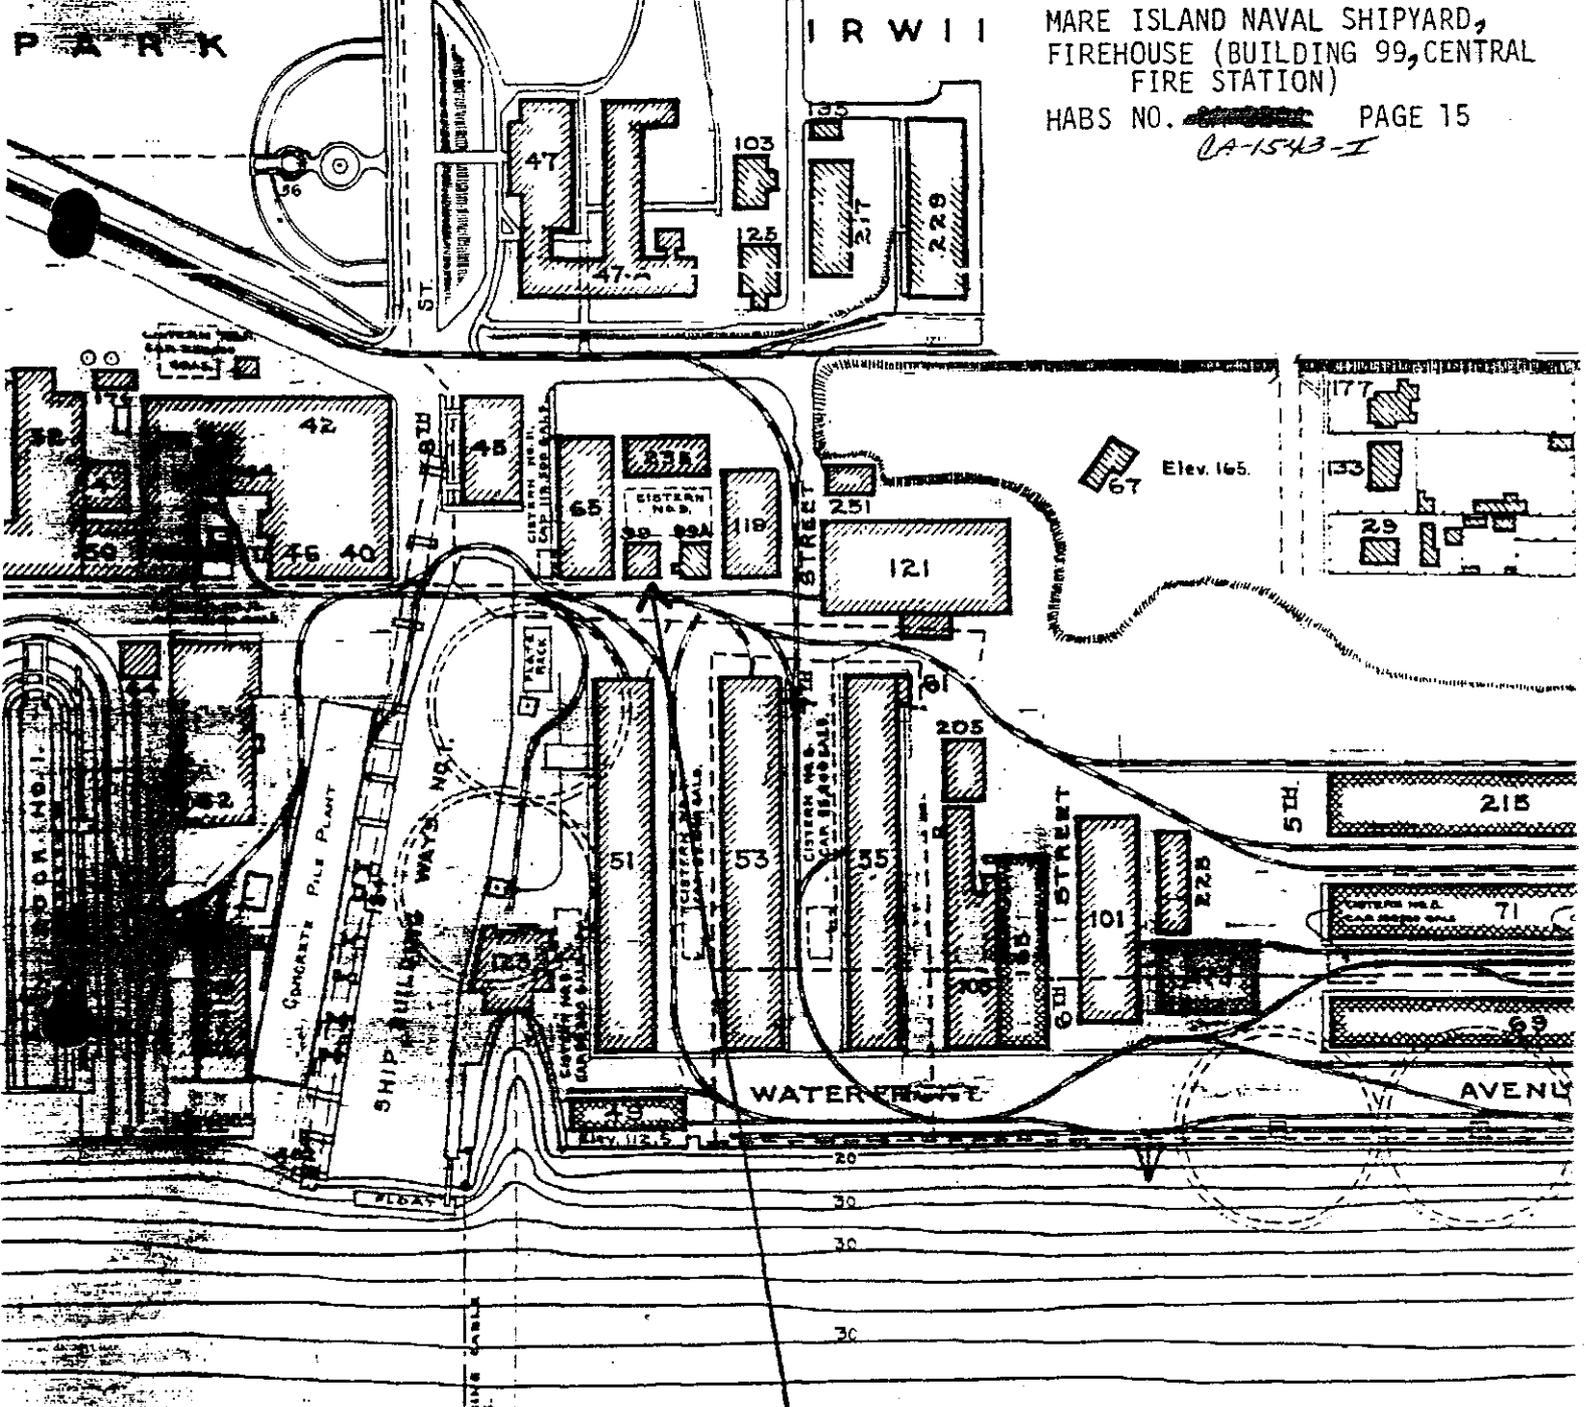
BUILDING 99 AFTER RELOCATION
