NORWICH WATER POWER COMPANY, DAM
(Norwich Water Power Company,
Greeneville Dam)
West bank of Shetucket River
approximately opposite Fourteenth Street
Greeneville section
Norwich
New London County
Connecticut

HAER No. CT-147-A

NORWICH WATER POWER COMPANY, DAM
(Norwich Water Power Company, Greeneville Dam)

Present Use: Raising and impounding water for power
canal

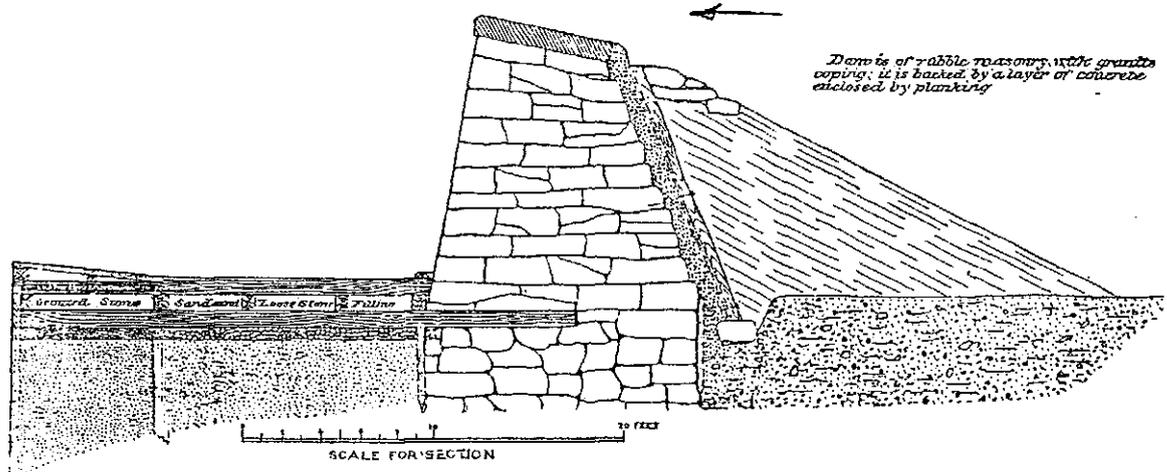
Section of dam as built in 1882, from W. P. Trowbridge (comp.), Reports on the Water-Power of the United States (1885)

In 1915 the timbers of the 1886 crib were found to be deteriorated and so the top seven or eight courses were reconstructed, including the downstream facing and aprons on both the timber-crib and masonry portions. The upstream face was also re-planked and a higher level of fill established

Although the apron was wide, thick, and well-constructed, it was severely damaged during a flood in 1886 when debris cresting over the dam crashed into the apron and smashed holes in the planking. As the water continued pouring over the dam, it excavated a progressively larger void underneath the apron and the dam itself, resulting in its collapse. It is not surprising, then, that the rebuilt structure used a much more inclined downstream face, thereby addressing the erosion problem with both an improved profile and a stepped apron to absorb whatever vertical impact remained. (A similarly sloped downstream crib had been added to the Holyoke, Massachusetts, dam in 1870; however, without the horizontal apron, the erosion of the river bed, though reduced in intensity, continued at the base of the Holyoke dam's new crib.) The 1886 construction at Greeneville, therefore, can be seen as a continuation of the
