GORGAS HOSPITAL, SECTIONS A AND B
(Gorgas Hospital, Buildings 255 and 253)
Culebra Road
Balboa Heights Vicinity
Former Panama Canal Zone
Republic of Panama

HABS No. CZ-11-E

GORGAS HOSPITAL, SECTIONS A AND B
(Gorgas Hospital, Buildings 255 and 253)

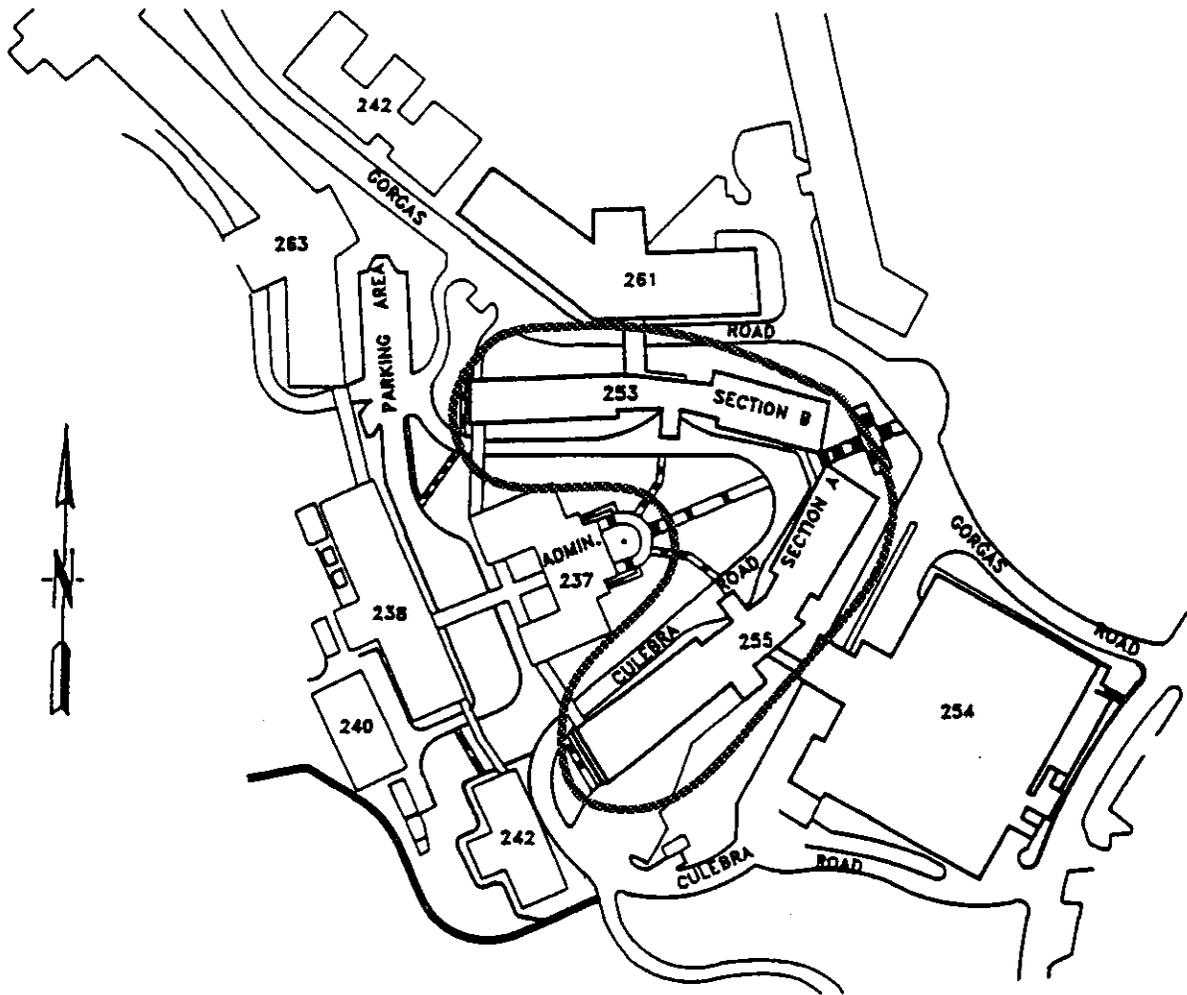
Figure 1 Map, 1996 (original located at Real Property Office, Corozal).
Mapmaker unknown.
GORGAS ARMY HOSPITAL COMPLEX

Section A (Building 255) faces north while Section B (Building 253) faces south. The buildings are angled and uniquely sited joining the central Administration and Clinics Building in a triangular formation. Both front elevations face Culebra Road. Diagonal parking is allowed by the main entries and curbside parking is afforded along both sides of Culebra Road which winds through the courtyard created by Sections A and B and the Administration and Clinics Building. Section A's rear elevation is skirted by a parking lot and the covered tunnel that connects Section A to
