ST. ELIZABETHS HOSPITAL, DETACHED DINING HALL
(Building No. 33)
544-560 Redwood Drive, Southeast
Washington
District of Columbia

HABS DC-349-AQ
HABS DC-349-AQ

ST. ELIZABETHS HOSPITAL, DETACHED DINING HALL (BUILDING 33)

HABS NO. DC-349-AQ

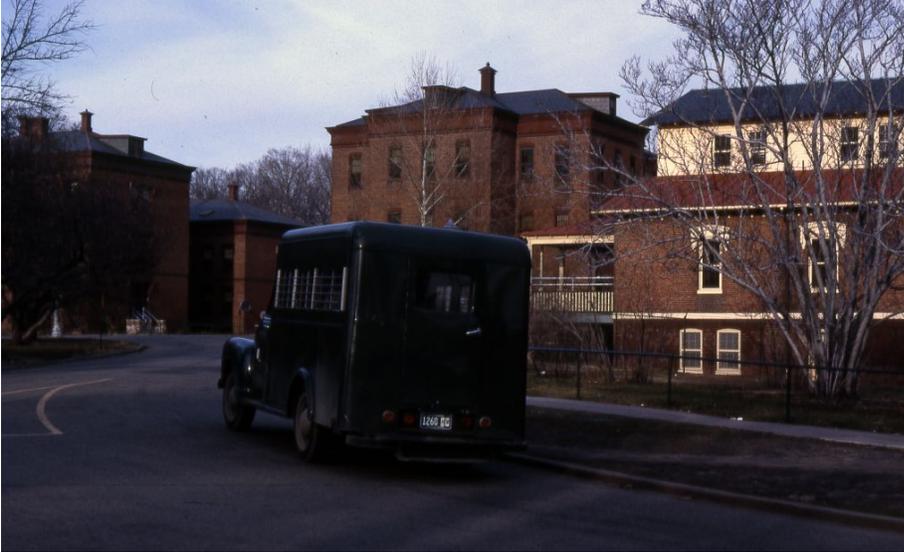
Figure 1. View of the Detached Dining Hall and Atkins Hall, 1964. Source: GSA archives, image DC1472SE0P087.

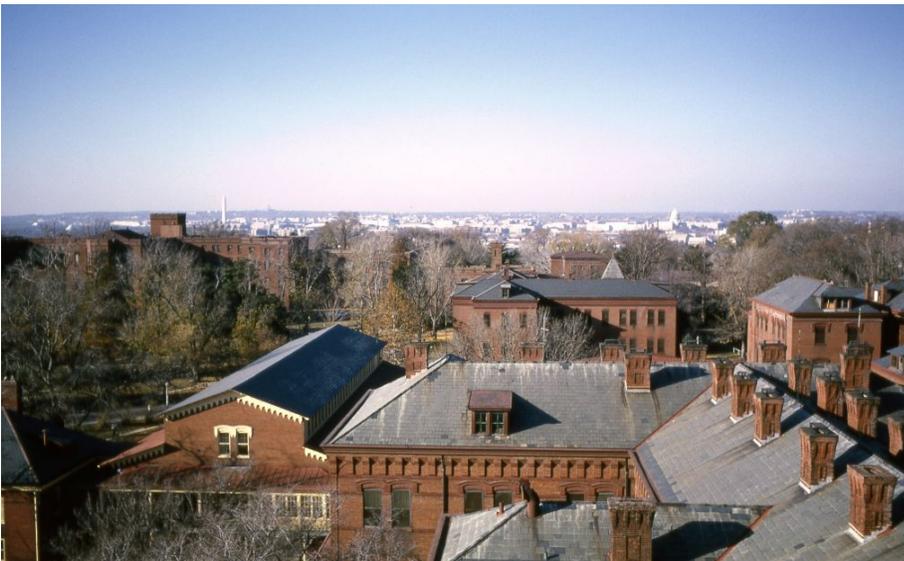
Figure 2. Aerial view of the Detached Dining Room, 1964. Source: GSA archives, image DC1472SE0P100.

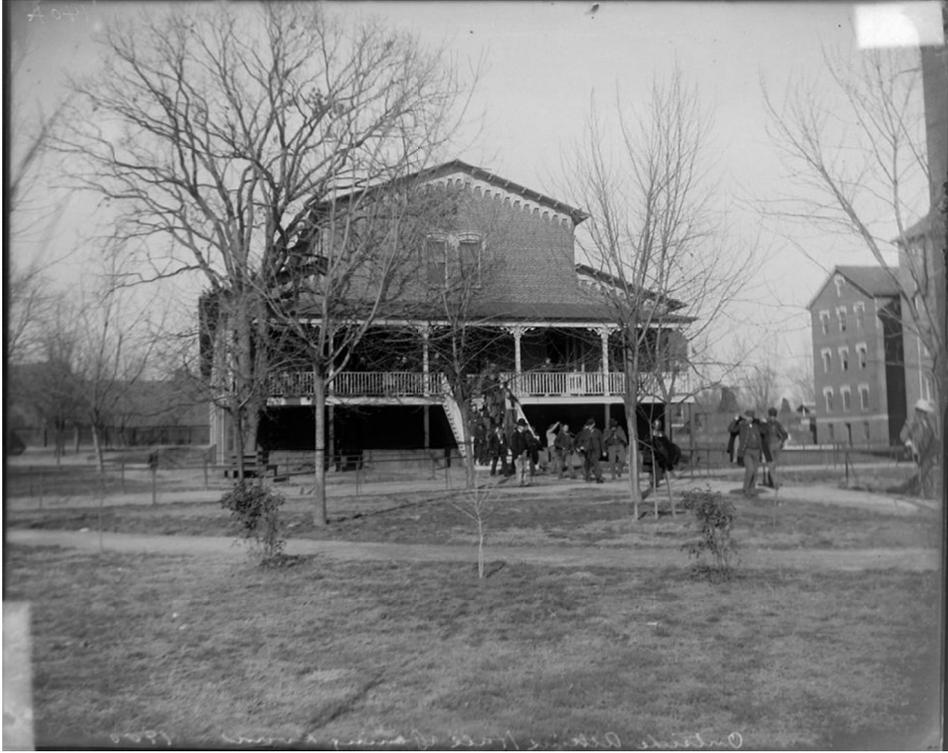
Figure 3. View from south of south elevation of Detached Dining Hall, circa 1900. Source: GSA archives, image DC1452SE0P009.

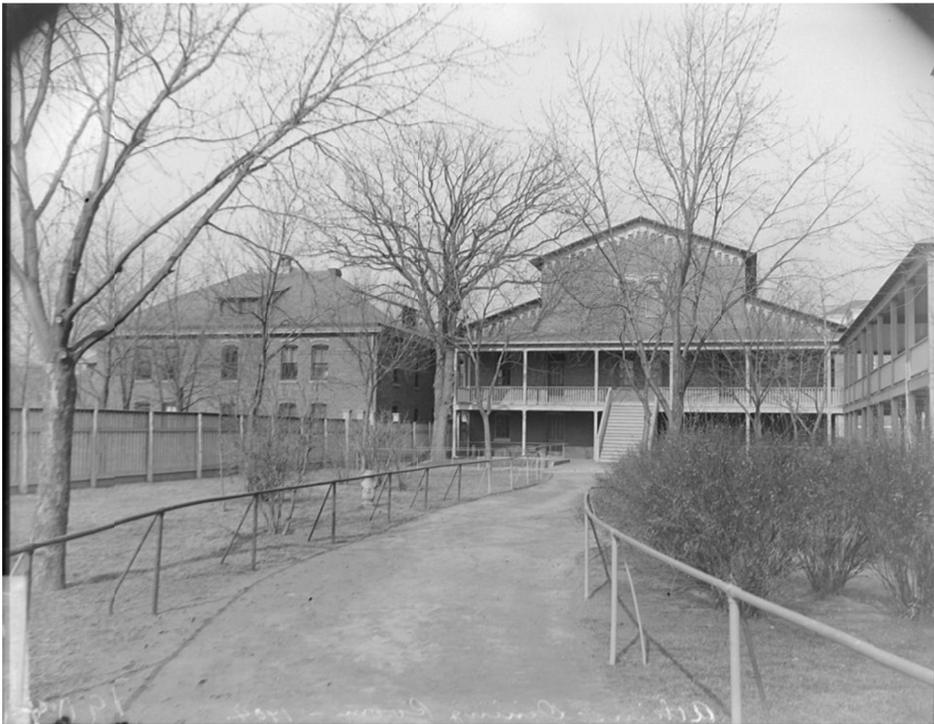
Figure 4. View from south of south elevation, circa 1904. Source: GSA archives, image DC1452SE0P006.

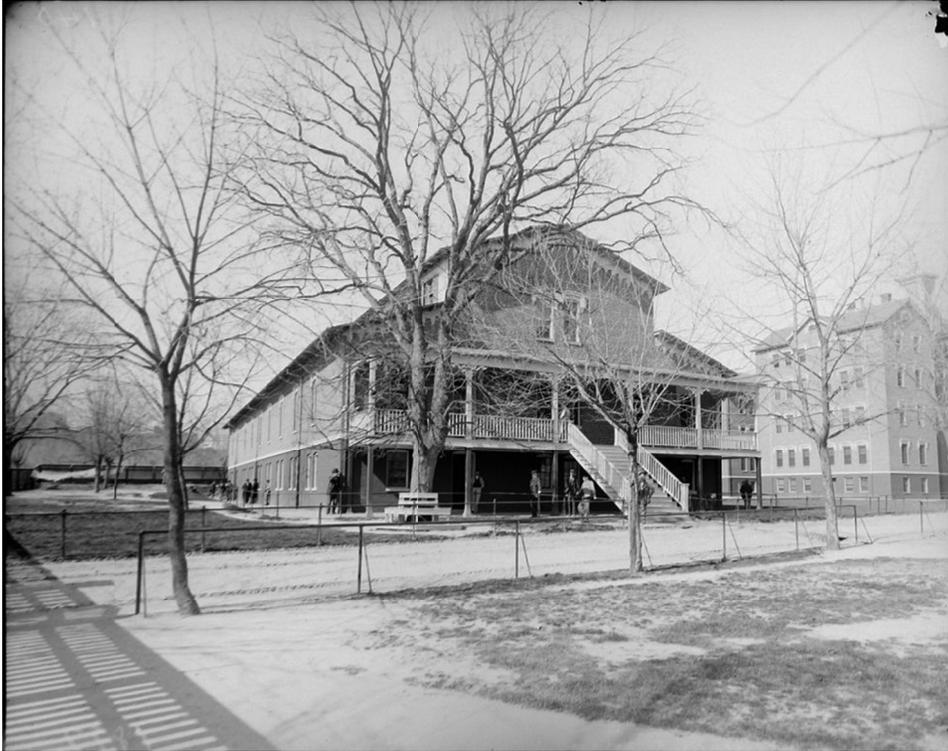
Figure 5. View from southwest of south elevation, circa 1897. Source: GSA archives, image DC1452SE0P007.

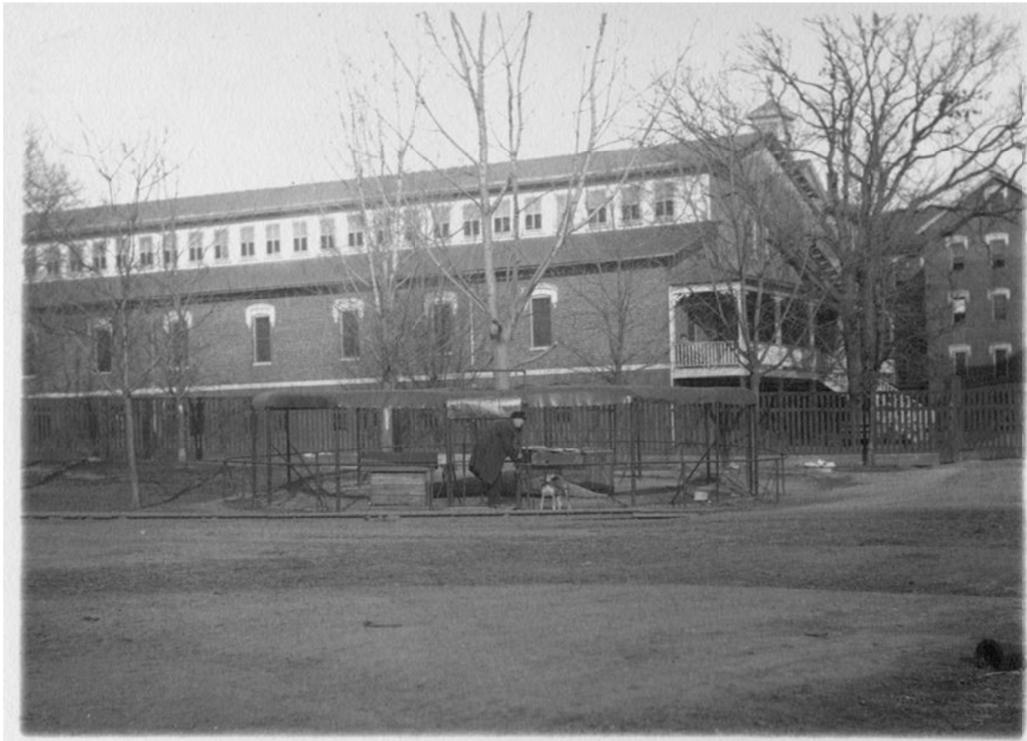
Figure 6. View from west of west elevation, circa 1897. Source: GSA archives, image DC1452SE0P011.

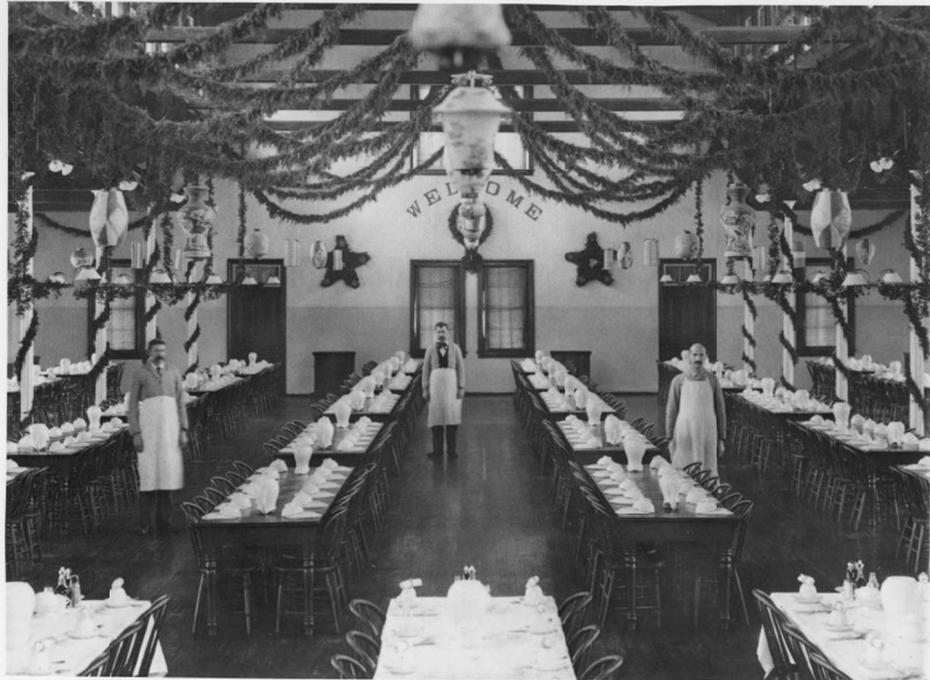
Figure 7. View of Detached Dining Hall first floor interior looking south, circa 1889. Source: GSA archives, image DC1452SE0P001.

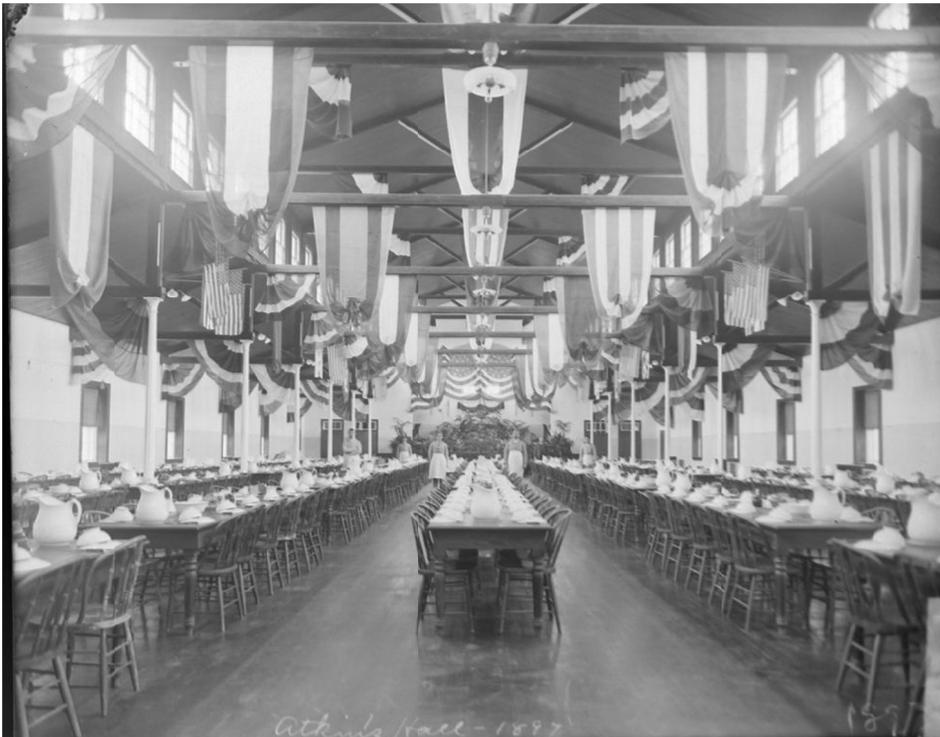
Figure 8. View of interior dining hall looking north, circa 1897. Source: GSA archives, image DC1452SE0P003.

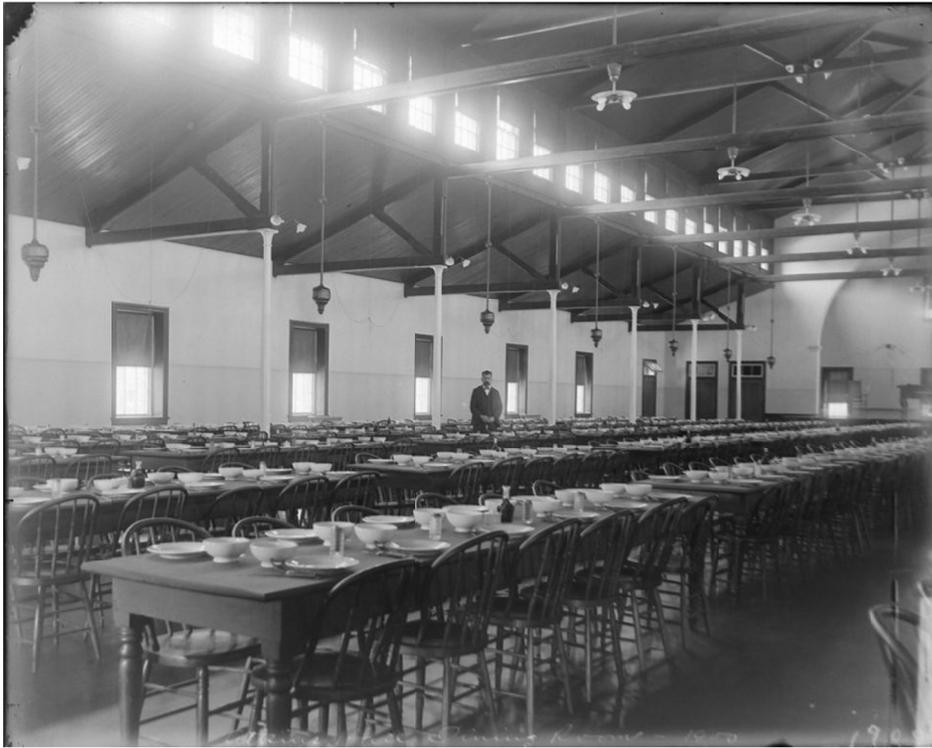
Figure 9. View of interior dining hall looking northwest, circa 1900. Source: GSA archives, image DC1452SE0P004.

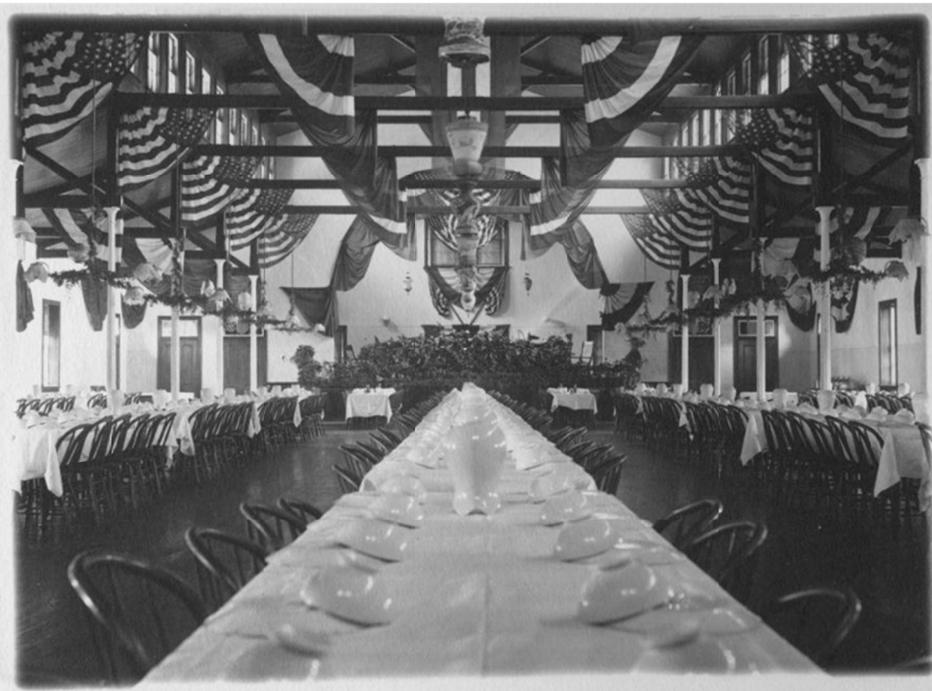
Figure 10. View of interior dining hall, looking north, circa 1897. Source: GSA archives, image DC1452SE0P010.

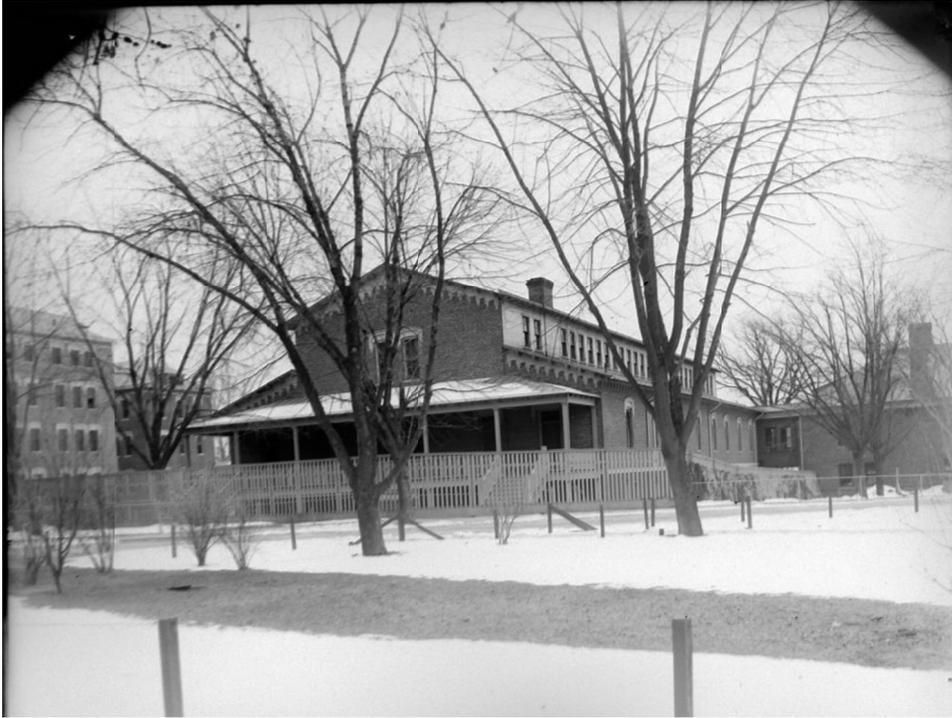
Figure 11. View from the northwest of the north elevation of Detached Dining Hall, 1912. Source: GSA archives, image DC1452SE0P008.

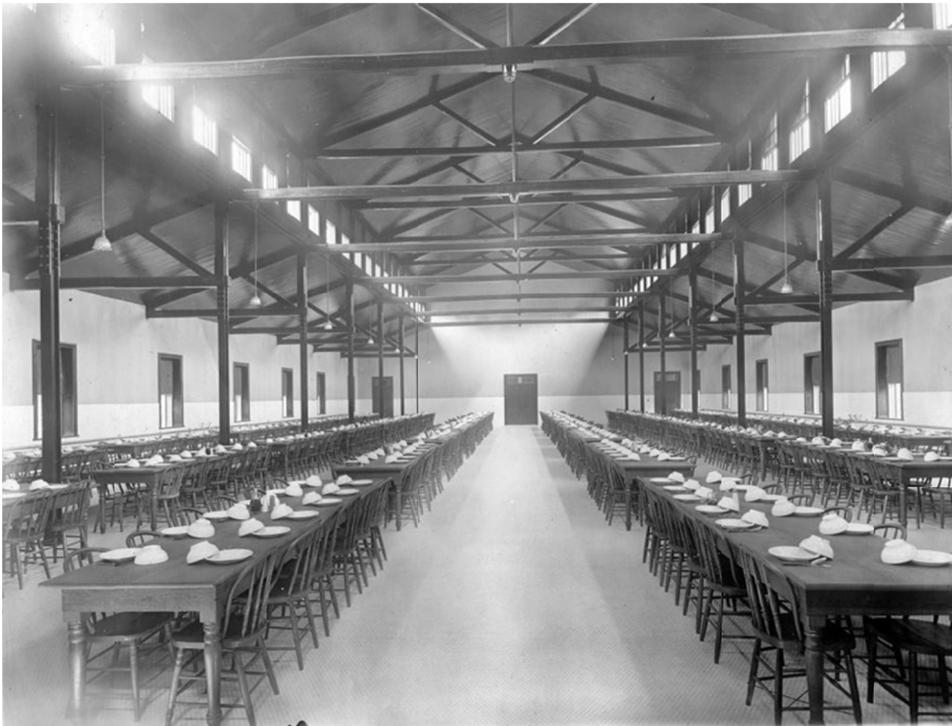
Figure 12. View of renovated dining hall looking north, circa 1915. Source: GSA archives, image DC1452SE0P012.

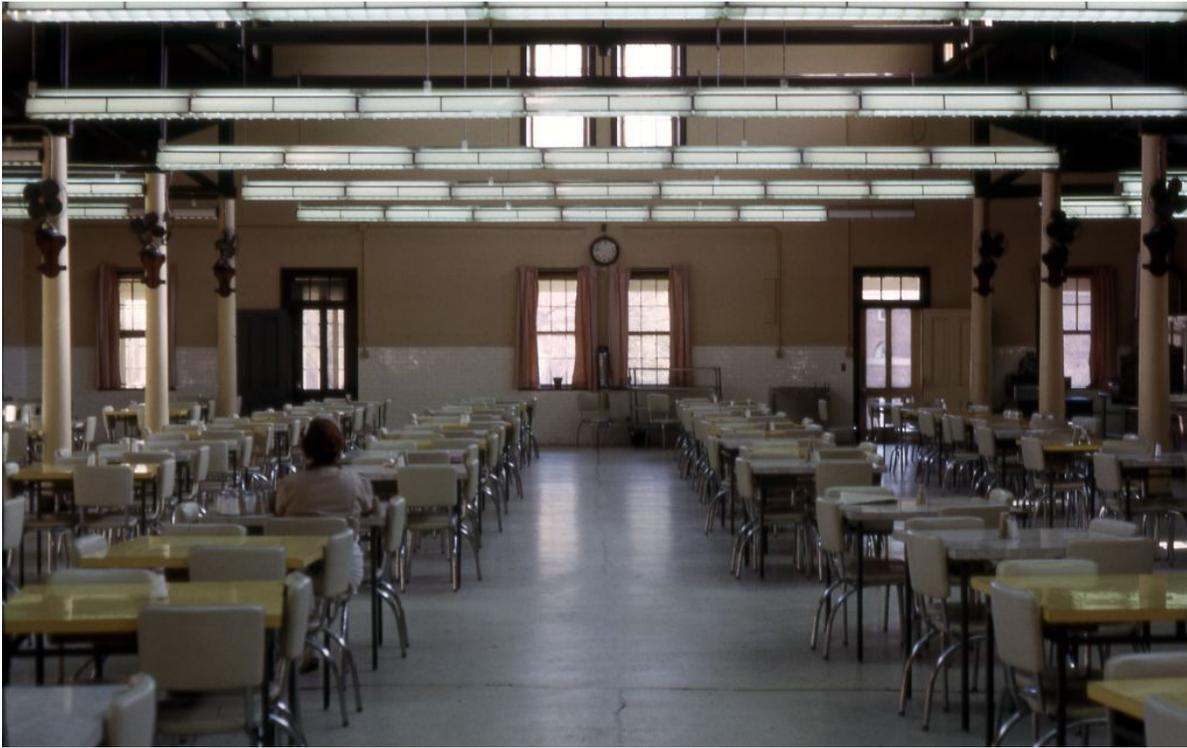
Figure 13. View of interior dining hall looking south, 1964. Source: GSA archives, image DC1452SE0P014.

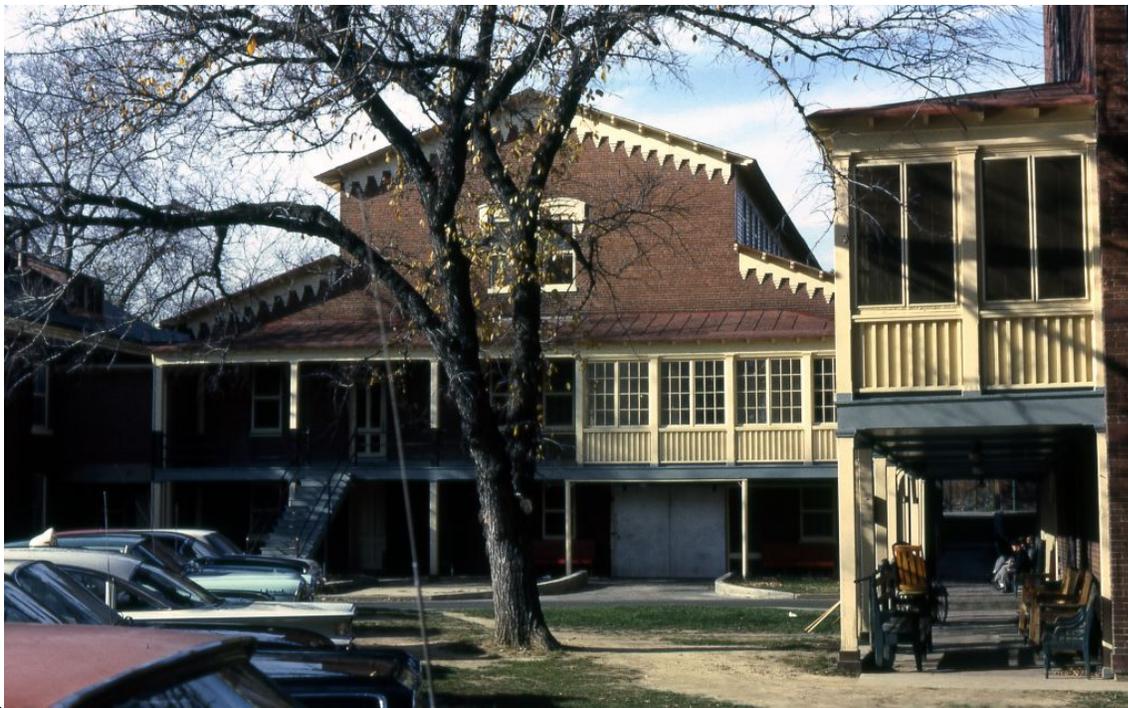
Figure 14. View from south of south elevation of Detached Dining Hall, 1964. The porch of the Home Building is in the foreground at right. Source: GSA archives, image DC1452SE0P013.

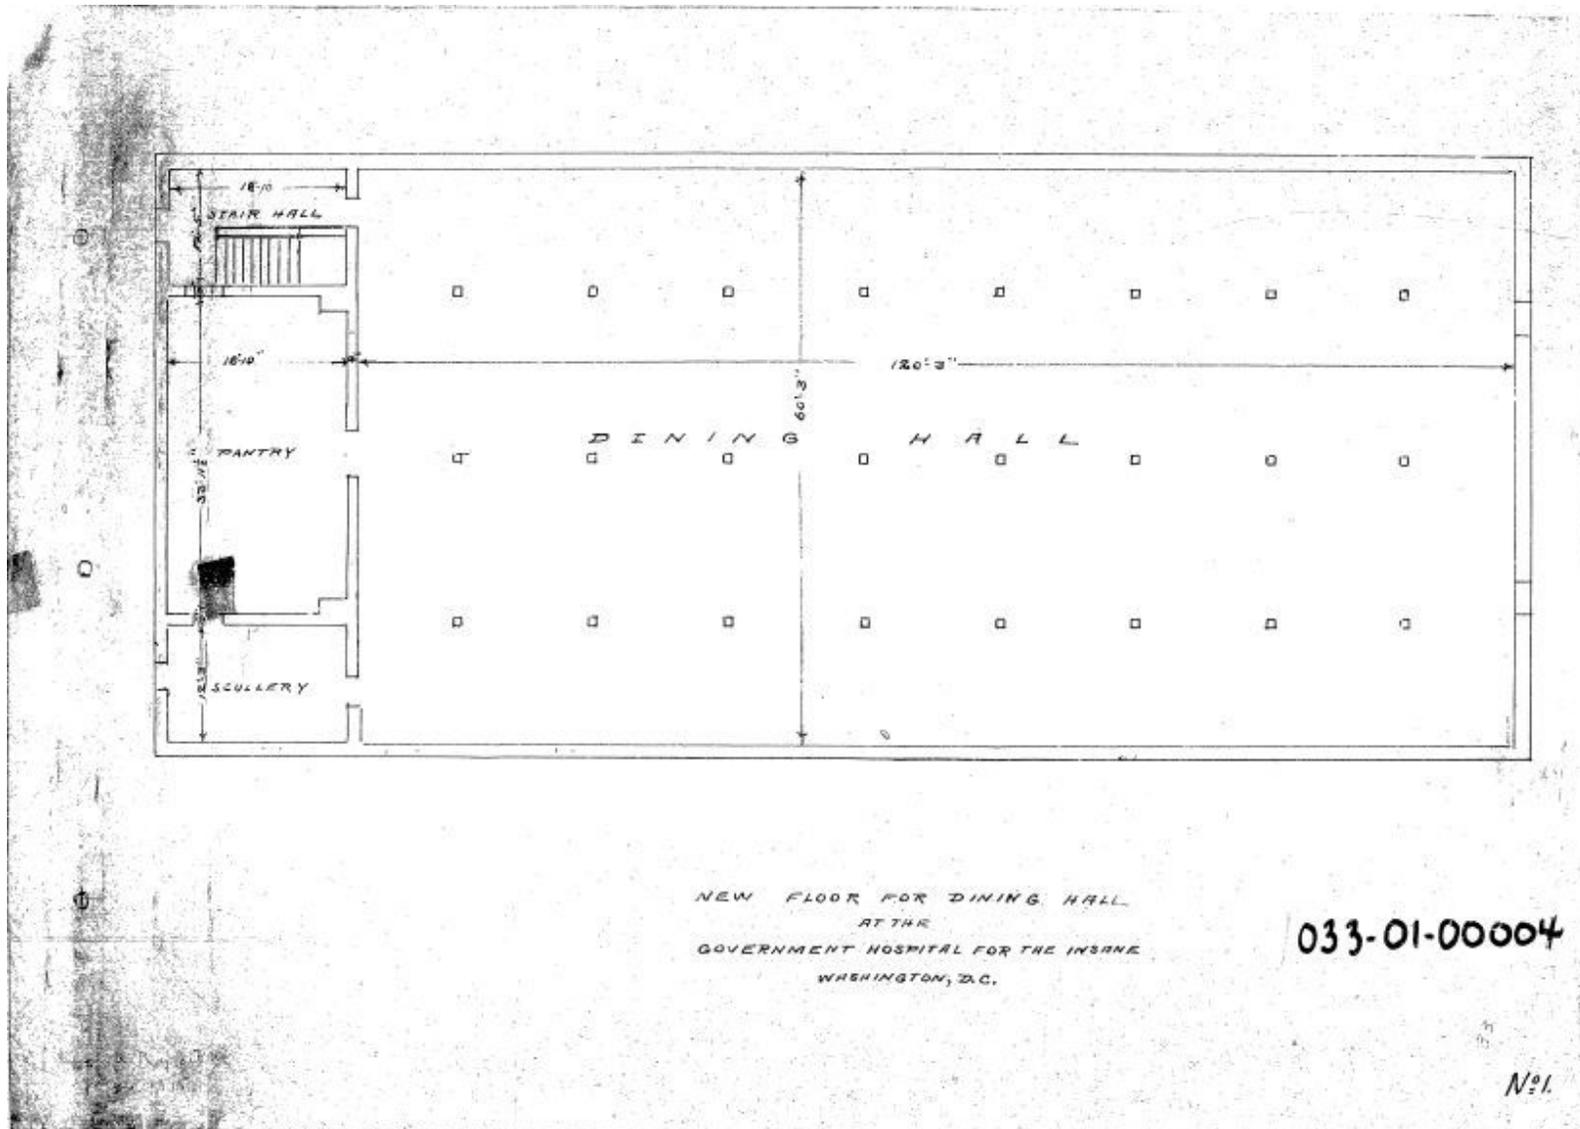
Figure 15. 1915 construction documents showing alterations to Dining Hall. Source: GSA archives, image DC1452SE0102.

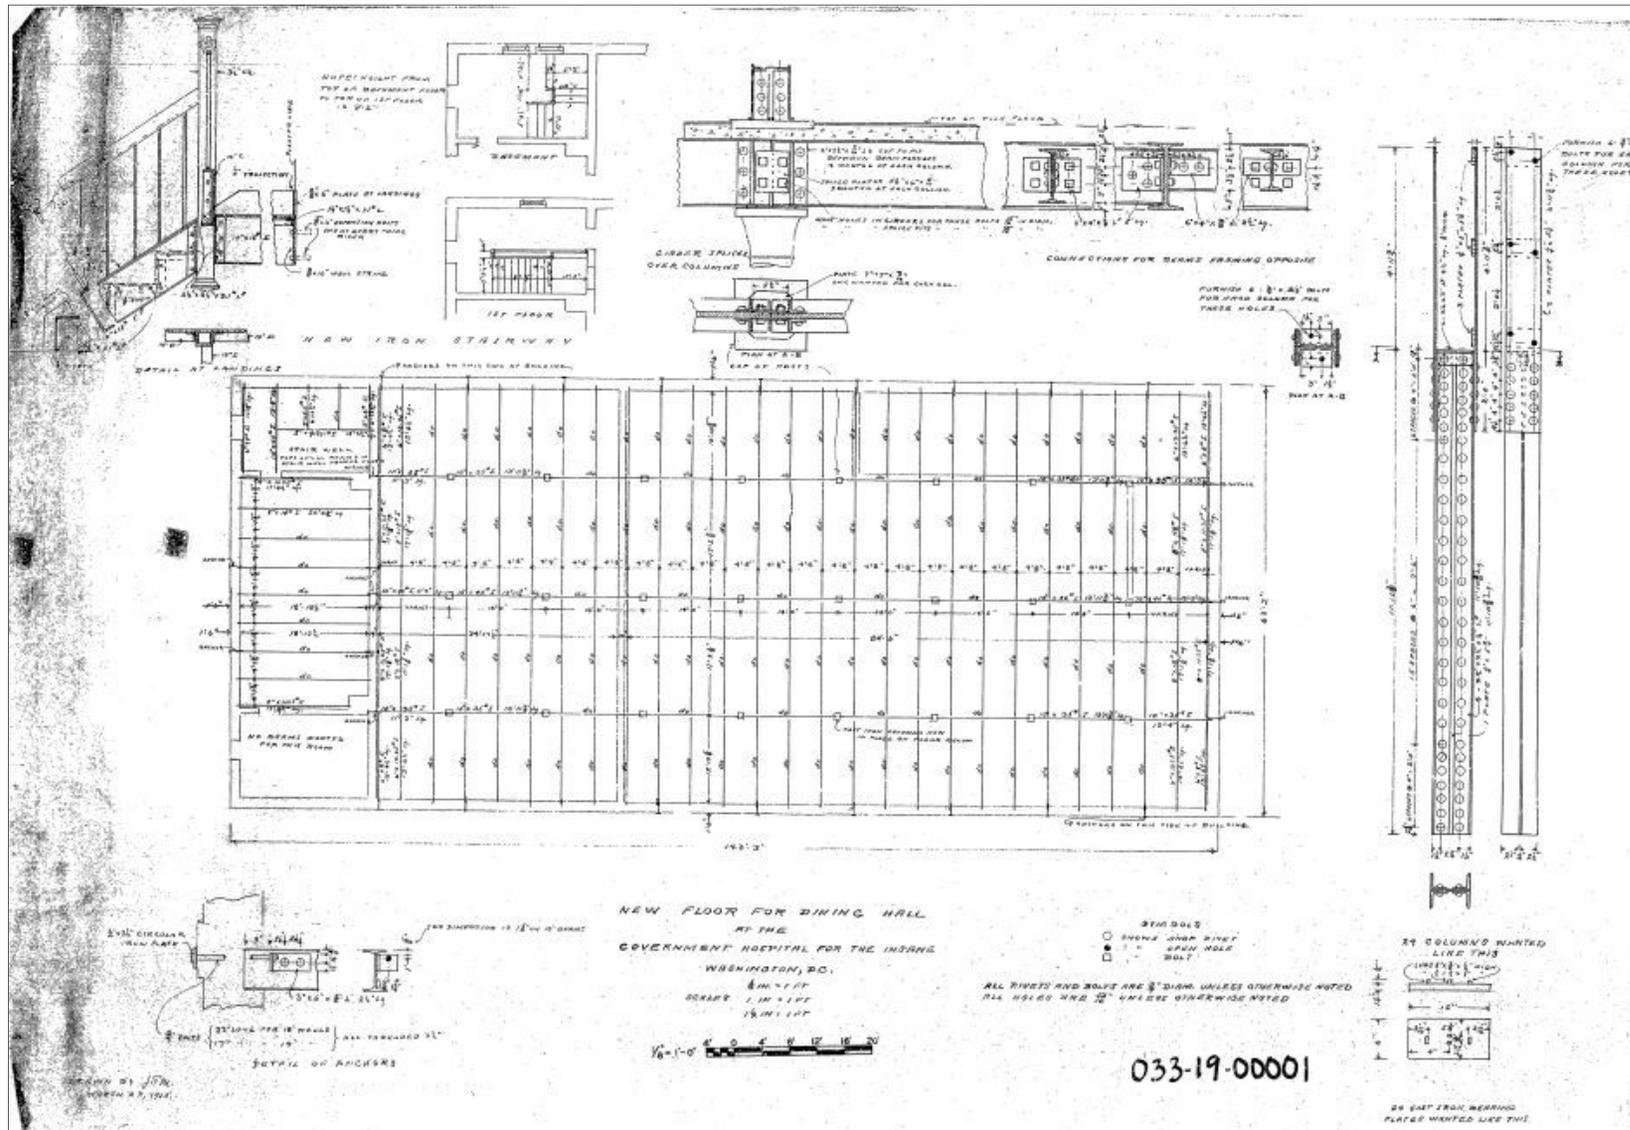
Figure 16. 1915 construction documents outlining alterations to Dining Hall, including new first floor framing. Source: GSA archives, image DC1452SE0103.
