ST. ELIZABETHS HOSPITAL, POWER HOUSE
(Building Nos. 56 and 57)
2700 Martin Luther King Jr. Avenue, Southeast, Ash Street, Southeast
Washington
District of Columbia

ST. ELIZABETHS HOSPITAL, POWER HOUSE (BUILDING 56/57)

HABS NO. DC-349-BN

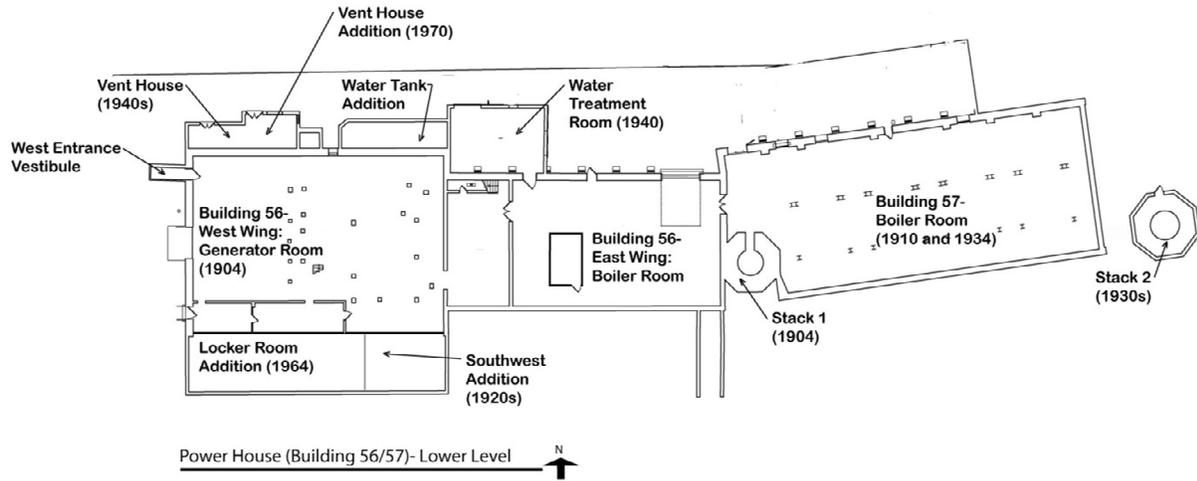
Figure 1. Key Plan of lower level of Power House.

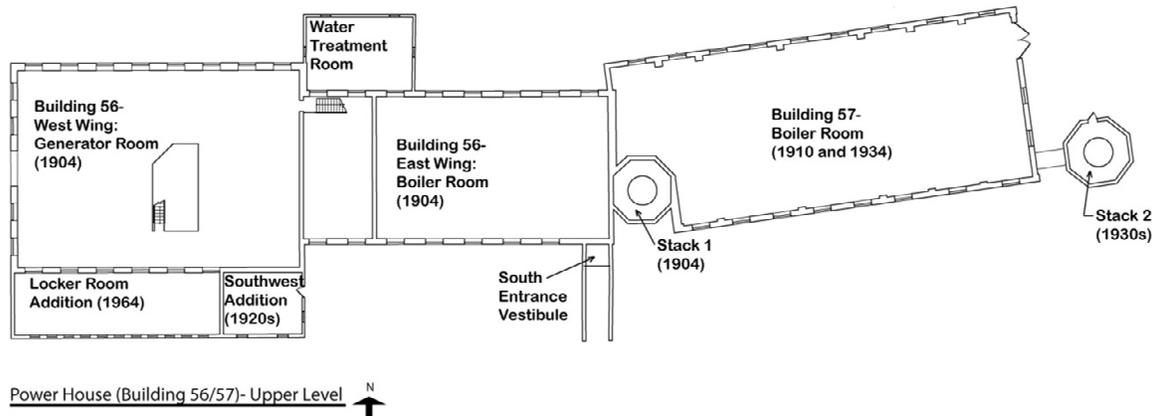
Figure 2. Key Plan of upper level of Power House.

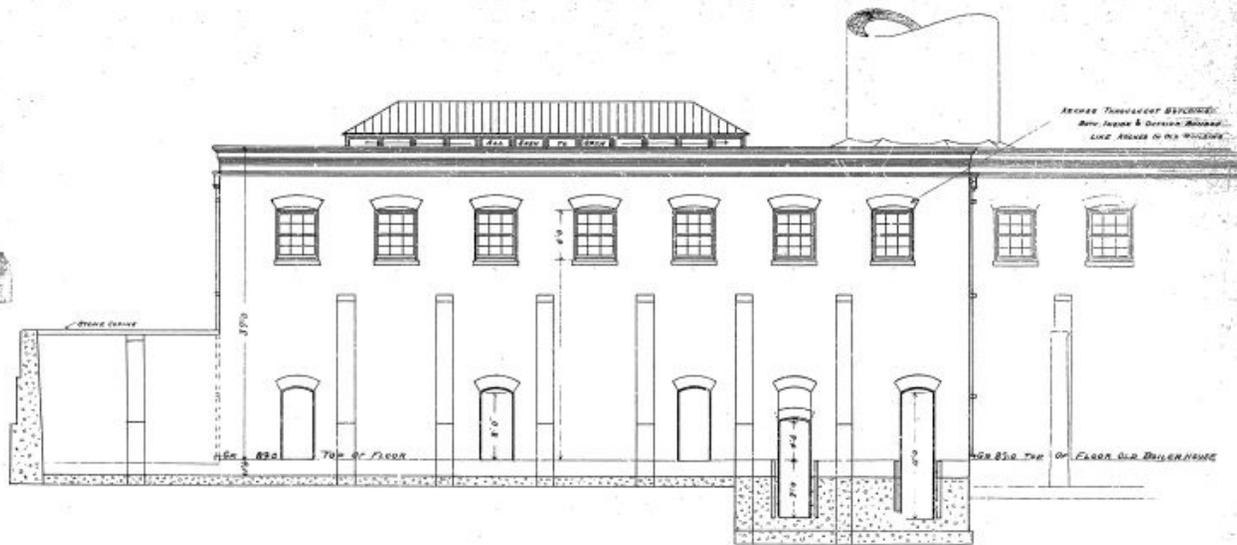
Figure 16. Source: GSA archives, image DC0100SE0105.

NORTH WEST ELEVATION
SCALE 1/8" = 1'-0"

ADDITION TO BOILER HOUSE
FOR THE
GOVERNMENT HOSPITAL
FOR THE INSANE
WASHINGTON, D.C.

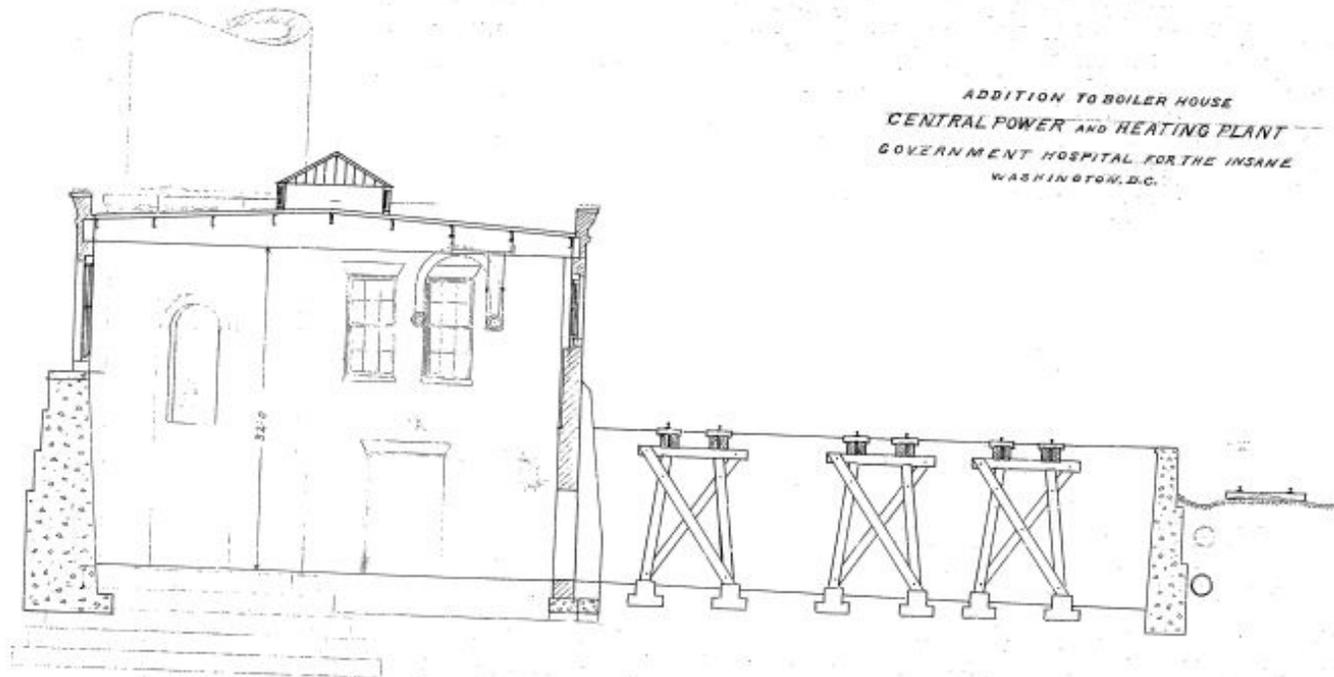
Figure 17. Source: GSA archives, image DC0100SE0106.

ADDITION TO BOILER HOUSE
CENTRAL POWER AND HEATING PLANT
GOVERNMENT HOSPITAL FOR THE INSANE
WASHINGTON, D.C.

SECTION ON LINE A-B
SCALE 1/8" = 1'-0"

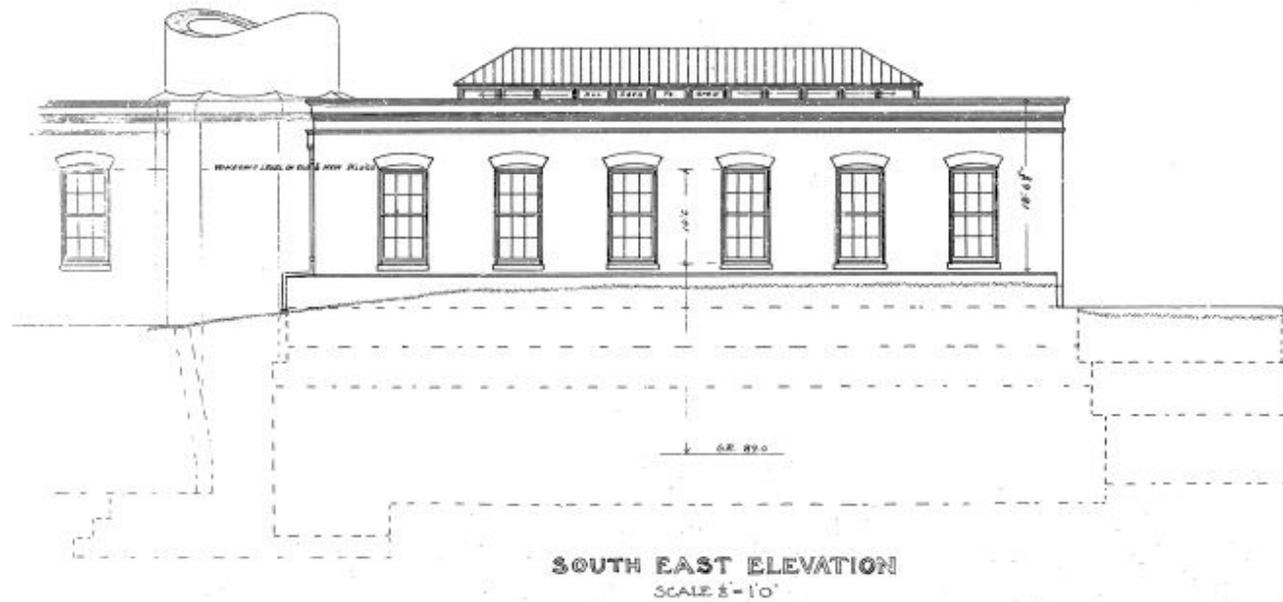
Figure 21. Source: GSA archives, image DC0100SE0110.

ADDITION TO BOILER HOUSE
FOR THE
GOVERNMENT HOSPITAL
FOR THE INSANE
WASHINGTON, D.C.
