U.S. NAVAL AIR STATION, SHOPFITTER & BLACKSMITH
SHOP
(Building No. 44)
Pensacola
Escambia County
Florida

U.S. NAVAL AIR STATION, *Shopfitter + Blacksmith Shop*
(BUILDING NO. 44)

HABS No. FL-370

Statement of
Significance: Building 44, a metal framed shopfitter and
blacksmith shop, was built in 1907, and
though of no special architectural signifi-
cance, became the first Seaplane Erecting
Shop following the establishment of Pensa-
cola Naval Aeronautic Station January 20,
1914.

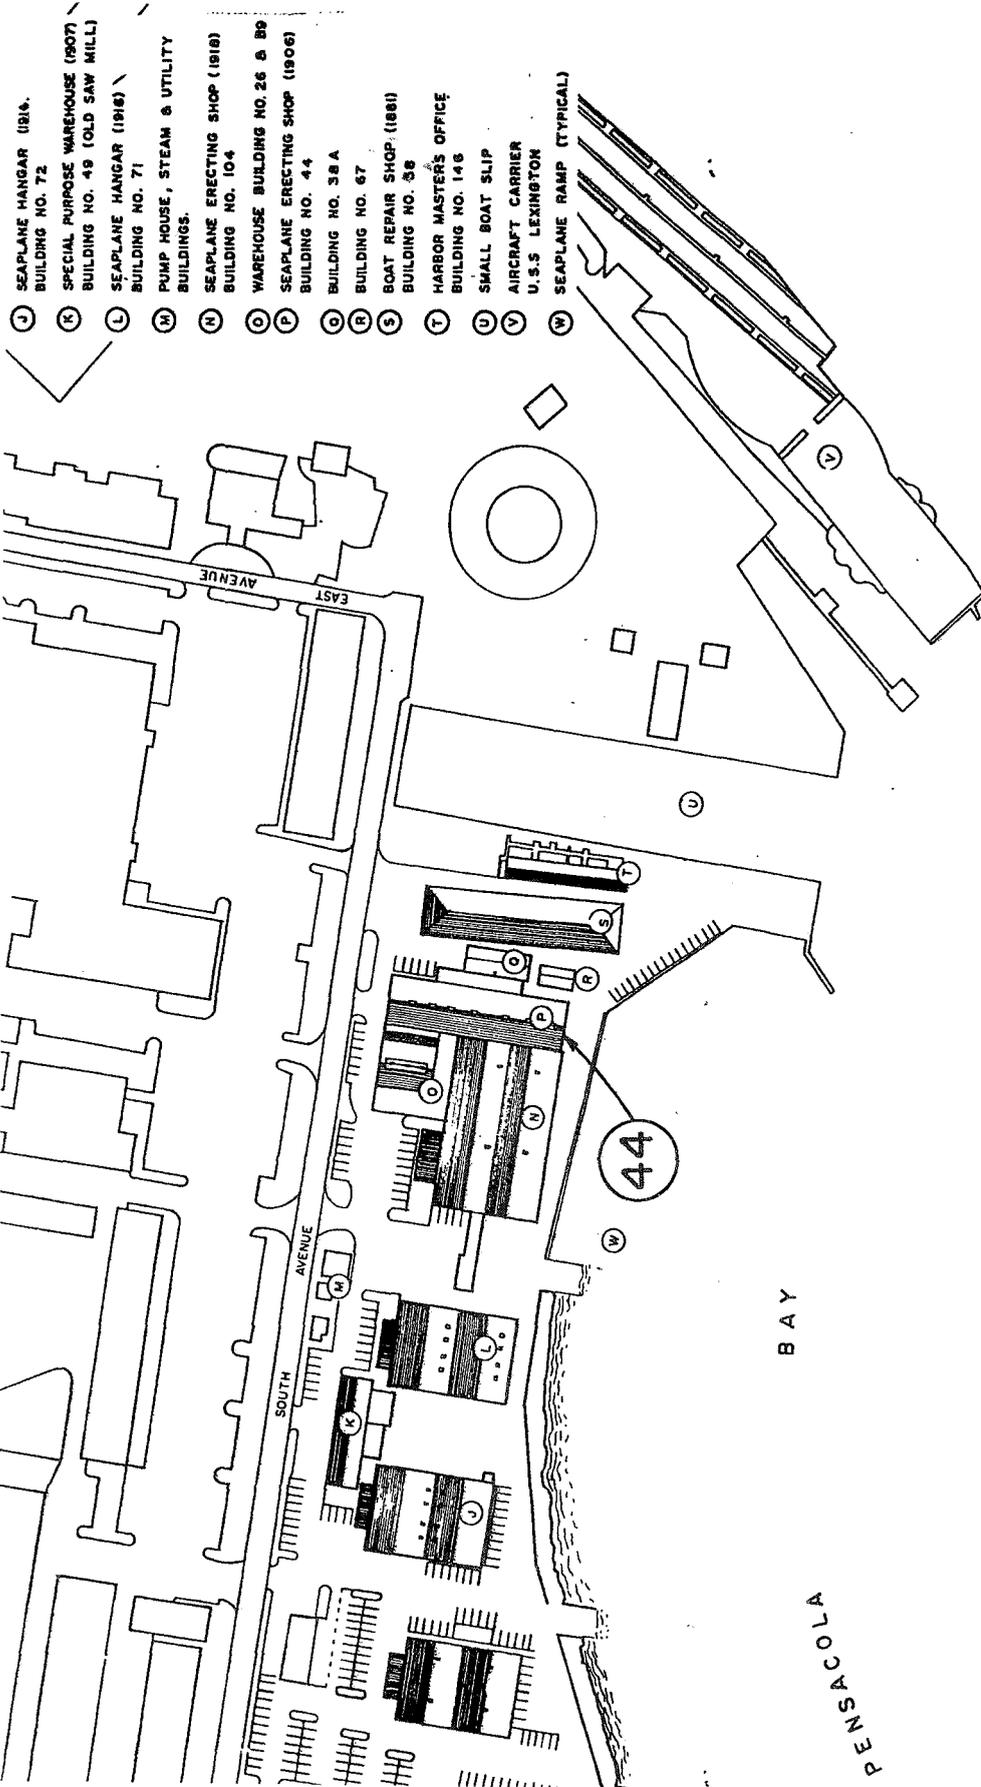
SITE PLAN

U. S. NAVAL AIR STATION
SEAPLANE ERECTING SHOP
BUILDING NUMBER 44 (1907)
