U.S. NAVAL AIR STATION, SEAPLANE HANGAR
(Gymnasium)
(Building No. 74)
521 South Avenue
Pensacola
Escambia County
Florida

HISTORIC AMERICAN BUILDINGS SURVEY

U.S. NAVAL AIR STATION, SEAPLANE HANGAR

HABS No. FL-513

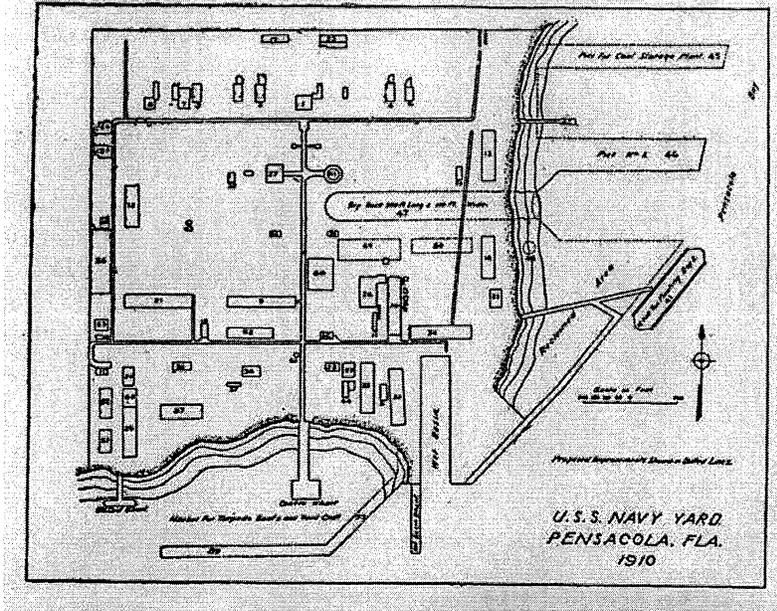
Figures 2 and 3. Hand-drawn plan and index showing the state of the Pensacola Navy Yard in 1910, one year before it was officially closed. (Map and index courtesy of the Public Works Center, NAS Pensacola, Florida).

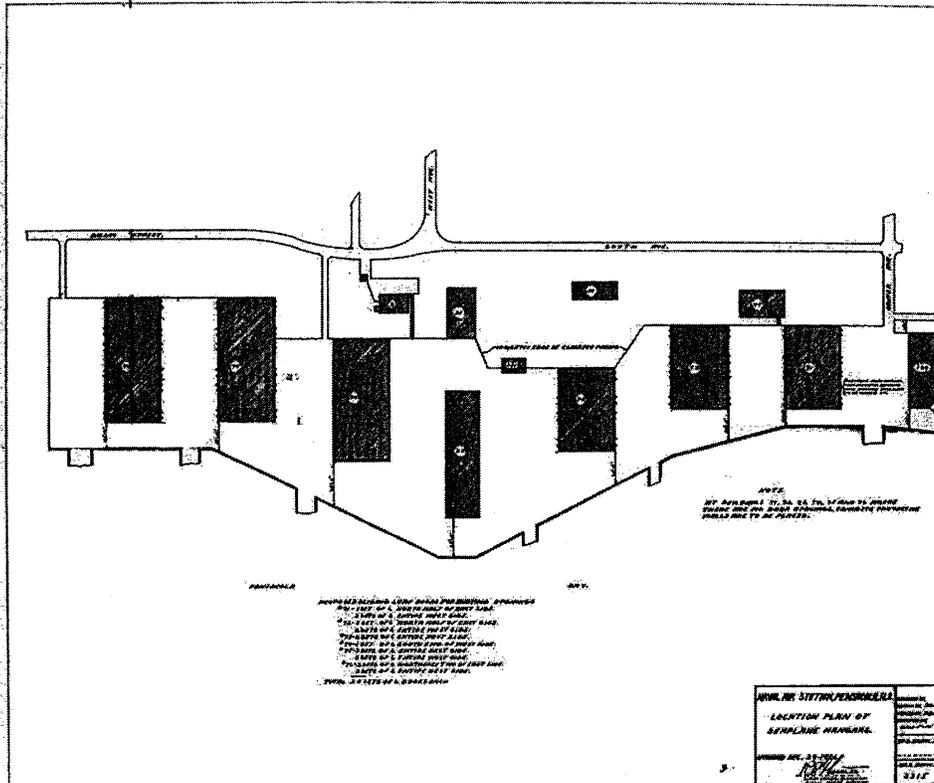
Figure 6. Location plan of seaplane [sic] hangars, dated December 29, 1926. (Original Architectural Plan courtesy of National Archives, NARA, College Park, Maryland).

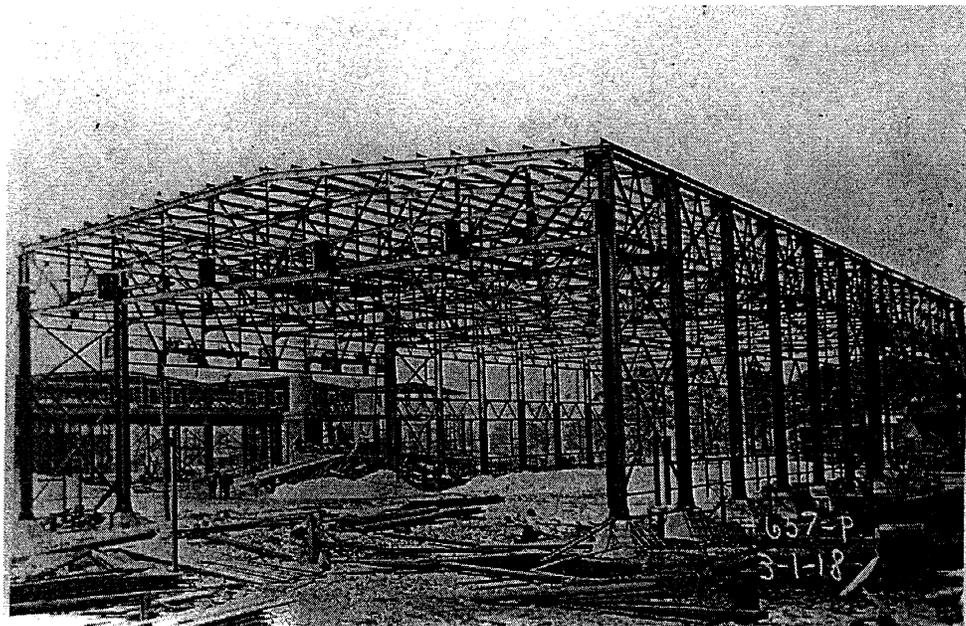
Hangar No 74. Looking N.W. Contract No 2357.

Figure 7. Photograph of Building No. 74 following completion of the steel frame and state-of-the-art trusses, dated March 1, 1918 (Photo courtesy of Still Pictures Unit, National Archives, College Park, Maryland.)

Constructed as a seaplane hangar, Building No. 74 supported NAS Pensacola's primary mission of naval aviation training through both World Wars. It is located along the western edge of the south waterfront, adjacent to two other seaplane hangars (Building Nos. 75 and 76) and four concrete ramps (Building Nos. 167, 168, 169, and 170). BuDocks supplied the architectural plans for Building No. 74.⁷⁵ Unlike many hangars constructed during this period, the structures at NAS Pensacola did not follow the standard seaplane hangar military form; they differed in size, building footprint, truss system, roof type, and were of permanent construction. BuDocks's standardized hangar, referred to as the Coastal Air Station Seaplane Hangar, was considered a portable, temporary building. It "measured 112' x 75' x 24', and also featured steel truss construction in a distinctive gambrel profile."⁷⁶ Another common hangar type of this period was the Foot Timber Seaplane Hangar, which was constructed entirely of wood.⁷⁷ The six seaplane hangars constructed at NAS Pensacola, including Building No. 74, were not like the others of this period (*Figure 7*), making the World War I-era hangars at NAS Pensacola unique.

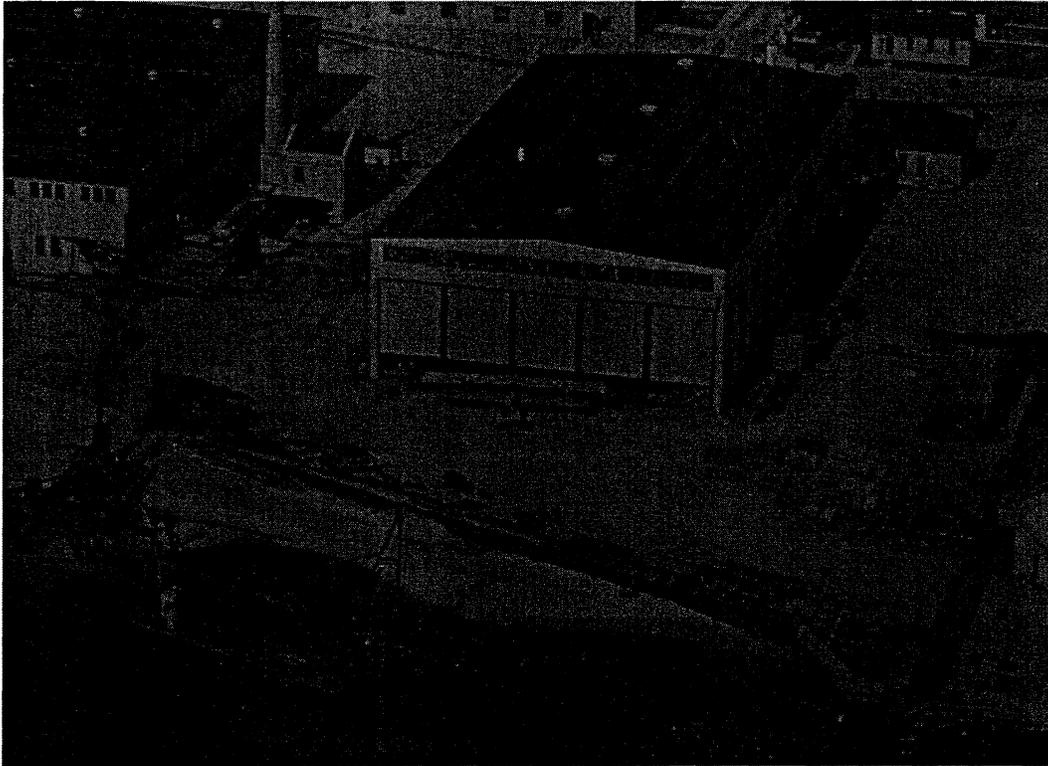
Figure 8. Building No. 74 prior to major renovations of the south facade, dated 1922. (Photo courtesy of the Naval Aviation Museum, NAS Pensacola, Florida).

Henry Monk, contractor, began construction of Building No. 74 on January 4, 1918, and completed the job within the year.⁷⁸ Building No. 74 differed from the other hangars at the base in that it was larger, taller, and the roof was single-gabled as compared to the triple-gabled roofs of the other five hangars (*Figure 8*). The steel structural support system of the approximately 220' x 103' hangar featured closed flat Pratt trusses, which was an early application of this truss system and was not seen at any other hangars constructed by the Navy during the World War I period.⁷⁹ The interior space was large and expansive, with a flight of stairs leading to a storeroom and office space on a mezzanine level. Both hangar and pedestrian doors were located on three of the four sides—south, east, and west. The exterior walls were clad with corrugated asbestos siding. The original building entrance was located along the south facade and fronted onto concrete seaplane ramps spaced along the waterfront.

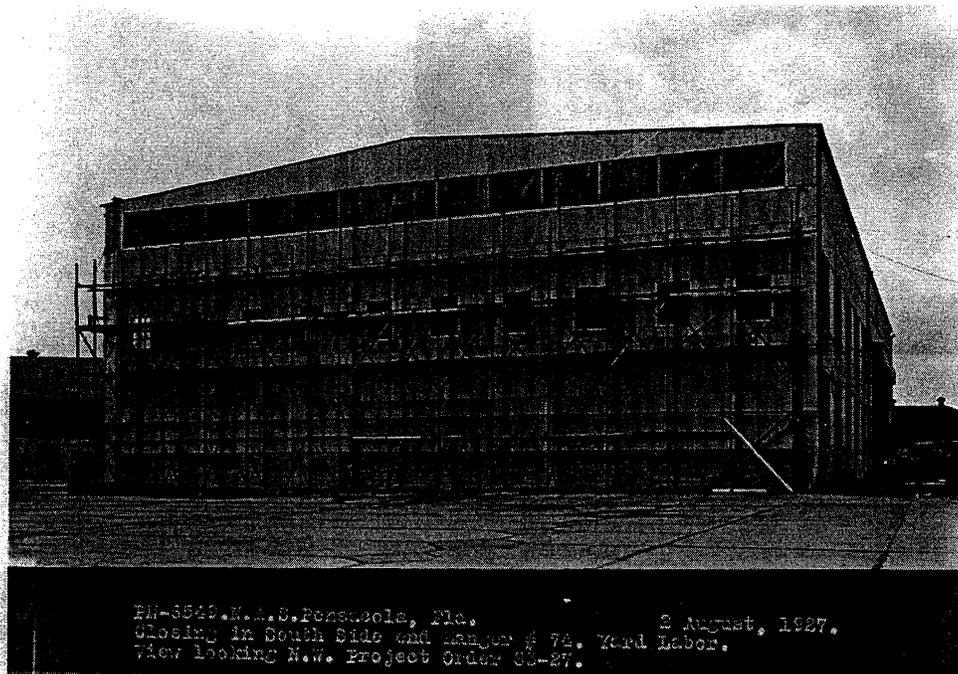
Figure 9. Building No. 74 following major renovations of the south facade in which a concrete protection wall enclosed the main entrance, dated August 2, 1927. (Photo courtesy of Still Pictures Unit, National Archives, College Park, Maryland).

In the late 1920s and early 1930s, NAS Pensacola undertook extensive repairs and renovations to Building No. 74, which included enclosing the south facade with a low concrete wall, making the west facade the building's new main entrance.⁸⁰ The south facade's concrete, storm wall was probably constructed for hurricane protection and as a flood barrier (*Figure 9*). In 1927, NAS Pensacola developed plans to replace the hangar's original doors, but the work did not actually begin until 1928. Station labor removed Building No. 74's original rolling metal doors on the east and west facades and replaced them with steel leaf rolling doors.⁸¹ Building No. 74's original steel sash windows were replaced between 1932 and 1933.⁸²

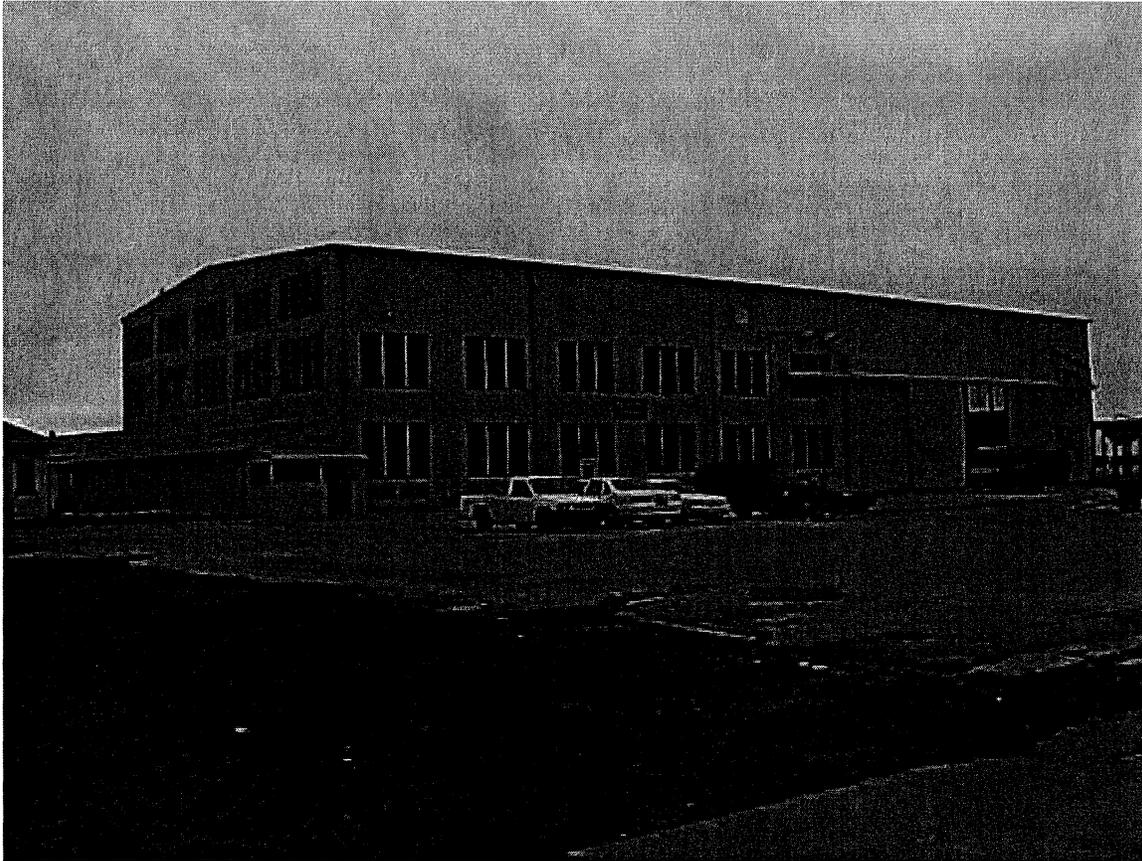
Figure 10. A recent view of Building No. 74 dated 2002. (Photo courtesy of HHM Inc., Austin, Texas).
