U.S. NAVAL BASE, PEARL HARBOR, ADMINISTRATION BUILDING
(U.S. Naval Base, Pearl Harbor, Naval Station)
(Facility No. 1)
Russell Avenue at Port Royal Street
Pearl Harbor
Honolulu County
Hawaii

HABS HI-407

U.S. NAVAL BASE, PEARL HARBOR, ADMINISTRATION BUILDING (U.S. Naval Base, Pearl Harbor, Naval Station) (Facility No. 1)

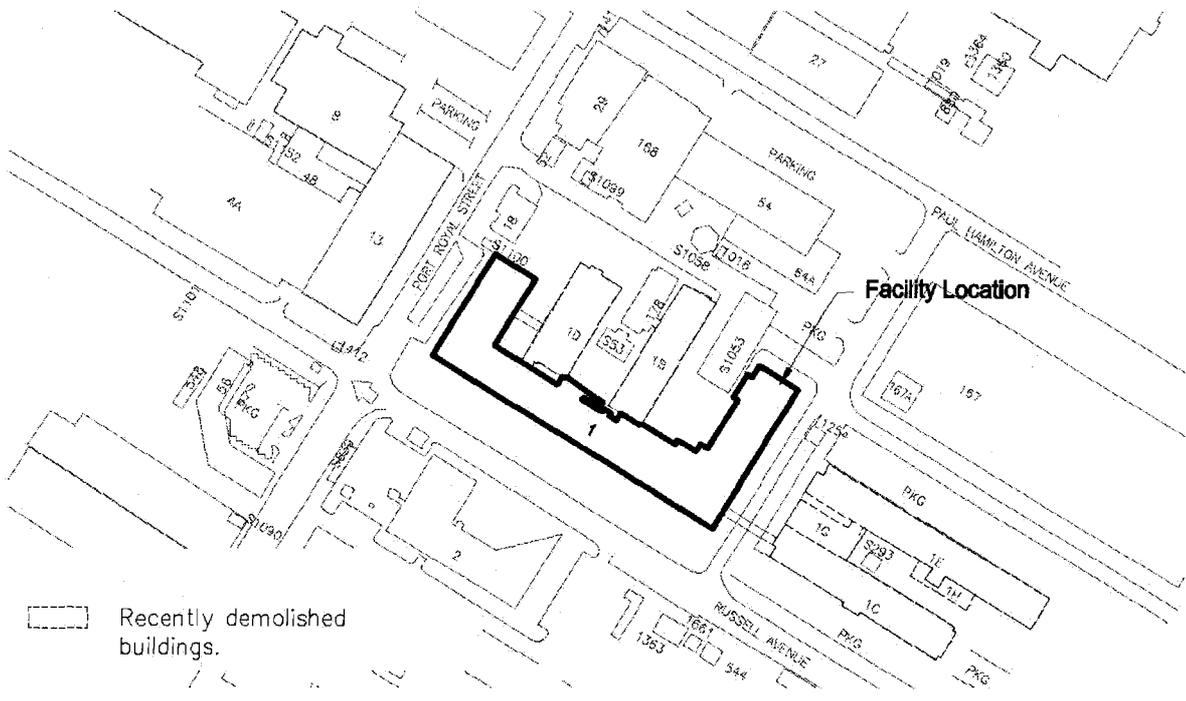
Site Map

--- Recently demolished buildings.

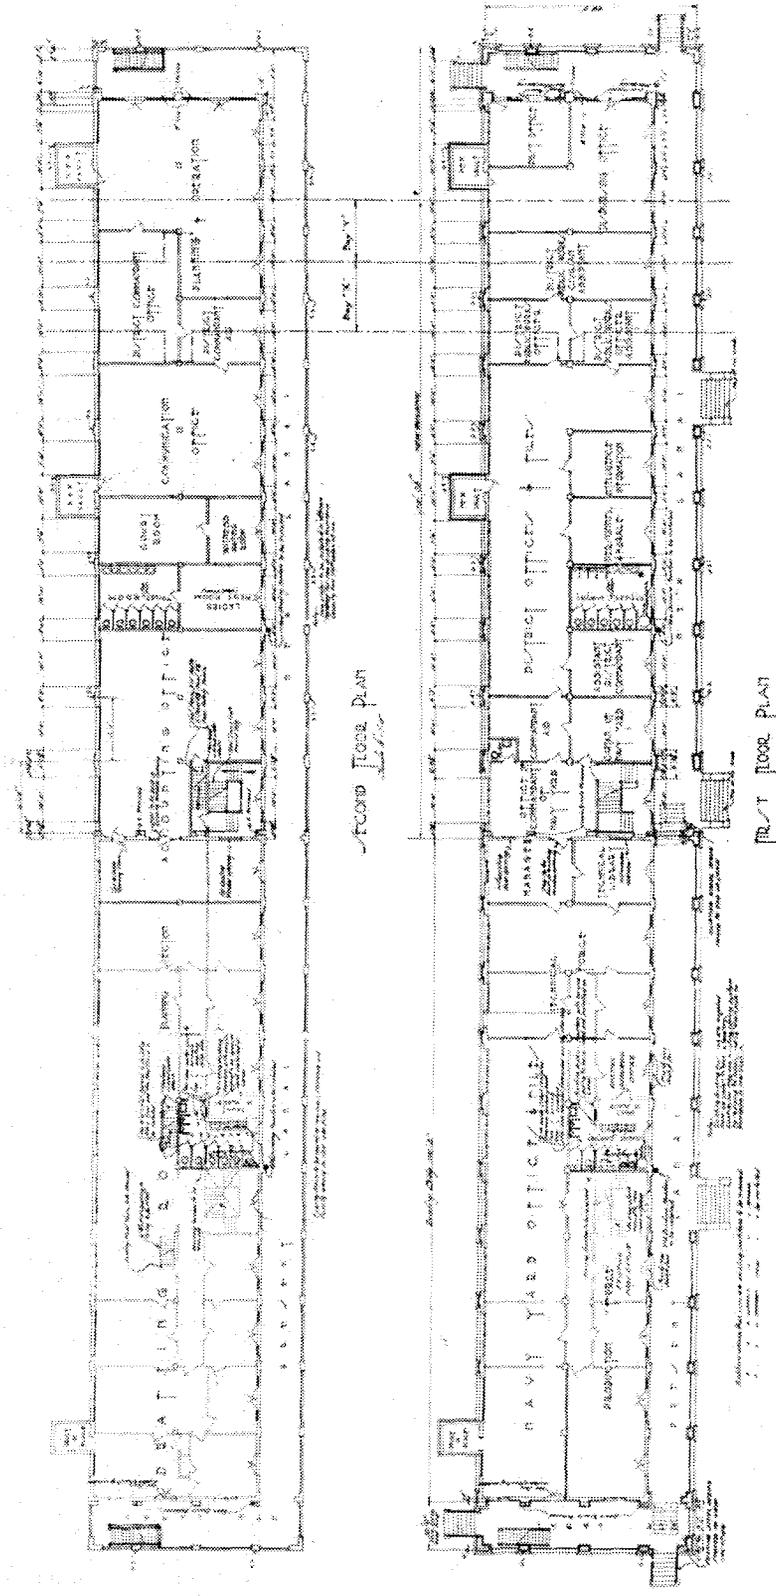
Drawing No. 101909, dated November 10, 1925 (Floor plans showing 1926 extensions)

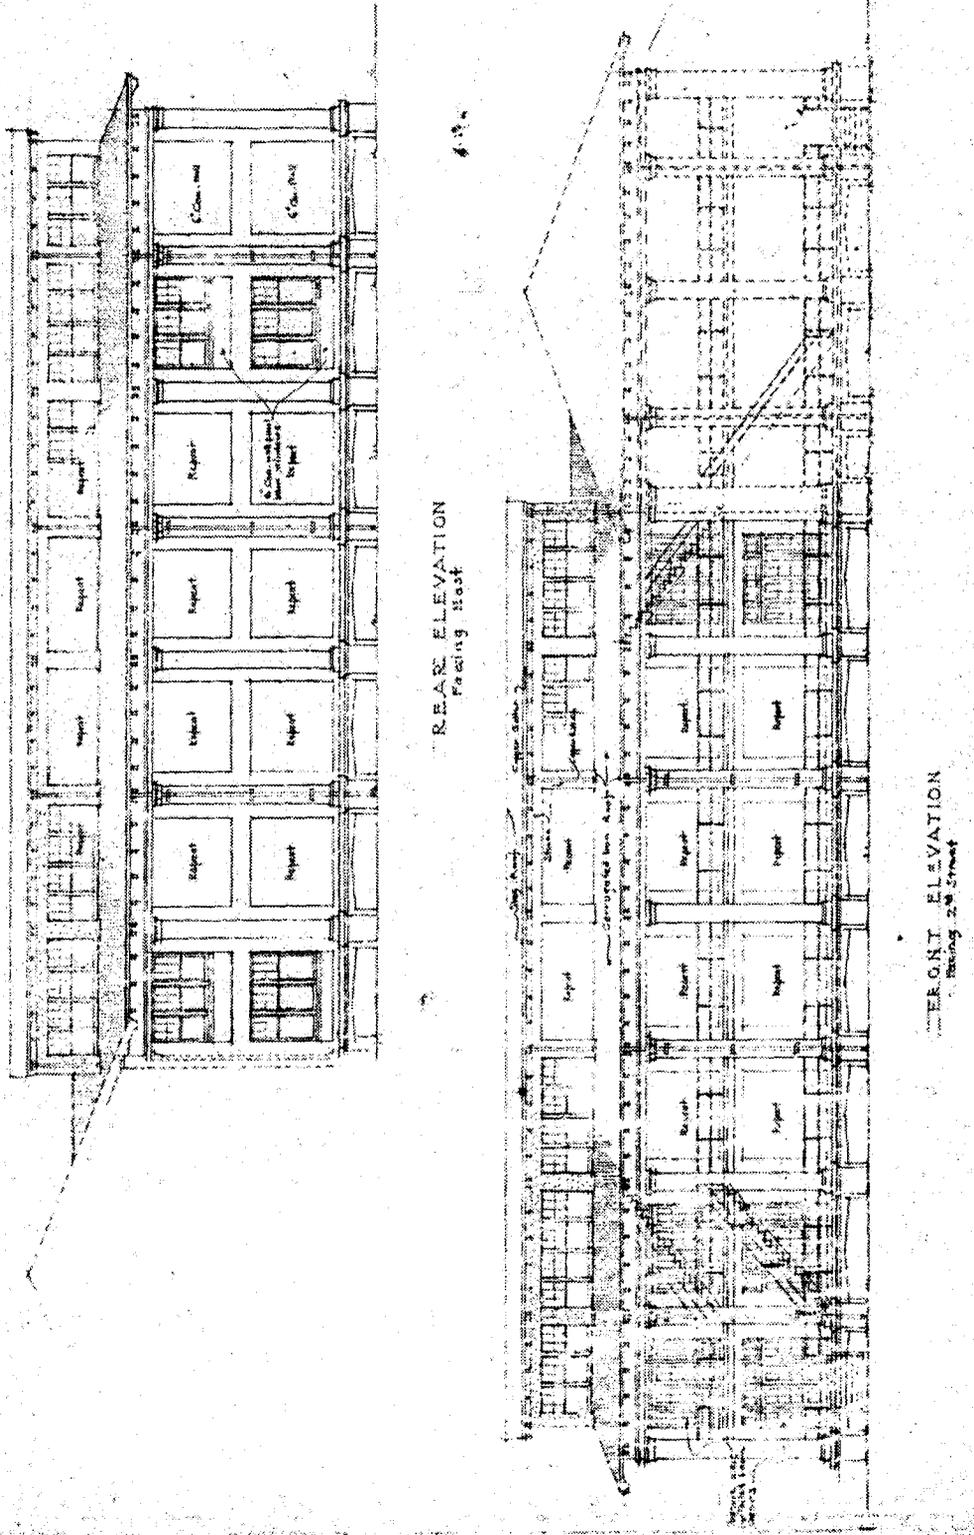
Portion of drawing No. I-N3-134, dated December 16, 1936 (Elevations of 1937 west wing)

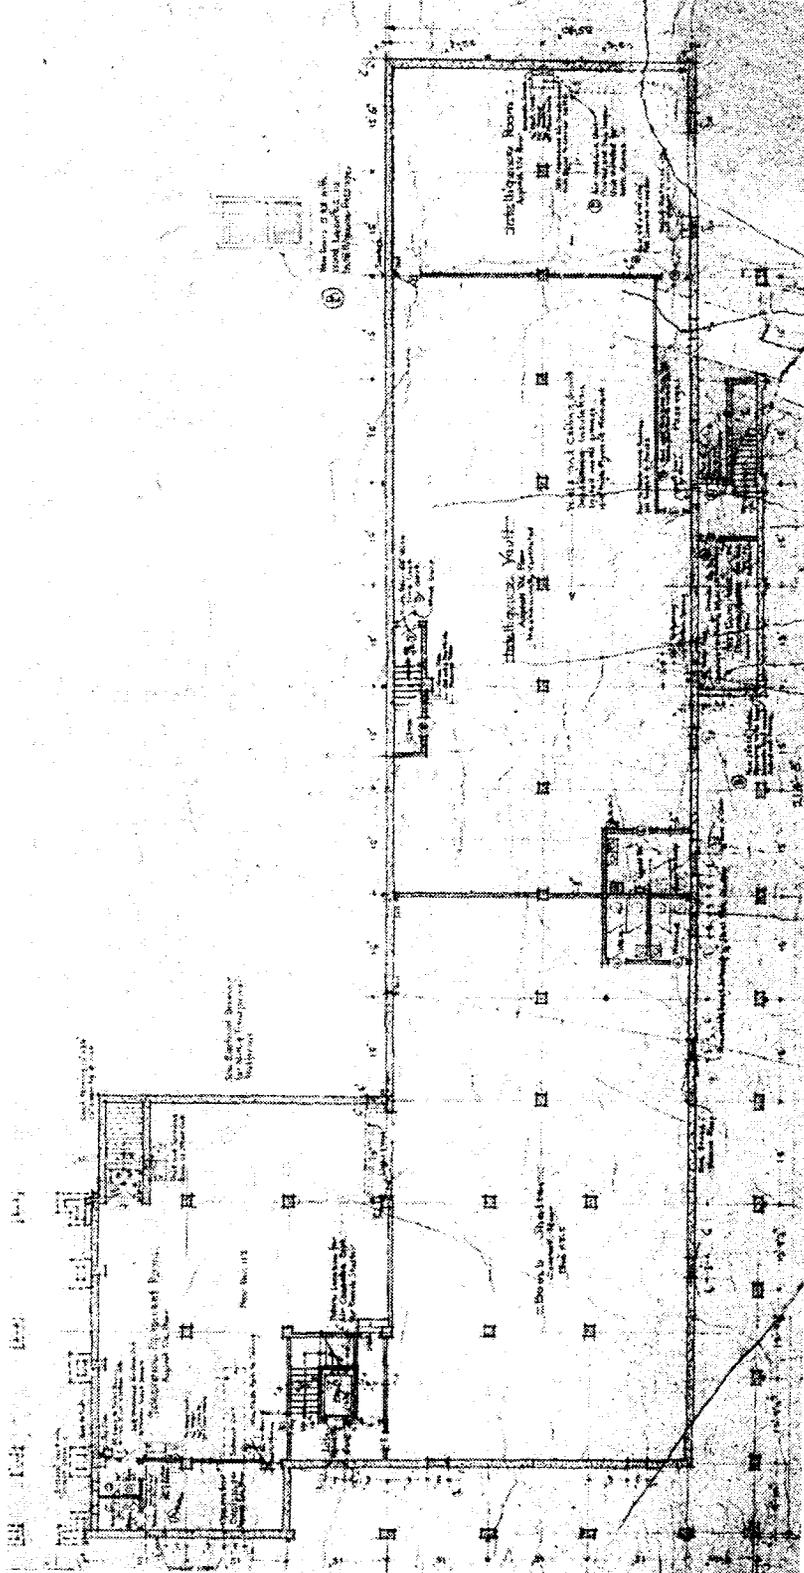
Portion of drawing No. 149390, dated May 17, 1941 (basement under east extension & wing)

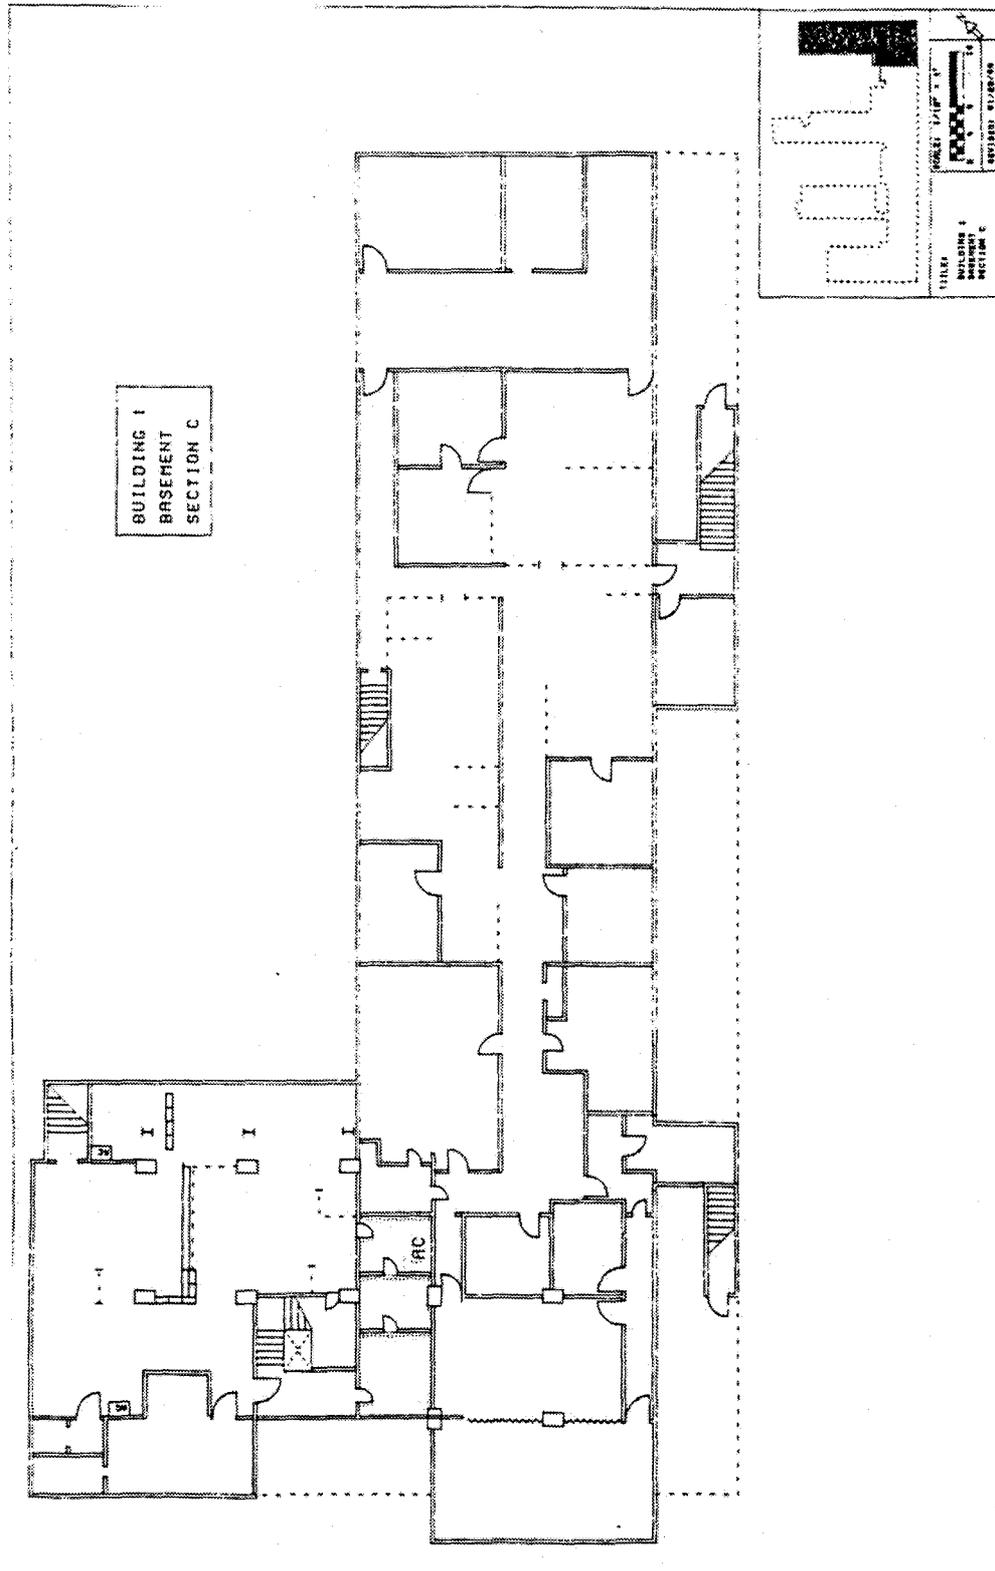
Basement Floor Plan, dated January 28, 1988 (from Naval Shipyard Files for Facility No. 1)

A set of as-built drawings (nos. 819797-819799) of the three floor plans were prepared for the main administration building and its immediate annexes in 1958. No basement drawing was done at that date. These sheets show the uses then in Facility No. 1, as well as in Facilities No. 1B and 1D. No similar overall building drawings have been prepared since then. In the Naval Shipyard files small sketches were found of four floor plans (including the basement of Facility No. 1) for these buildings.

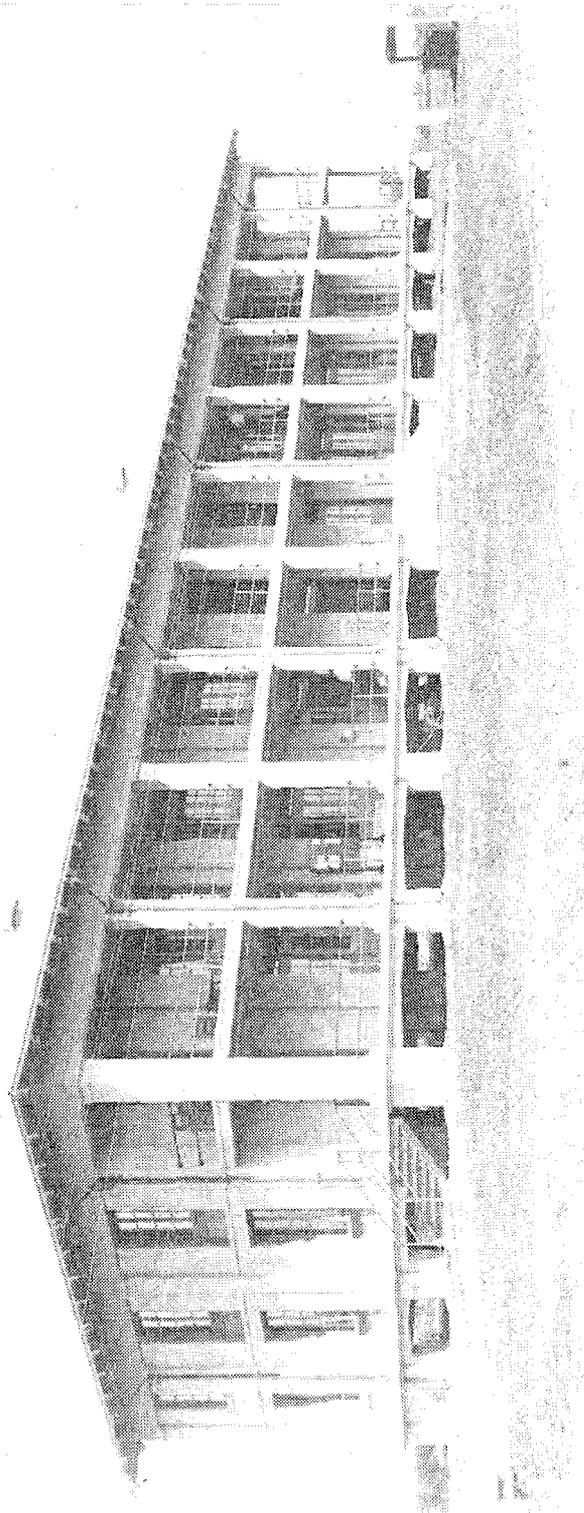
**Historic photo of front façade and west end, dated Oct. 5, 1913
(National Archives II, in RG 71 CA – 165C)**

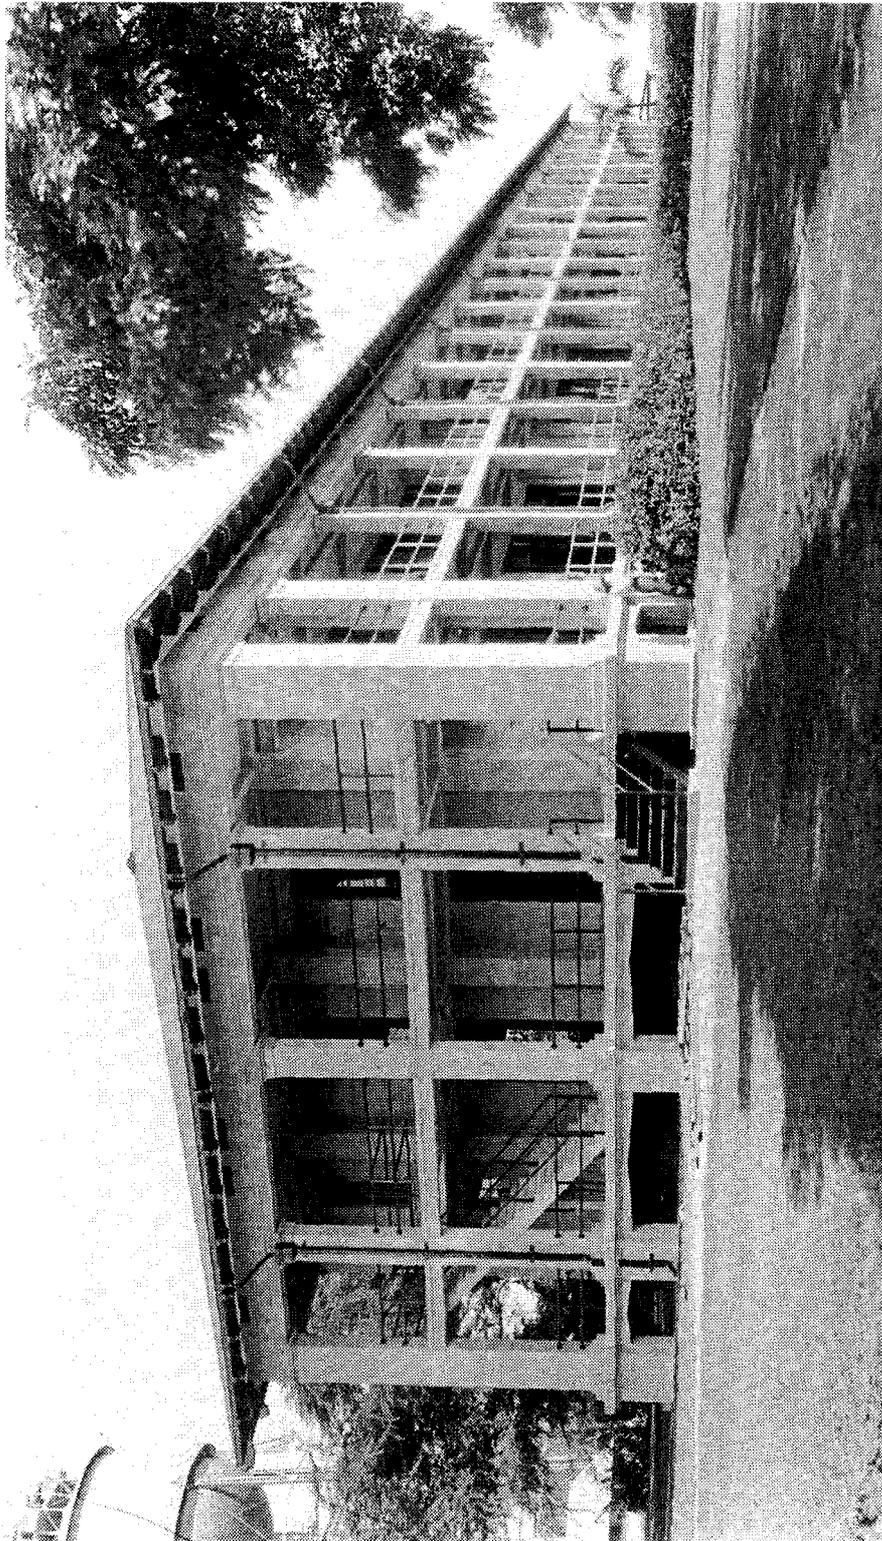
**Historic photo of front façade and west end, dated Dec. 1, 1926
(National Archives II, in RG 71 CA – 171D)**

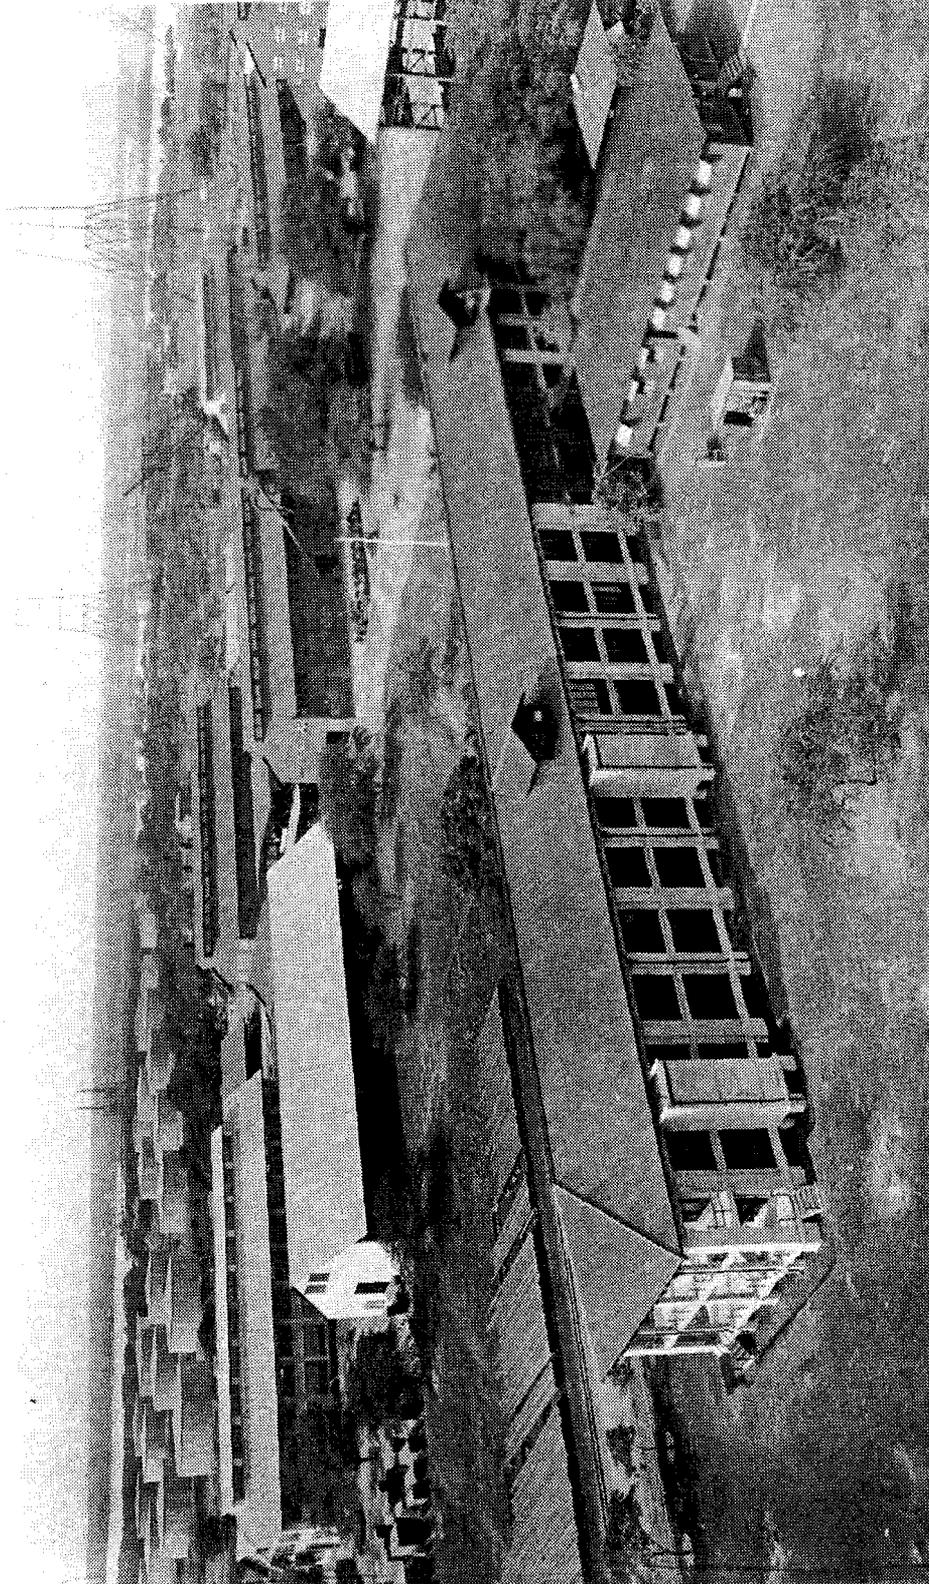
Historic photo of rear façade, dated Dec. 1, 1926 (National Archives II, in RG 71 CA – 171D)

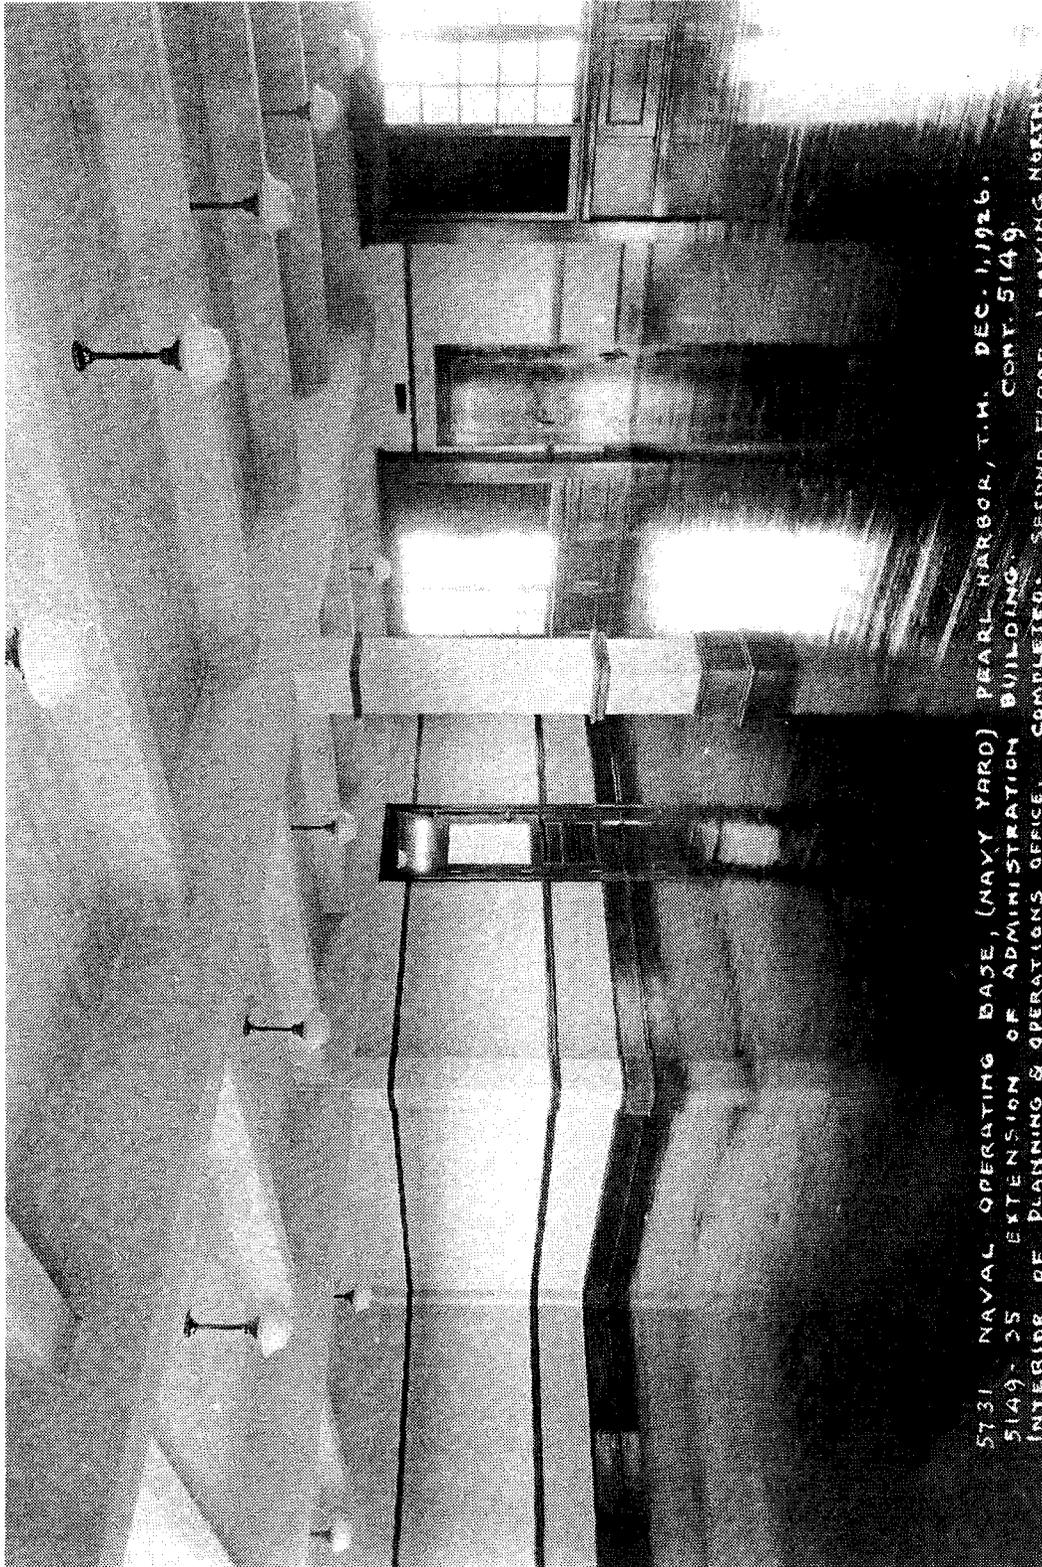
Historic photo of interior, dated Dec. 1, 1926 (National Archives II, in RG 71 CA - 171D)

5731 NAVAL OPERATING BASE, (NAVY YARD) PEARL HARBOR, T.H. DEC. 1, 1926.
5149-35 EXTENSION OF ADMINISTRATION BUILDING CONT. 5149.
INTERIOR OF PLANNING & OPERATIONS OFFICE. COMPLETED. SECOND FLOOR. LOOKING NORTH.

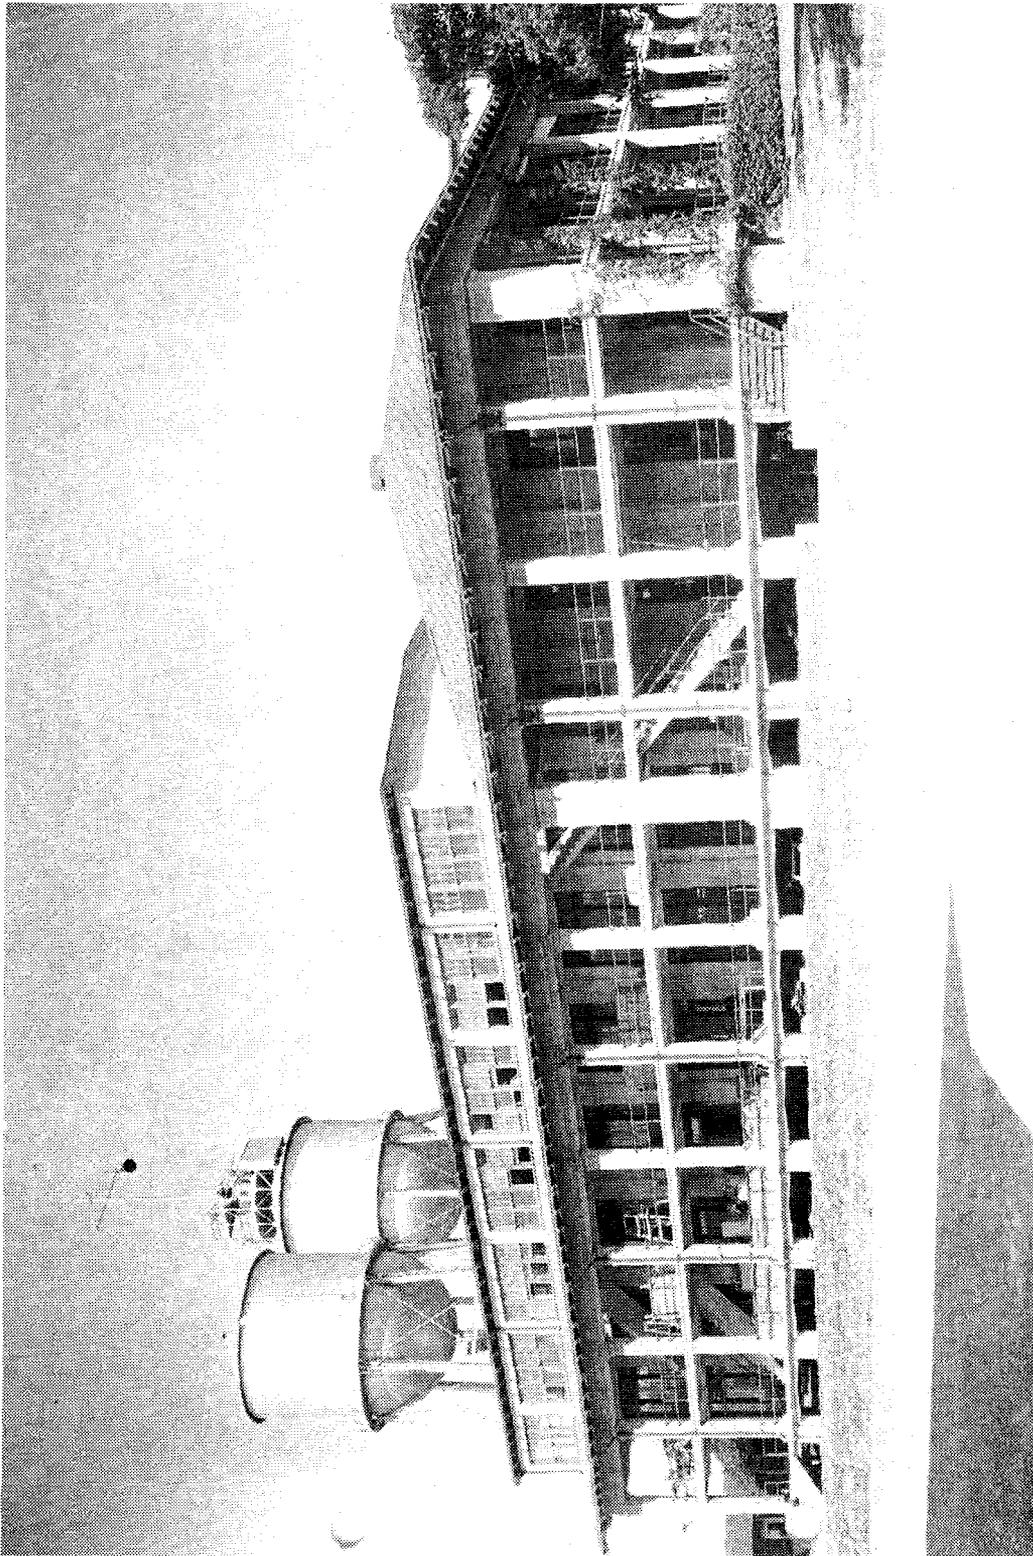
**Historic photo of west wing addition, dated May 5, 1937
(National Archives II, in RG 71 CA – 171D)**

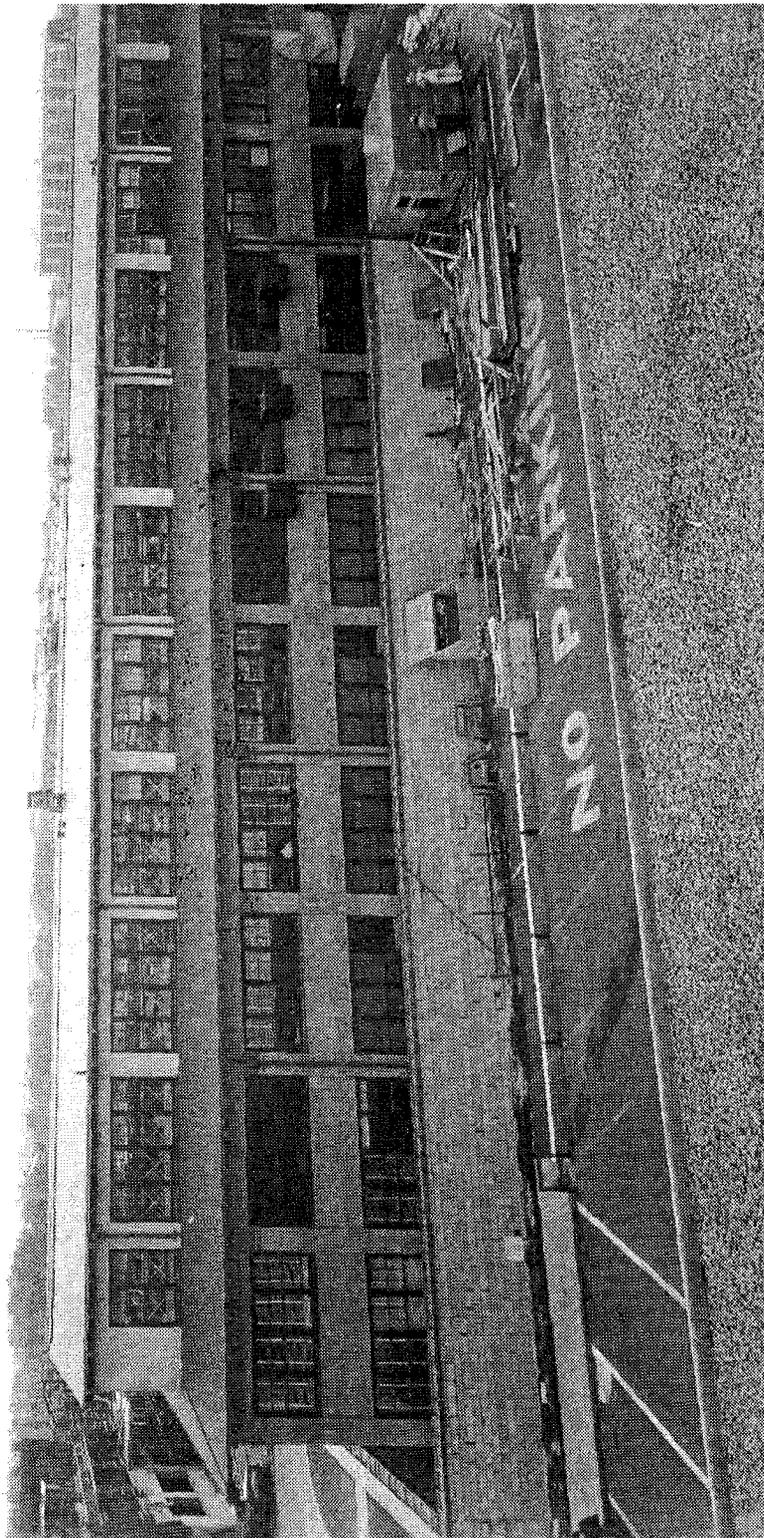
Historic Photo of east wing, dated March 8, 1942 (National Archives II, in RG 71 CA – 171D)
