**U.S. NAVAL BASE, PEARL HARBOR, BLOCH RECREATION  
CENTER AND ARENA  
(U.S. Naval Base, Pearl Harbor, Naval Station)  
(Facility No. 161)  
Between Center Drive and North Road near Nimitz Gate  
Pearl Harbor  
Honolulu County  
Hawaii**

**HABS No. HI-416**

**WRITTEN HISTORICAL AND DESCRIPTIVE DATA**

**HISTORIC AMERICAN BUILDINGS SURVEY  
National Park Service  
U.S. Department of the Interior  
Oakland, California**

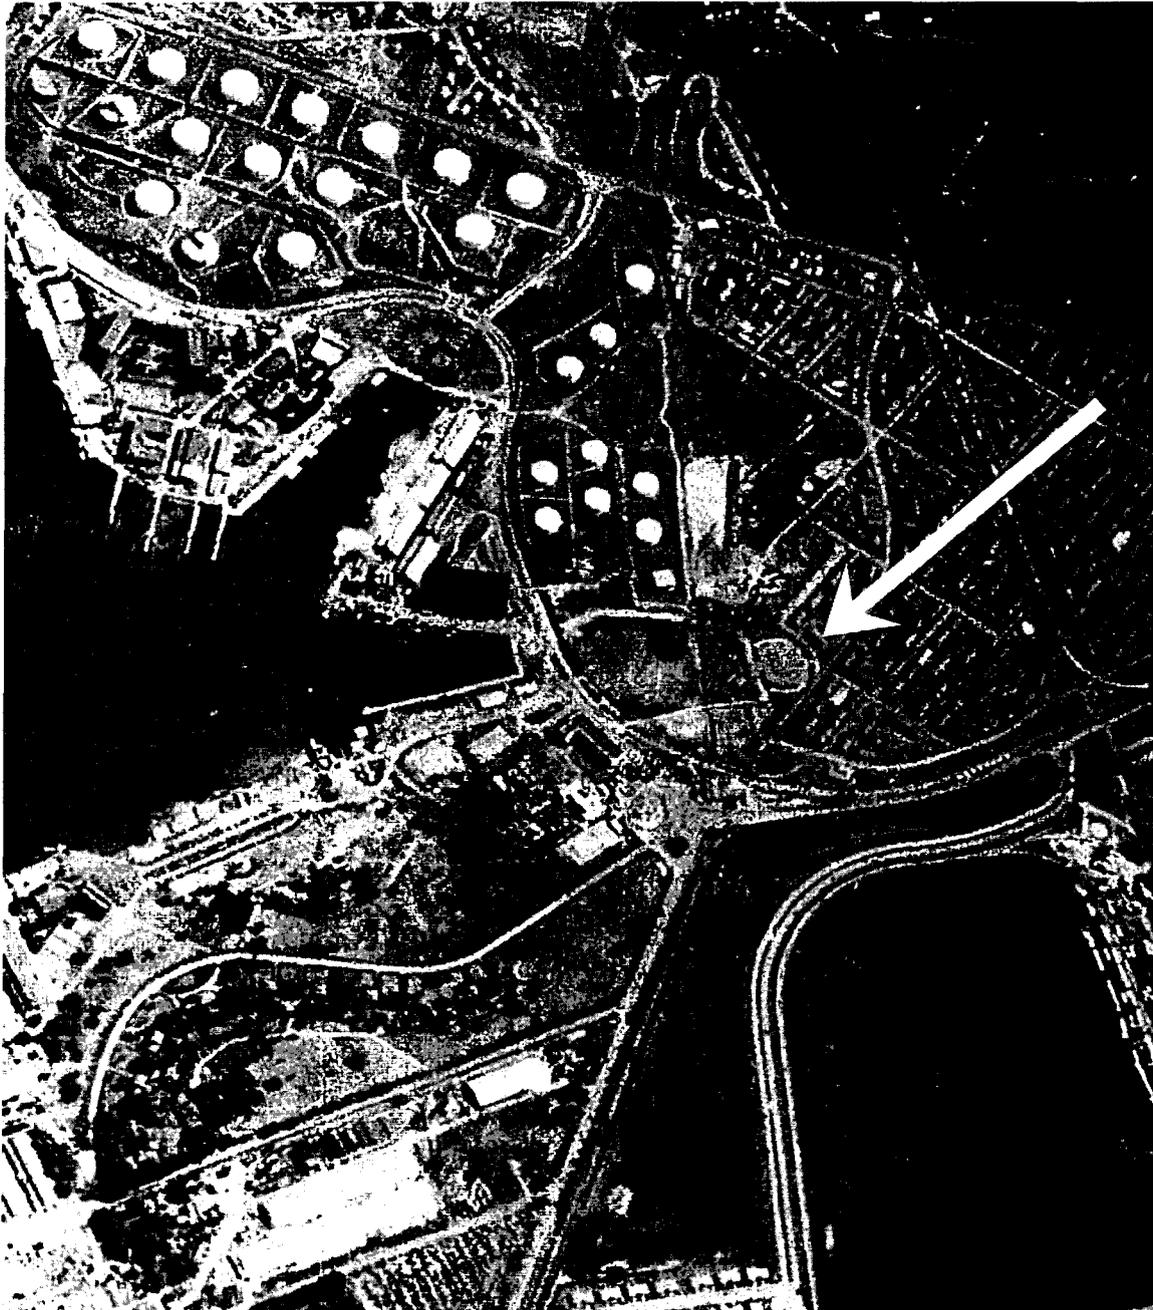
Portion of photograph dated October 30, 1941 showing Bloch Arena (added arrow). Note the open air portion of the building at the left (north). NARA RG-71-CB Box 101 folder (Operating Base) aerial view AN 41,153. October 30, 1941.

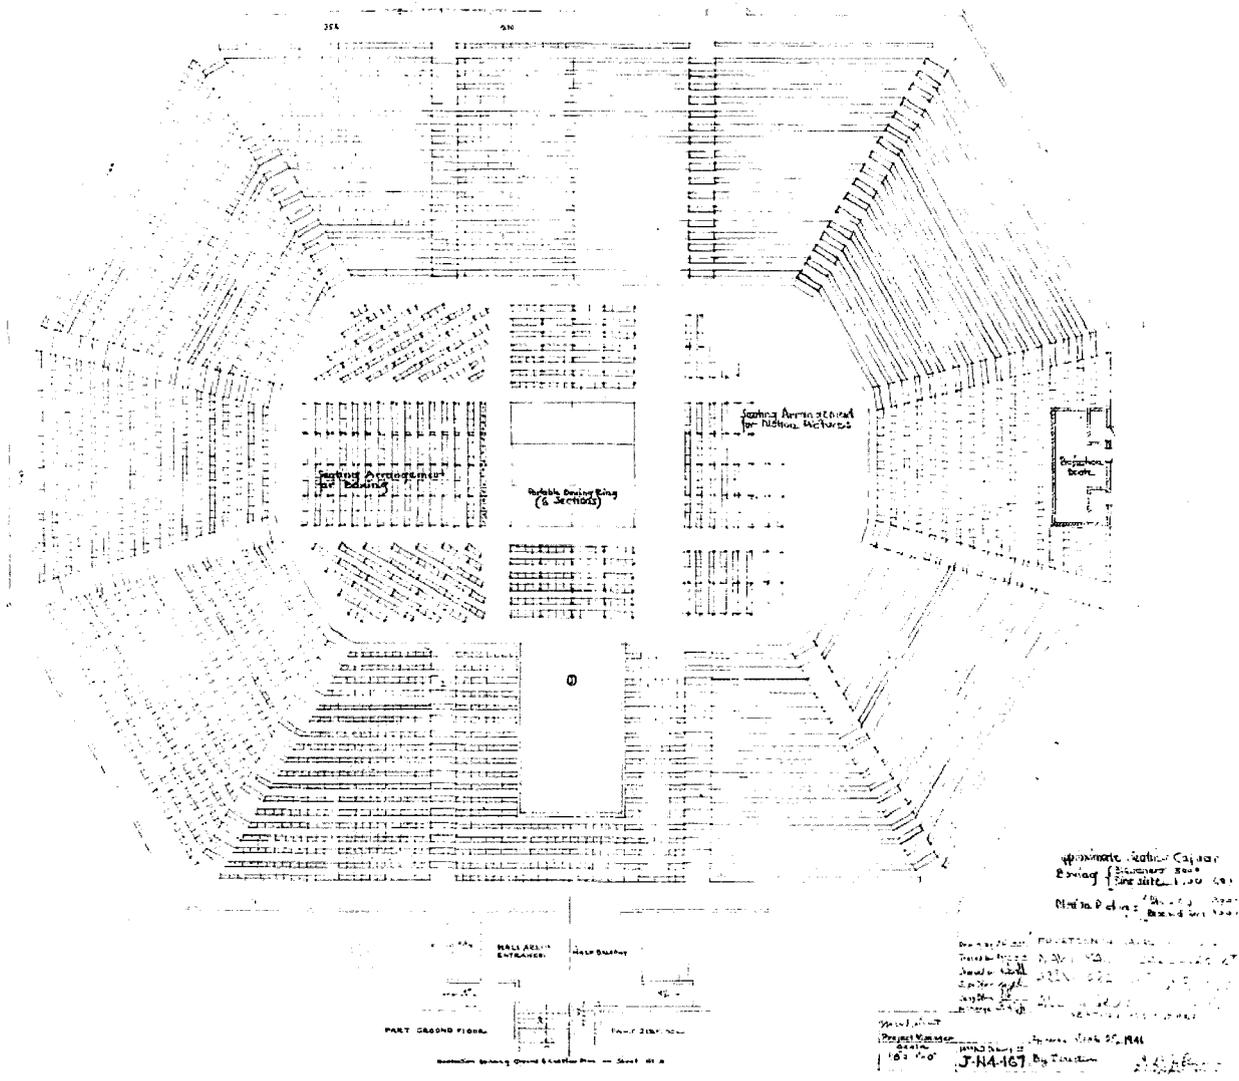
Portion of drawing dated June 25, 1941 showing the seating plan for the arena. Note the position of the "portable boxing ring (6 sections)" in the center of the main floor and the seating arrangements, on left of the ring is seating for boxing events and on the right of the ring is the seating for motion pictures. The projection booth is at the right edge of the arena. From NAVFAC Plan Files drwg J-N4-167.

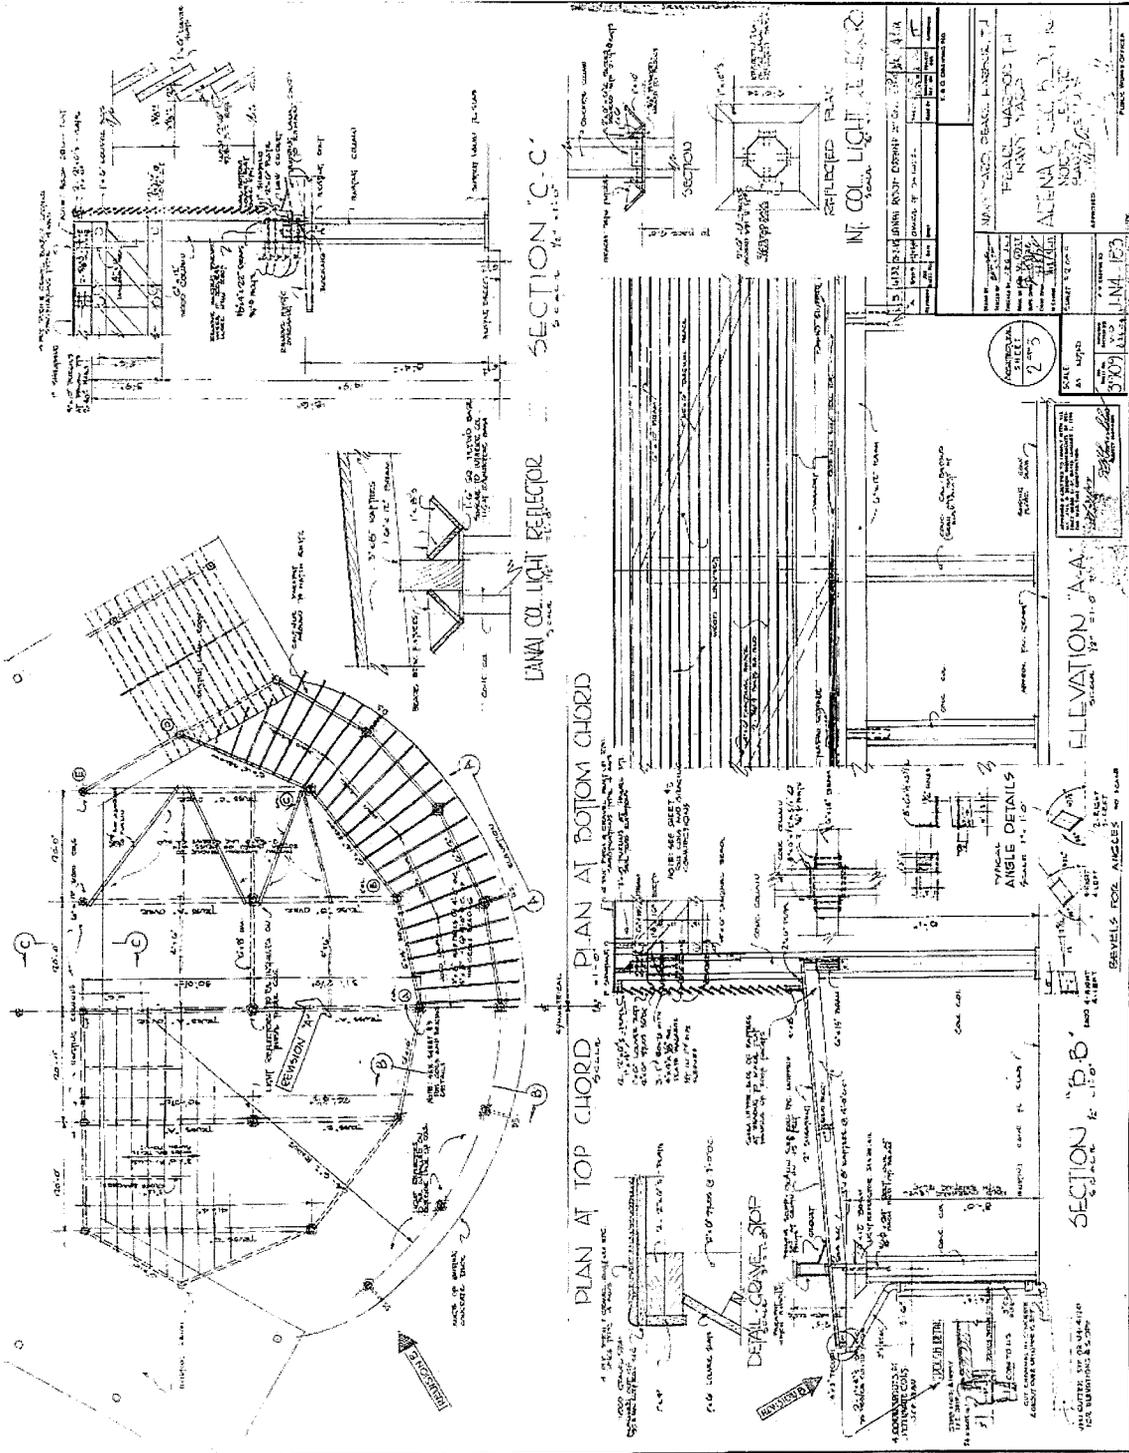
**Drawing dated February 22, 1944 showing the addition of a roof over the dance floor at Facility 161. From NAVFAC Plan Files drwg J-N4-183.**

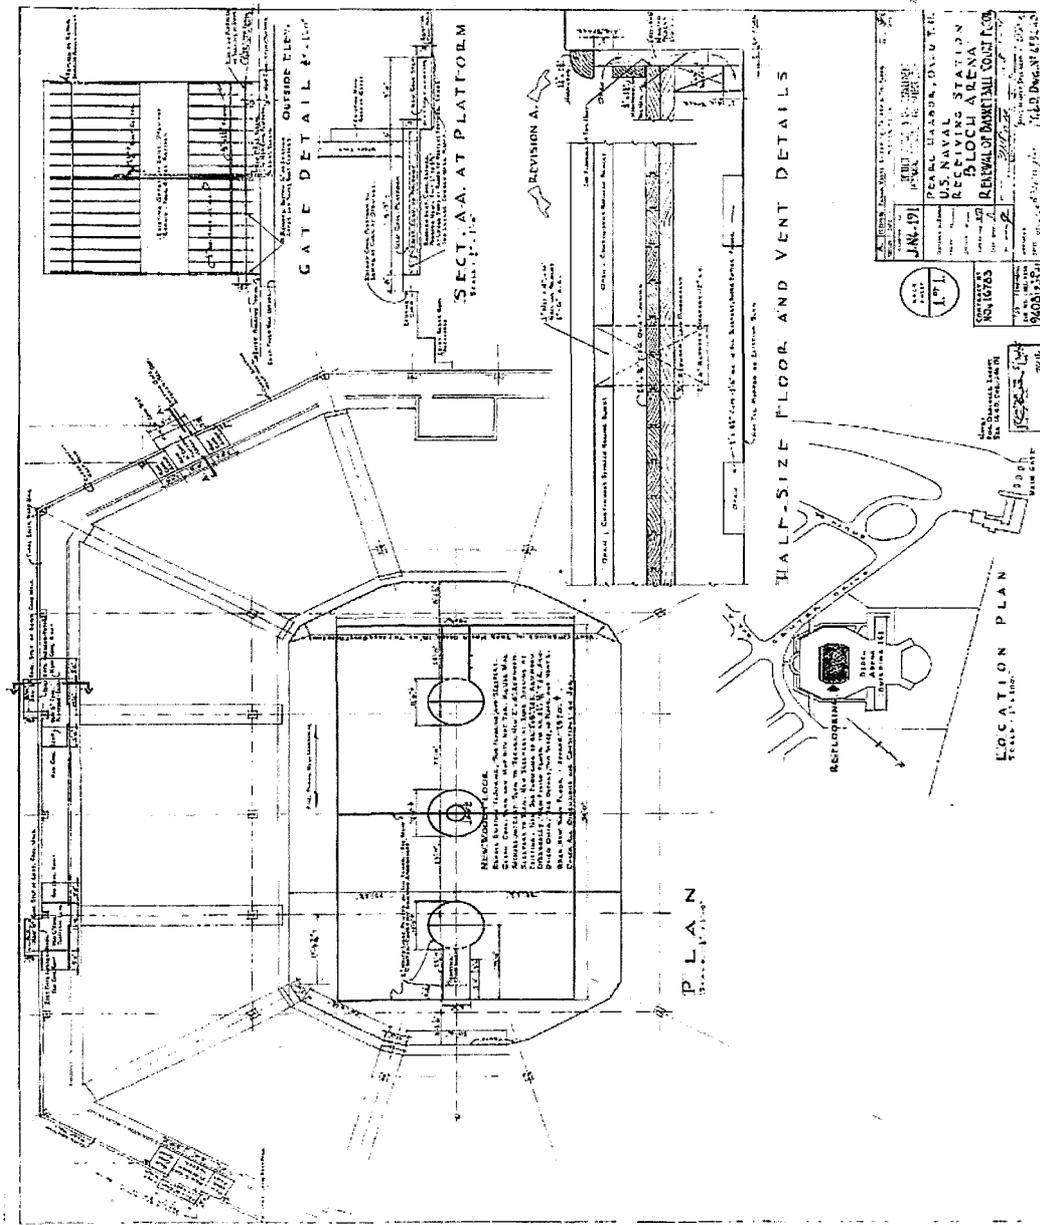
**New Wood Floor**

Drawing dated July 30, 1948 showing the installation of ohia wood strip flooring at the area of Facility 161. From NAVFAC Plan Files drwg J-N4-191. Text at center reads:

Remove existing flooring, sub flooring, and sleepers. Clean conc. slab and mop with hot tar. Reuse wire anchors in exist. slab to secure new 2" x 4" redwood sleepers to slab. New sleepers at same spacing as existing. New sub flooring to be 1" x 8" T&G redwood diagonally. New finish floor to be 2 1/4" x 25/32" T&G kiln-dried ohia.

At the arena portion of the building, the original wood floor was replaced with ohia wood flooring in 1948. The new ohia floor covered the entire

main floor of the arena, about 7,570 square feet. It was constructed of 2" x 4" redwood sleepers with 8" tongue and groove redwood subflooring, laid diagonally. Over this was laid 2¼" x ¾" tongue and groove ohia flooring, laid lengthwise along the long dimension of the arena floor.<sup>16</sup> Ohia (varieties of the species *Metrosideros*, family Myrtaceae) is a large endemic Hawaiian tree, which can often grow to 80' in height and is found in a wide range of habitats on the major Hawaiian Islands. It produces dense dark wood which was used for flooring in Hawaii and on the mainland since at least 1912.<sup>17</sup>

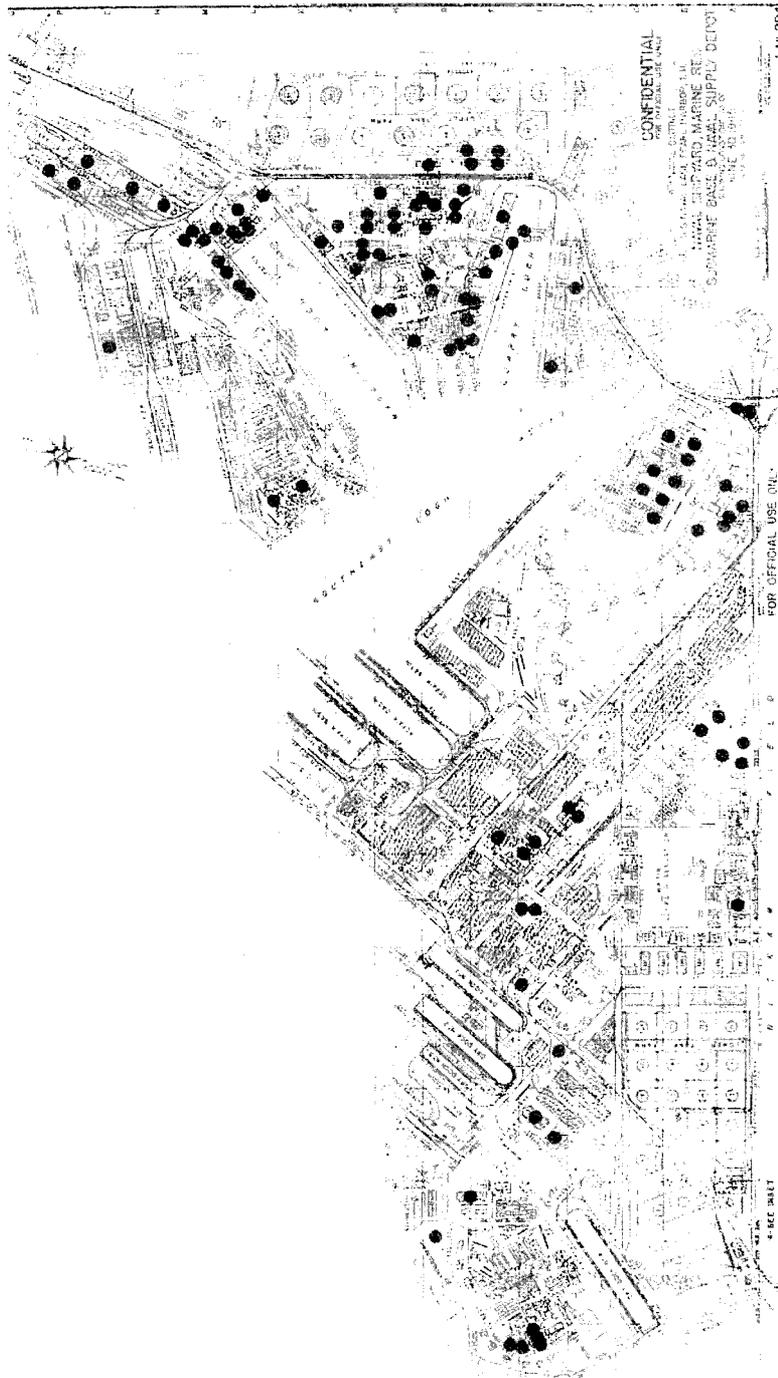
**Map showing Pearl Harbor buildings as of June 30, 1945. The buildings with added dot highlights were of wooden construction, built during WW II. Compare this map with the map on the next page that shows the base as of June 30, 1941 to see the extent of construction during the war.**

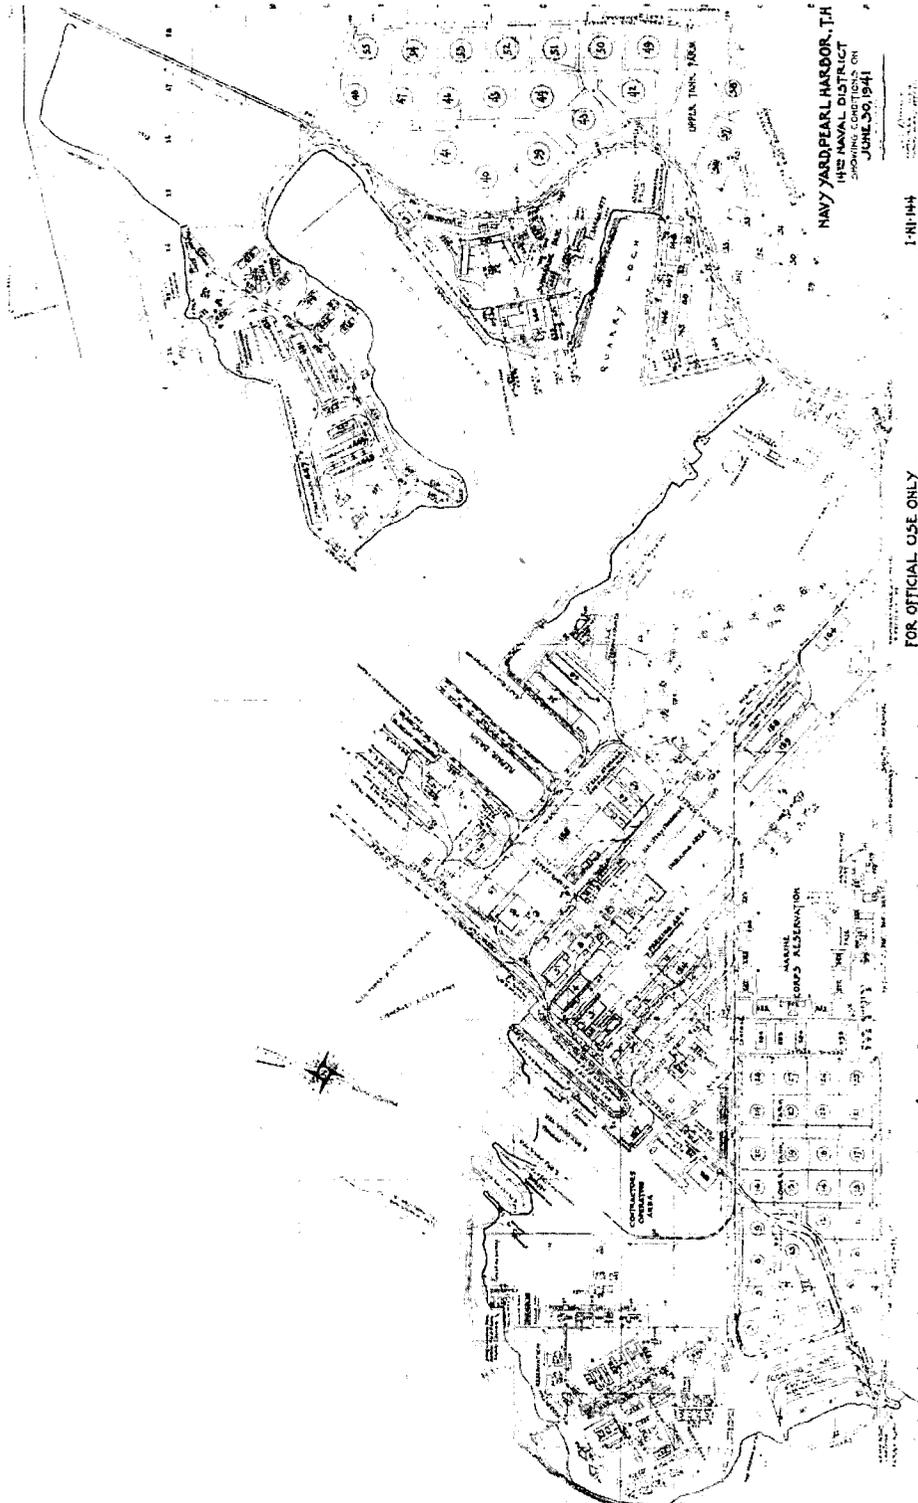
Map showing Pearl Harbor as of June 30, 1941. Compare with 1945 map on the previous page to see the extent of wooden construction during the war.
