U.S. NAVAL BASE, PEARL HARBOR, SOUTH QUAY WALL &
REPAIR WHARF
(U.S. Naval Base, Pearl Harbor, Naval Shipyard, Facility Nos. B-1 &
N-2)
L-shaped portion of quay walls starting at east side of mouth of Dry
Dock No. 1, continuing along ocean side of Sixth Street, adjacent to
Pier B-2
Pearl Harbor
Honolulu County
Hawaii

U.S. NAVAL BASE, PEARL HARBOR, SOUTH QUAY WALL & REPAIR WHARF (U.S. Naval Base, Pearl Harbor, Naval Shipyard) (Facility Nos. B-1 and N-2)

HABS
HI-514
C-100-2
HABS No. HI-514

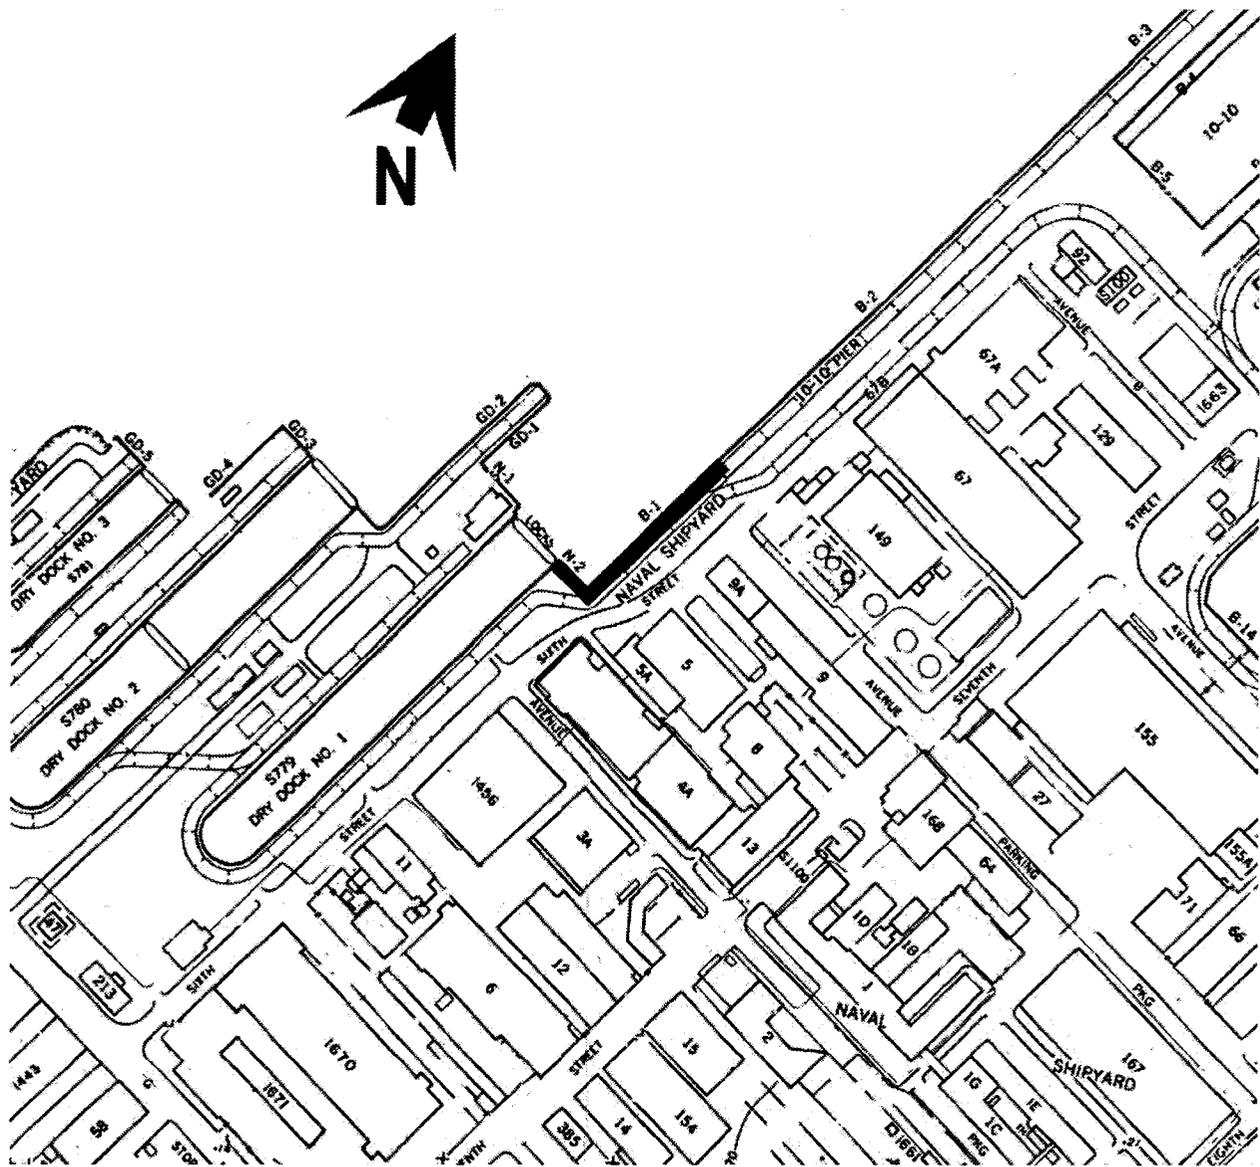
Enlarged Area Map (reduced, not to scale)

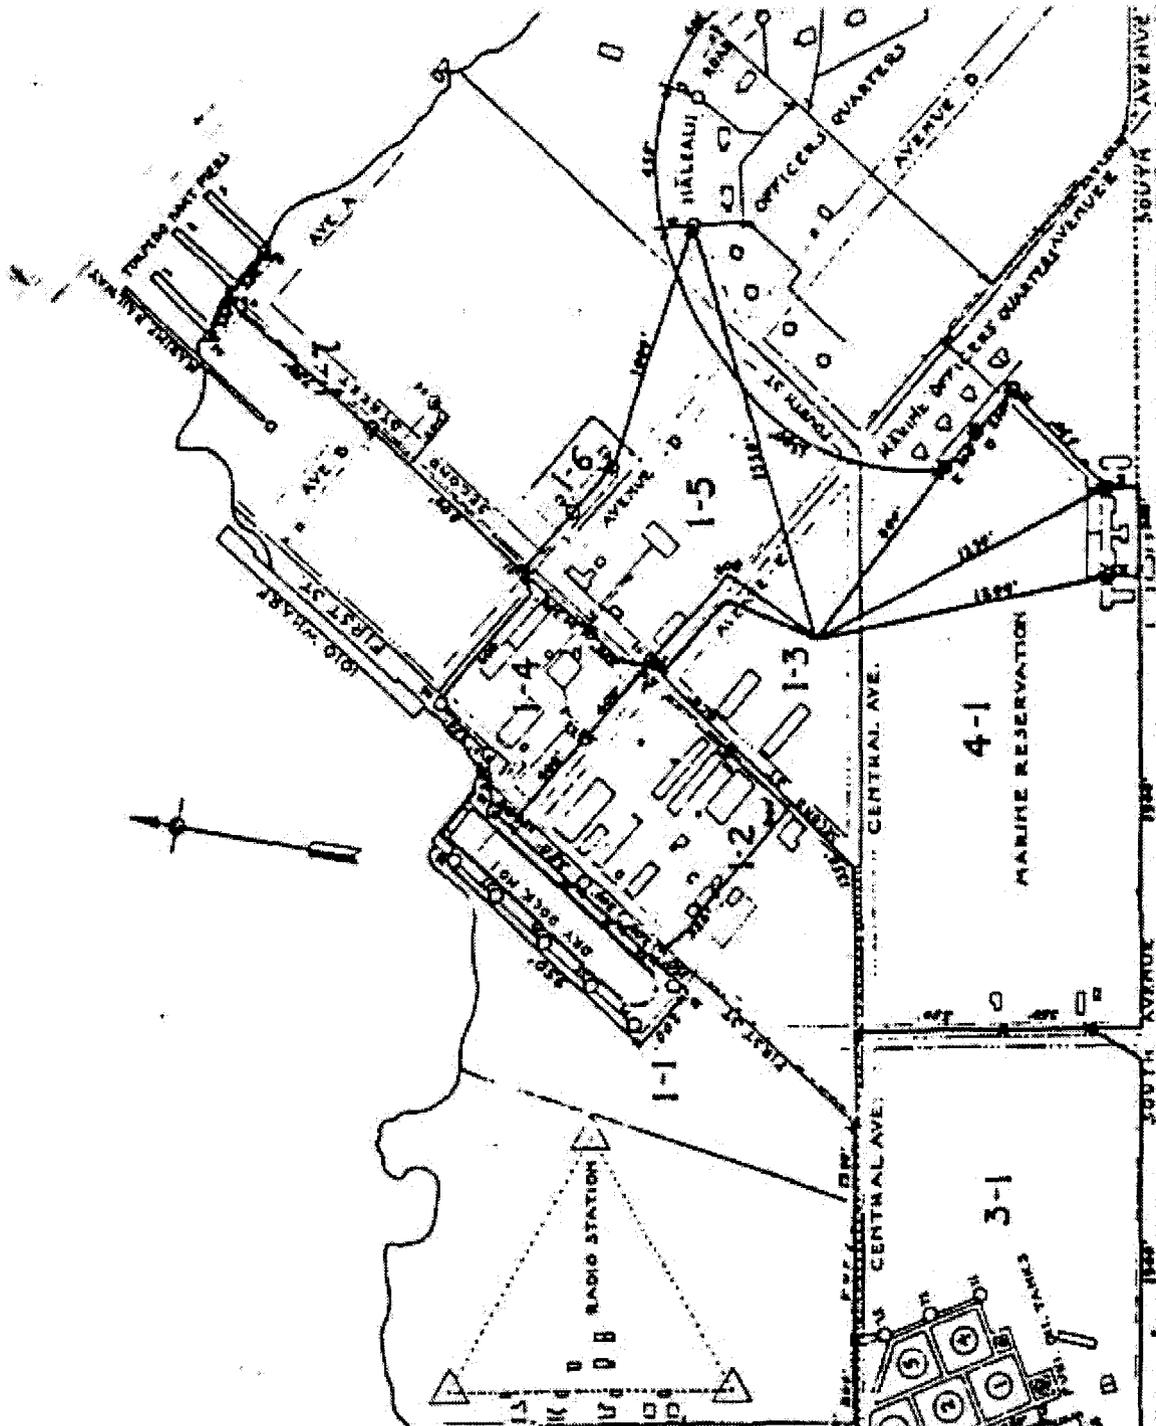
1920 Map of Shipyard Showing Area Before Construction of South Quay Wall (Jan. 2, 1920 Fire Map of Yard) (reduced, not to scale)

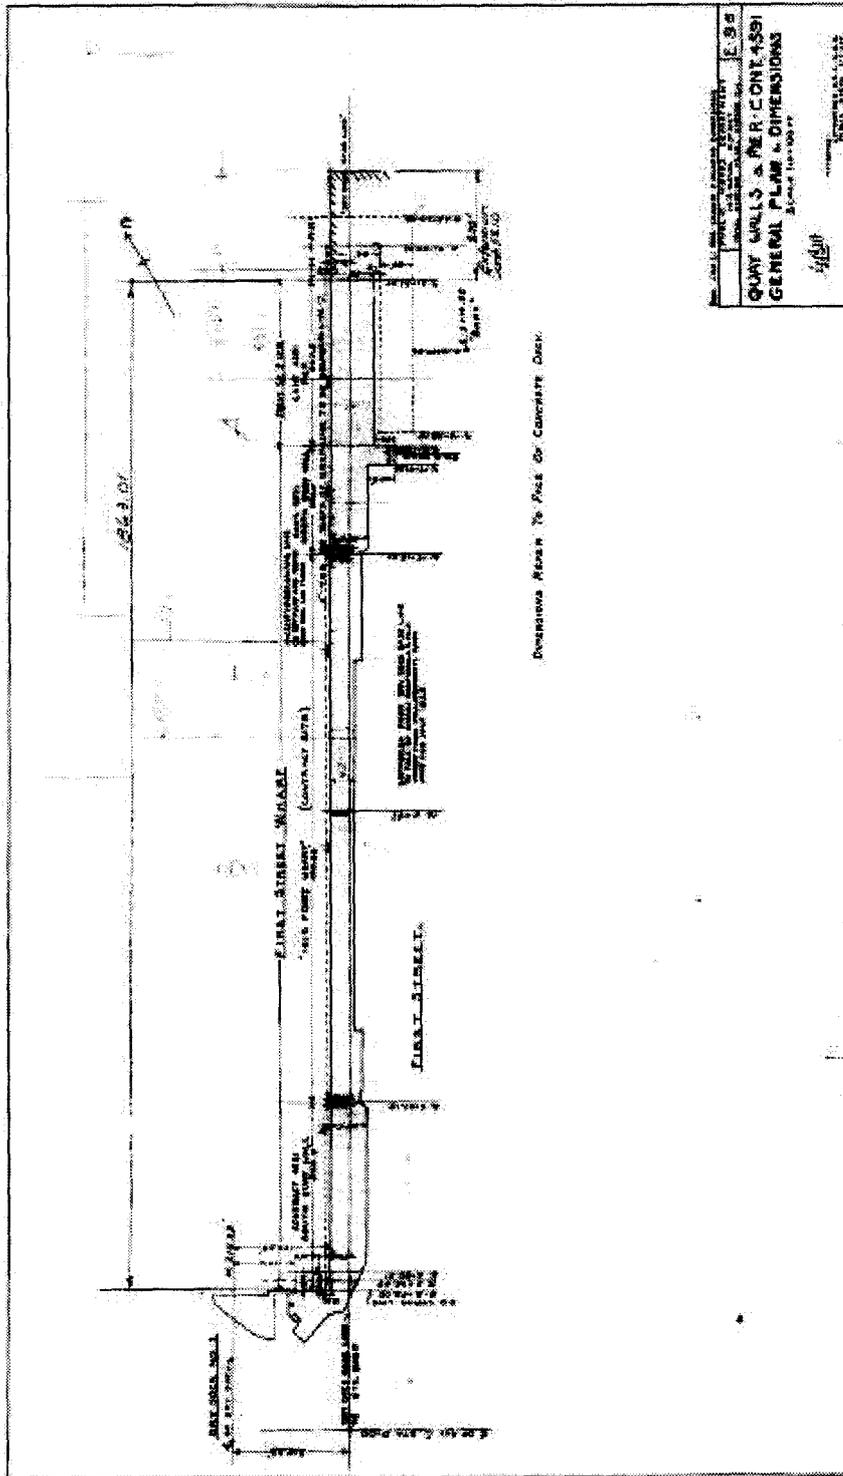
General Plan and Dimensions of Quay Walls and Pier, including South Quay Wall
 (Drawing No. E-96, dated 1/21/1926) (reduced, not to scale)

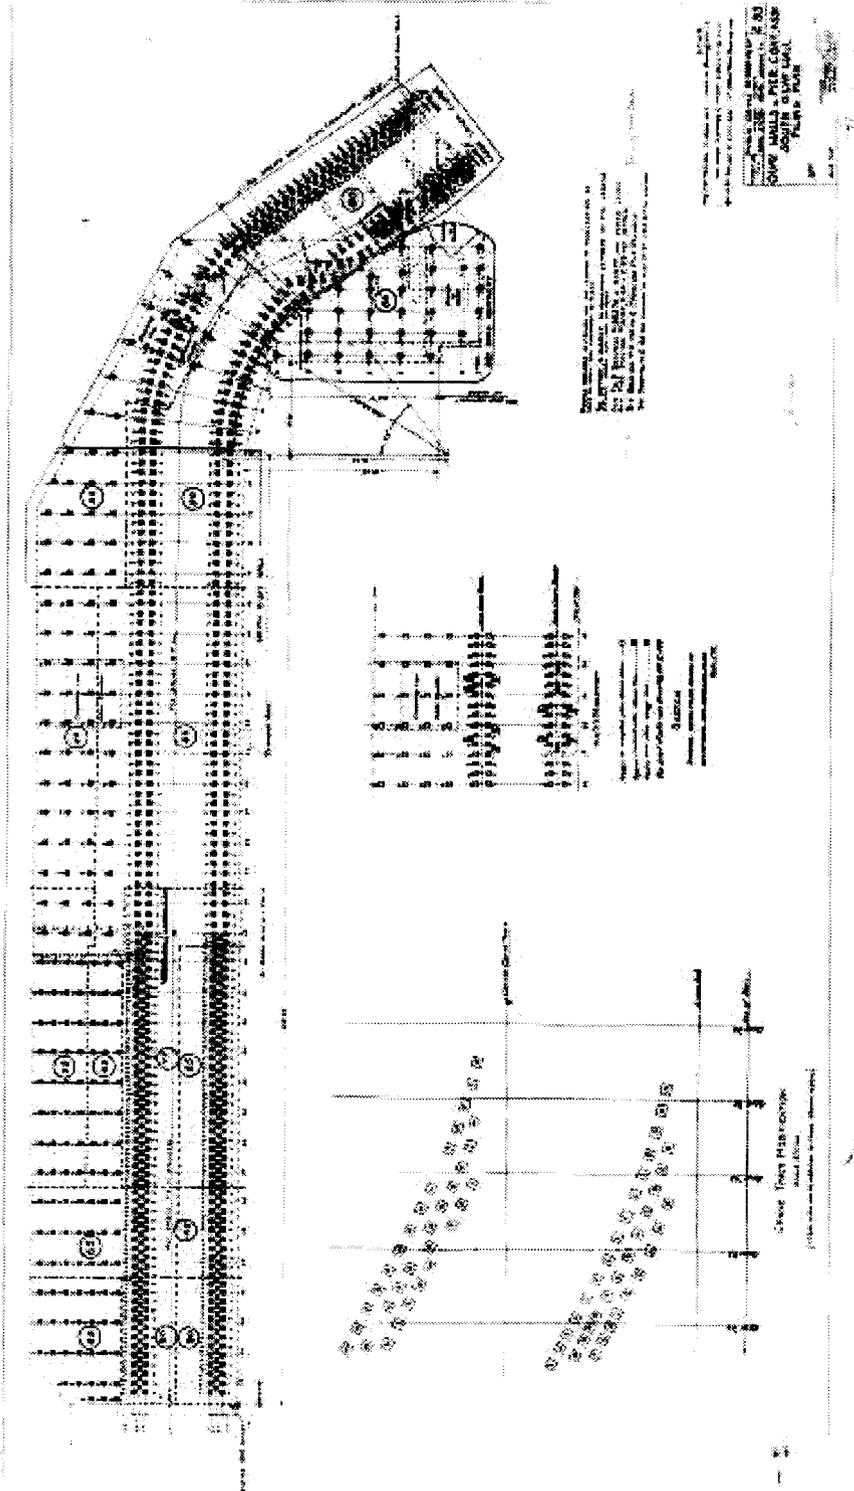
South Quay Wall Piling Plan (Drawing No. E-93, dated 3/29/1923) (reduced, not to scale)

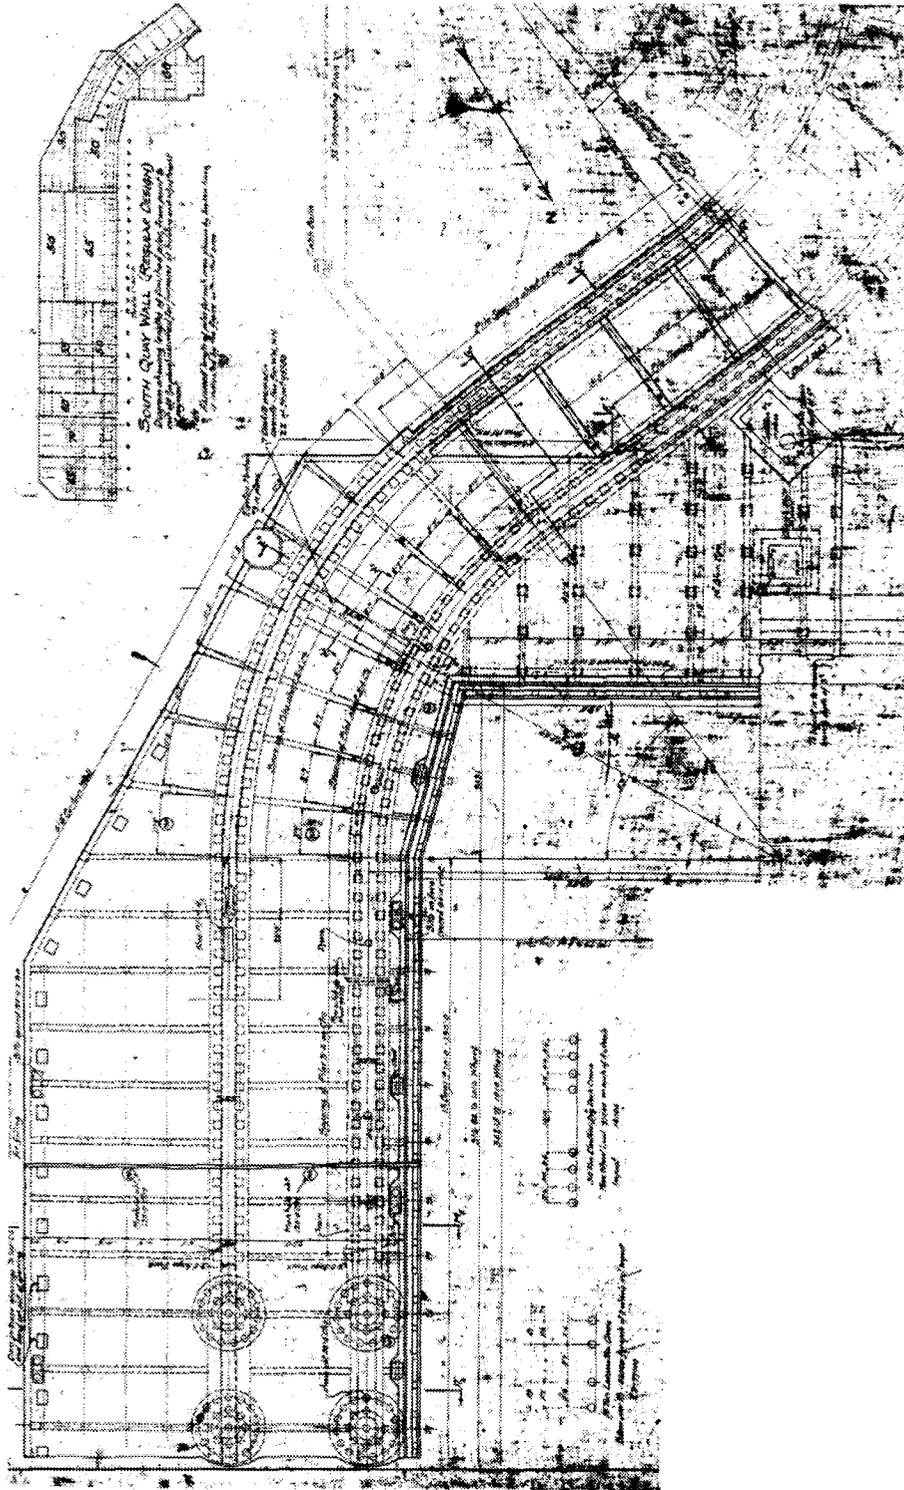
General Layout of South Quay Wall (portion of Drawing No. 95577, dated 6/6/1922)
(reduced, not to scale)

The South Quay Wall was built to support ship docking and repair; it also incorporated an area for small boat berthing adjacent to Dry Dock No. 1. As a connection piece between Dry Dock No.1 and the 1010 Wharf, its shape is slightly organic, suggestive of an L with a thicker short leg that curves at the intersection of the legs. Its organic form follows the curvilinear form of the train tracks that ran along 6th Street curving at the corner of Dry Dock No.1 and the South Quay Wall.

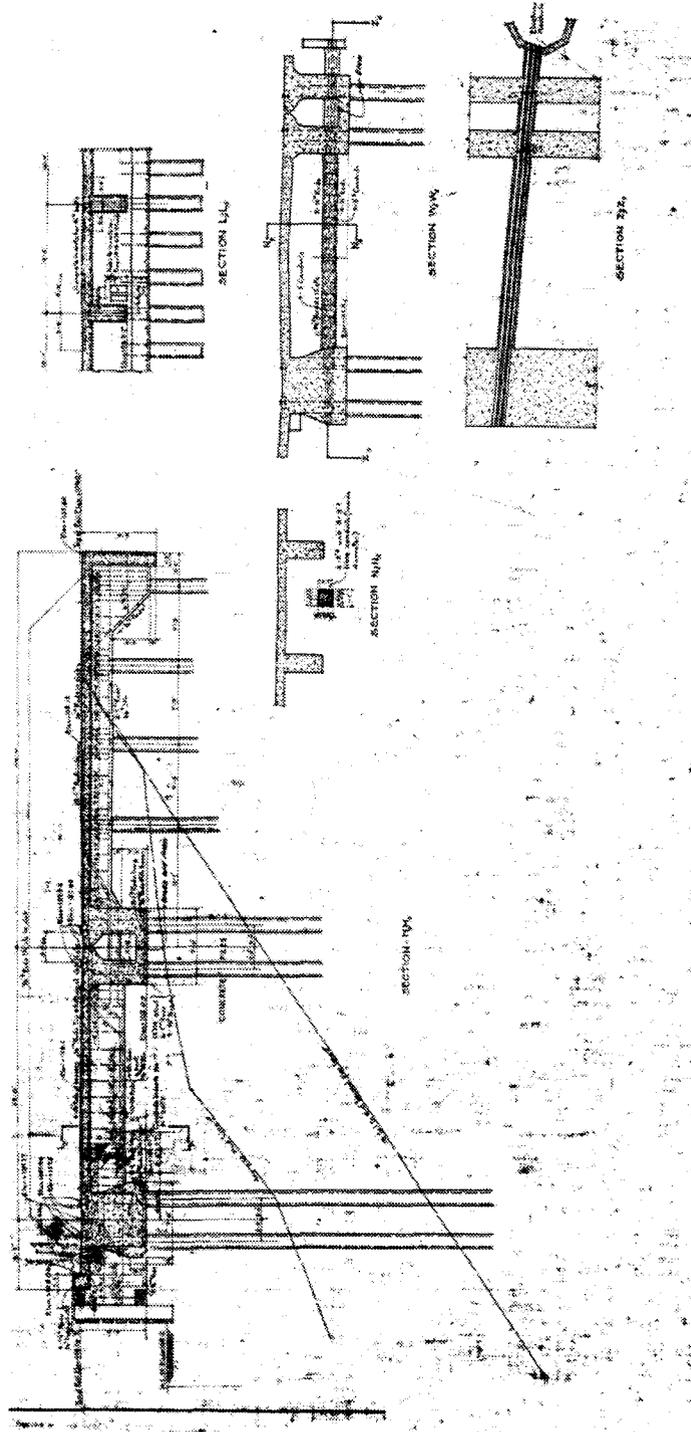
Plans and Sections of South Quay Wall (portion of Drawing No. 95580, dated 6/6/1922)
(reduced, not to scale)

The deck, bents, and beams are of reinforced concrete. Both concrete and composite piles were used. The wearing surface of the

Originally, a wood fender assembly of timber piles and horizontal timber planks attached to the concrete bents. Timber piles butted directly up against the concrete bents and were bolted to a 12" x 12" 'wale' piece at the top of the concrete curb with 4" x 12" x 12" blocking pieces between the wale and the concrete. 8" x 12" or 12" x 30" 'chocks' run between the timber piles, giving the piece stability and strength. On the outside face of the timber piles were horizontal wood planks attached. In 1966, when the quay wall was widened, this well-integrated fender, was replaced with intermittently spaced round creosoted timber piles measuring approximately 1'-6" in diameter. The timber piles are supported by a horizontal row of chocks and blocks that is attached to the top of the curb.

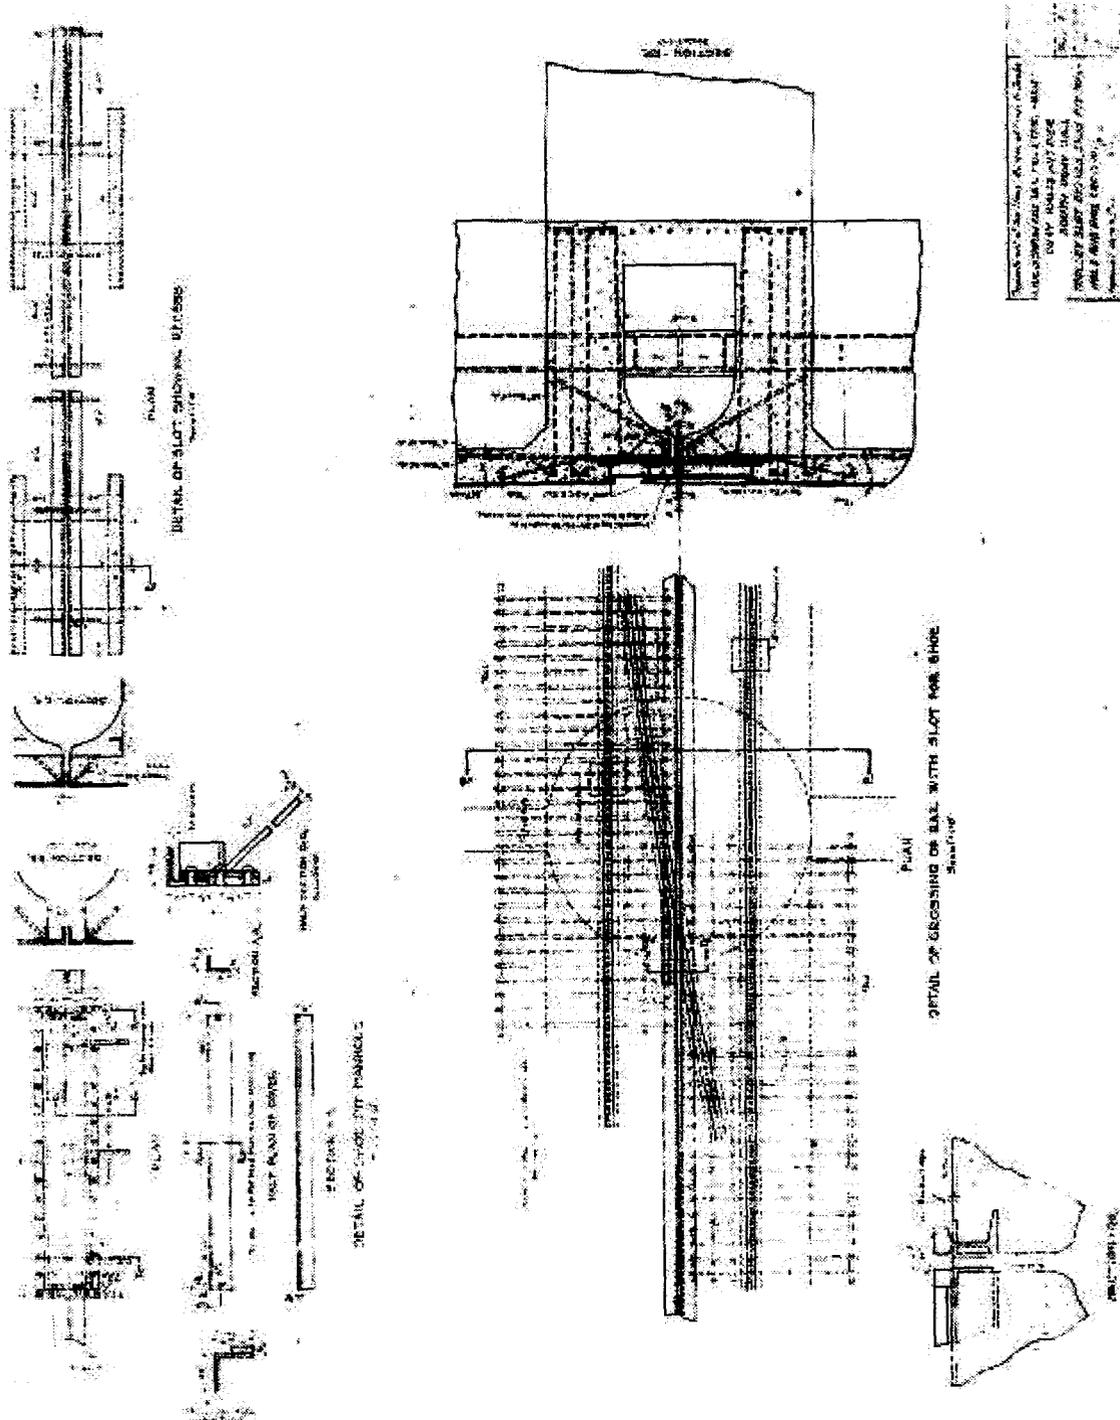
Trolley Slot Details, Shoe Pit Manhole and Rail Crossing (Drawing No. 95596, dated 6/6/1922) (partial drawing, reduced, not to scale)

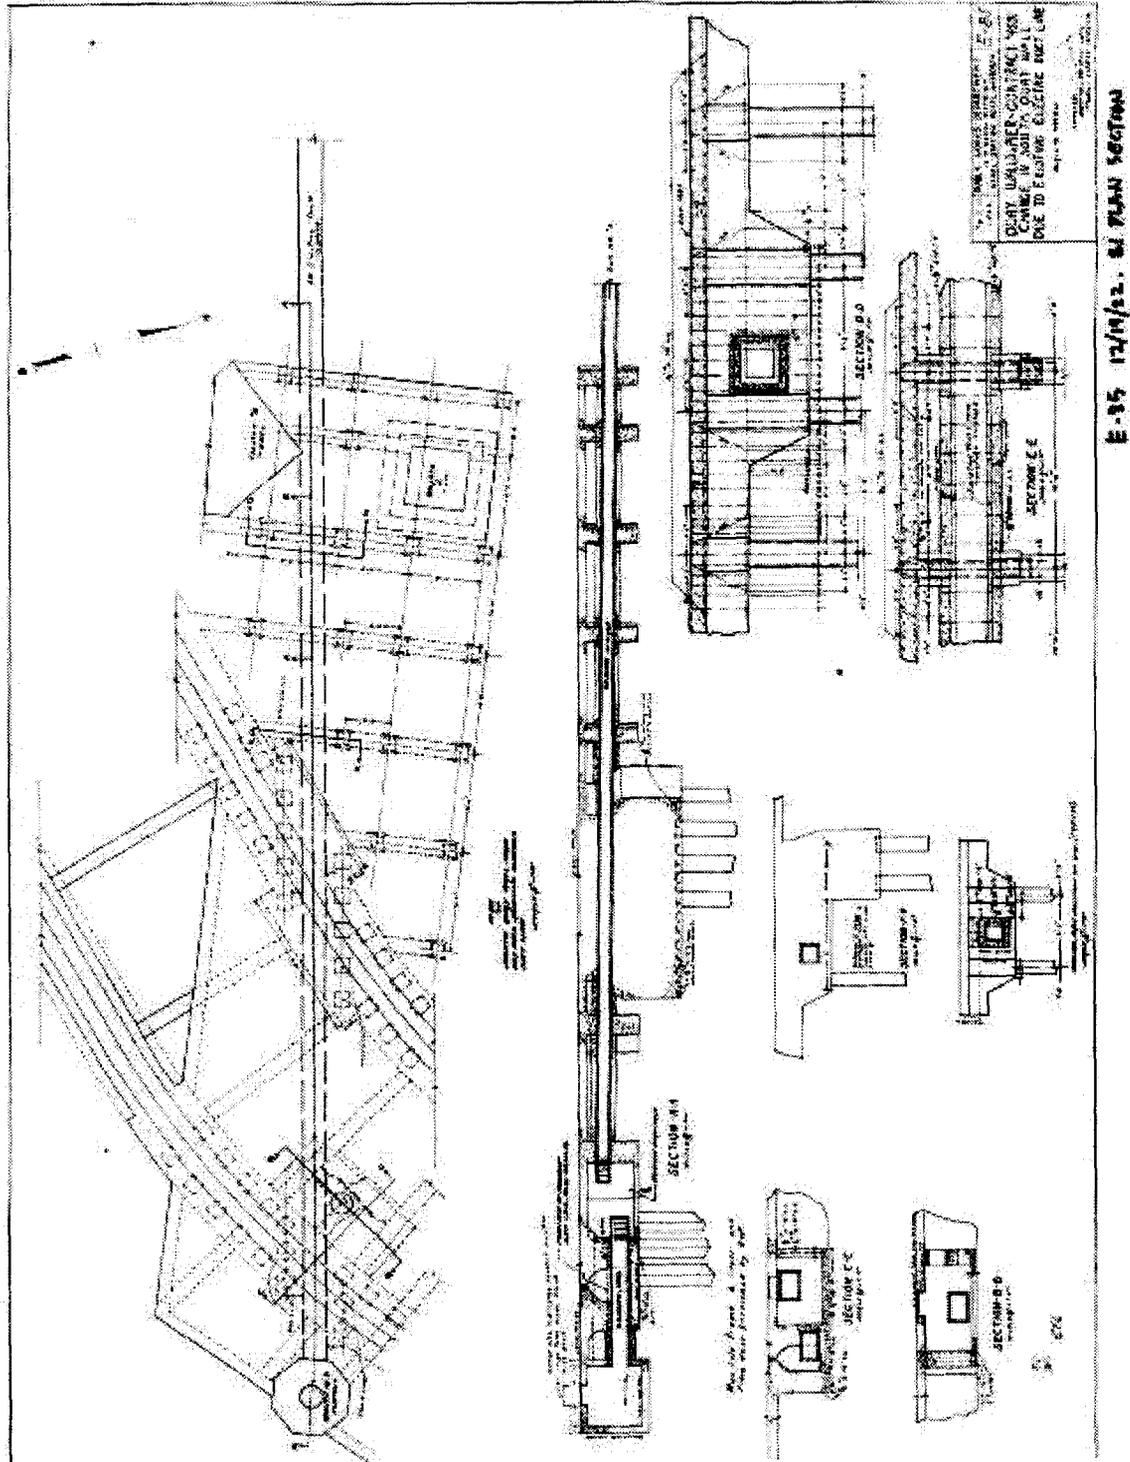
Change in South Quay Wall due to Existing Electric Duct Line
(Drawing No. E-85, dated 12/19/1922) (partial drawing, reduced, not to scale)

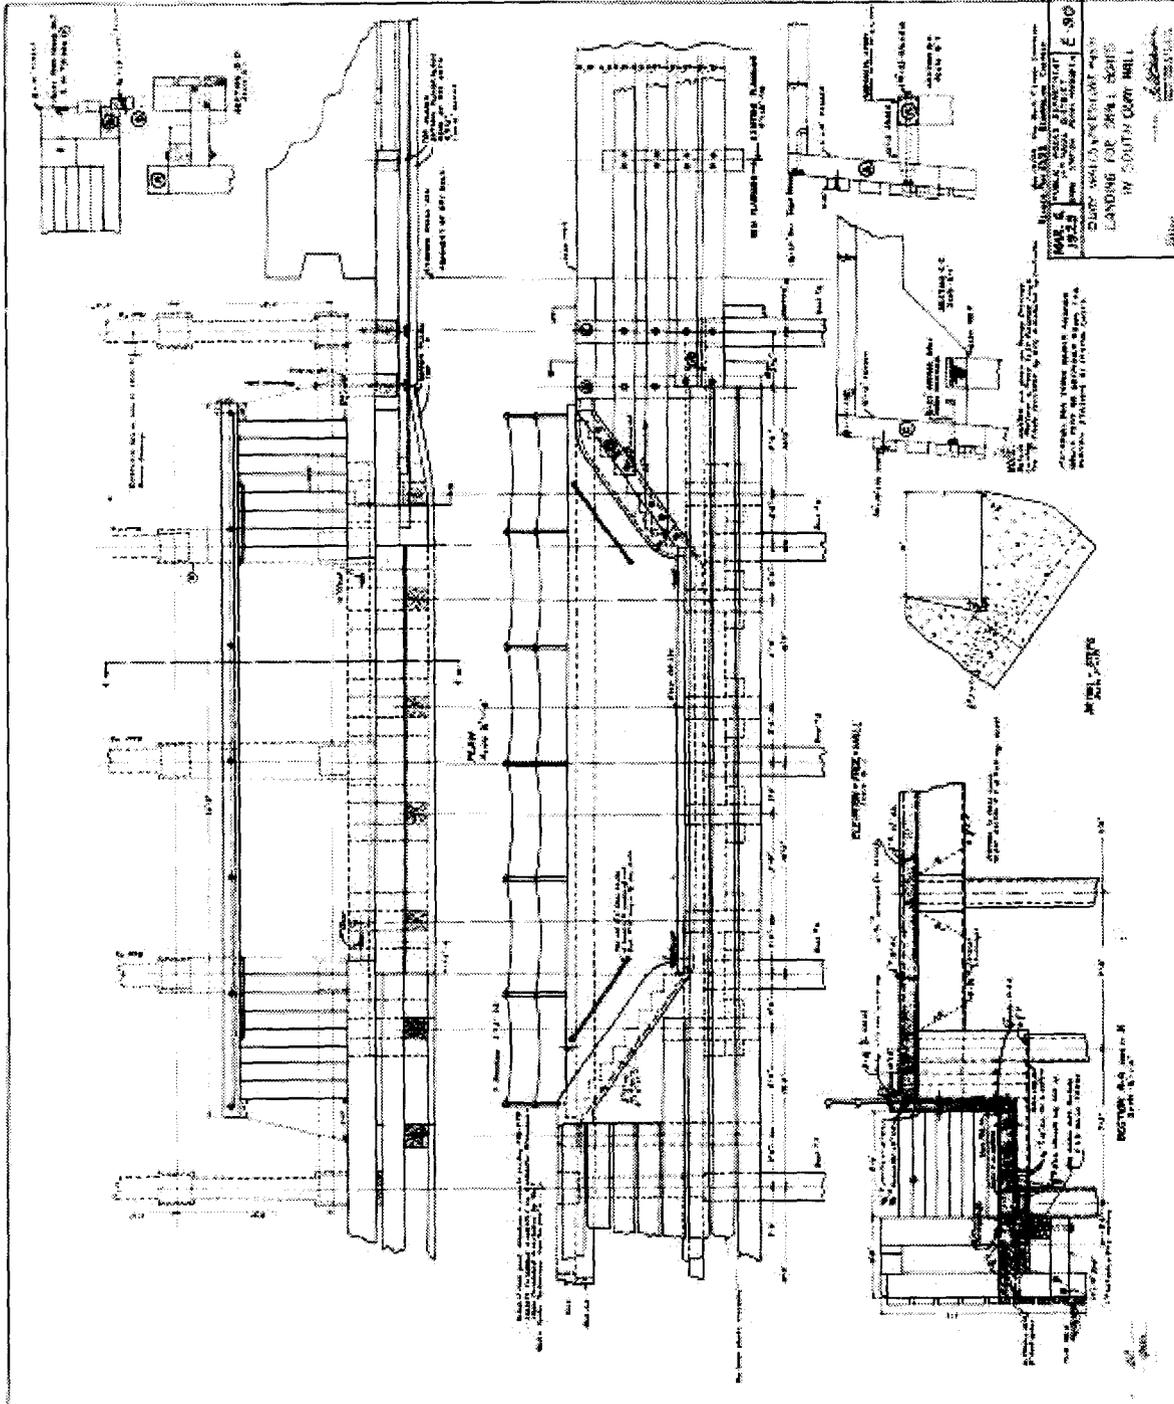
Landing for Small Boats in South Quay Wall (Drawing No. E-90, dated 3/6/1923)
(reduced, not to scale)

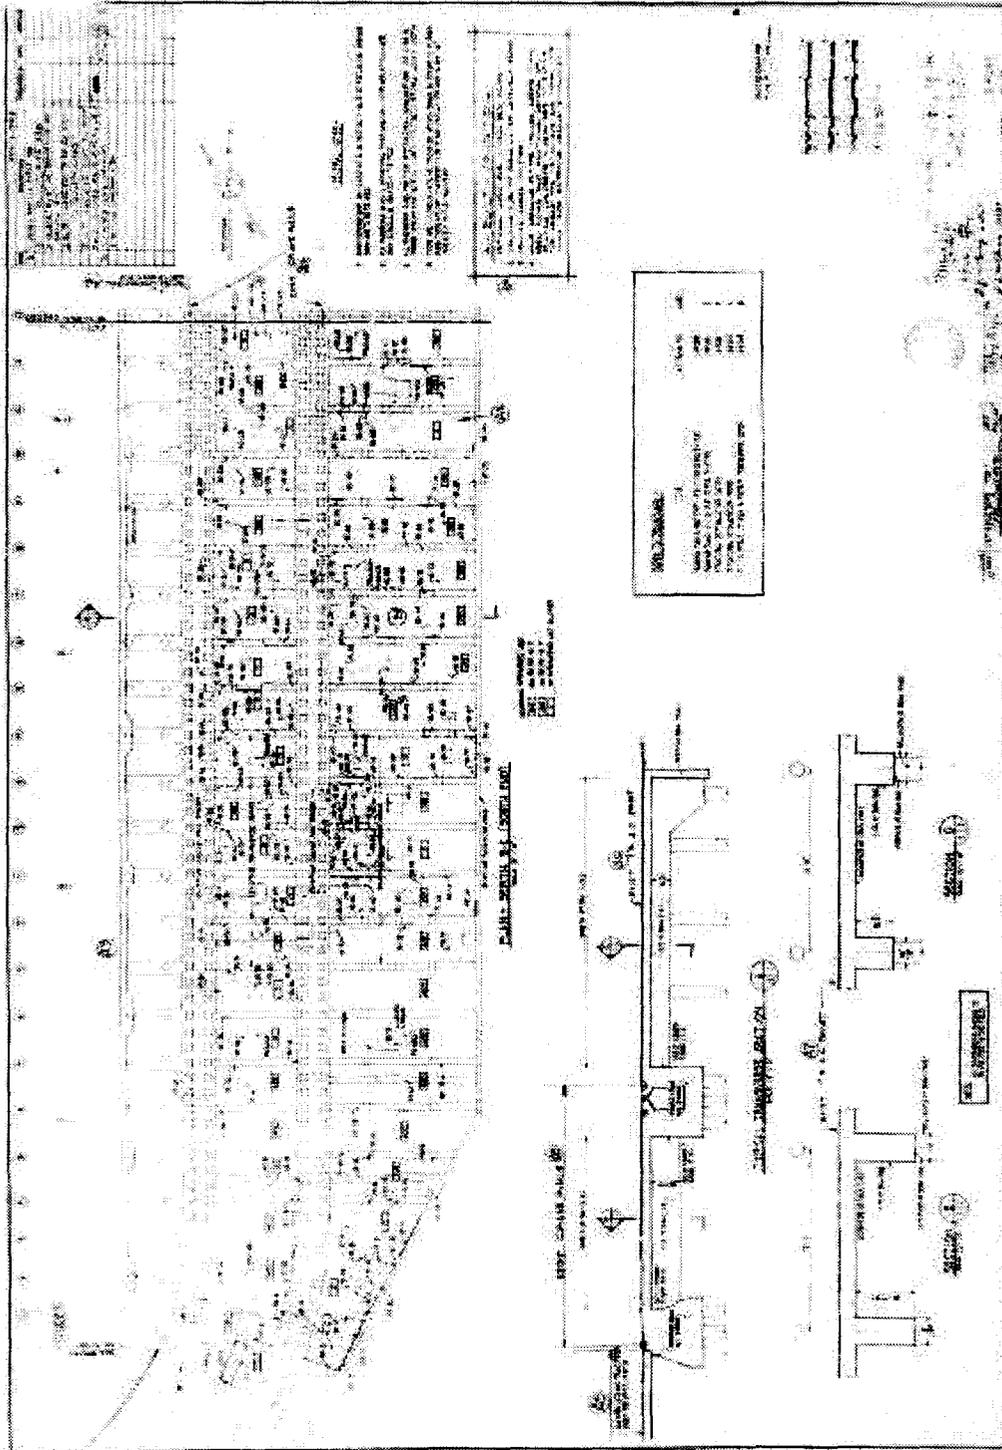
Framing Plan and Section of Reconstruction of Pier B-1
(Drawing No. 1084259, dated 6/17/1966) (reduced, not to scale)

In 1966, the quay walls along the length of First Street were enlarged, repaired, and upgraded. Under MCN Projects U106-01 and V101-01 Contract No. Nby-50755, Hawaiian Dredging Company reconstructed several portions of quay walls B-1, B-2, and B-3. The work included wharf expansion and upgrading of electrical and water lines. Total cost for the construction of Facility B-1 was \$888,322.00. More upgrades were undergone in 1982 and again in 1997.
