U.S. NAVAL BASE, PEARL HARBOR, PIER & QUAY WALLS  
(U.S. Naval Base, Pearl Harbor, Naval Shipyard, Facilities Nos. GD  
-3, GD-4 & GD-5)  
Entrance to Dry Dock No. 2 & Repair Wharfs, east & west sides of  
Dry Dock No. 2 & west side of Dry Dock No. 3  
Pearl Harbor  
Honolulu County  
Hawaii

U.S. NAVAL BASE, PEARL HARBOR, PIER & QUAY WALLS  
(U.S. Naval Base, Pearl Harbor, Naval Shipyard)  
(Facilities Nos. GD-3, GD-4, & GD-5)

**Location:** Quay walls at east and west sides of Dry Dock No. 2 and west side of Dry Dock No. 3  
Pearl Harbor Naval Base  
City and County of Honolulu, Hawaii  
These facilities' UTM coordinates are 04.607780.2361460.

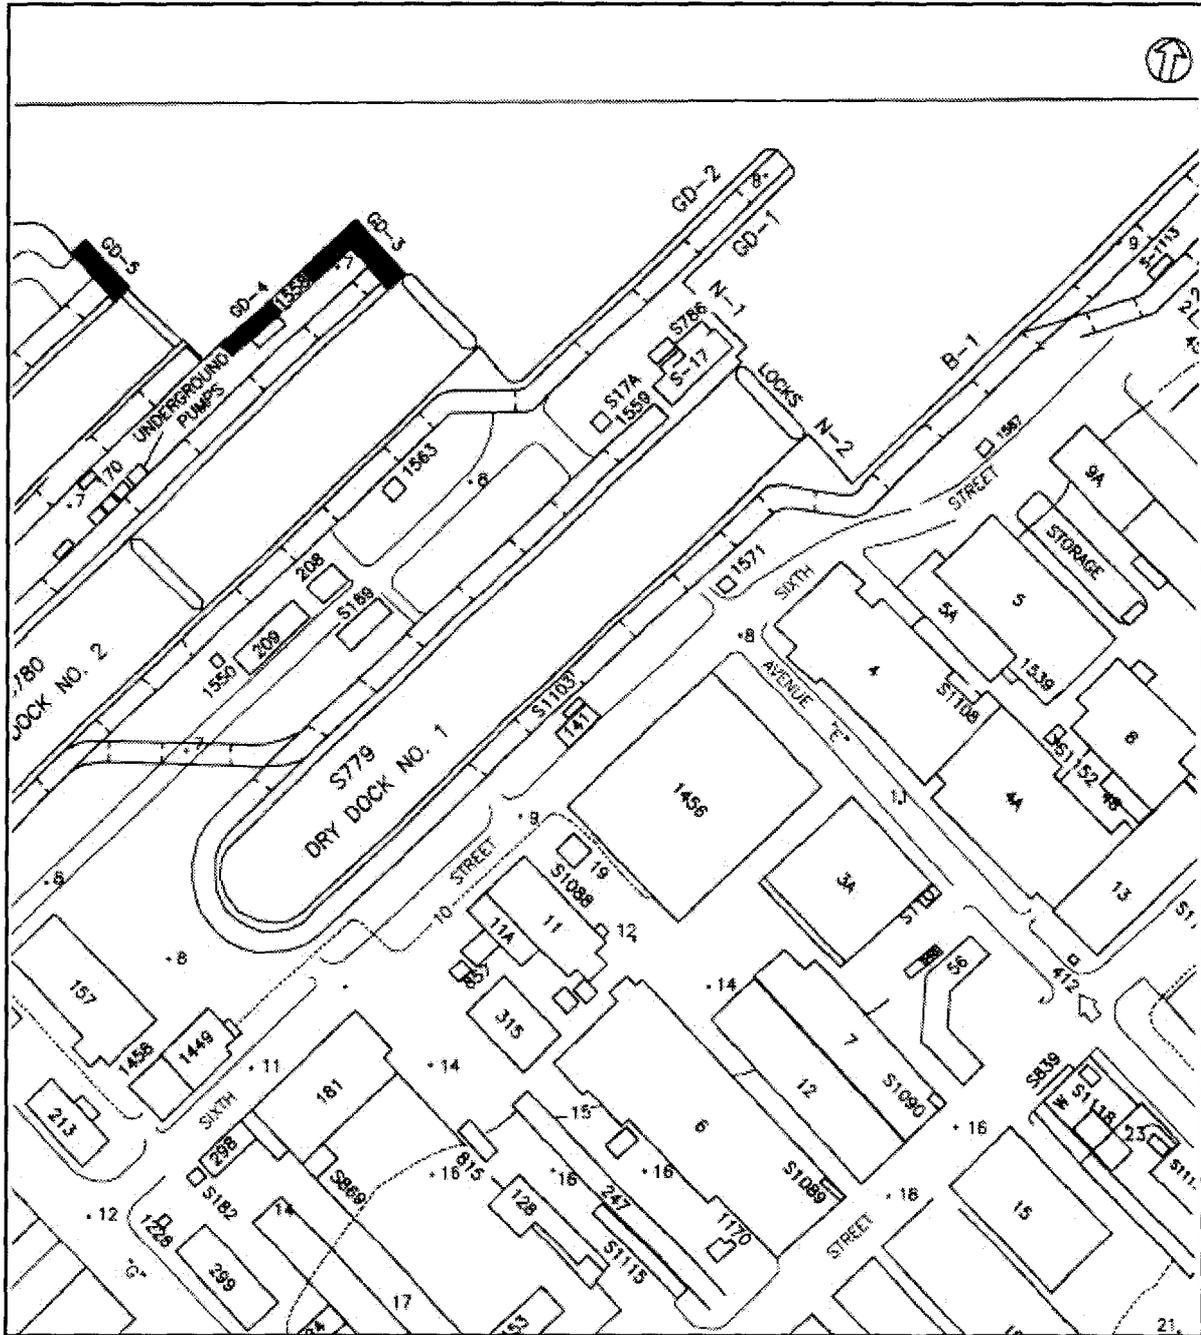
Enlarged Area Map (reduced, not to scale)

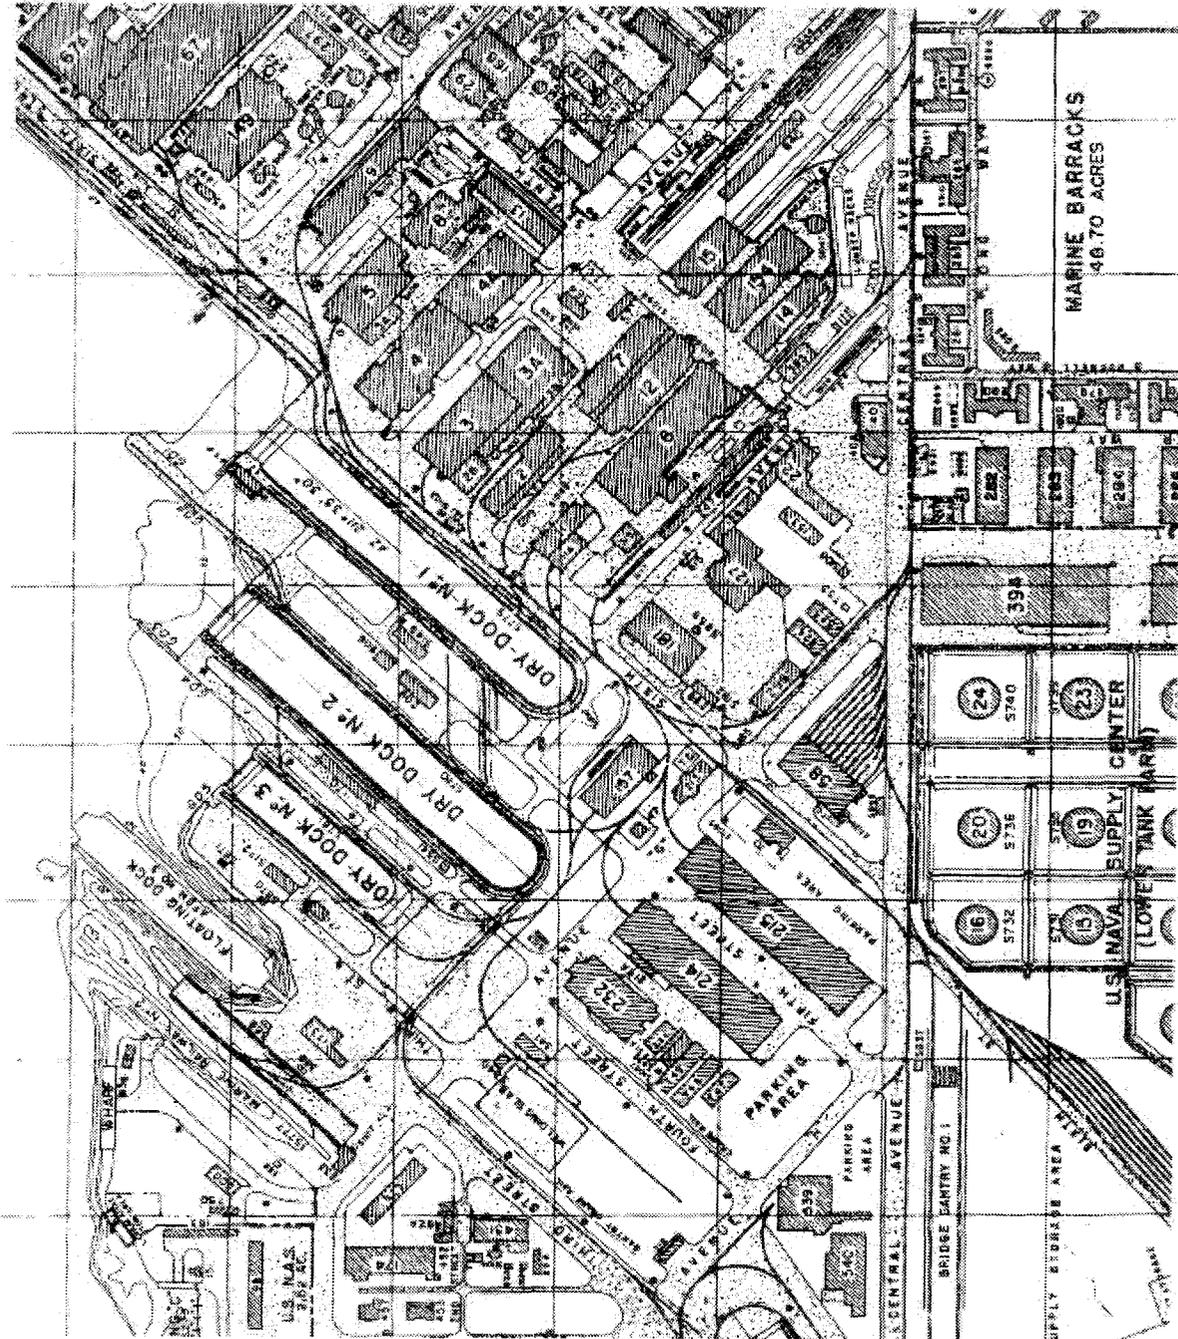
**1951 Map Showing Dry Dock Area including the original GD3 Pier before its Demolition**  
(Pearl Harbor, Oahu, T.H. Fourteenth Naval District, 30 June 1951)

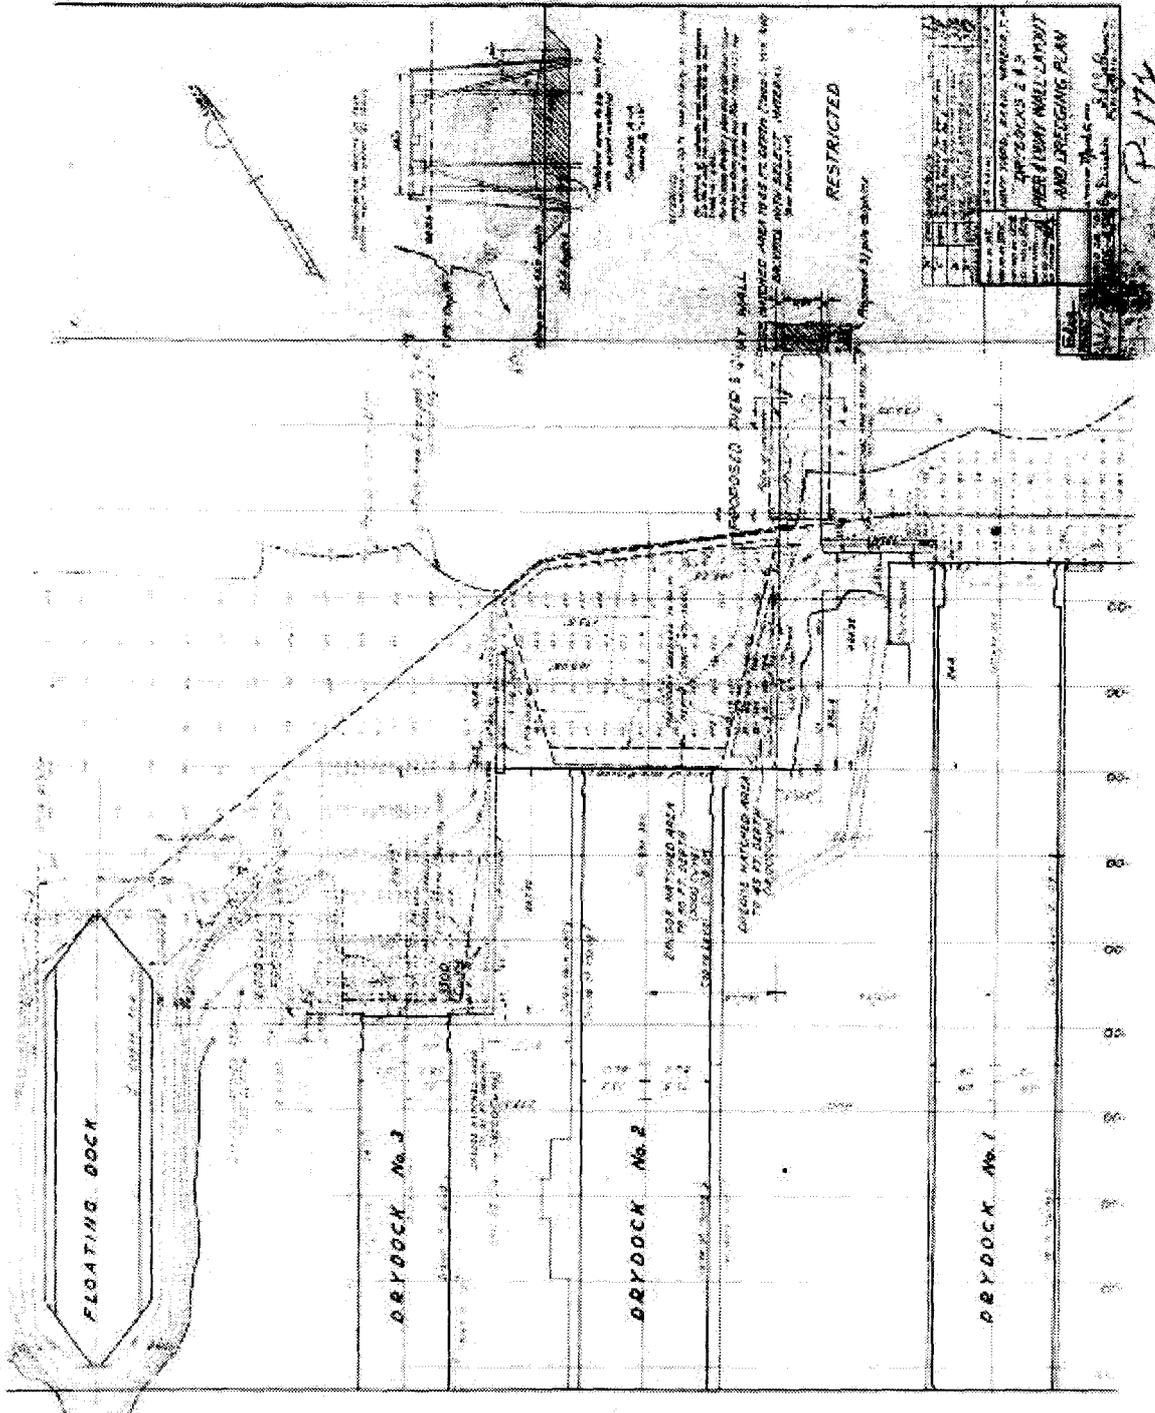
**Dry Dock Nos. 2 and 3 Dredging Plan, Showing Quay Wall and Dock Locations  
 (Drawing No. I-N16-454, dated 3/6/1941) (reduced, not to scale)**

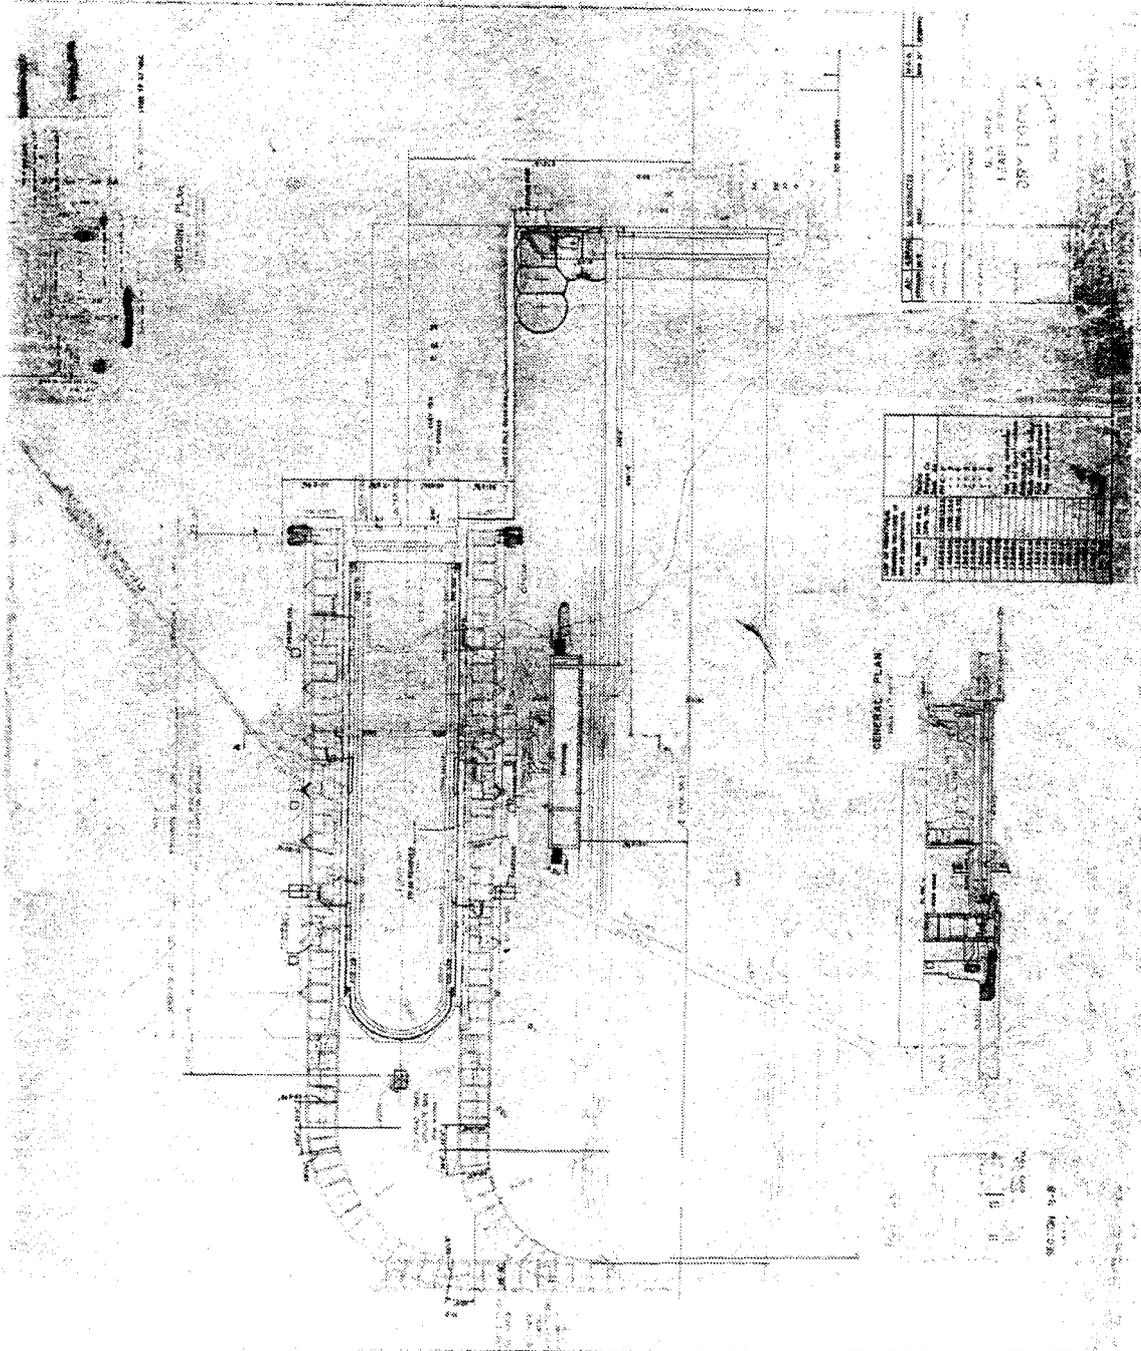
Dry Dock Nos. 2 and 3, General Layout (Drawing No. 134003, dated 4/28/1942)  
(reduced, not to scale)

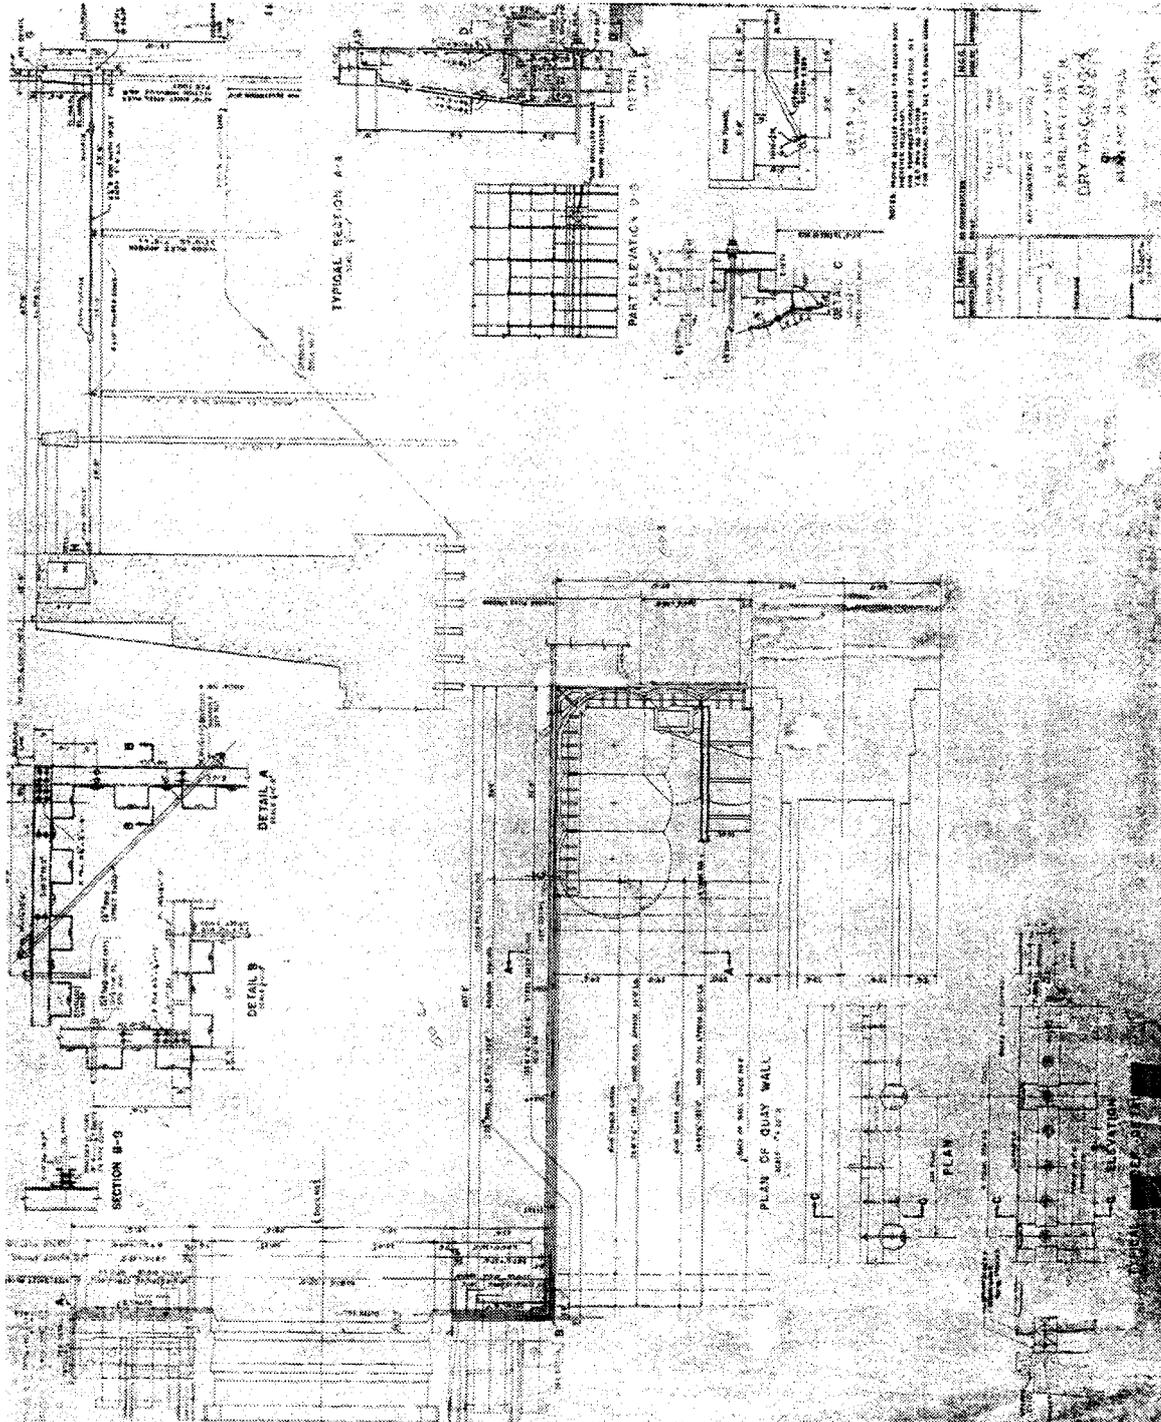
**Dry Dock Nos. 2 and 3, Plans, Sections, and Details (Drawing No. 134019, dated 4/28/1942) (reduced, not to scale)**

Quay Walls GD3 and GD4 are supported by steel sheet pilings as well as timber piles. At the ocean end of the corner of Dry Dock No. 2 where GD3 and GD4 meet, circular-shaped sheet piles held together by steel rods intersect each other, supporting the deck above. The steel sheet pilings have a diameter of 45.84 feet with 108 piles per cell. The intersections of the circular sheet piles in plan create the unusual V-shape indentations in the elevation of the deck's walls when looking at it from the ocean side. These exterior walls were once exposed sheet metal piling; however, due to deterioration, these have been repaired and concrete walls, which follow the circular pilings below, have been built. There are 2'-0" diameter drainage pipes within the walls, opening out at the face of the wall to allow water to escape.

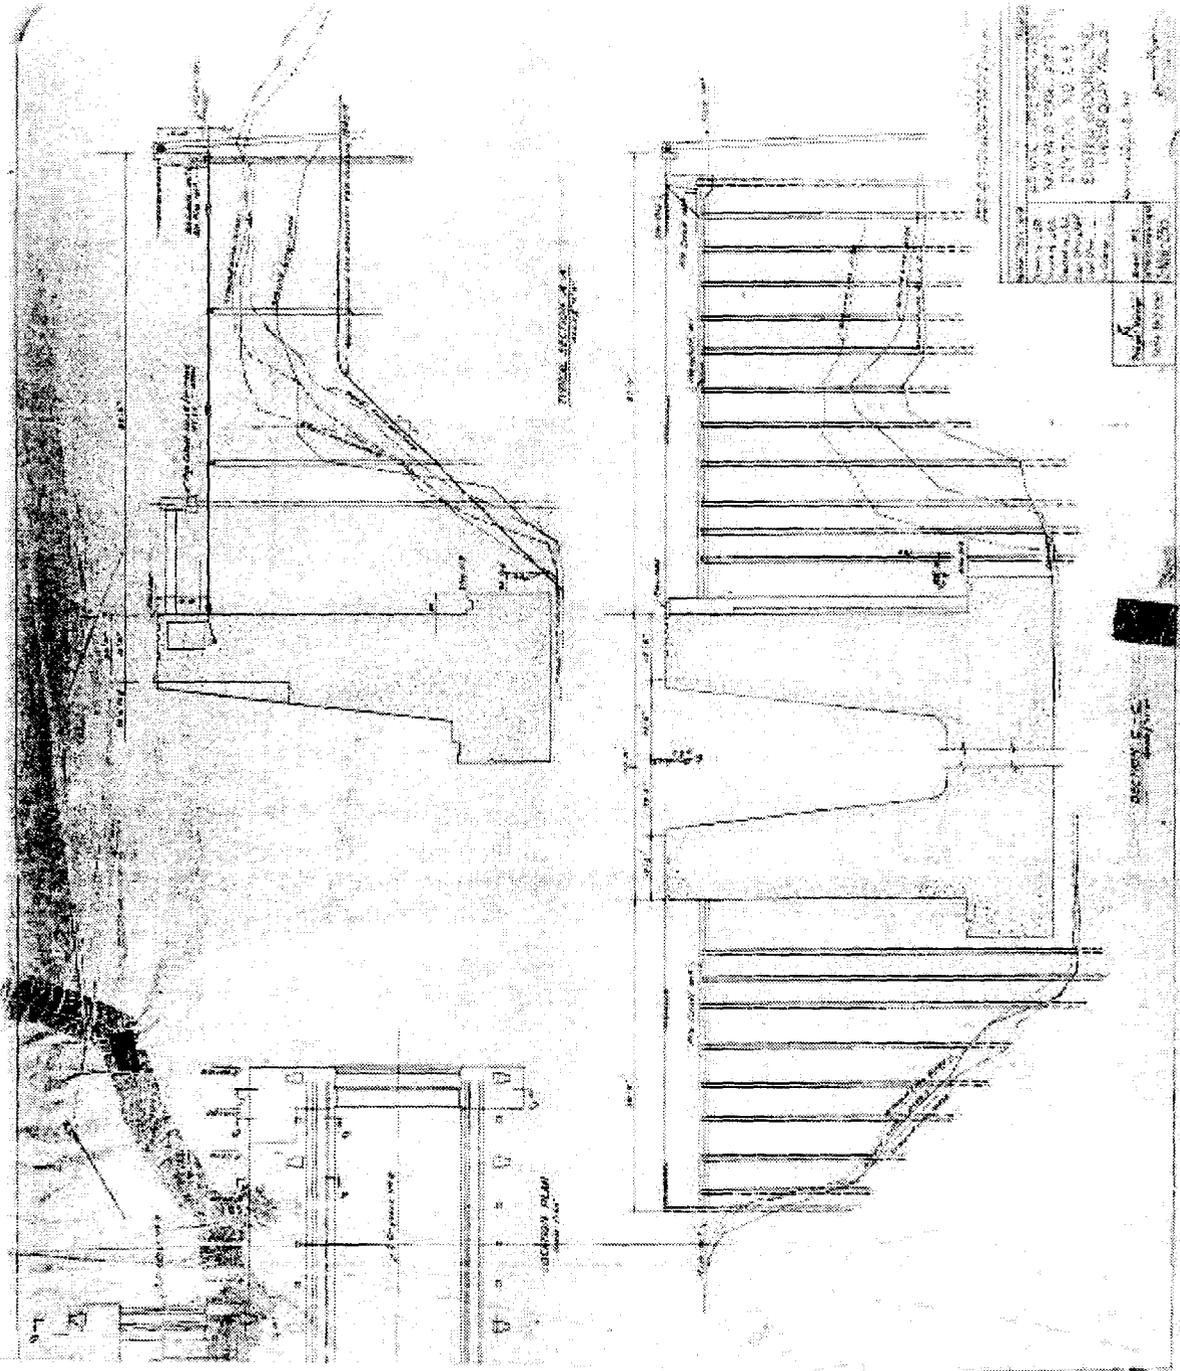
**Dry Dock Nos. 2 and 3, Plans and Cross-Sections (Drawing No. I-N16-258, dated 5/13/1940) (reduced, not to scale)**

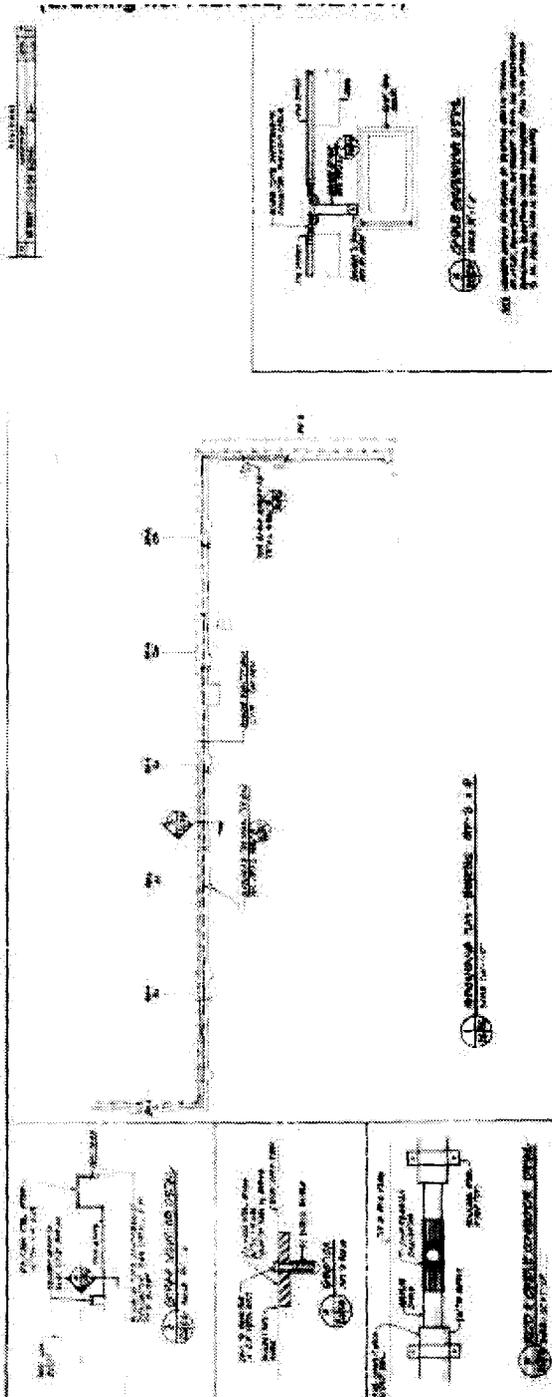
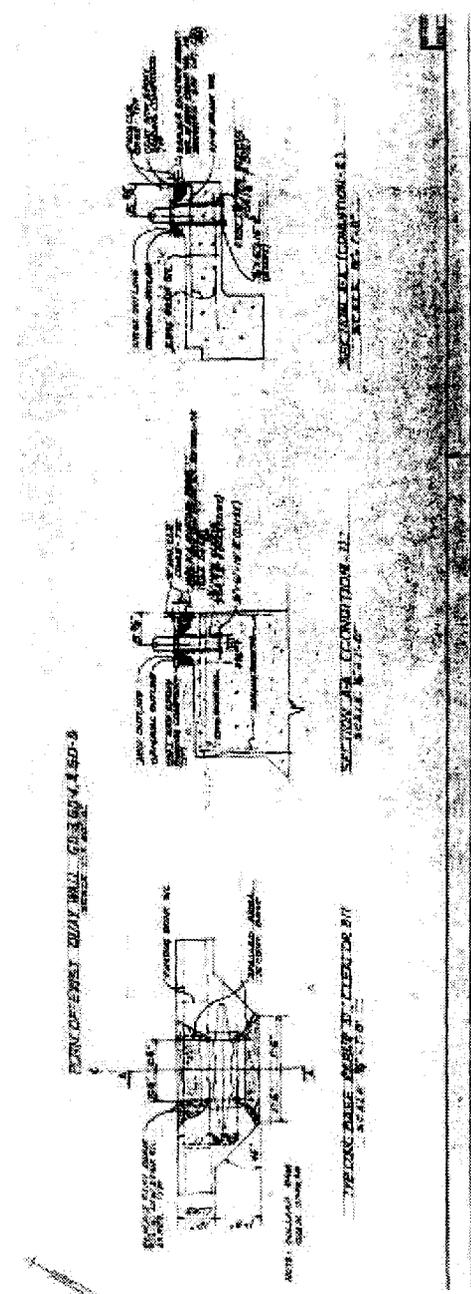
**Dry Dock Nos. 2 and 3, Electrical System Safety Improvements (Drawing No. 7027062,  
 dated 5/12/1981) (reduced, not to scale)**

In 1972, the cleats were repaired and some concrete work was performed. In 1981, the electrical system was upgraded. Presently, the quay walls are in relatively poor condition, including the fenders. The exterior walls are cracking in places. The deck is in fair condition.
