HAWAII VOLCANOES NATIONAL PARK WATER COLLECTION
SYSTEM

HAER HI-76

HISTORIC AMERICAN ENGINEERING RECORD

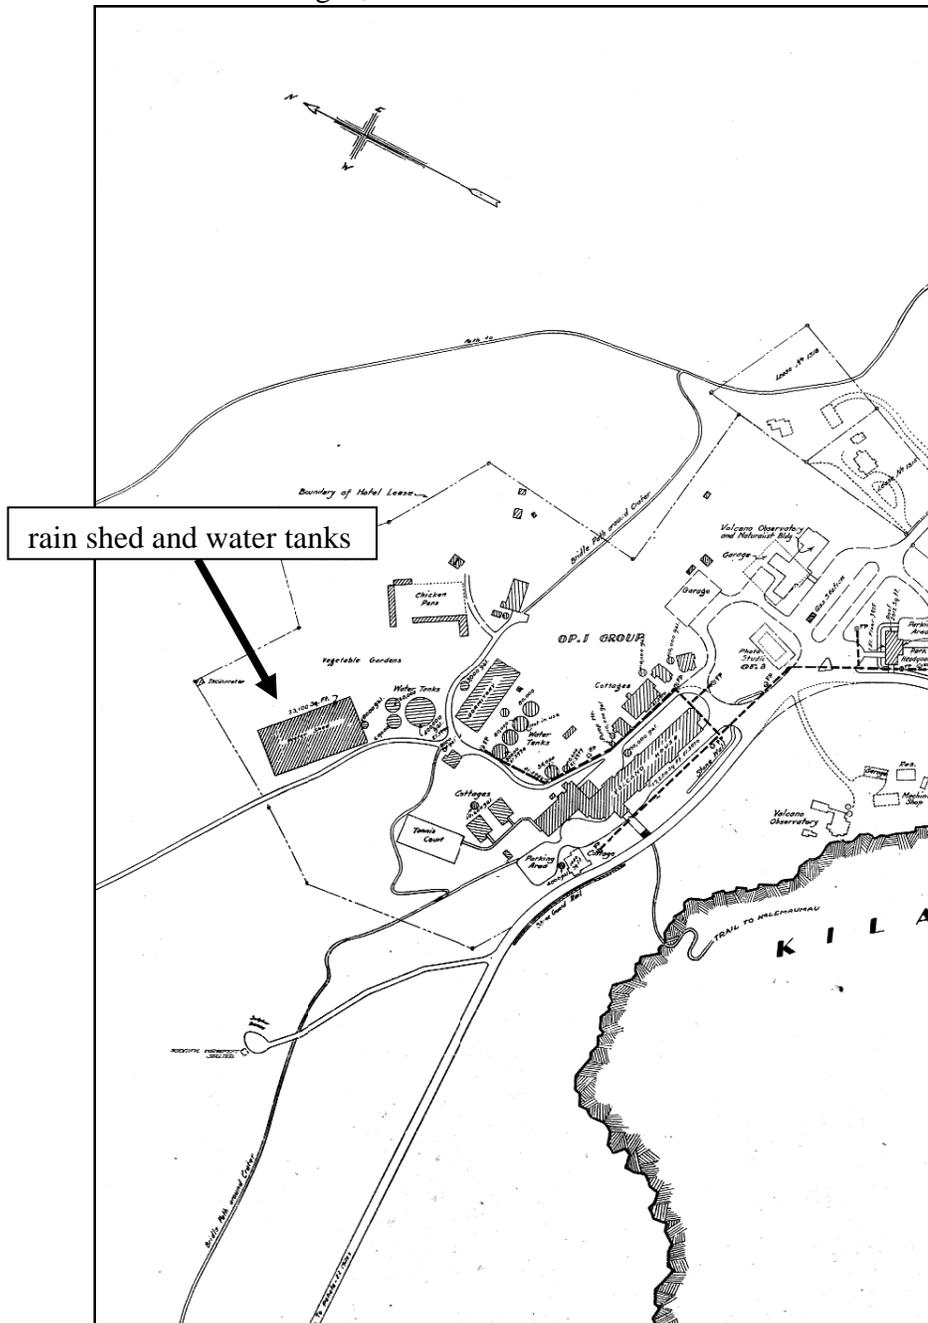
Figure 1: Map notes the square footage of the rain shed was 23,100 square feet. Note the water tanks have not yet been installed north of the shed. Detail from Department of the Interior, National Park Service, Hawaii National Park, "Existing & Proposed Water Lines," Map to accompany report by W.E. Robertson, Associate Engineer, Office of Chief Engineer, 1937.

Plans of the headquarters area dating to 1937 and 1938 depict the early water collection system and its proposed changes (See Figure 1). The Volcano House Hotel Company had a collection of tanks with capacities ranging from 4,000 to 80,000 gallons scattered behind the hotel, as well as a rain shed and pump house to supply the hotel with water. The park's water collection system consisted of tanks associated

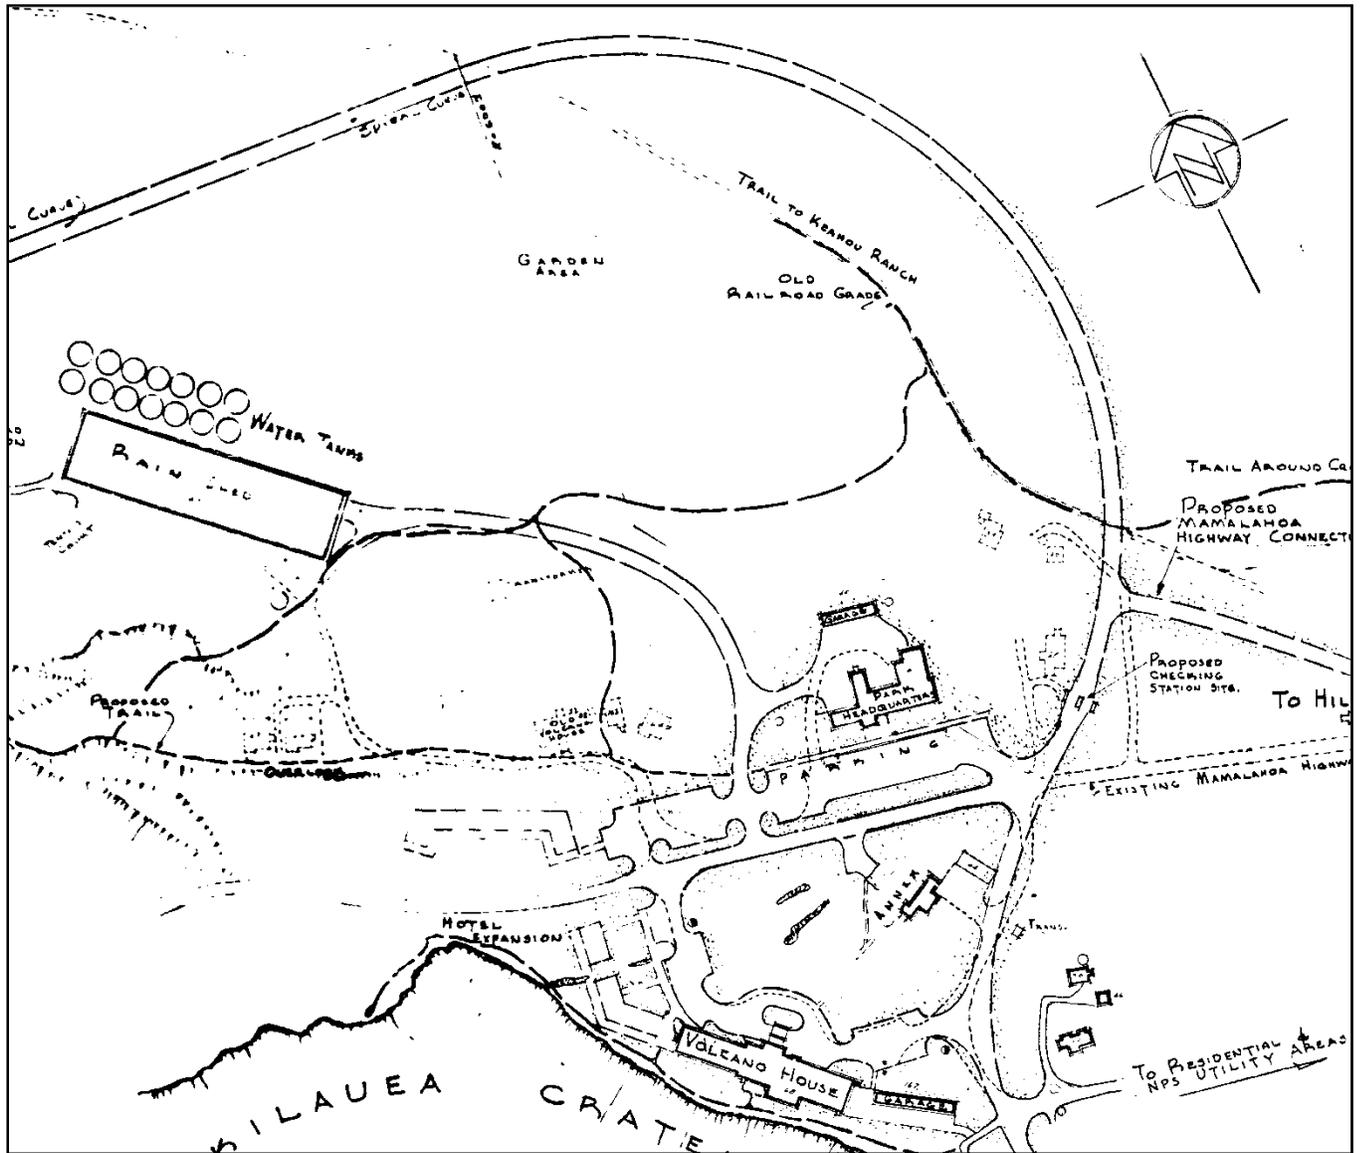
Figure 2: Detail of map showing 1949-50 extension of the rain shed by 176' to the southeast and fourteen water tanks on the northeast side of the shed and relationship of site to visitor center (delineated Park Headquarters on map) and Volcano House hotel. Note that the row of water tanks extends beyond the northwest end of the shed. United States Dept. of the Interior, National Park Service, Landscape Division, "Headquarters Area," Drawing HAW-2035, 1951.

shed extension. By March 1950, the construction of the roof was complete, as was the painting (see Figure 2). A completion report notes: “salvaged material for additional extension (16’). Completed additional extension. Total length completed 176’. Entire length of rainshed to be painted.” The suggestion in the completion report of an “additional extension” seems to indicate that the plans were changed. This may explain why in April 1950, the project was noted as only 80 percent complete when in January it had been at 90 percent. It was estimated that the extension and resulting increase of roof surface would allow the collection of 2,344,896 gallons a year, based on the “water collection formula of 59 gallons per square foot of shed per year.”⁵⁵ Further work was undertaken on the building in July, when a windbreak was added at the northeast side of the building “to eliminate the possibility of damage to the building in the event of a severe windstorm and to provide better protection to the heavy equipment” stored within the building. Salvaged materials, this time from a dismantled barracks at the former CCC camp, were used in this project as well.⁵⁶

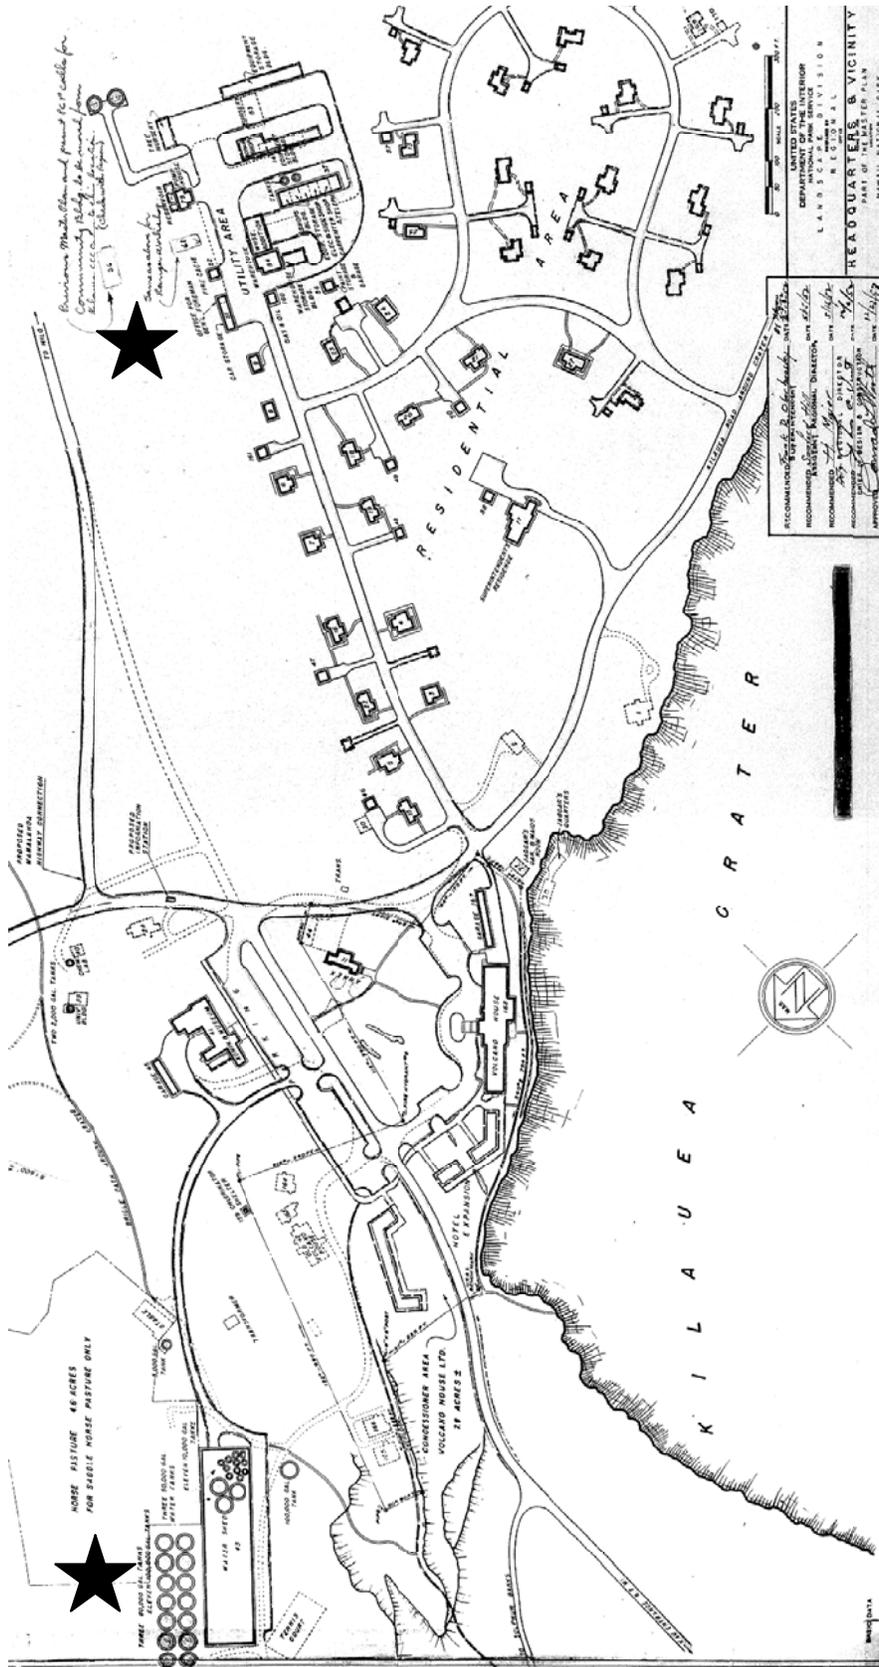
Figure 3: 1952 map detail. Star to left is over rows of water tanks extending beyond the northwest wall of the watershed. Note also the random placement of water tanks under the shed roof. The star to the right is over the Utility Area. United States Department of the Interior, National Park Service, Landscape Division, "Headquarter and Vicinity," Drawing 3049-I, 1952.

condition, as evidenced by a photograph depicting decaying chime joists in one tank that had been built over a steam vent.⁵⁹ In addition to adding some of the Volcano House hotel's former tanks to the system, the park also incorporated the 10,000-gallon tanks formerly in use at the CCC camp. In January and February of 1950 eleven tanks were moved from the CCC camp and installed under the rain shed at the headquarters area.⁶⁰ By 1953, there were fourteen tanks located under the rain shed with one outside the southwest corner. To the rear of the rain shed and shielded from visitor's eyes was a collection of fourteen redwood tanks grouped in two rows, with plans to locate an additional six tanks at the end of the battery (see Figures 3 and 4).⁶¹

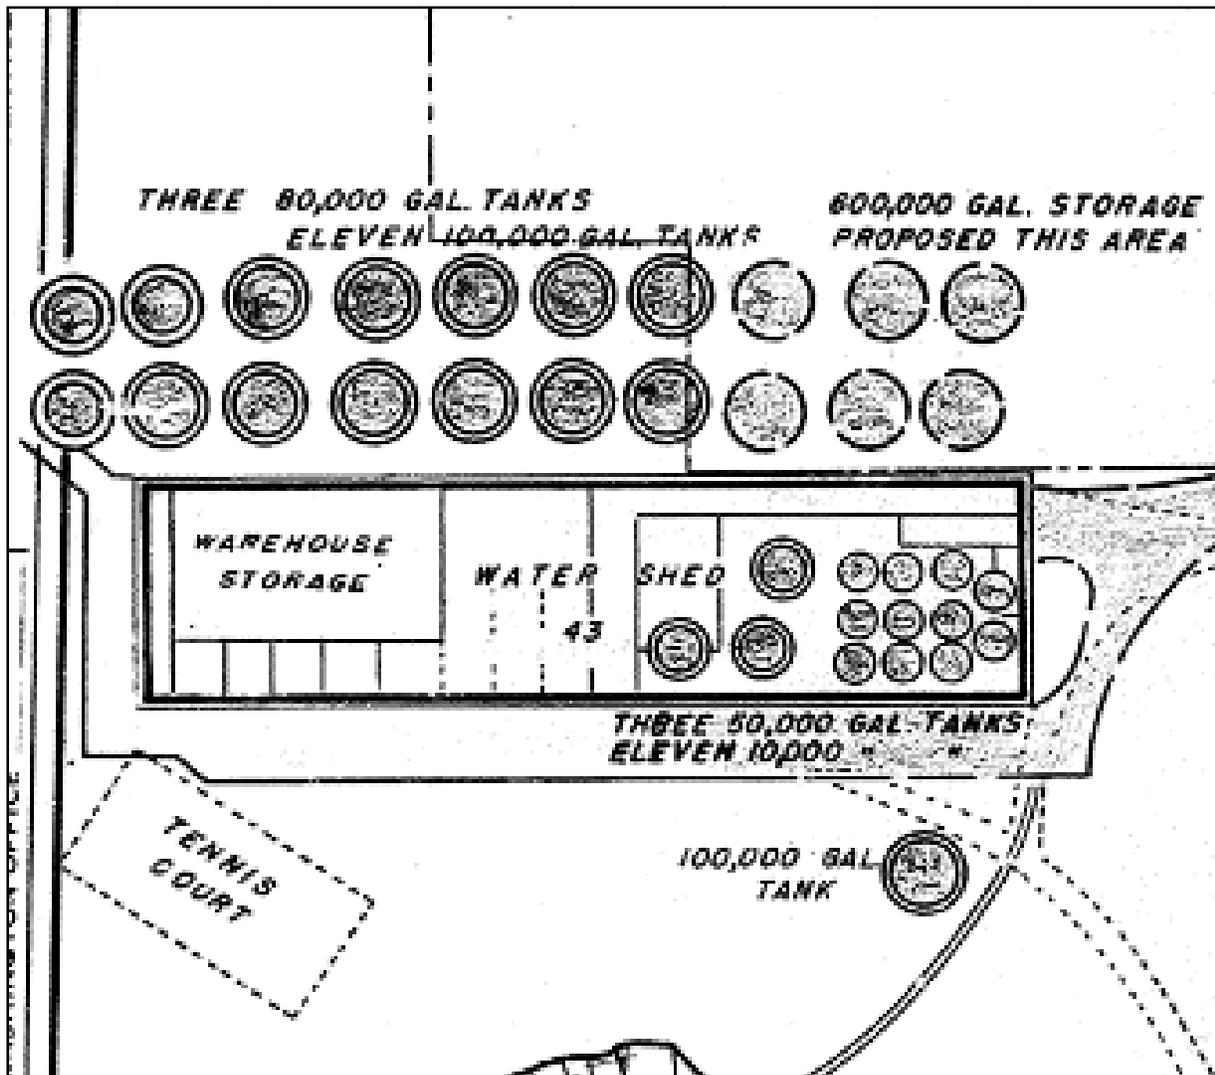
Figure 4: Detail of 1953 map depicting the interior floor plan/layout of the rain shed. United States Department of the Interior, National Park Service, Landscape Division, "Headquarters and Vicinity," Drawing 3049-J, 1953.

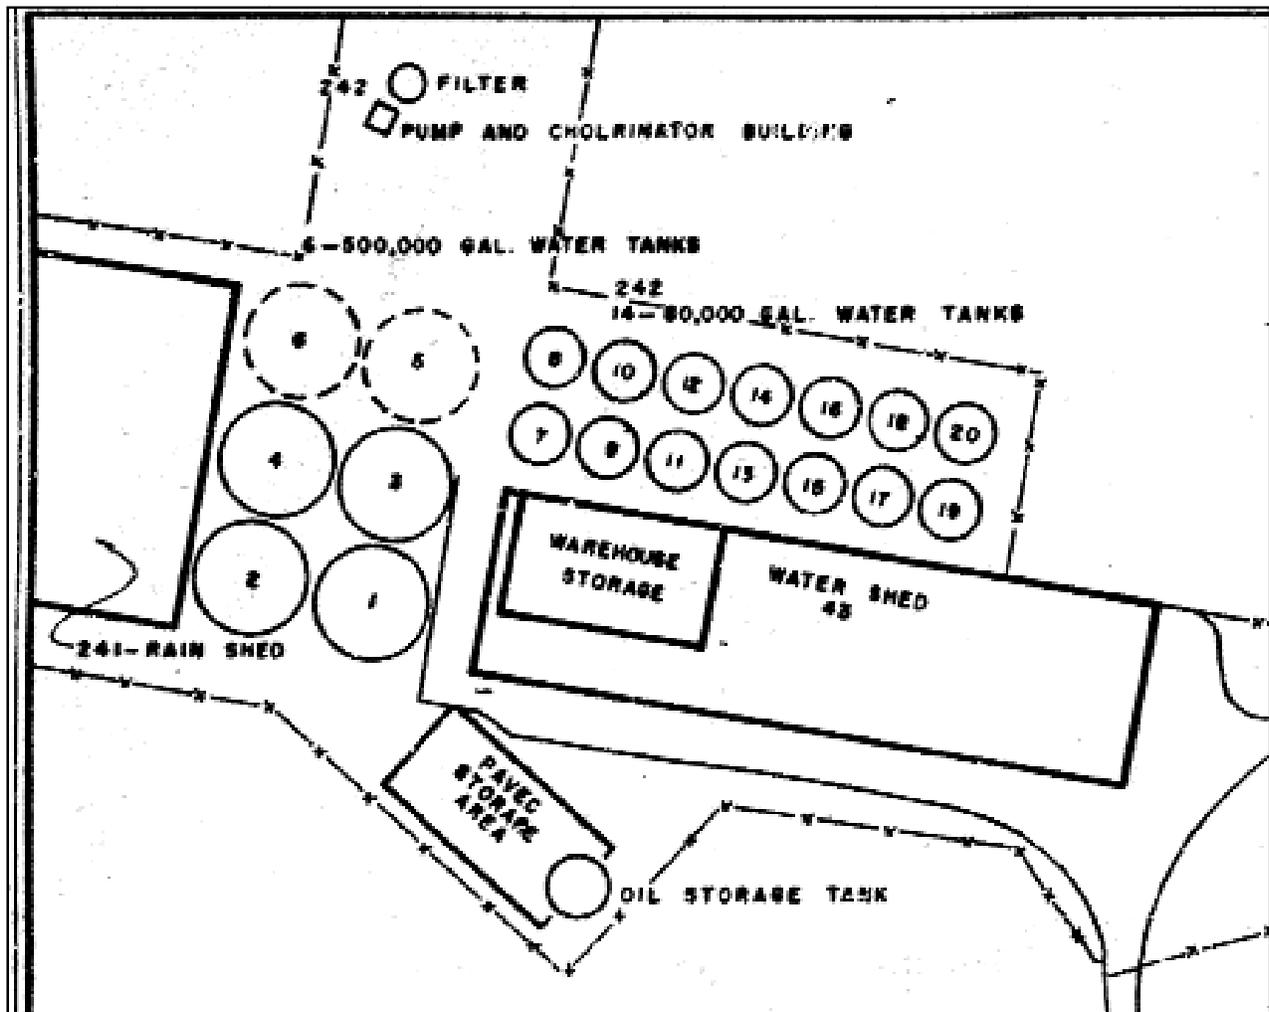
Figure 5: Detail of 1964 Master Plan showing the corner of the new rain shed (Building 241), old rain shed (Building 43), fourteen redwood water tanks (numbers 6-20), constructed and planned steel water tanks (numbers 1-6), filter, and pump house. United States Department of the Interior, National Park Service, Engineering Division, Hawaii Volcanoes National Park, "Kilauea Headquarters Area, Part of the Master Plan, Hawaii Volcanoes National Park," Drawing No. NP-HAVO 3049-L, August 1964.

to one of the four 500,000-gallon steel water tanks. Numbered one through four, the tanks were not only connected to the filter tank by a 2 ½" pump line but also were connected to the 6" main distribution line, which made a loop around the headquarters and residential sections of the park (see Figure 5). The 6" main was connected to the residences and buildings via 6" and 4" mains.¹²⁰ In 1962, the distribution system was extended to the U.S. Geological Survey's Hawaiian Volcano Observatory on Uwekahuna and a pump house constructed.¹²¹
