Plowman Sawmill (Lois Amyx Barn)  
N. Bank of Payette River  
Montour  
Gem County  
Idaho

HABS No. ID-47

## HISTORIC AMERICAN BUILDINGS SURVEY

PLOWMAN SAWMILL  
 (Lois Amyx Barn)

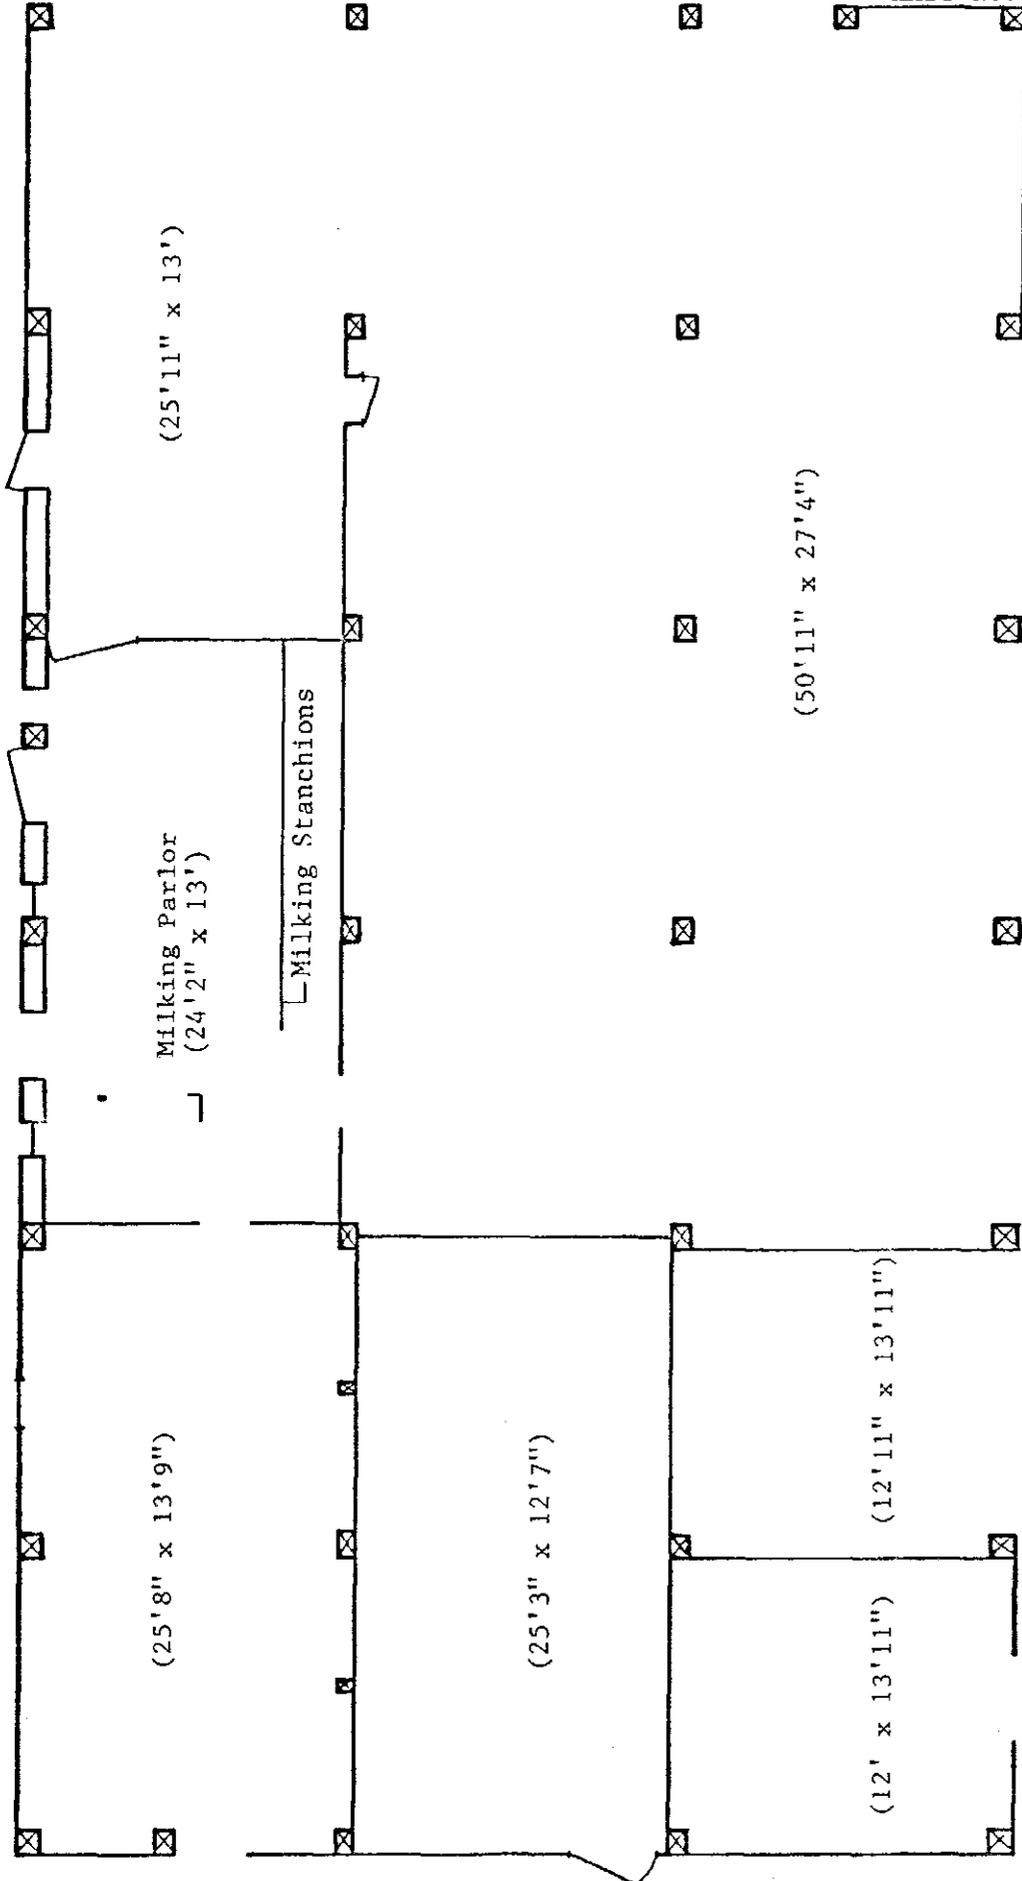
PLOWMAN SAWMILL - First Floor  
Approx 1/8 Scale (now used as a barn)

1. Foundations: Under the corner posts at the southeast end of the building, there are concrete pier foundations. The aggregate is exposed; it is river gravel. Similar pier foundations are visible along the southwest side. Elsewhere, piers were not accessible to be seen, owing within the building to a large accumulation of litter. Where they were found, the foundations were 0 to 6 inches above ground level.
2. Wall construction: The walls are of vertical boards. They range from  $\frac{3}{4}$  to  $\frac{7}{8}$  inch thick and from 10 to  $11 \frac{3}{8}$  inches wide. Many of them rise the height of the

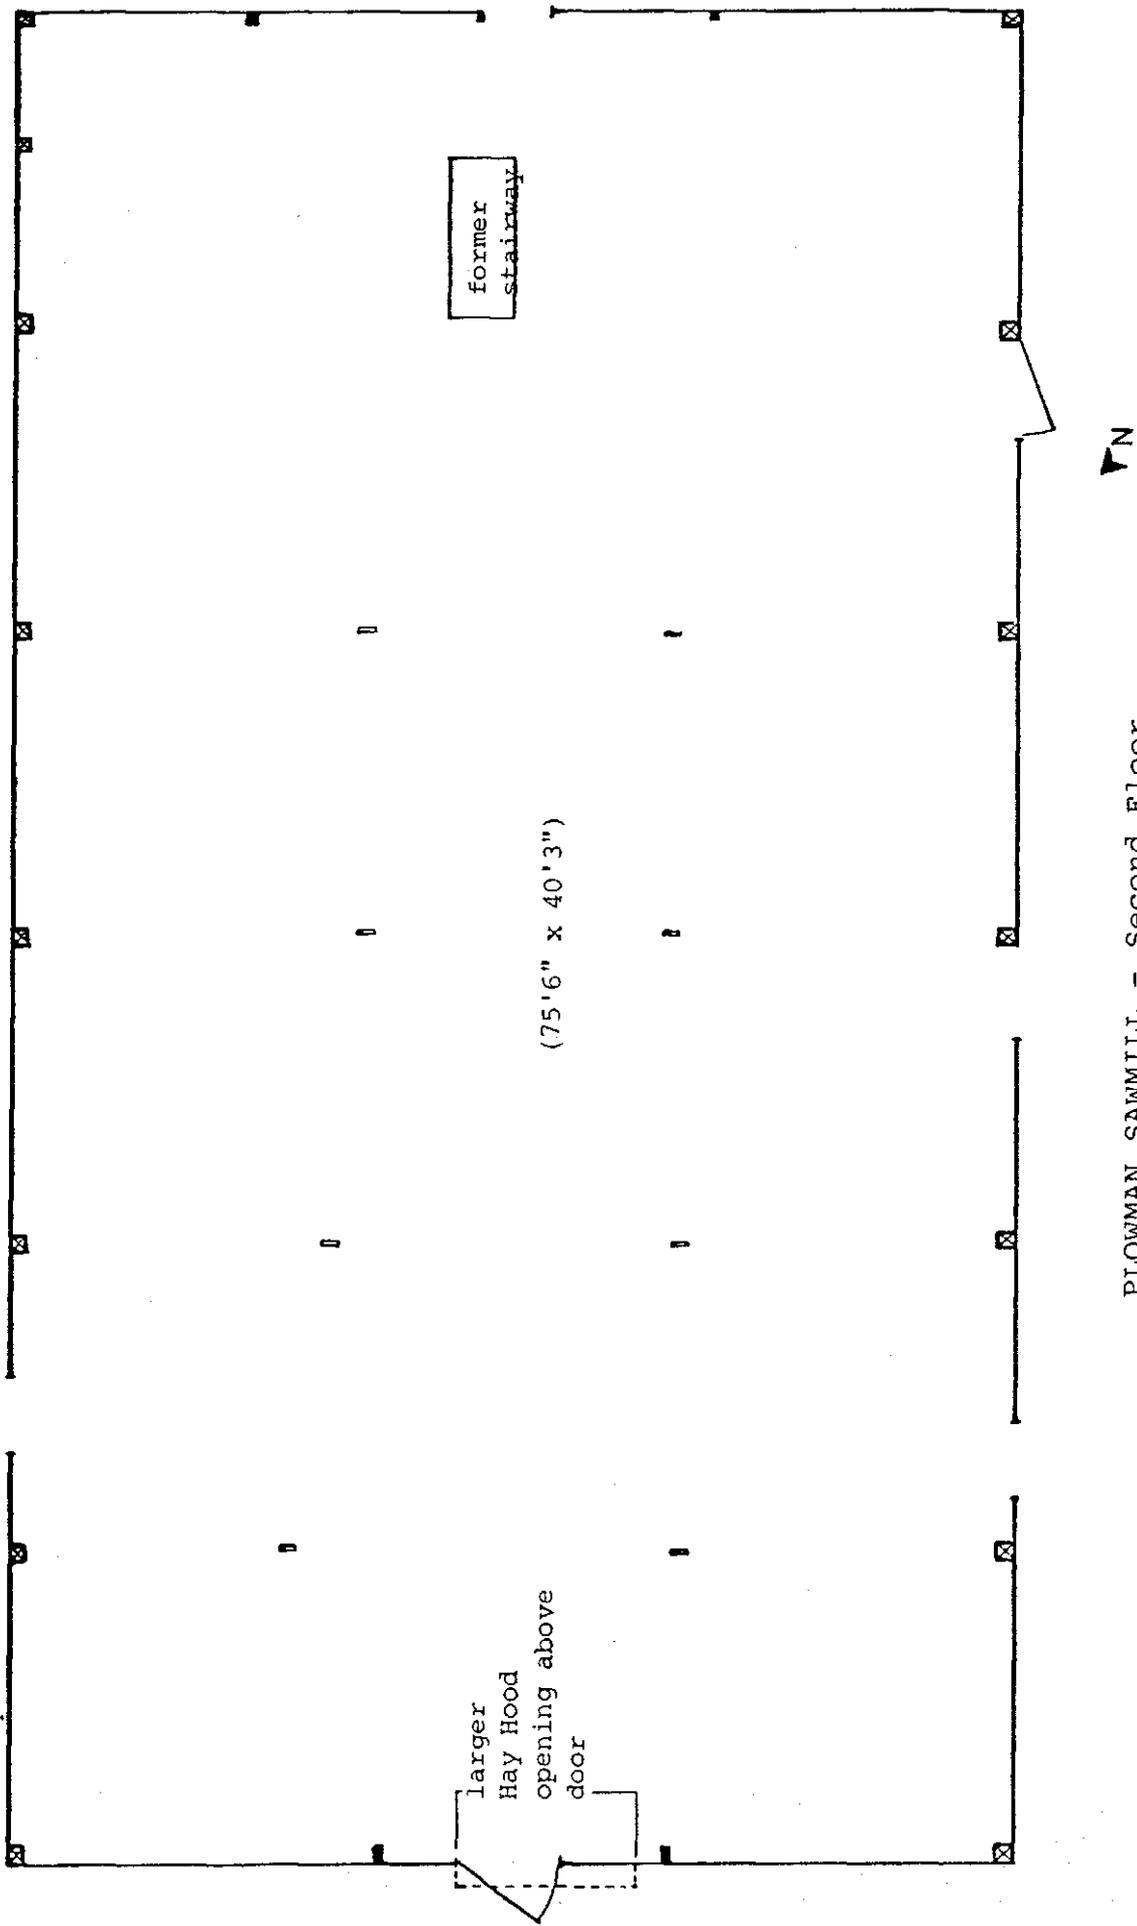
PLOWMAN SAWMILL - Second Floor  
approx. 1/8 scale (now used as a barn)

At the upper level the flooring in most of the center bay on the southeast end and the adjoining bay on the northwest is principally vee-grooved matchboards. The rest of the upper-level flooring appears to be of the same material as the exterior siding and in some places is in poor condition.
