Merkel Farmstead, House
8570 Louella Lane
South Side of U. S. 64
Vicinity of Shiloh
Shiloh Valley Township
St. Clair County
Illinois

HABS No. IL-1191-A

MERKEL FARMSTEAD, HOUSE

PART II. ARCHITECTURAL INFORMATION

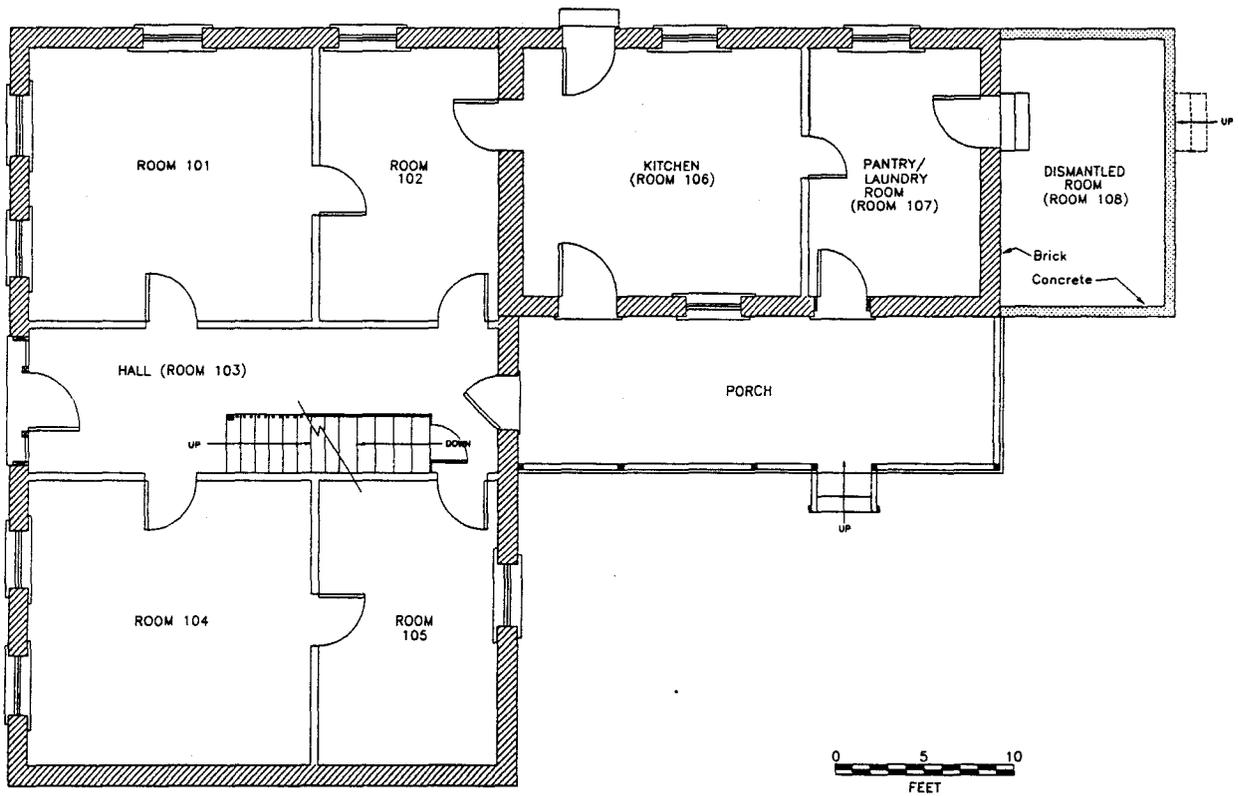
Figure 1. Ground floor plan of Merkel House.
Drawn by F. Mansberger.

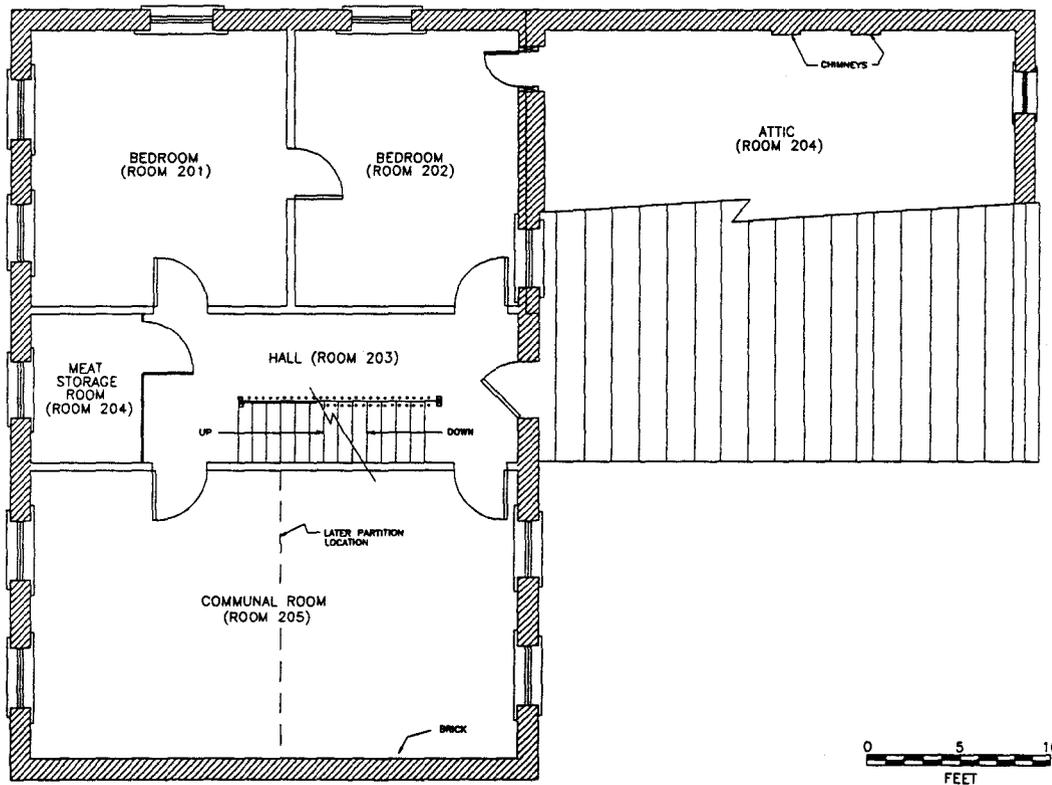
Figure 2. Second story floor plan of the Merkel House.
Drawn by F. Mansberger.

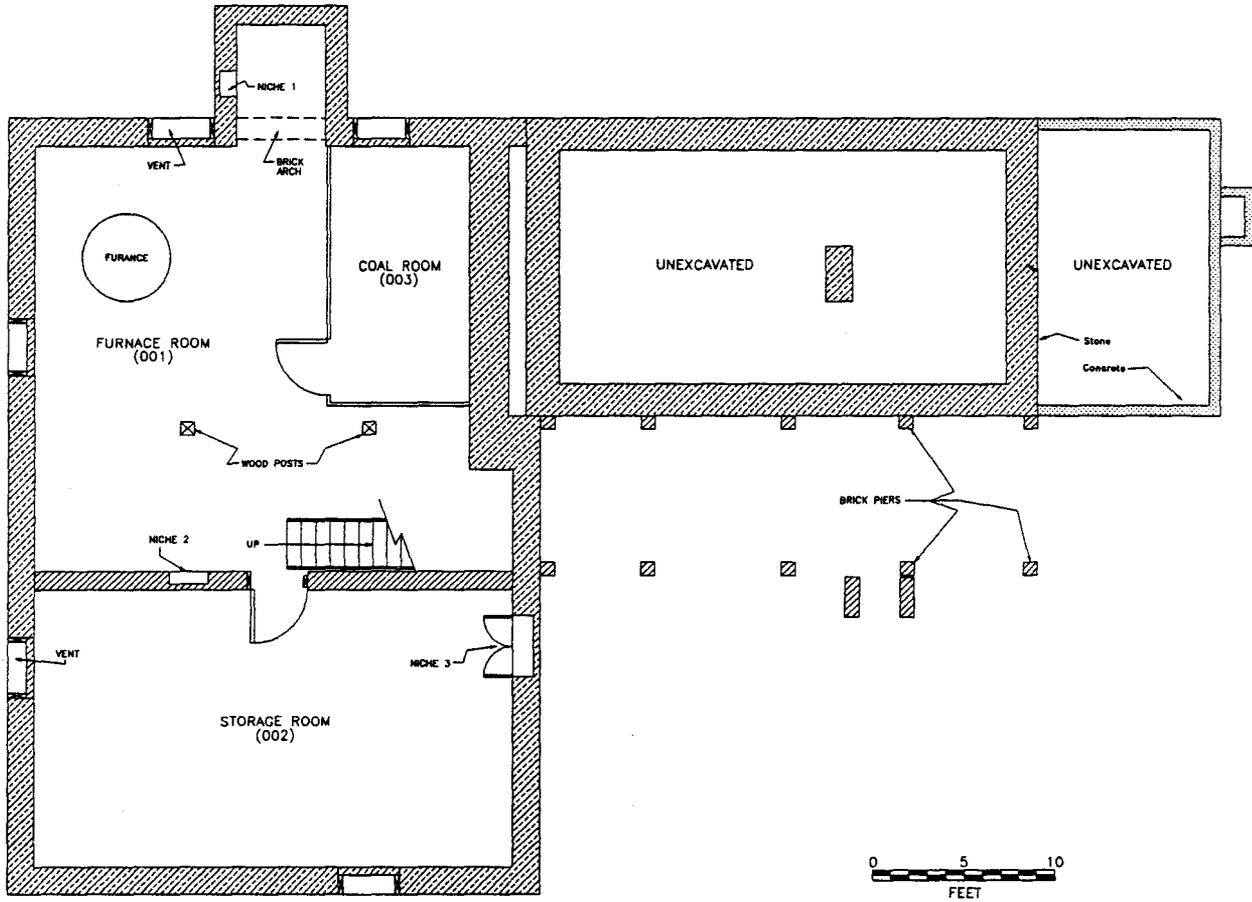
Figure 3. Basement floor plan of the Merkel House.
Drawn by F. Mansberger.

Beneath the front portion of the house is a large, two-roomed basement. The wall separating the two basement rooms is of brick construction resting on a shallow stone foundation. A plank door separates the two rooms.

The larger of the two basement rooms (Room 001) is approximately 22'x23' in size. Both the bulkhead entrance (leading outside) and the stairs leading to the upstairs hallway are located in this room. Within the past 50-60 years, a gravity-fed coal burning furnace (with its associated coal room) has been placed in this room. Presently, this room has a concrete floor. Also in this room are two of the three wall niches which are present in the basement. The smaller of the wall niches (Niche 3) is located in the west wall of the bulkhead entranceway. This recess is only 1'-1" tall, 1'-2" wide and 11" deep. The small opening is spanned with a brick arch. The base of the niche is 3'-0" above the floor. The function of this niche is unclear. It may have held a light (although no evidence of smudging is present on the roof of the wall niche) or a water (or other liquid refreshment) jug. The larger of the two niches in this room is located in the brick partition wall separating Rooms 001 and 002. This niche (Niche 1) is 2'-9" tall, 2'-1" wide and 8" deep. It is spanned with a

The smaller south room (Room 002) measures approximately 15'x26'. This room is dirt floored and has a single wall niche. Several small recesses in the south foundation wall suggest that wood storage racks may have been an original feature of this room. The rotted remains of what may have been a barrel rack and vegetable bin are presently located in this room. The wall niche, which is located along the eastern stone foundation wall, is the largest of the three niches in the basement. This niche (Niche 1) is 3'-3" tall, 4'-0" wide, and 1'-5 1/2" deep. The base of this wall niche is 2'-1" above the dirt floor. It is spanned by a brick arch and originally had a single shelf and two doors. It is suspected that this wall niche functioned as a food cellar for the storage of perishable foods.

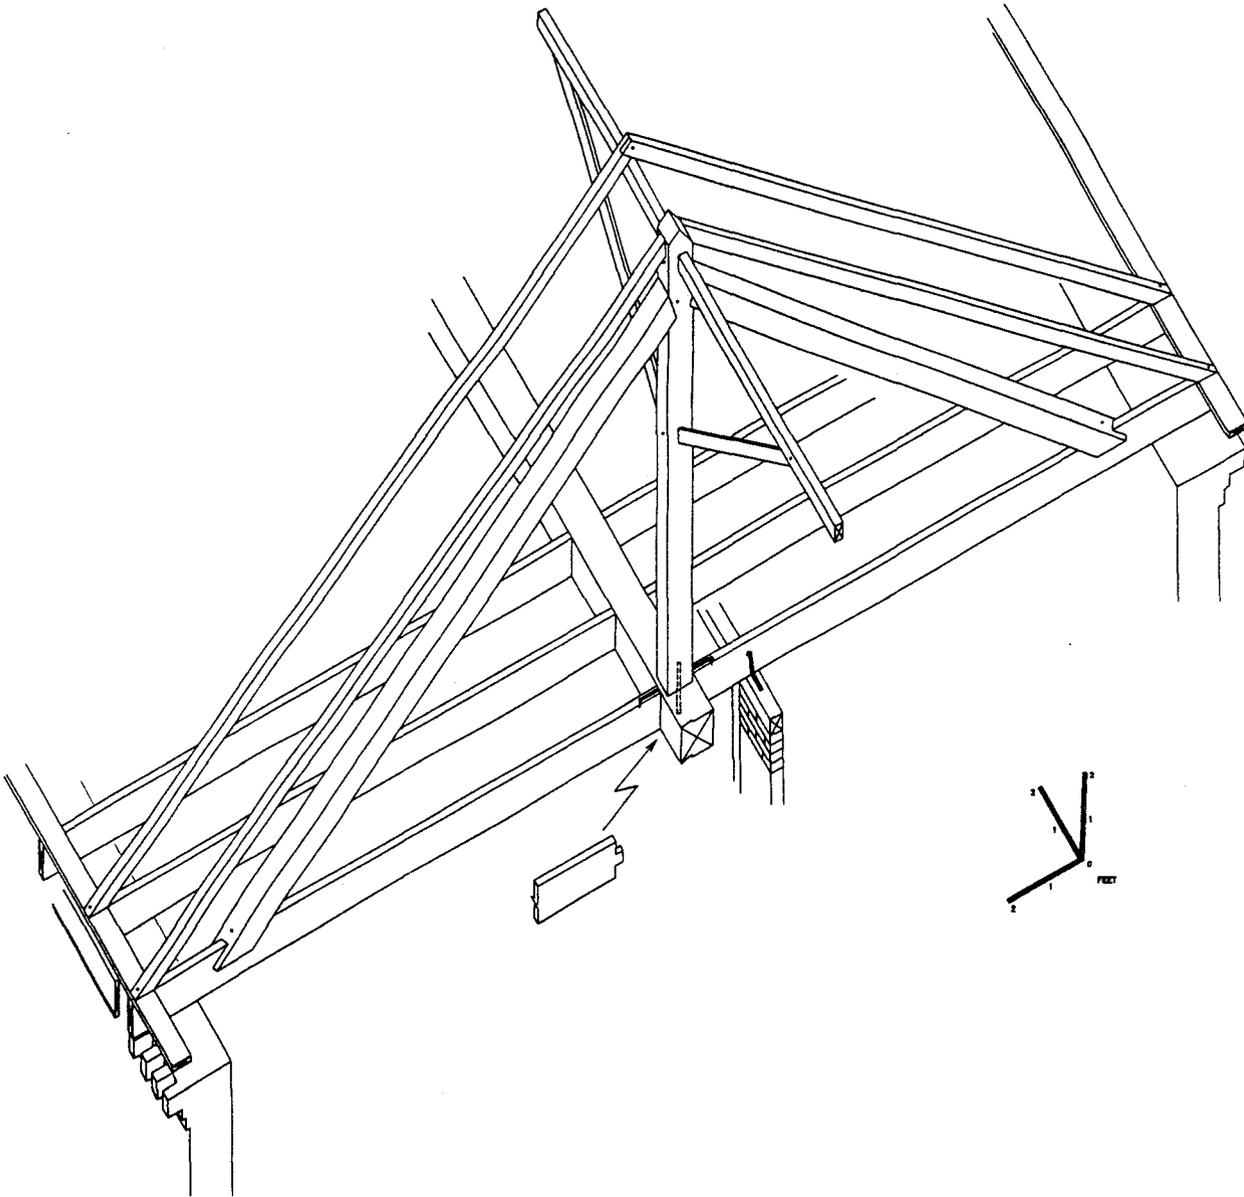
Figure 4. Detail of roof truss system at the Merkel House. The collar beams have been left out for clarity. Drawn by F. Mansberger.

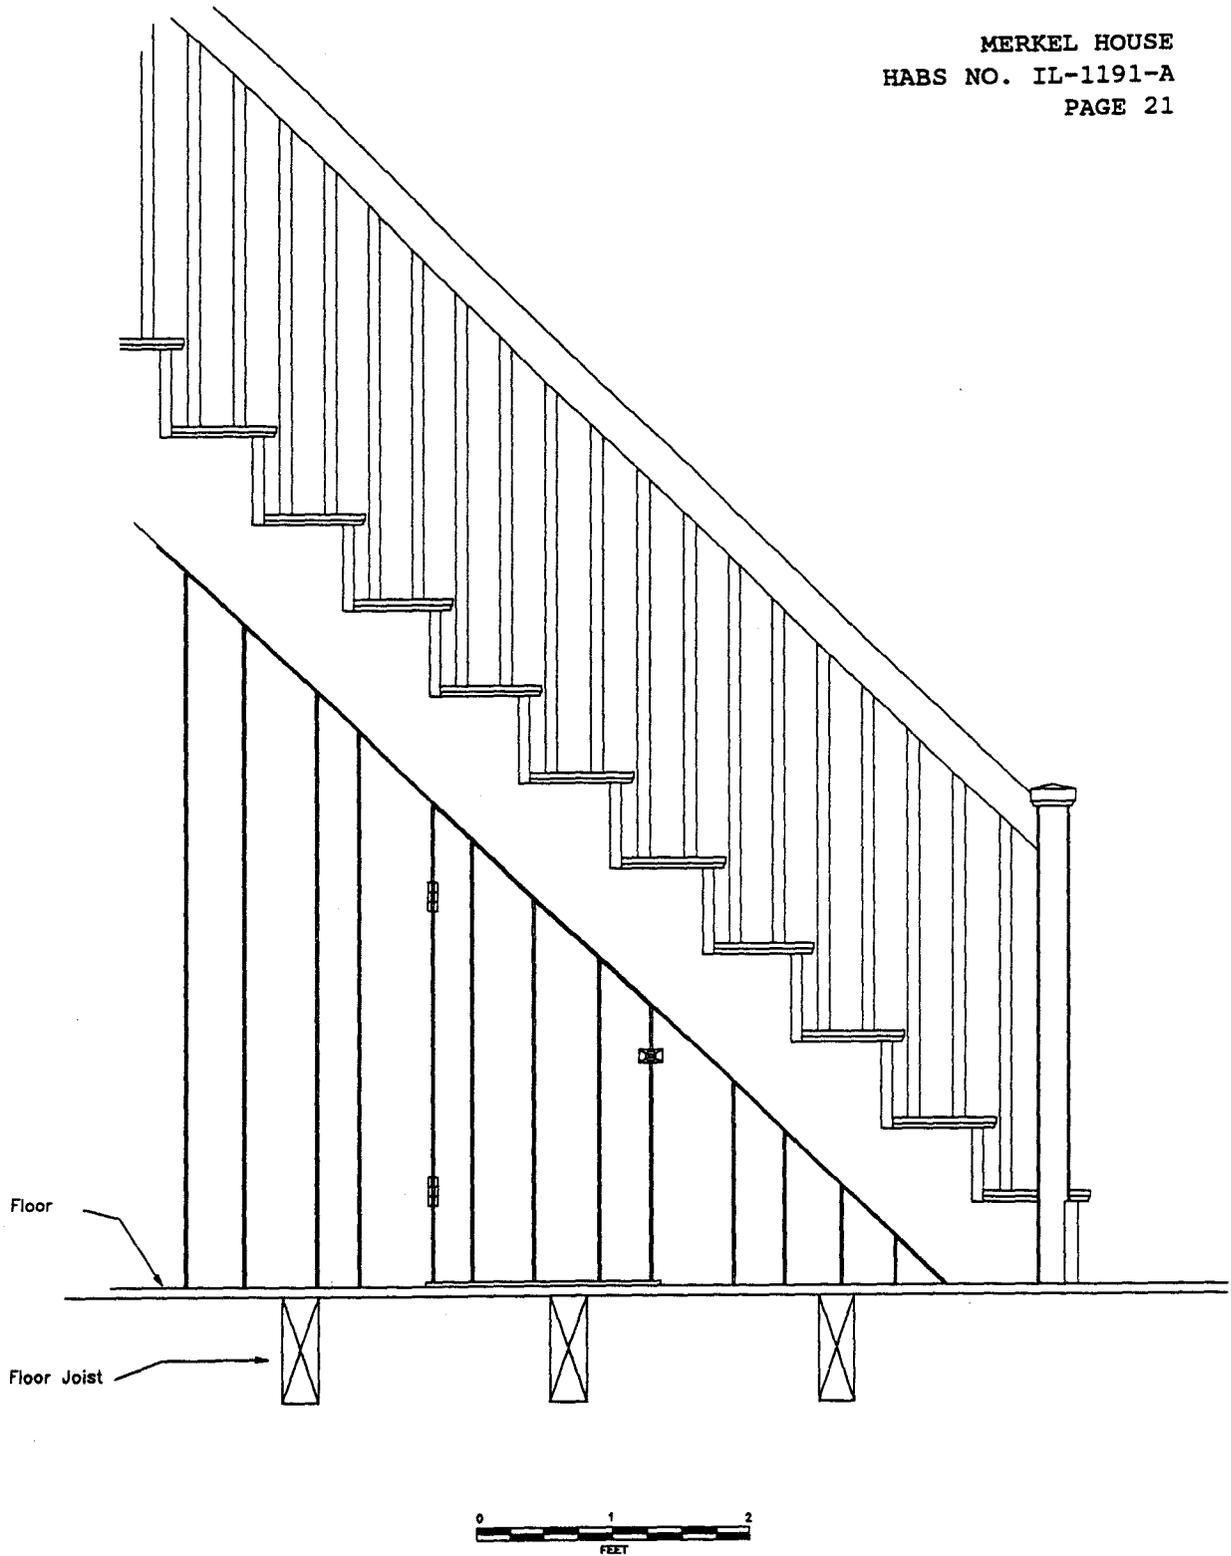
Figure 5. Stairway detail of the Merkel House.
Drawn by F. Mansberger.

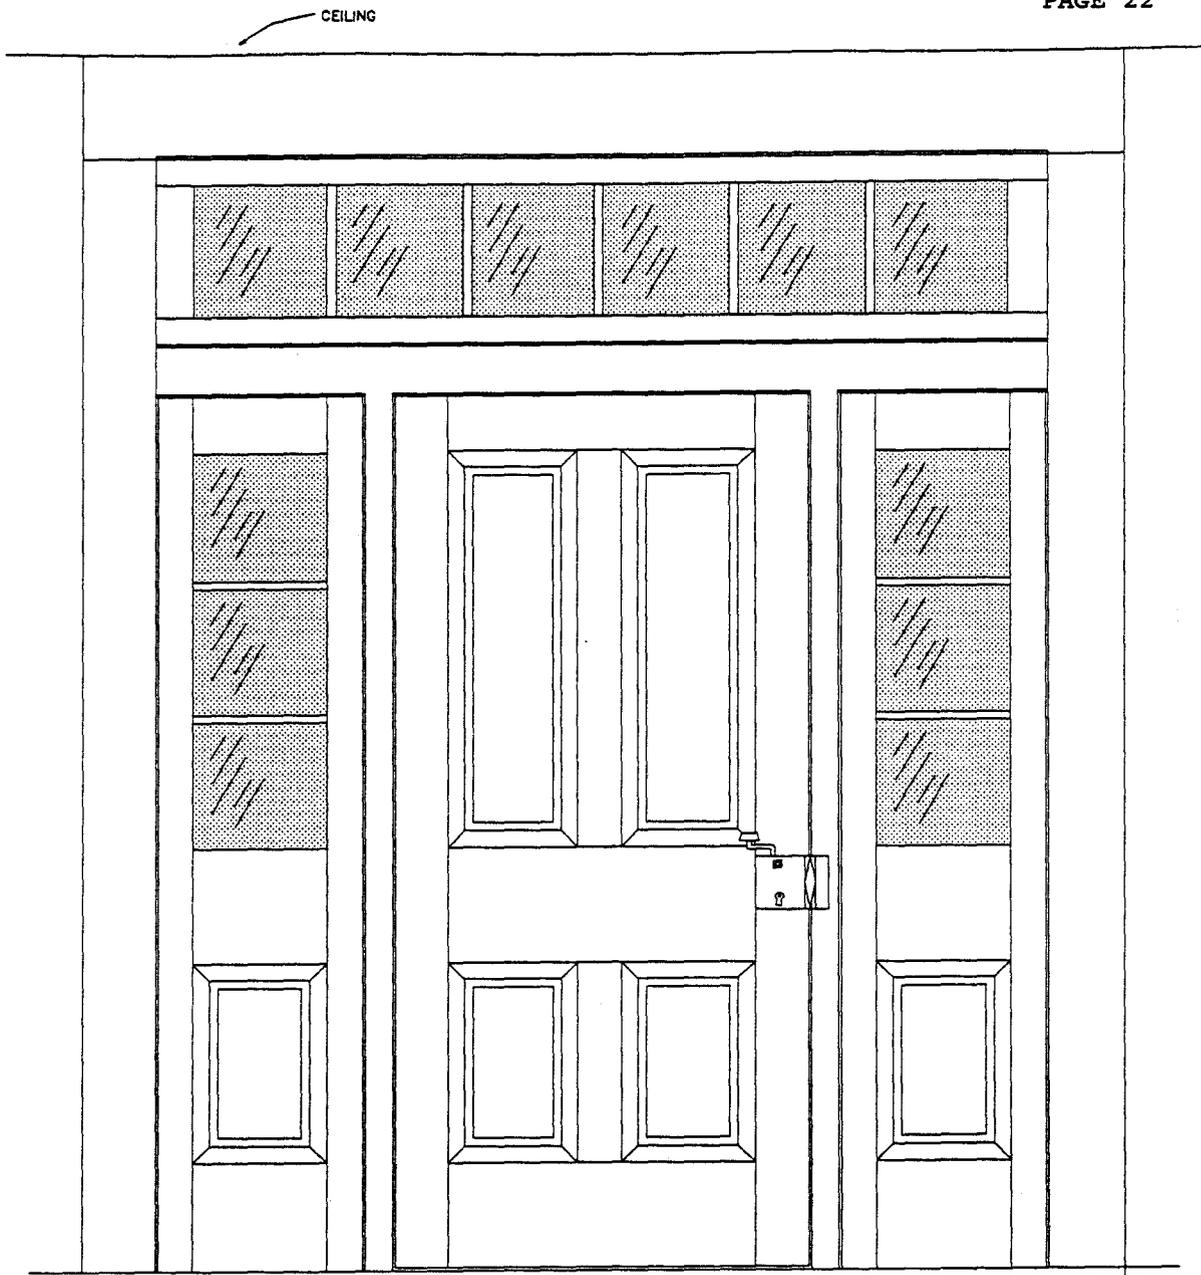
Figure 6. Detail of the Merkel House main entrance (interior view). Drawn by F. Mansberger.

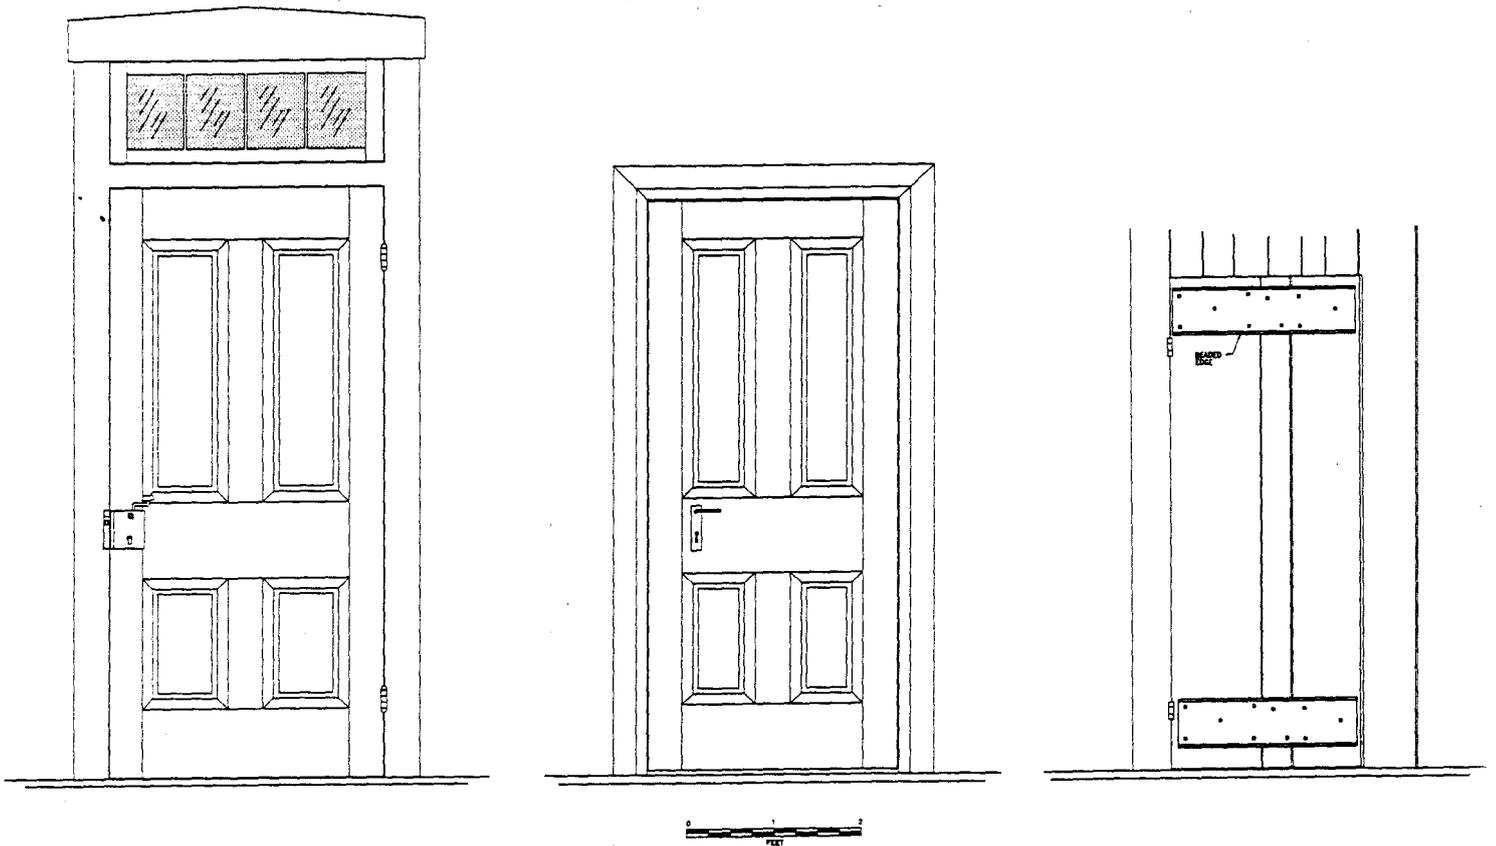
Figure 7. Miscellaneous door details at the Merkel House.
Left detail is the rear central hallway door looking
from the inside; middle detail of interior door; right
detail is plank door leading to the basement (as viewed
from the basement). Drawn by F. Mansberger.

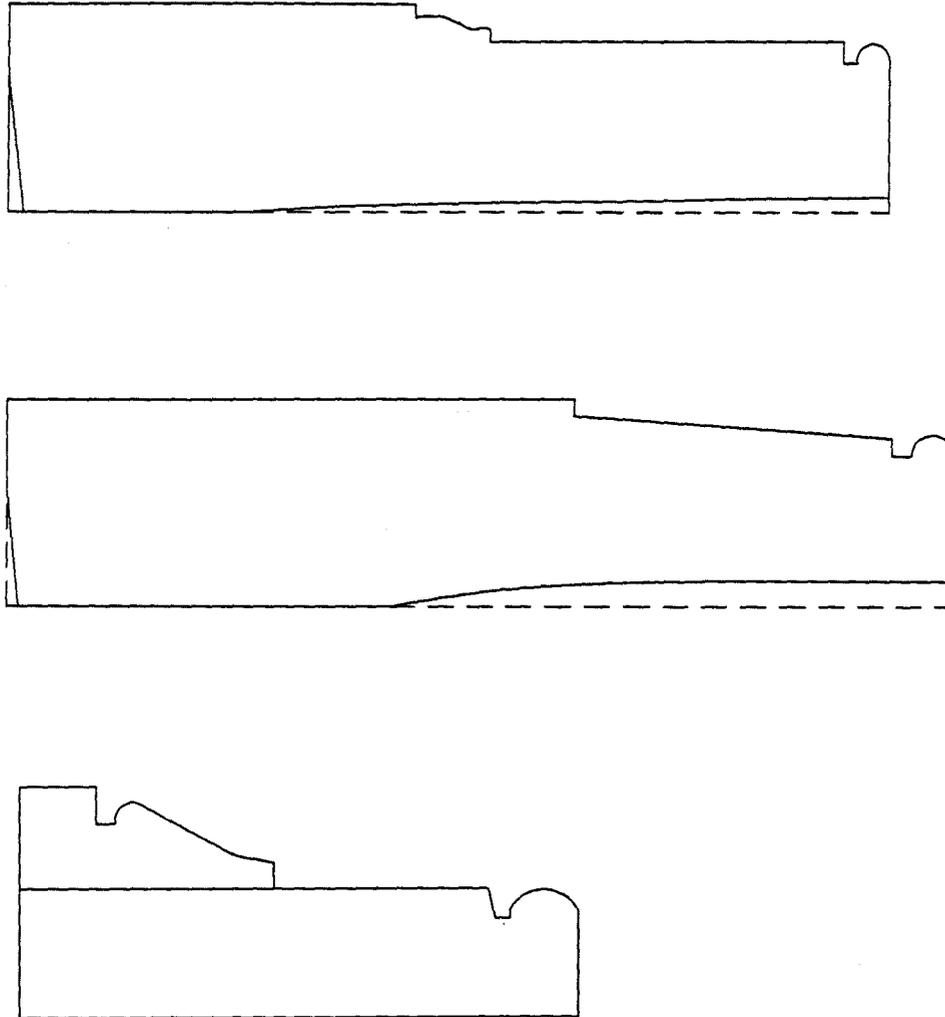
Figure 9. Door trim details at the Merkel House.
Top trim is the upstairs in the main body of the house; middle trim is the downstairs of the main body of the house; bottom trim is kitchen wing.
Drawn by F. Mansberger.

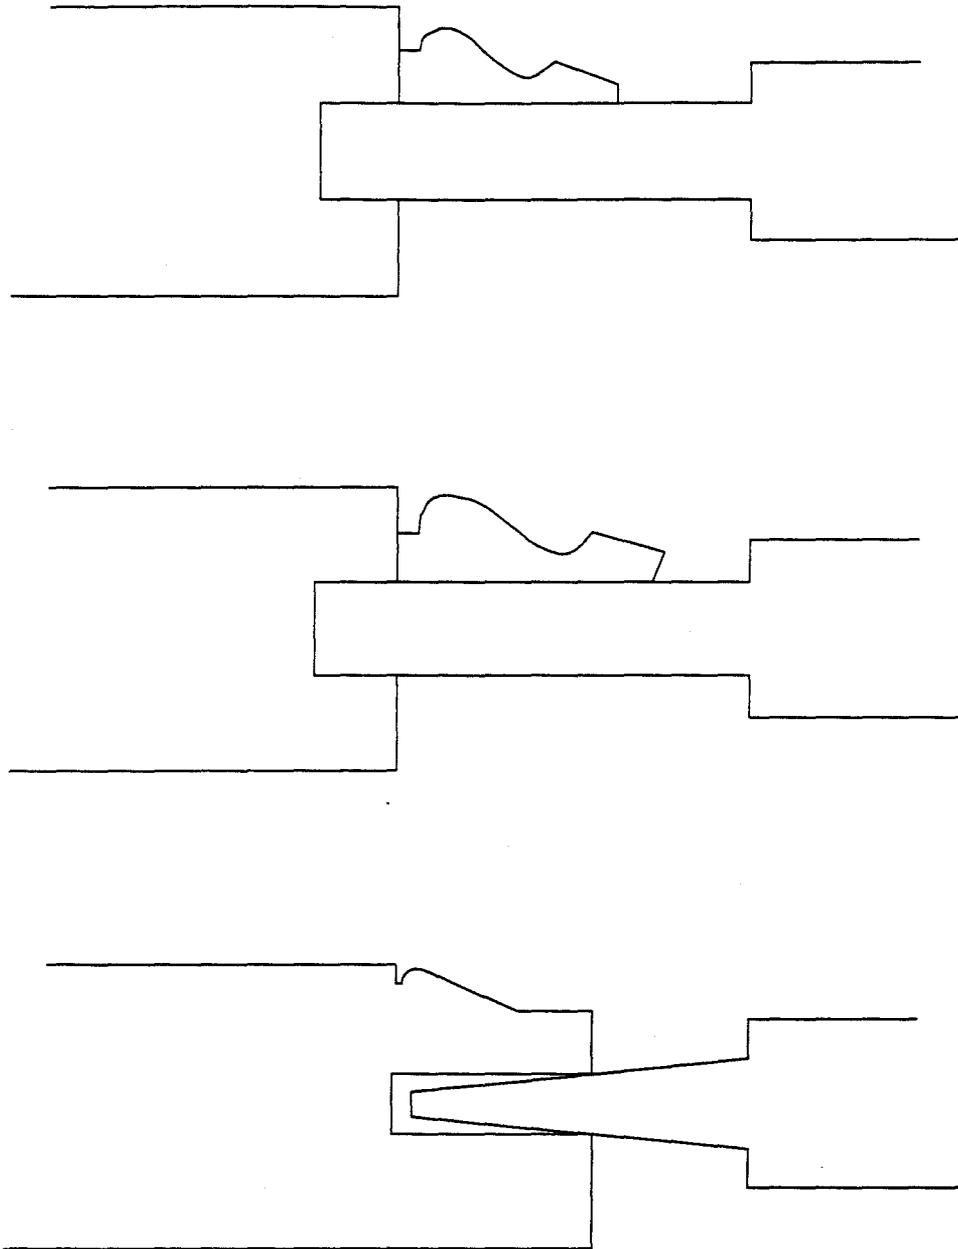
Figure 10. Details of door construction at the Merkel House. Top trim is the original kitchen wing of the house; middle detail is downstairs of the main body of the house; bottom is the upstairs of the main body of the house. Drawn by F. Mansberger.
