BALTIMORE INNER HARBOR, PIER 4
South side of Pratt Street between
Frederick Street and Market Place
Baltimore City
Maryland

HAER No. MD-86-C

Baltimore Inner Harbor, Pier 4

Significance: Designed by Oscar F. Lackey and constructed in 1908-1910, remaining original bulkheads on Piers 4, 5, and 6 in the Baltimore Inner Harbor were among the first reinforced concrete structures erected in seawater in the United States. These and other early concrete piers in the U.S. pioneered the acceptance of reinforced concrete in American harbors. The solid piers, consisting of filled reinforced concrete bulkheads, played a significant role in the evolution from timber pile to reinforced concrete for seawater construction.

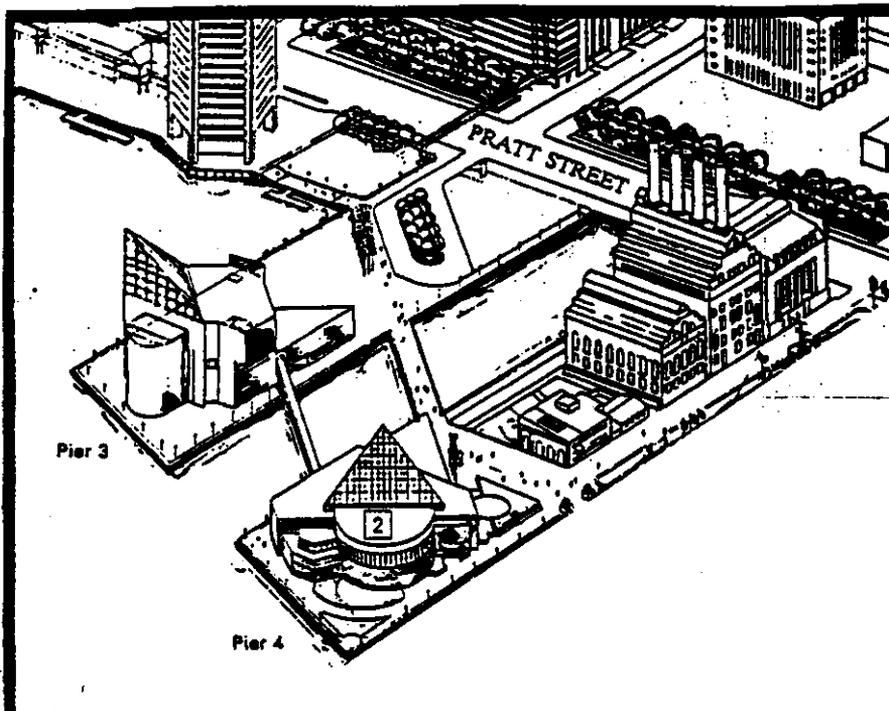
Source: Adapted from architectural rendering of the Christopher Columbus Center in Simmons, *An Investigation of Archeological Resources Associated with Piers 5 and 6*, p. 151.
(Piers 5 and 6 not shown)

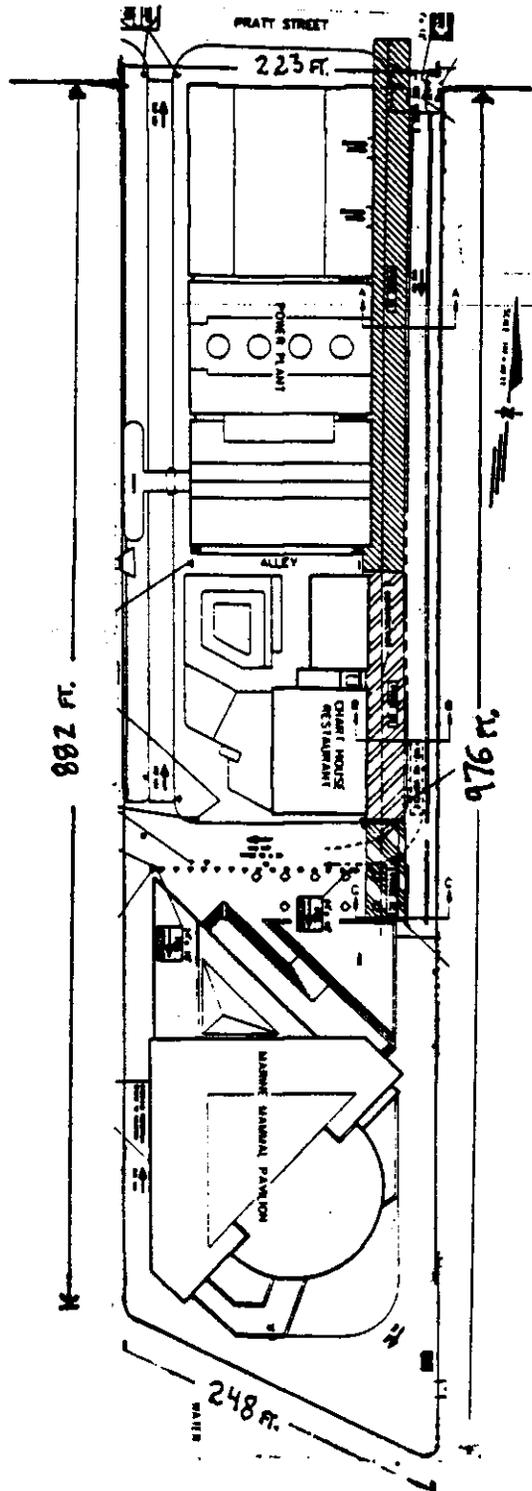
Source: Baltimore Bureau of Transportation drawing, Jan. 1993.
(Dimensions are approximate measurements taken with rotator wheel)

A later article noted that, "the water for condensing purposes is taken from one slip and returned to the other so the temperature of the water in the first slip is not raised."⁹ Diagrams of the Power Plant show 5 intake wells situated on the west side of the pier and 5 discharge wells on the east. A discharge well for overflow is shown adjacent to Discharge Well No. 4.¹⁰ (Please see Pratt Street Power Plant, HAER No. MD- for further information about the Power Plant.)

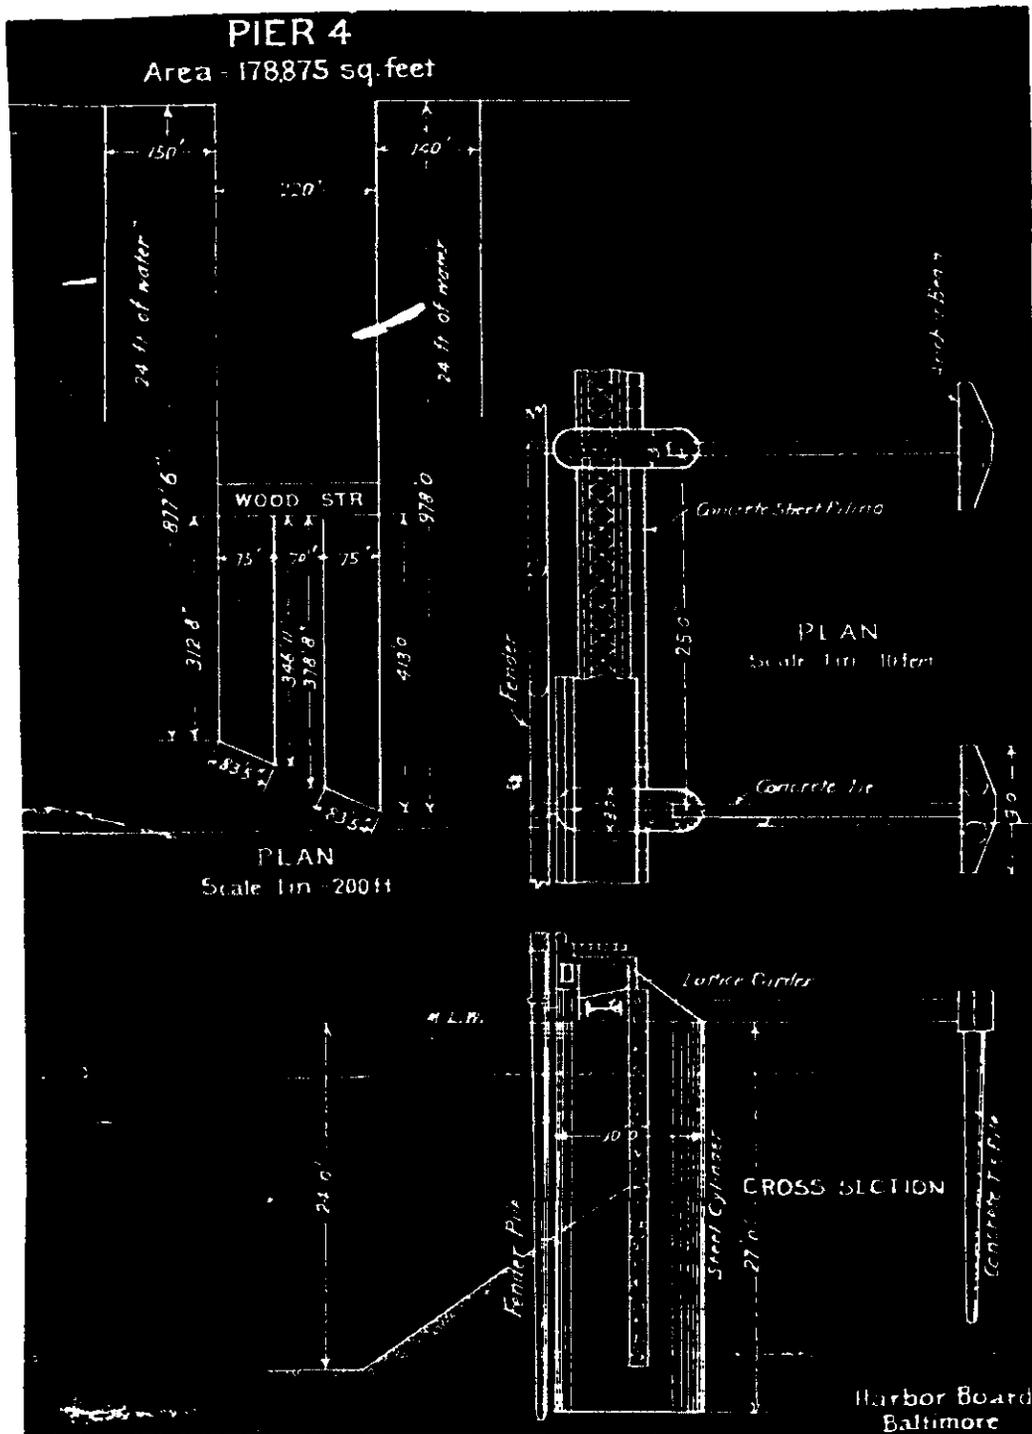
Source: Harbor Board, *Survey of the Port of Baltimore*, Vol. 1 (1920).
