ALLEN PARK VETERANS ADMINISTRATION HOSPITAL, BUILDING NO. 6
(Allen Park Veterans Administration Hospital, Director's Quarters)
Southfield Expressway & Outer Drive
Allen Park
Wayne County
Michigan

HABS No. MI-427-B

WRITTEN HISTORICAL AND DESCRIPTIVE DATA

ALLEN PARK VETERANS ADMINISTRATION HOSPITAL BUILDING 6 (Director's Quarters)

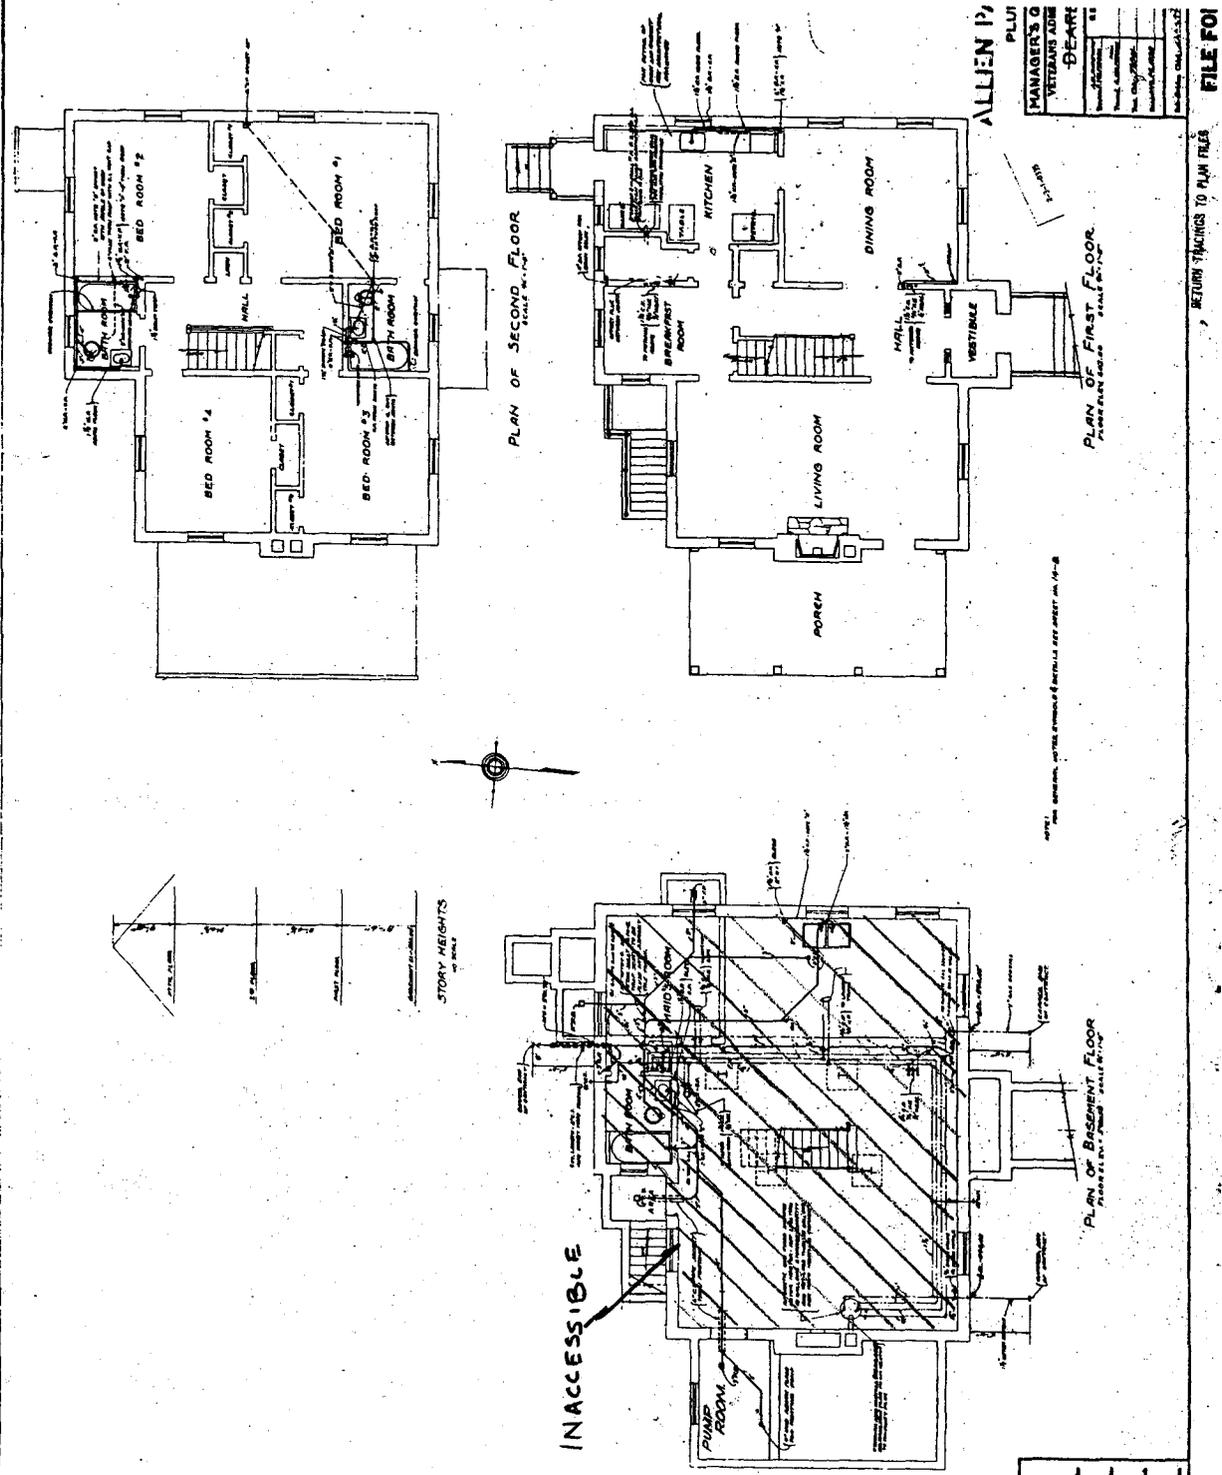
ALLEN PARK VETERANS
 ADMINISTRATION HOSPITAL
 BUILDING 6
 (Director's Quarters)
 HABS No. MI-427-B
 (Page 10)

Reduced Copy of Current Plan, February 2002

- b. **First Floor:** The building has a center hall plan with a living room located in the western half of the house and a dining room and kitchen located in the eastern half of the house. The hallway is entered from the exterior through a vestibule. A breakfast room is located at the end of the hallway. The original pantry, located between the breakfast room and the kitchen, was converted into a bathroom in the 1970s. The kitchen was also modified at this time, with the cabinets and fixtures replaced. A screened porch is located off of the living room with access into the house, and a rear entry into the kitchen provides a third point of entry.

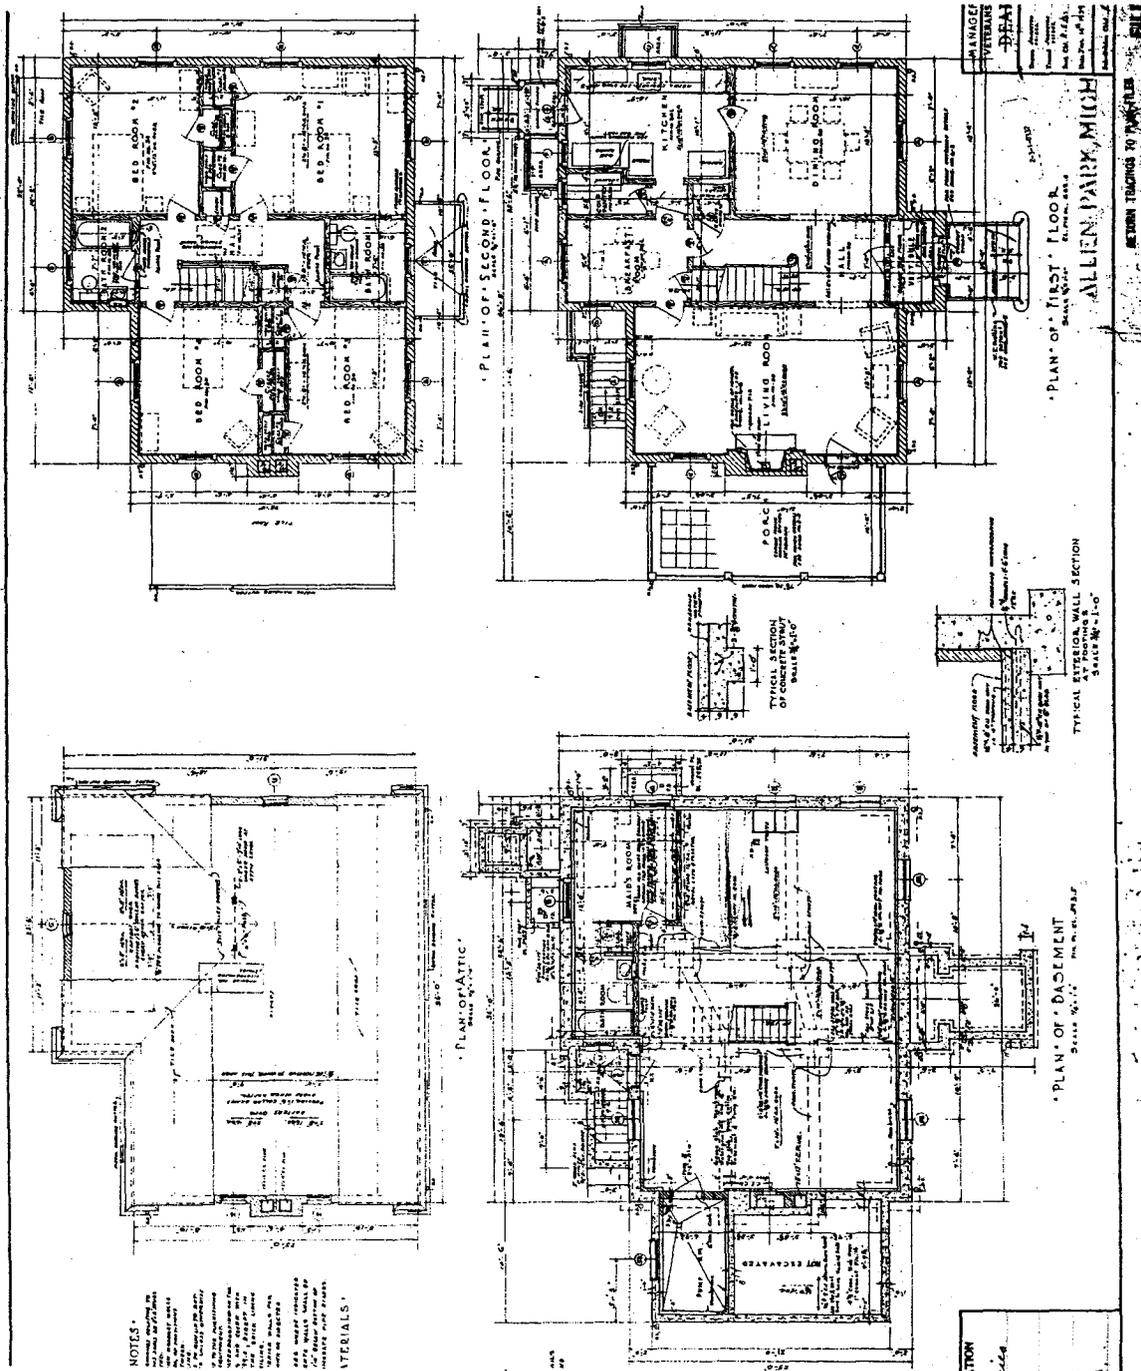
ALLEN PARK VETERANS
 ADMINISTRATION HOSPITAL
 BUILDING 6
 (Director's Quarters)
 HABS No. MI-427-B
 (Page 11)

Reduced Copy of Historic Plan, dated January 14, 1939
 On file at the John D. Dingell Department of Veterans Affairs Medical Center, Detroit,
 Michigan

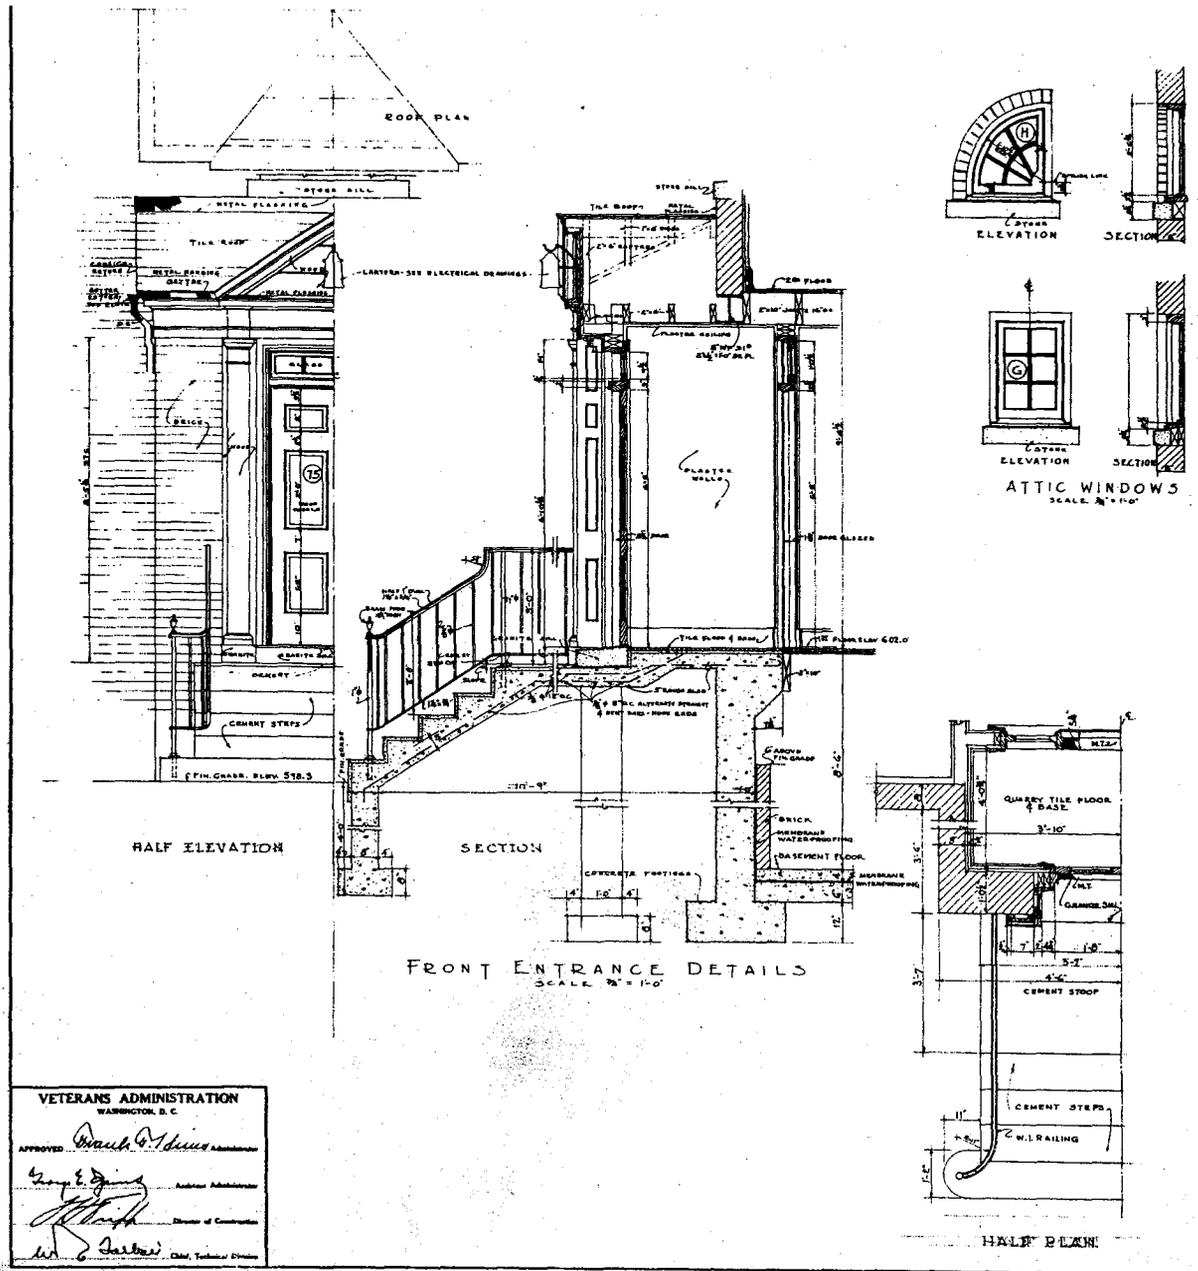
Reduced Copy of Historic Plan, dated January 14, 1939
 On file at the John D. Dingell Department of Veterans Affairs Medical Center, Detroit,
 Michigan
