ALLEN PARK VETERANS ADMINISTRATION HOSPITAL, BUILDING NO. 7
(Allen Park Veterans Administration Hospital, Day Care Treatment Center
Allen Park Veterans Administration Hospital, Nurses' Quarters)
Southfield Expressway & Outer Drive
Allen Park
Wayne County
Michigan

HABS No. MI-427-C

**ALLEN PARK VETERANS ADMINISTRATION HOSPITAL
BUILDING 7**

(Nurses' Quarters/Day Care Treatment Center)

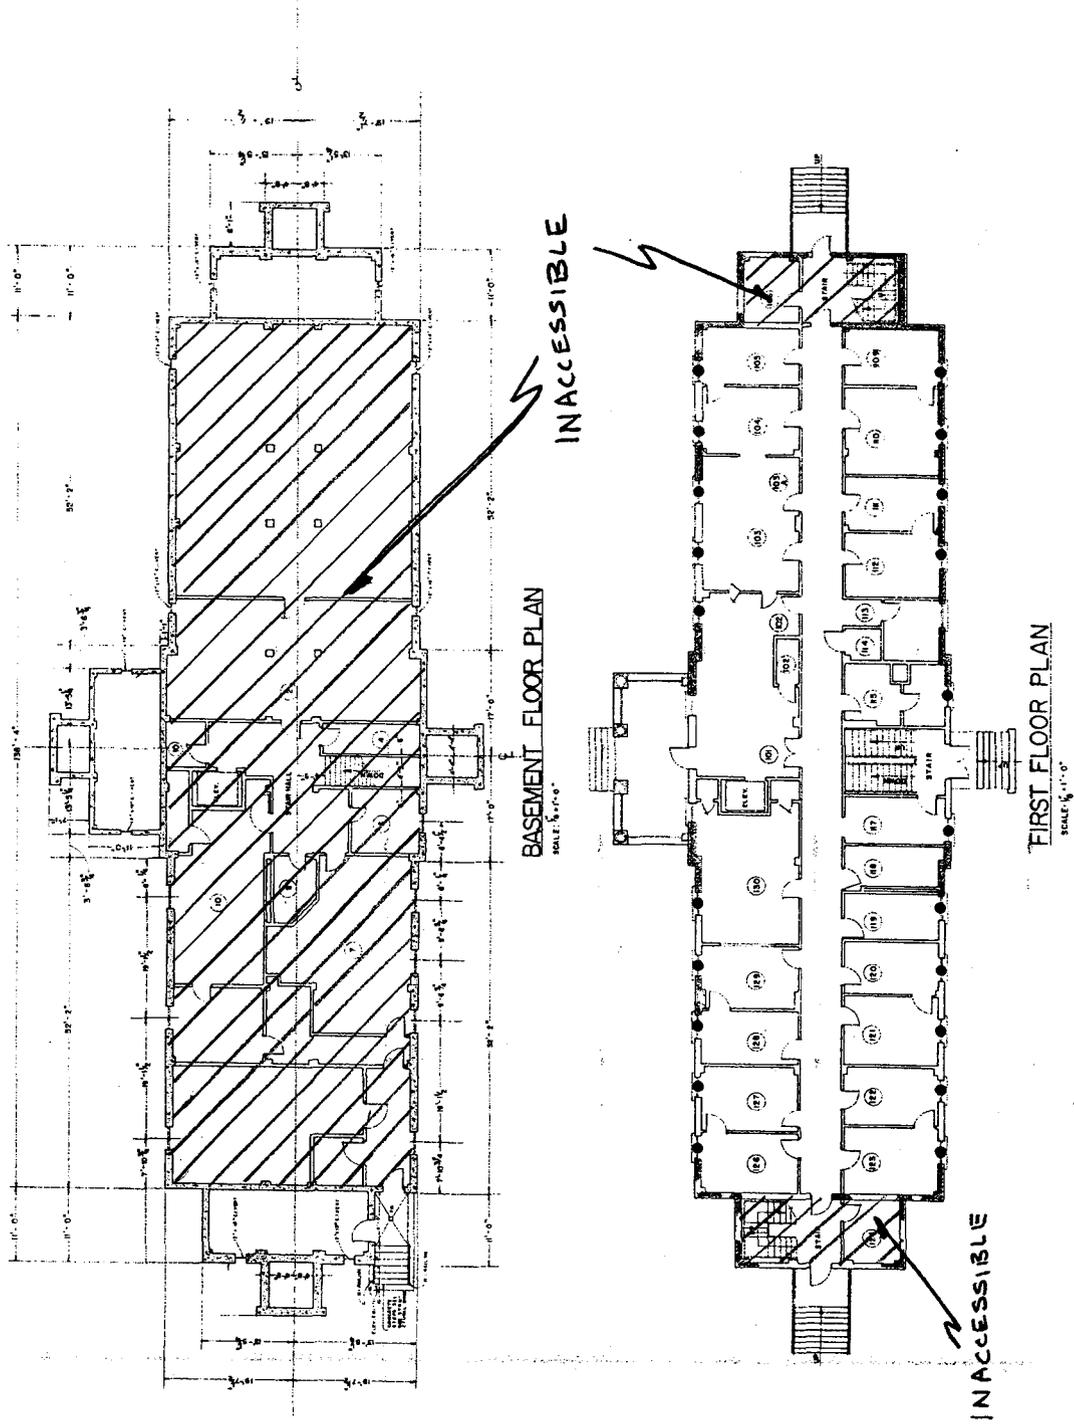
Reduced Copy of Current Plan, February 2002

BLDG. 7 BSMT 8 1ST. FLR.	DAY CARE TREATMENT CENTER
PROJECT: BLDG. 7 ARCHITECT: CALDWELL ENGINEER: CALDWELL	BUILDING NO. 7 ALLEN PARK MICH.

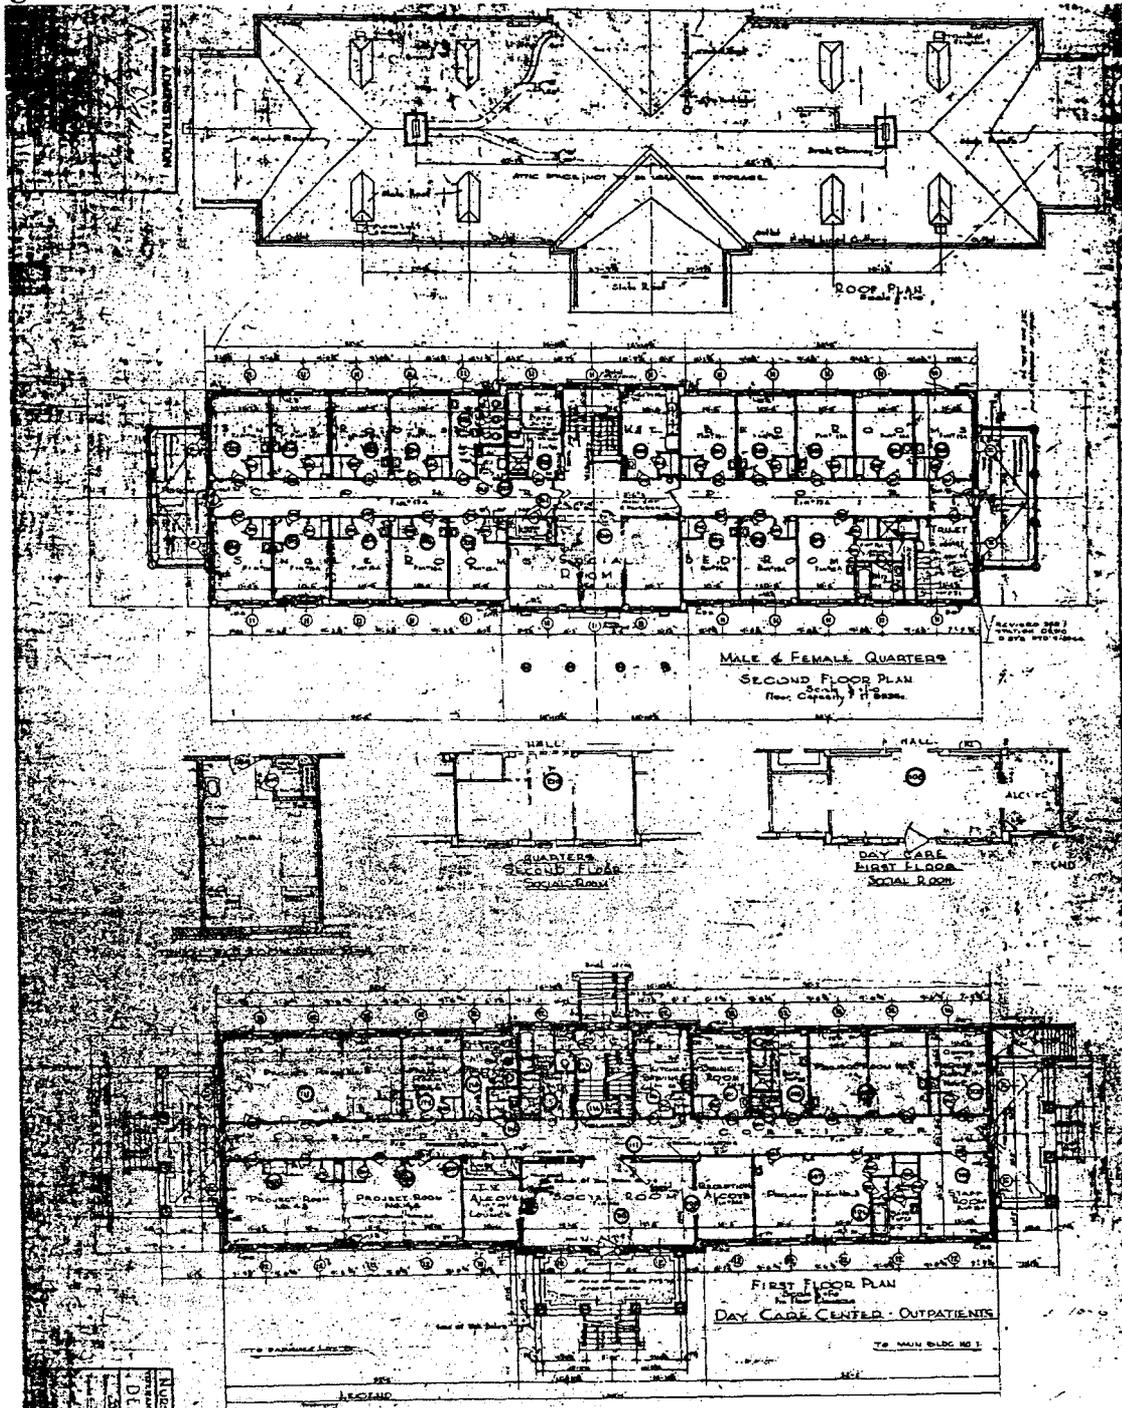
Reduced Copy of Historic Plan, dated April 15, 1939
On file at the John D. Dingell Department of Veterans Affairs Medical Center, Detroit,
Michigan
