MINNEAPOLIS WAREHOUSE DISTRICT,
28 NORTH FIRST STREET (RESTAURANT)
City of Minneapolis
Hennepin County
Minnesota

HABS No. MN-110-AF

MINNEAPOLIS WAREHOUSE DISTRICT,
28 NORTH FIRST STREET
(RESTAURANT)
HABS No. MN-110-AF
(page 1)

MINNEAPOLIS WAREHOUSE DISTRICT,
28 NORTH FIRST STREET (RESTAURANT)

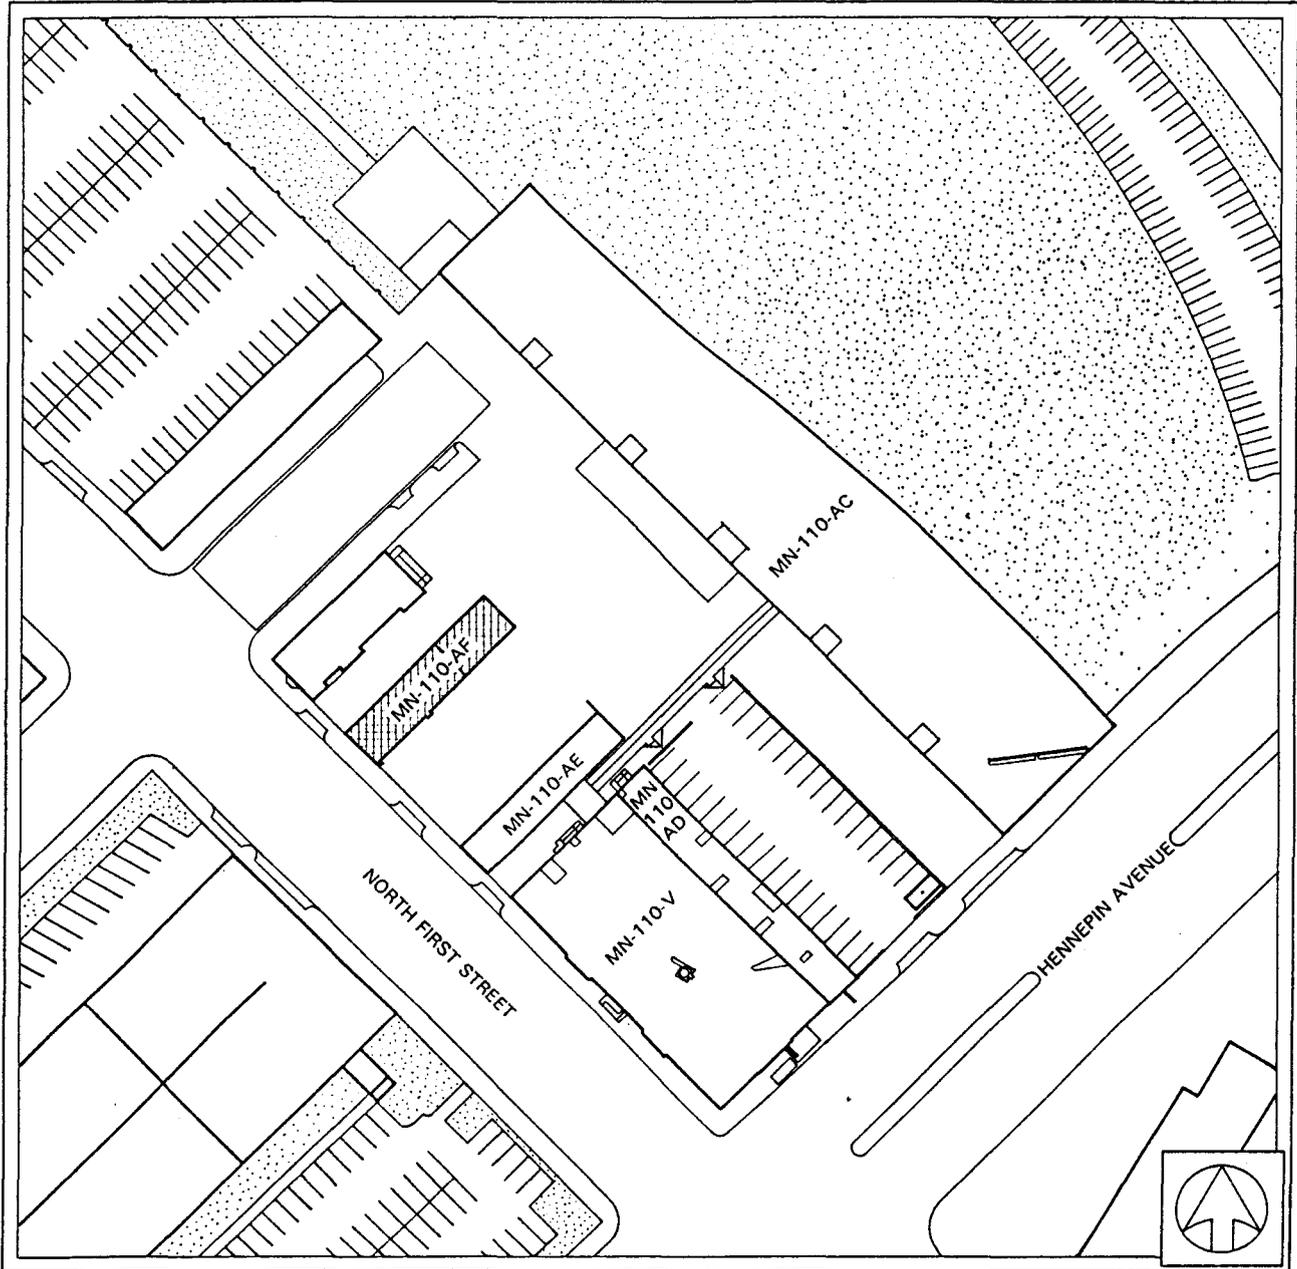
SITE PLAN

Adapted from Aerial Photograph
"Minneapolis, Hennepin County, Minnesota, Metropolitan Area" Sheets 55C and 56A

Feet 1" = 100'- 0"

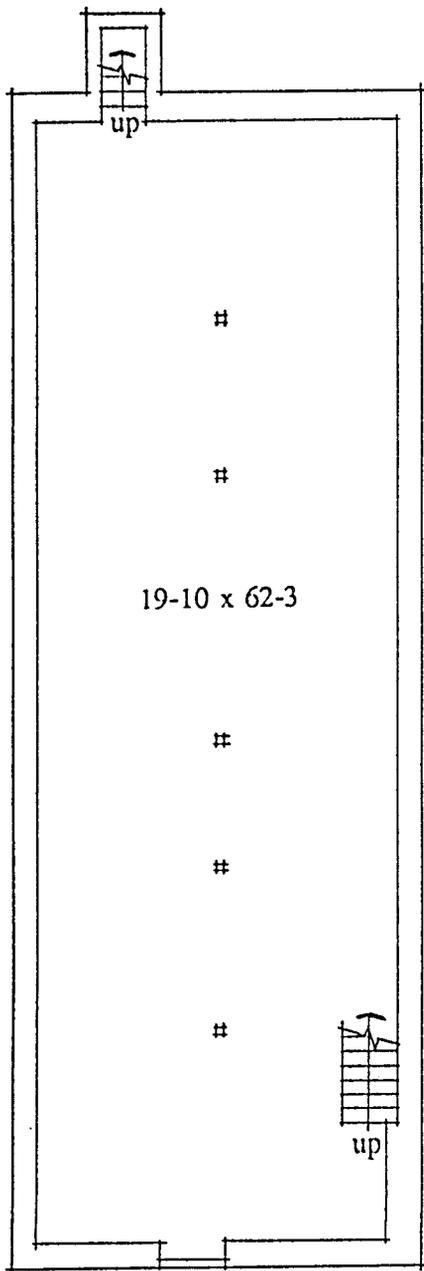
sketch plan:
BASEMENT

December 1993

dimensions given in
feet - inches

2. Foundations: Random ashlar limestone with some concrete-block infill.

4. Wall and ceiling finish: The limestone basement foundation walls are finished primarily with a skim coat of plaster although some plaster is missing and limestone is exposed. There is also concrete-block infill which has not been finished. The north corner walls where the toilet room is located and the toilet room walls themselves are covered with painted beadboard. The stairway walls and ceiling between the basement and main floor are also covered with beadboard. The basement ceiling is not finished. The joists and subflooring of the first floor are exposed.

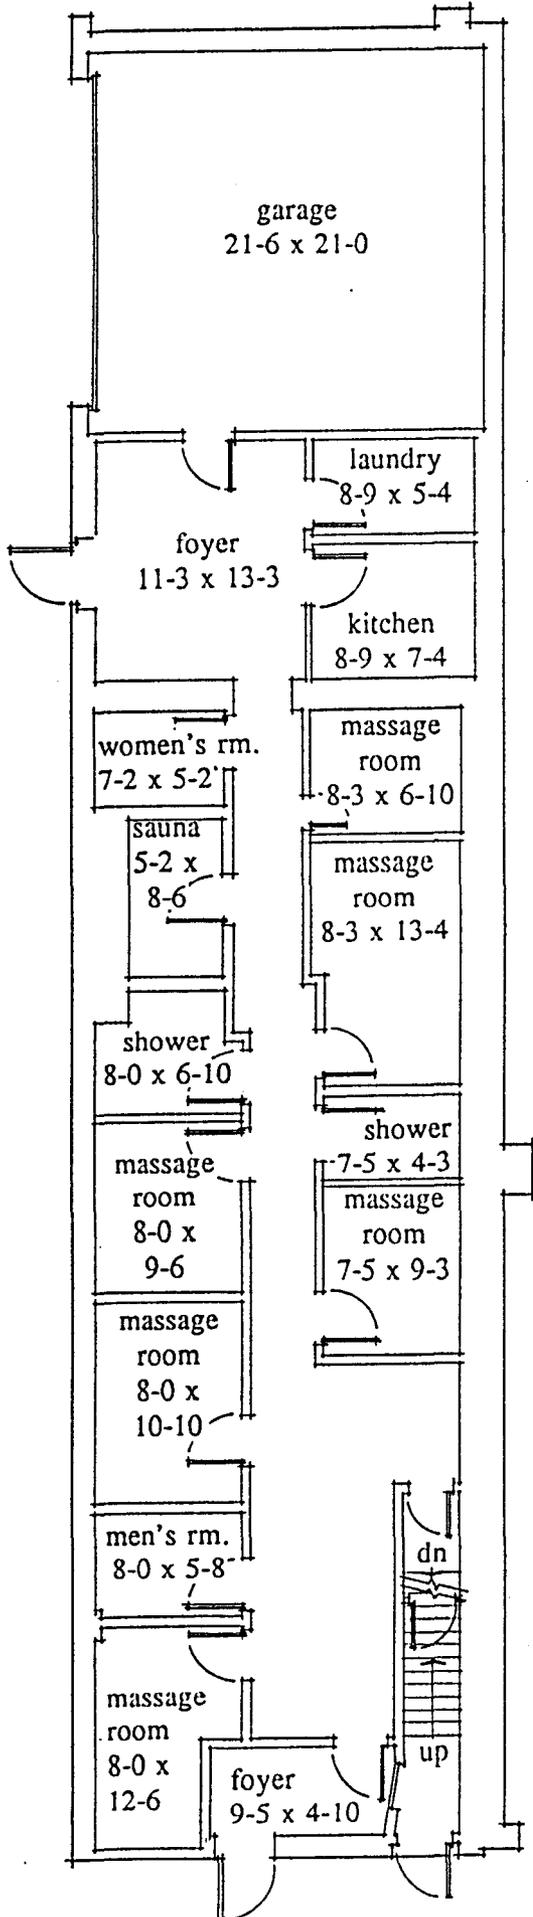
sketch plan:
FIRST FLOOR

December 1993

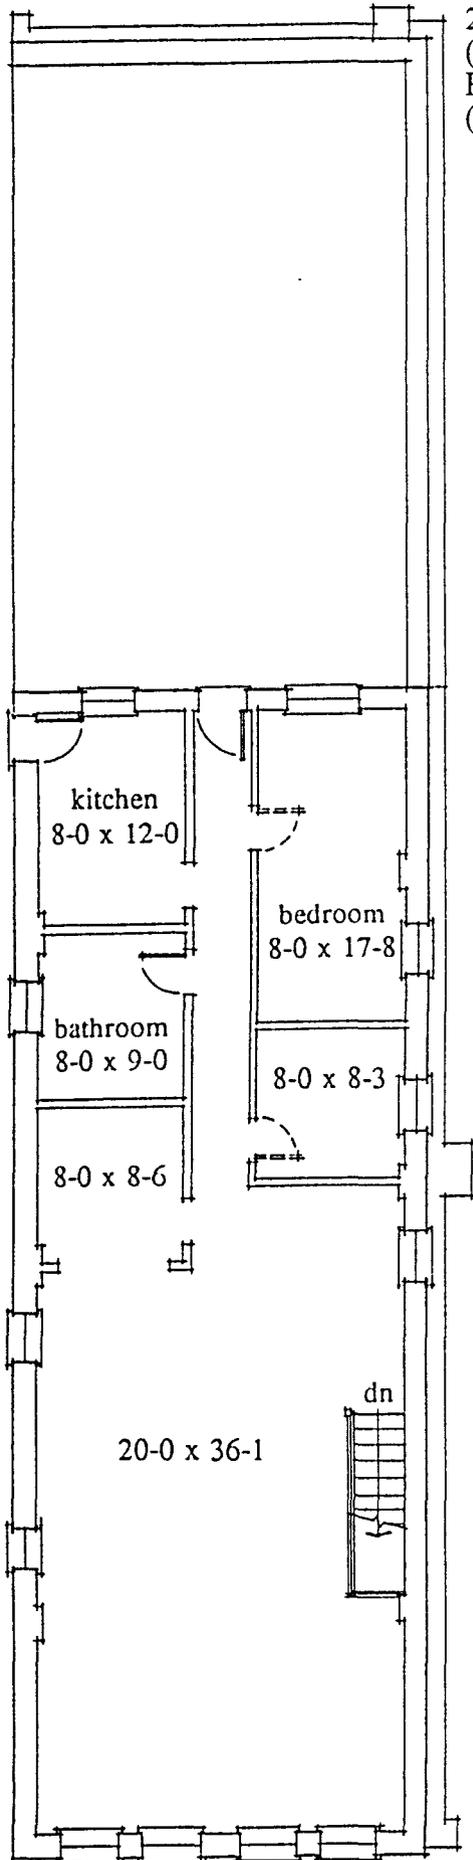
sketch plan:
SECOND FLOOR

December 1993

The second floor walls are plaster on lath in poor condition. In one room, a sheet of particle board has been attached to the wall to prevent the plaster from falling off the wall and another wall has a large portion of plaster missing. The second floor has wood baseboards and caps throughout. The ceilings are also plaster and the above mentioned room has a suspended ceiling to cover its poor condition.

Second floor doors are missing except for two. Both are wood panel doors but one is not original as it does not fit the opening. Frames are all wood and originally had transom windows above which are not visible or are boarded over.
