Clearwater Beach Bathhouse  
(Noblett Bathhouse)  
Noblett Lake Recreation Area  
Mark Twain National Forest  
Vanzant Vicinity,  
Douglas County,  
Missouri

HABS No. MO-1874

PHOTOGRAPHS  
WRITTEN DESCRIPTIVE AND HISTORICAL DATA

HISTORIC AMERICAN BUILDINGS SURVEY

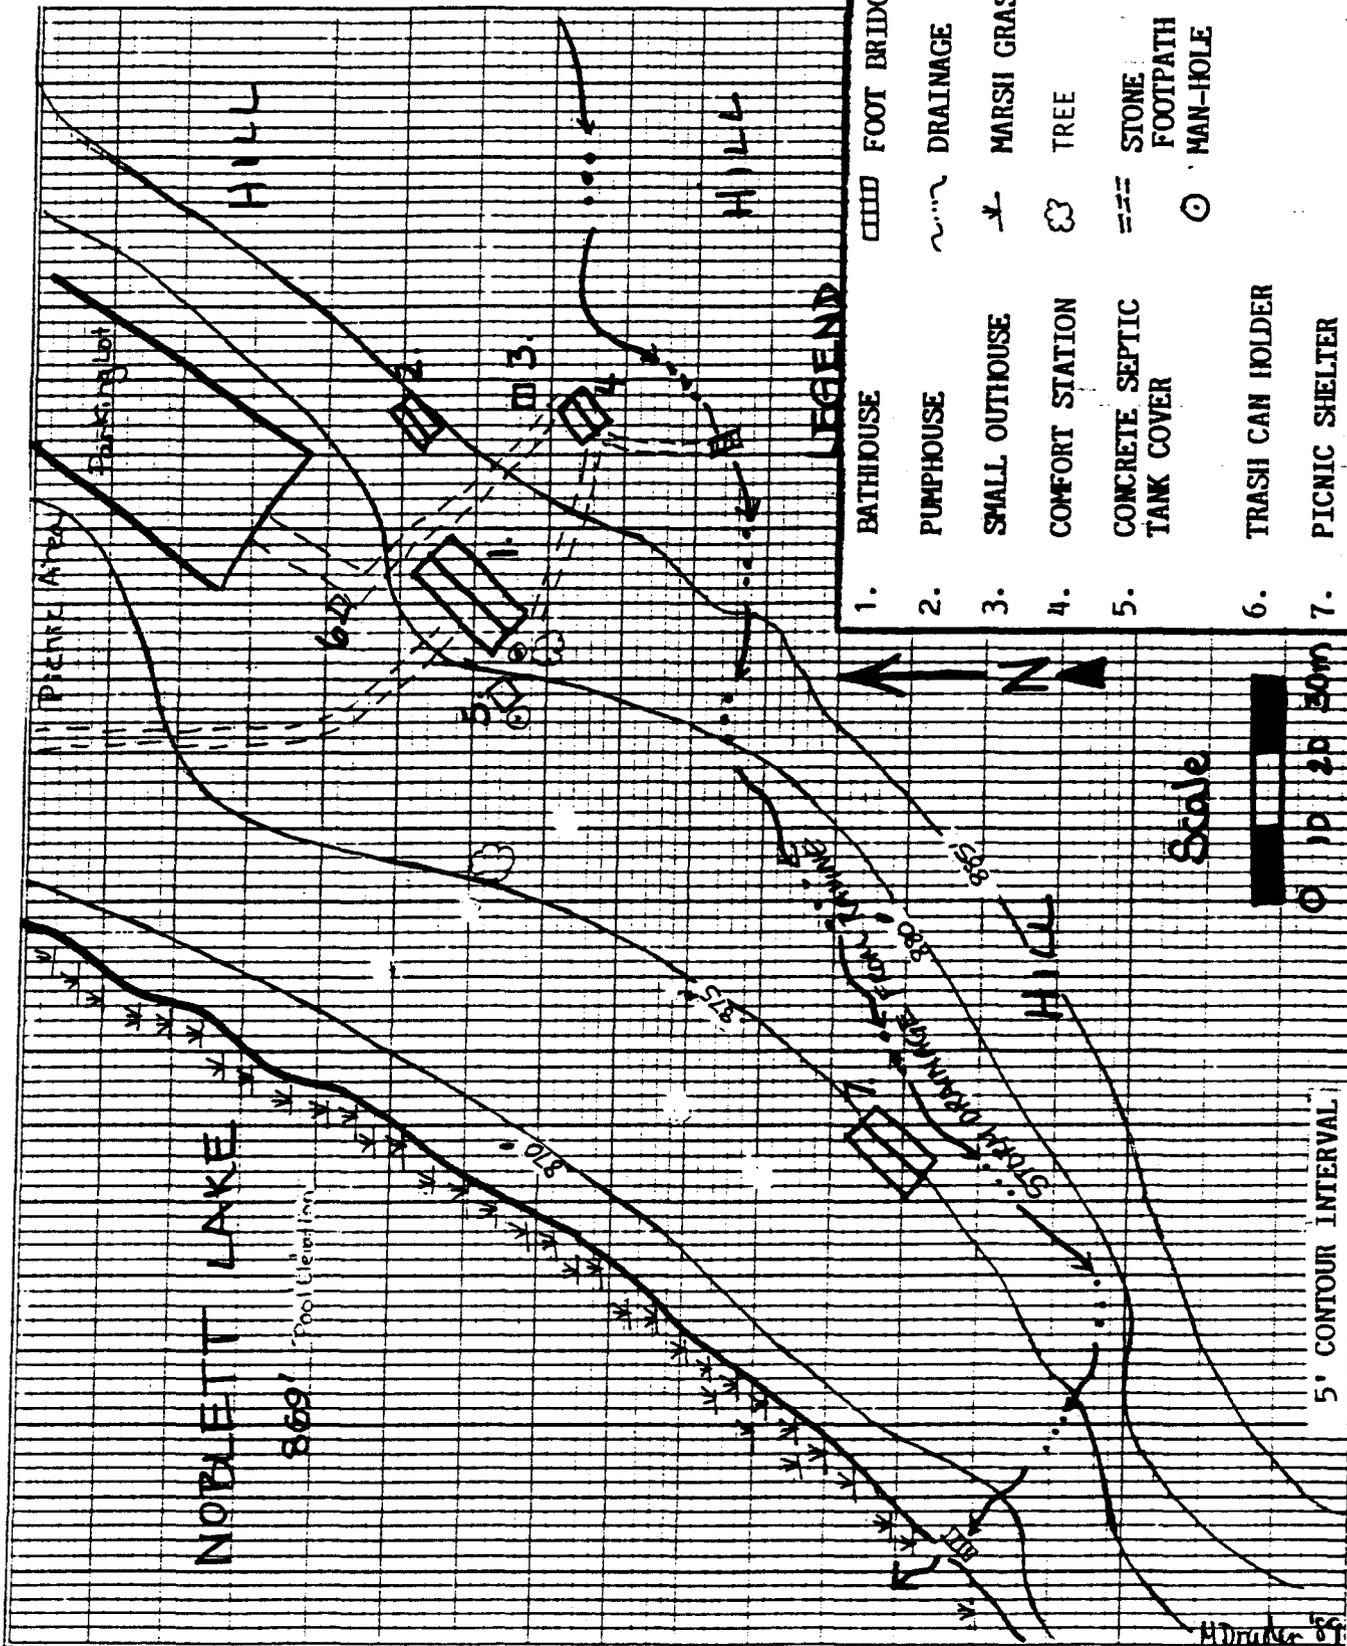
SCHEMATIC DRAWING OF  
EXISTING BATHHOUSE

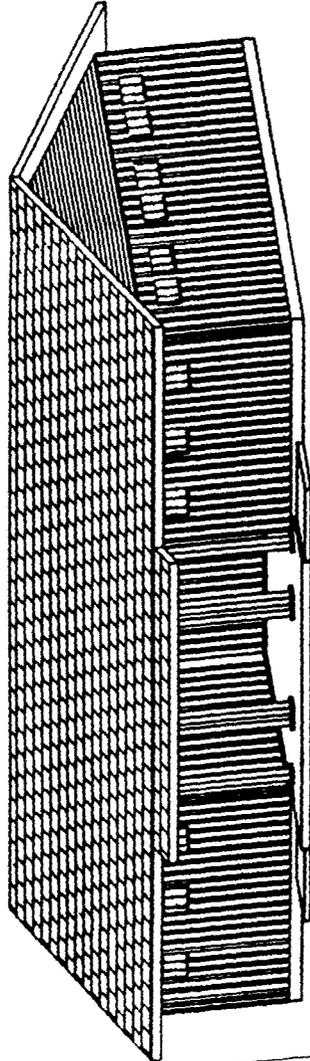
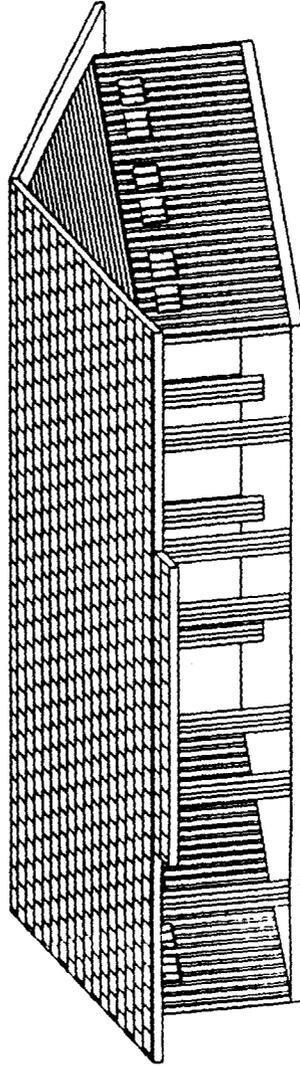
PROPOSED SHELTER AFTER RENOVATION

DRAWING NOT TO SCALE

MARK TWIN NATIONAL FOREST					
U.S.D.A. FOREST SERVICE R-9					
NOBLETT LAKE PICNIC SHELTER					
SCHEMATIC DRAWINGS: BEFORE/AFTER					
DATE	7/8/67				
BY					
CHECKED					
SCALE					
SHEET	2	OF	6

1. Maintain as much of the original exterior wall surface as possible.
2. Remove plastic skylights, aluminum fans, and vents. Reroof building with asphalt shingles that are compatible with those found on the other structures within the complex.
3. Retain the original style of the structure.
4. Reserve some of the siding and windows to have as stock for repairing this and other recreation site buildings.
5. Leave the hopper-style windows in place on the sides of the structure.
6. Put board and batten siding on the two interior walls.
7. Re-lay the limestone path in the areas where the grade is being raised so as to better reflect the new traffic pattern of the structure.

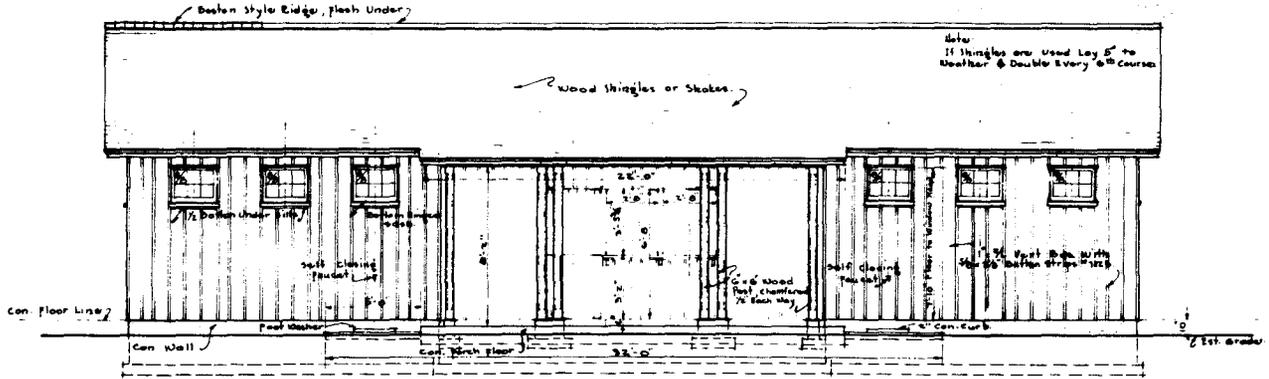
"FRONT ELEVATION"  
SCALE 1/8" = 1'-0"

Note:  
Vary Depth of Footings to Meet Soil  
& Climatic Conditions. Minimum Depth  
1'-0" Below Grader.

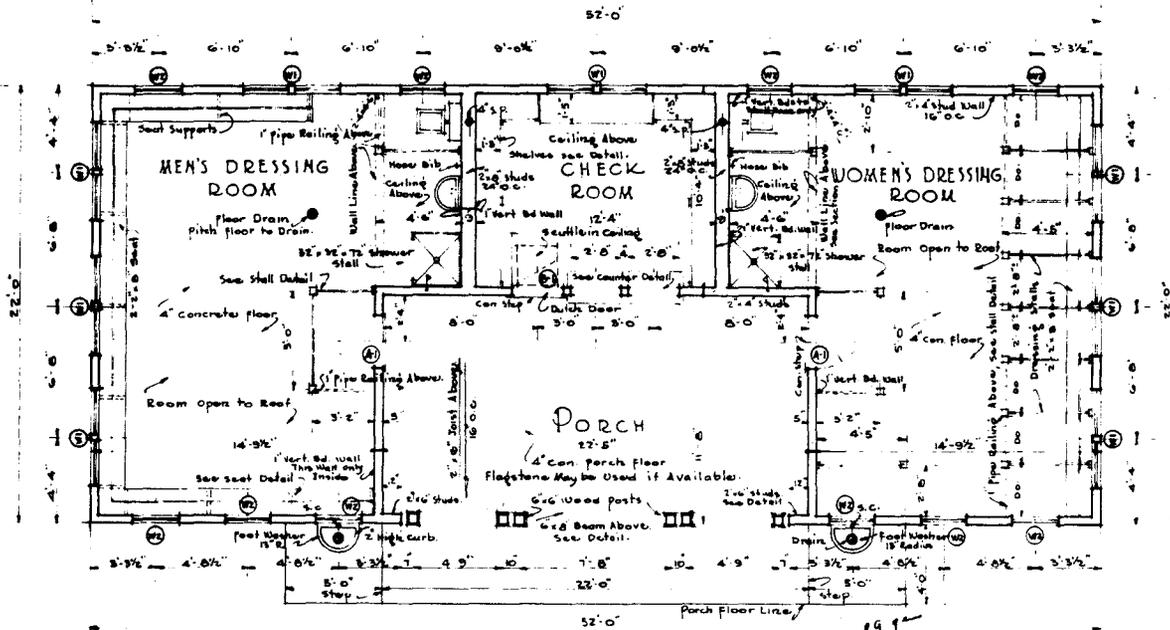
"FLOOR PLAN"  
SCALE 1/8" = 1'-0"

*Not to be used for new construction  
Refer to U-PLANS 291  
7/1/59  
WST*

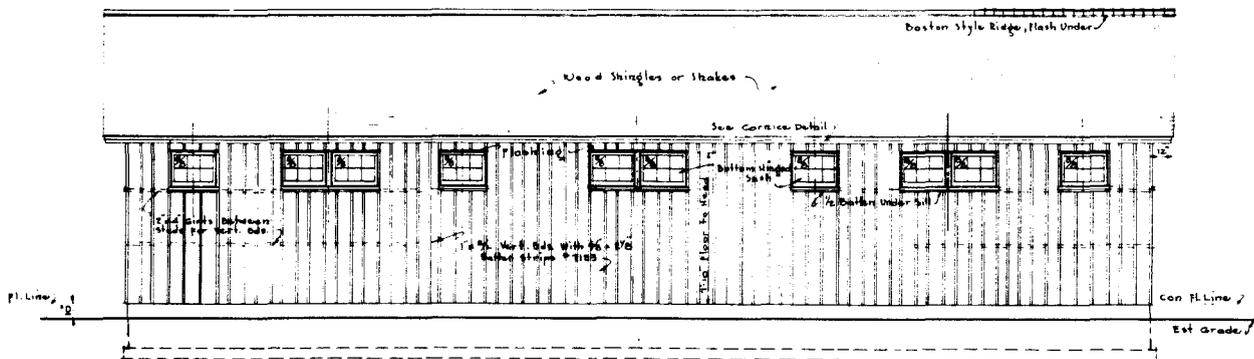
REAR ELEVATION  
SCALE 3/16"=1'-0"

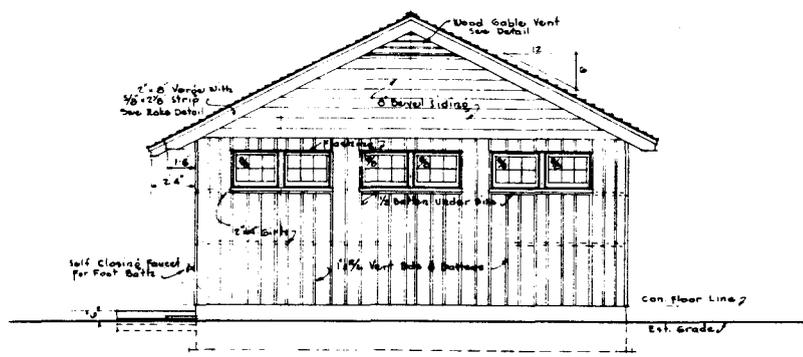
END ELEVATION  
SCALE 3/16"=1'-0"

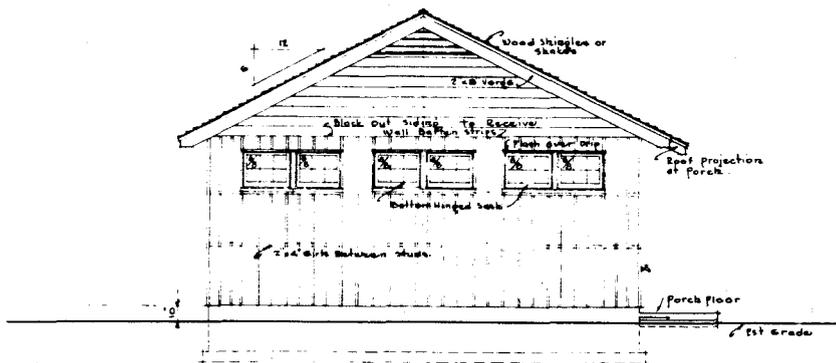
END ELEVATION  
SCALE 3/16"=1'-0"
