USDA PLANT QUARANTINE BUILDING
209 River Street
Hoboken
Hudson County
New Jersey

HABS NO. NJ-1231

USDA PLANT QUARANTINE BUILDING HABS No. NJ-1231

Significance: Constructed in 1940 to carry out the provisions of the National Plant Quarantine Act of 1912, the USDA Plant Quarantine Building is significant as an excellent example of a government building designed in the Art Deco style under the Works Progress Administration. The building is also important as a hub of maritime activity and the agricultural commodity trade. The function of the building was to allow for the detection and removal of plant pests that may be harbored on imported plant material. Plant pathologists at Hoboken became responsible for disease determination for nineteen ports in a territory extending from New York south to Norfolk, Virginia and west to Chicago, Illinois.

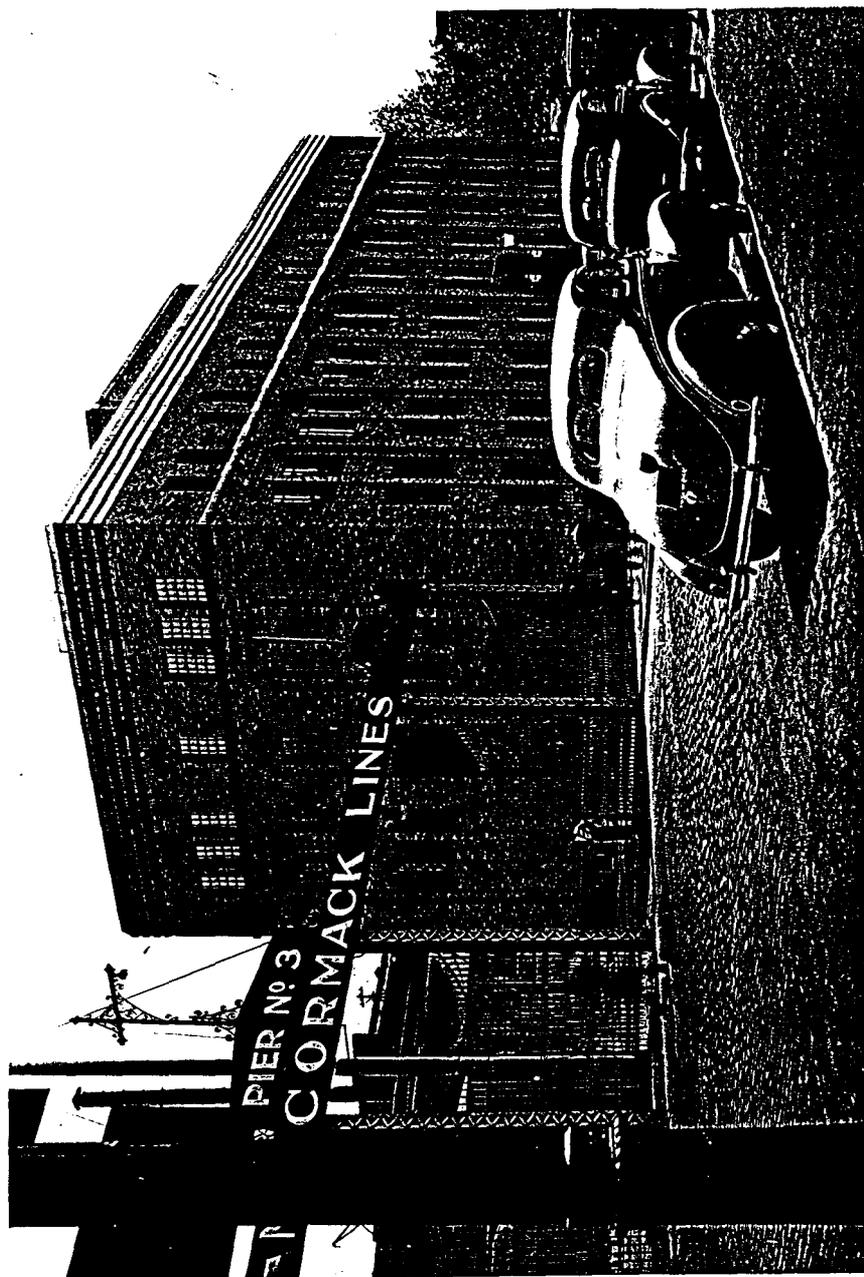
Fig. 3 (Hoboken 6). Northwest view of Hoboken Inspection House as seen when approached from the direction of the Holland American piers.

The building itself is located at 209 River Street, Hoboken, New Jersey, and is in front of the building joining piers 3 and 4 of the old North German Lloyd Steamship Company which piers were taken over by the United States during World War I (see figures 2, 3, and 4 incl.).

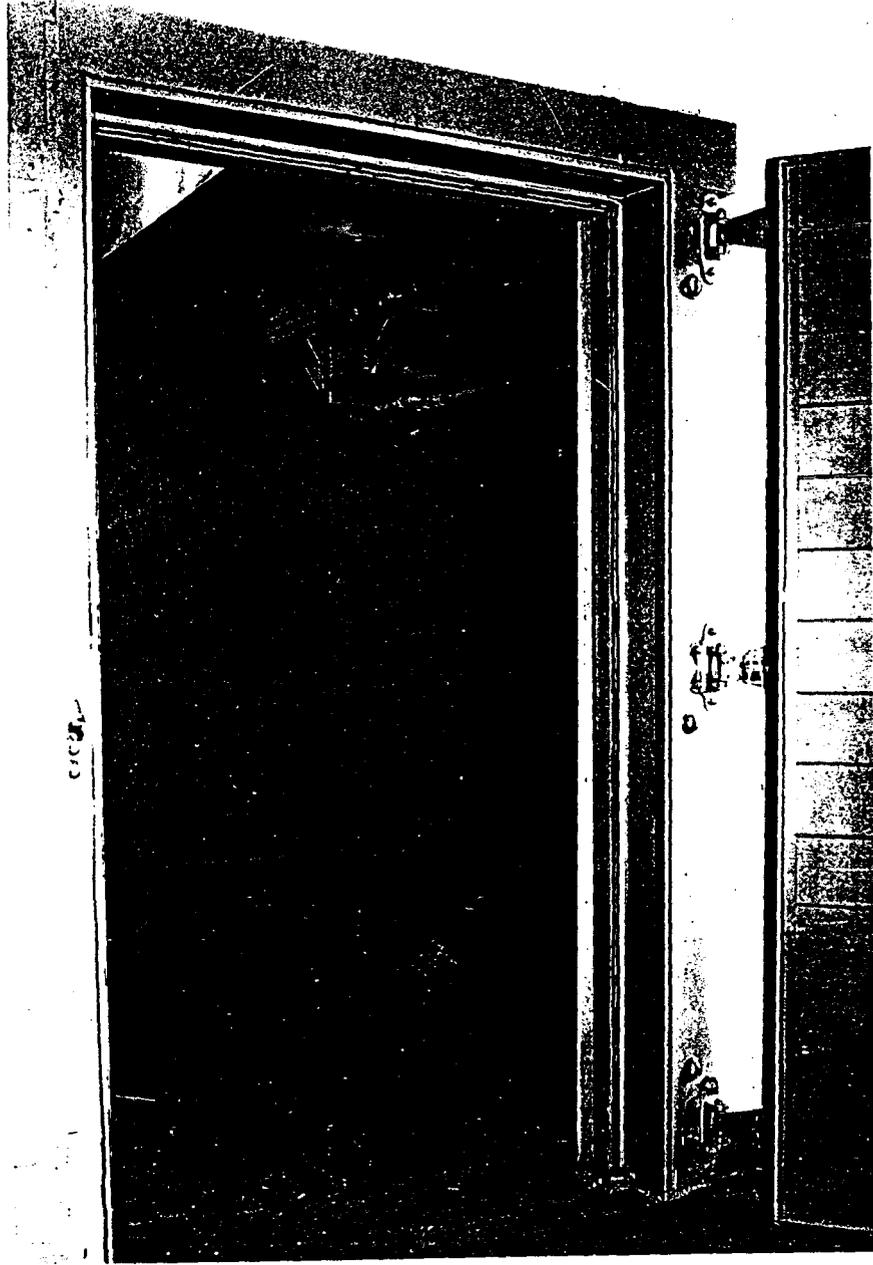
Fig. 9 (Hoboken 108). Showing part of the interior of one of the refrigerating chambers.

At the north end of the shipping and receiving room are two cold storage chambers (111, and 112, figure 6) one with approximately 2,500 cu. ft., and the other with approximately 2,600 cu. ft. of storage space. Figure 9 shows a part of the interior of one of these storage chambers.

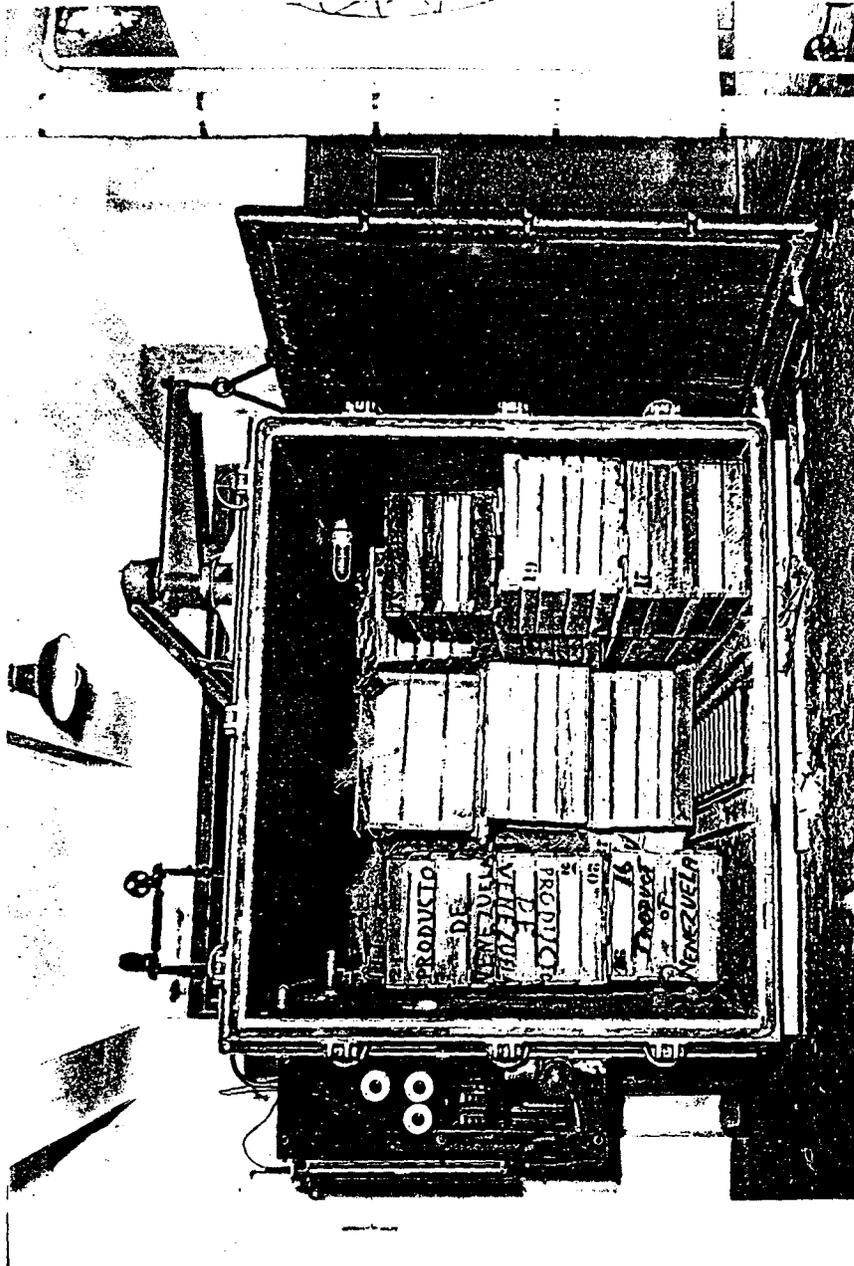
Fig. II (Rebohan 159). The 1000 cu. ft. tank is loaded for fumigation. About 85 of the cases shown in Fig. 7 are in the tank.

At the south end of the shipping and receiving room is a vacuum fumigation tank of 1,000 cu. ft. capacity. This is illustrated in figures 10 and 11. This tank, unlike those on the second floor is not steam jacketed, nor is it tied in with the gas supply system for the vacuum fumigation tanks on the second floor. It has its own applicator, and when used, a cylinder of the liquified fumigation gas is trucked over to the tank and connected with the applicator.

In the foreground at the top of the tank will be seen the device from which the door is suspended. (Figure 11 gives a better idea of the door suspension arrangement). By swinging this around to the proper position the door can be fastened in place by the wheel lugs (better seen in figure 20). The hole in the upper left corner of the rear wall is the vent through which air is drawn. In the center of the rear wall is an electric plug mostly used for connecting a fan. The pipe on the ceiling of the tank is for admitting gas. The rod-like structure projecting from the ceiling near the left wall is part of the temperature-recording device. The tank is double walled and steam may be injected between the two walls for dry-heat treatments.

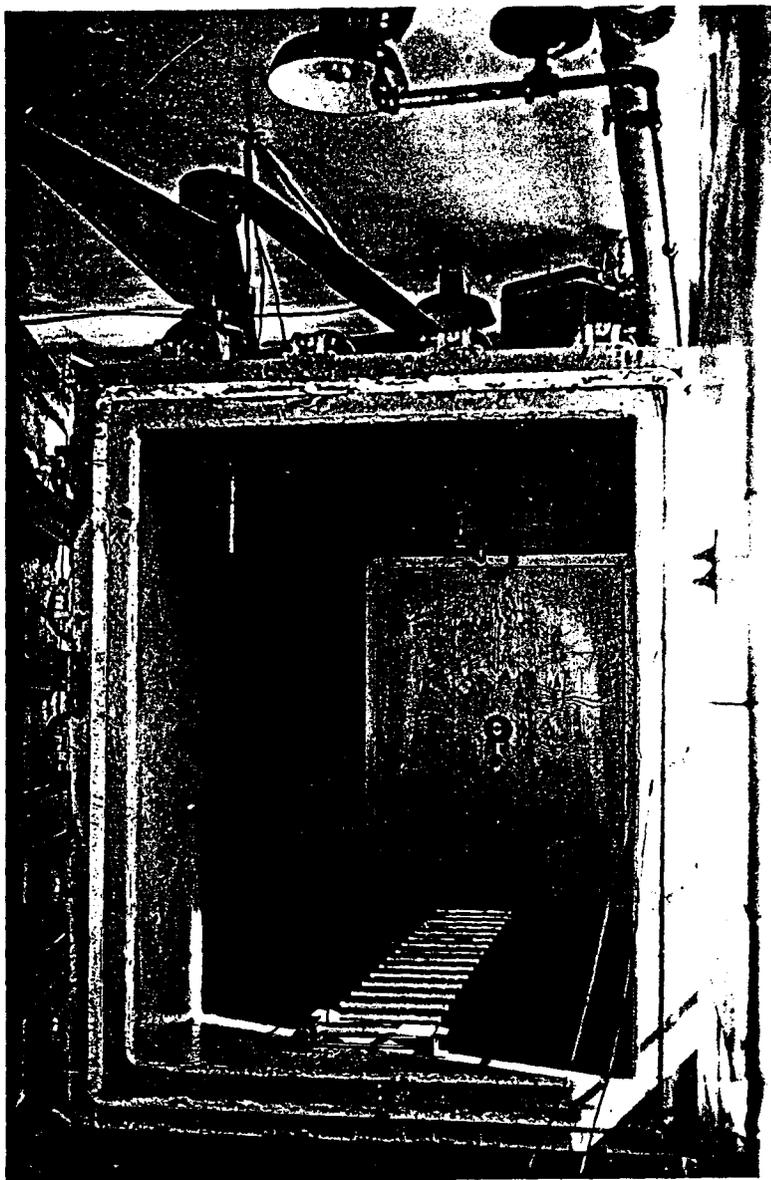
Fig. 21 (Hoboken 19). The 200 cu. ft. fumigation tank.

Figure 21 shows the interior arrangement of the 200 cu. ft. fumigation tank which is the same as the 100 and 400 cu. ft. tanks. Figure 22 shows the interior arrangement of one of the 50 cu. ft. fumigation tanks.

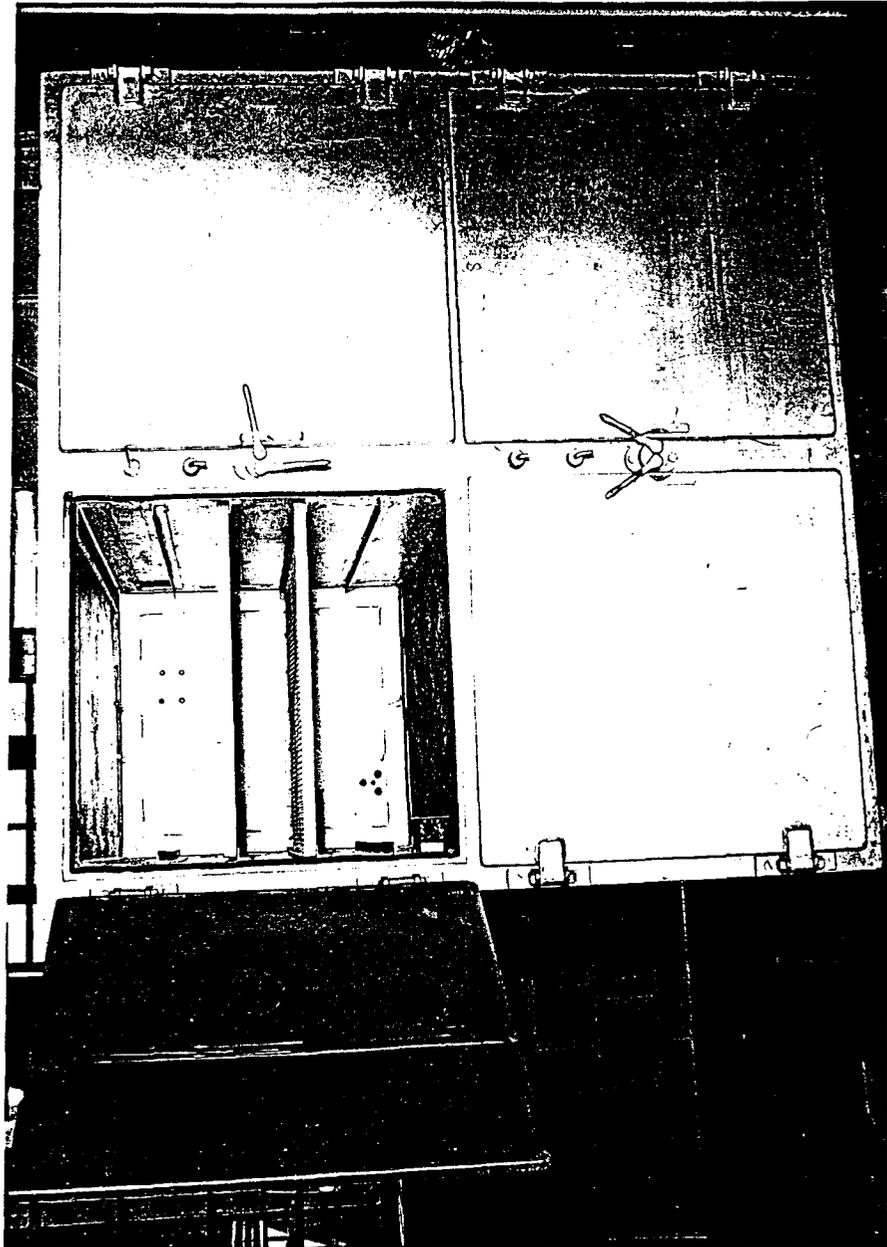
On the upper right wall of the open box an opening is visible. Through this gas is drawn by means of a suction fan which serves these four units. A small rod is seen protruding from the front exposure of the partition between the open chamber and the chamber to the right of it. When this rod is shoved in the vent is closed.

Fig. 23 (Hoboken 230). The four 25 cu. ft. atmospheric fumigation chambers.

Figure 23 shows the four 25 cu. ft. atmospheric pressure fumigation boxes all built in one unit. These fumigation boxes have subsequently been connected with the vacuum system and a "snifter" valve has been installed to prevent lowering of pressure more than an inch or two. A small applicator has likewise been installed for these boxes. This arrangement makes it possible to lower the pressure in the boxes just enough to suck in the methyl bromide. The boxes are not used for fumigations with HCN.

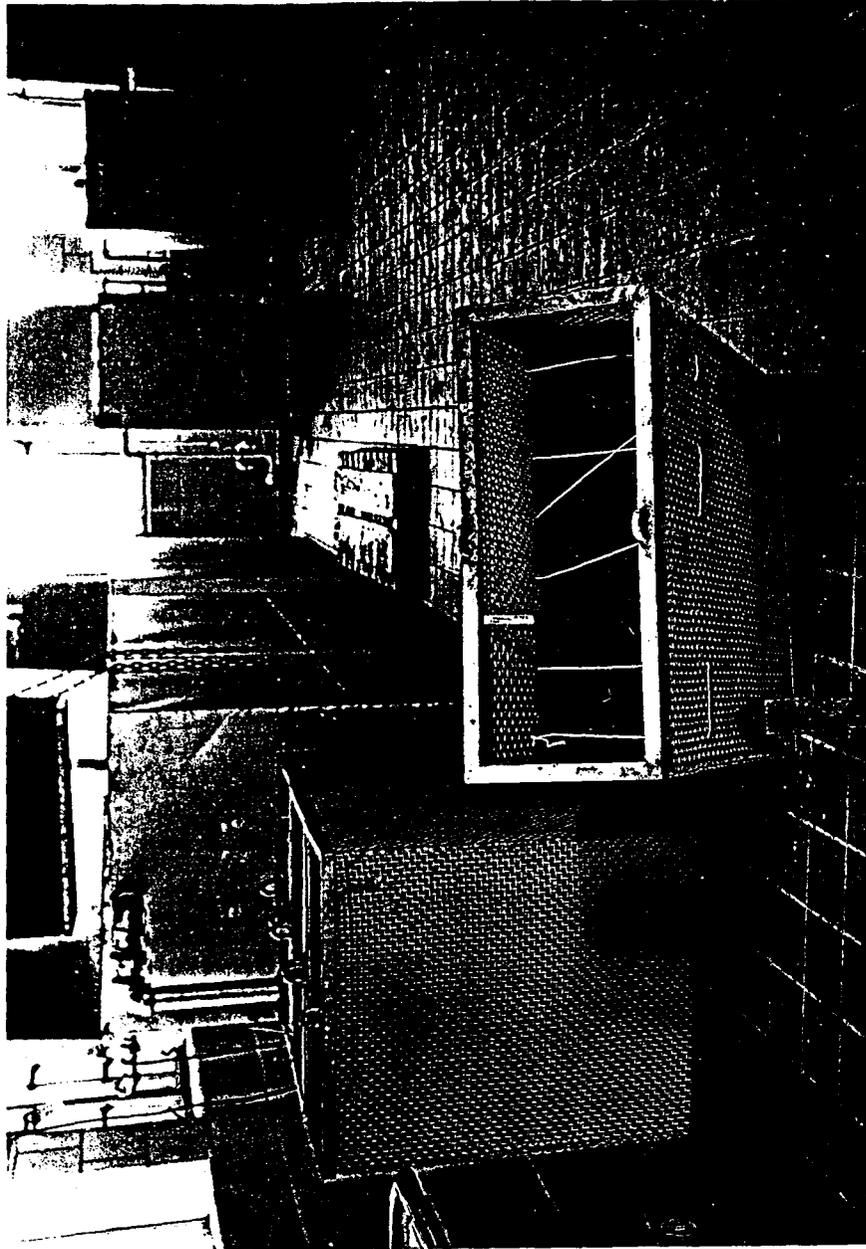
Fig. 28 (Hoboken 37). Woven wire hot-water treating baskets.

The construction of the woven wire baskets used in the tanks is better seen in figure 28. They are made of $1/8$ " galvanized wire woven in a $1/2$ " mesh. They are reinforced with $1/2$ " round iron inside and, in addition, with 1-inch angle iron at the top and bottom. Eyelets are provided at the top of the frame for lifting the baskets with a chain hoist. One of the baskets shown in figure 28 has been loaded with bulbs, and gunny sack has been fastened across the top of the bulbs to prevent them from floating.

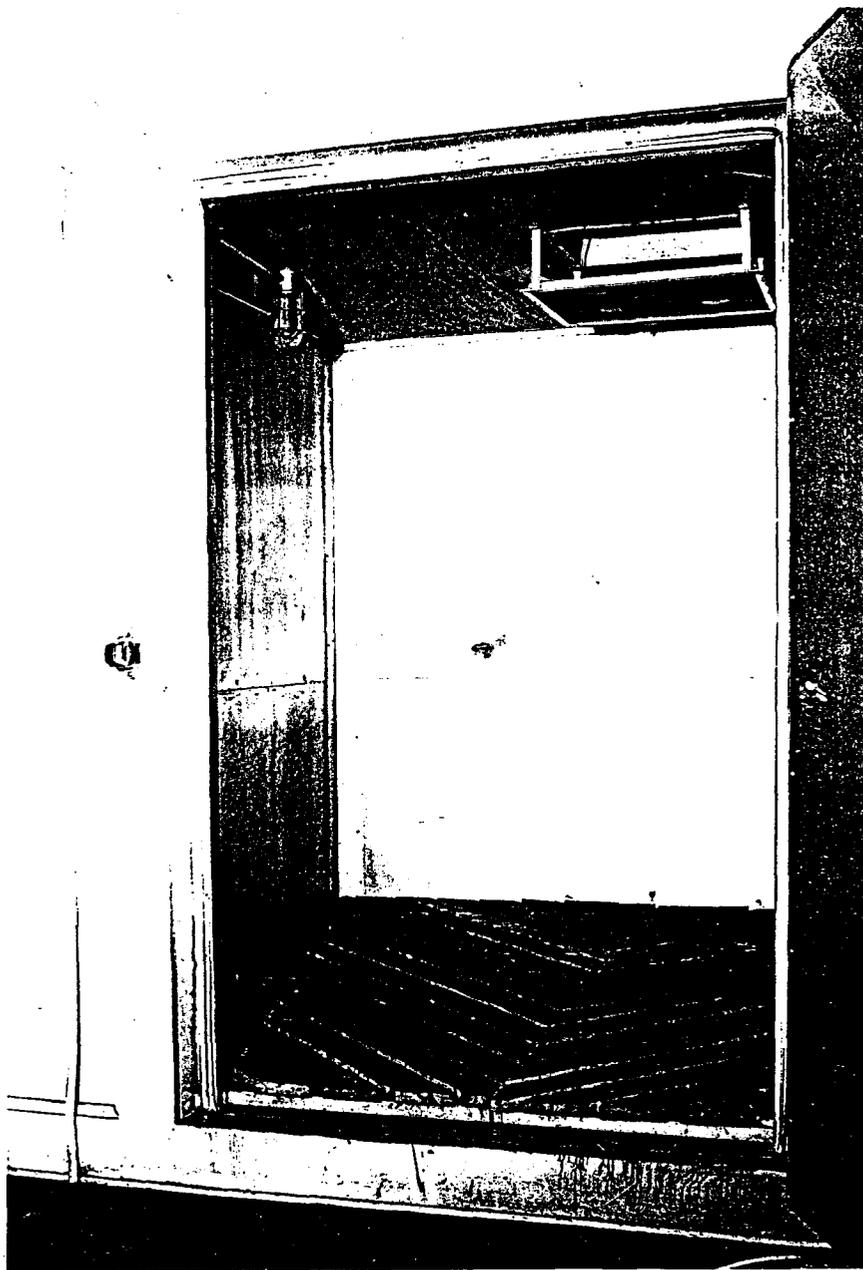
Fig. 30 (Hoboken 107). Vapor heat chamber in
vapor-heat treating room.

Figure 30 shows the interior of one of the vapor heat chambers. Each of these chambers has a capacity of approximately 268 cu. ft. The heated and humidified air is blown in under the false flooring and is drawn out from the top by a suction fan. As the air goes through the heating elements, 10 percent of fresh air is added. The air is heated by being passed over a radiator enclosed in a chute. The temperature of the air must be manually controlled by means of a temperature regulator which makes this possible within a range of 80 to 120 degrees Fahrenheit. The regulator merely sets the flow of steam through the radiator. Steam vapor is added after the air passes over the radiator and this too must be controlled manually.
