ADDENDUM TO:  
ABRAHAM HASBROUCK HOUSE  
94 Huguenot Street  
New Paltz  
Ulster County  
New York

HABS No. NY-4363

REDUCED COPIES OF MEASURED DRAWINGS

HISTORIC AMERICAN BUILDINGS SURVEY  
National Park Service  
U.S. Department of the Interior  
1849 C St. NW  
Washington, DC 20240

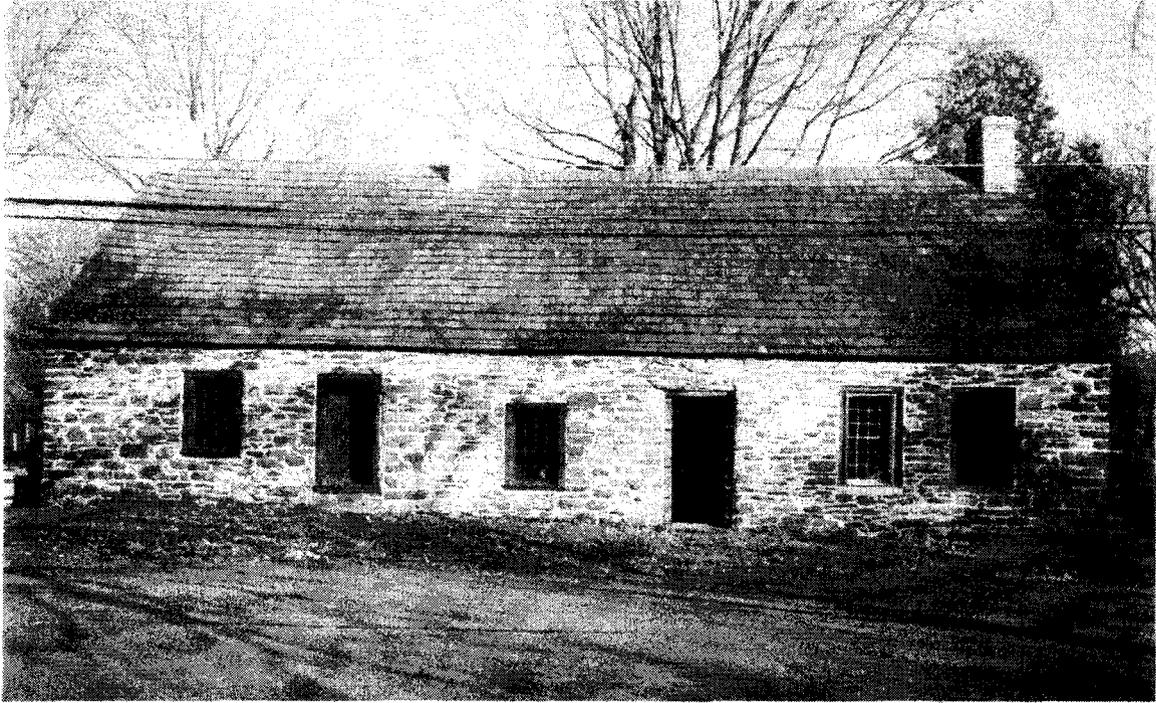
fig. 1: Abraham Hasbrouck House, west elevation, HABS photograph, 2002

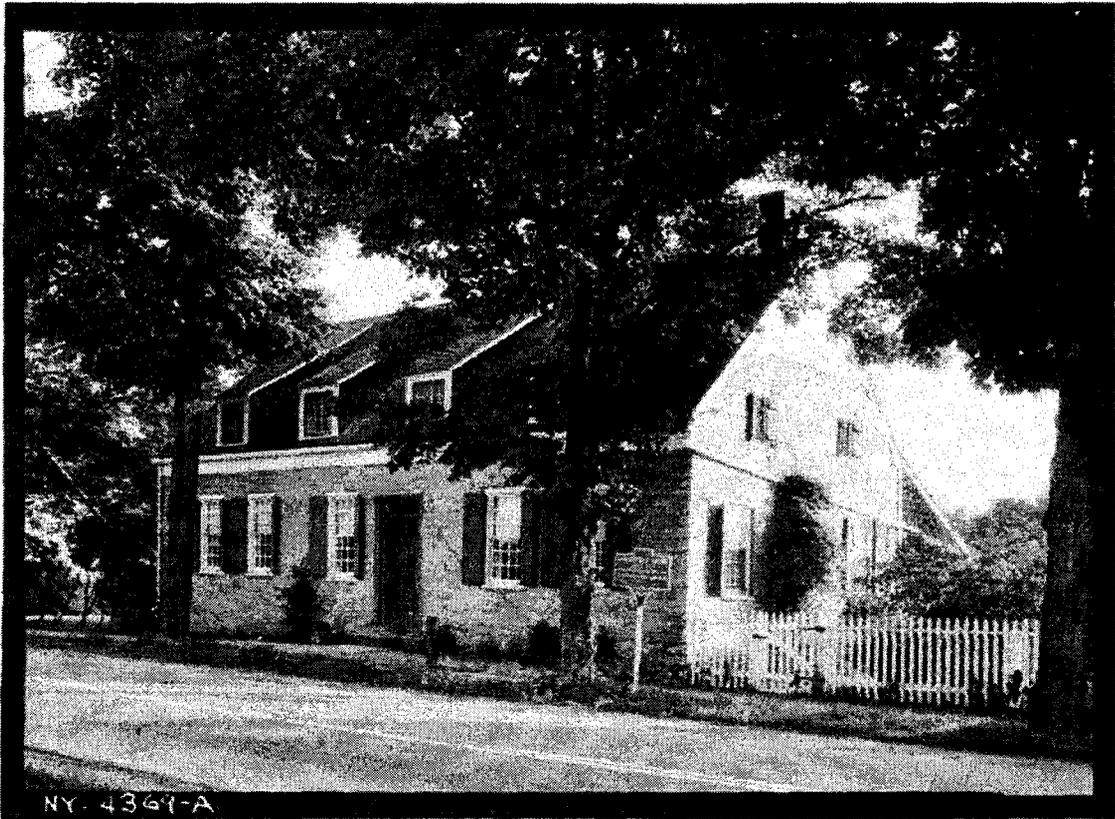
fig. 2: Van Dusen House, Hurley NY, c1744 [from HABS NY-4369]

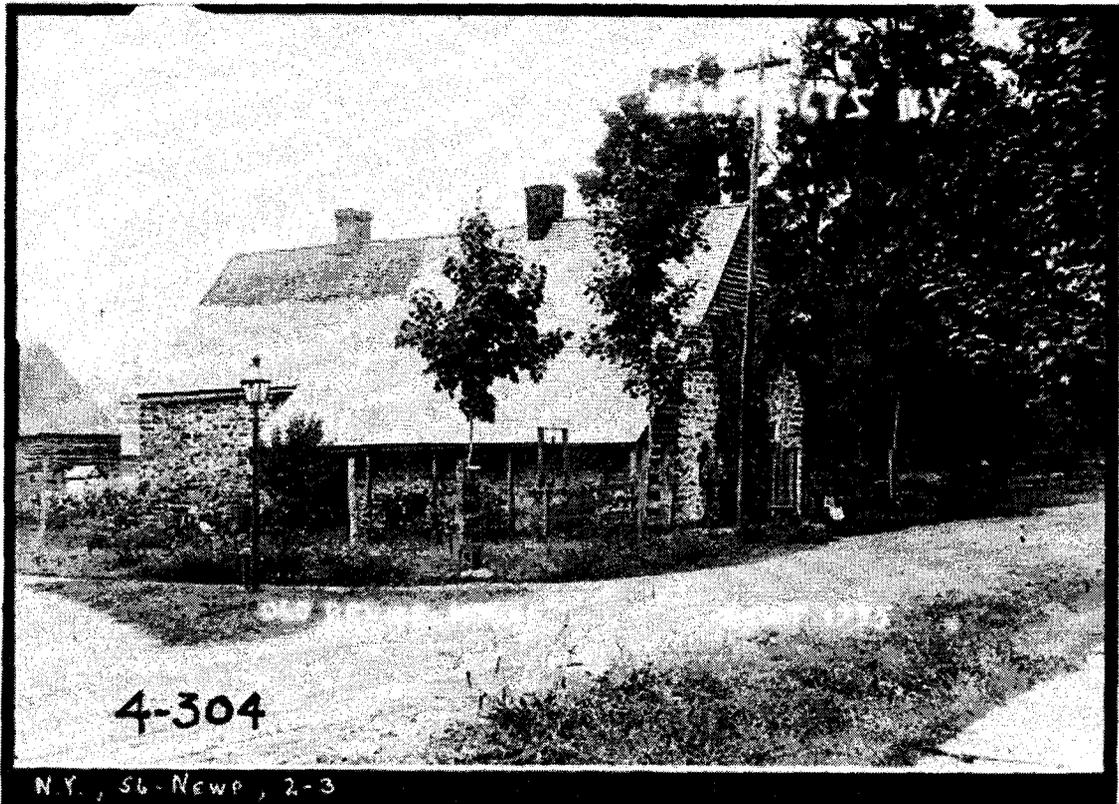
fig. 3: Bevier-Elting House, New Paltz NY, c1705-1735 [from HABS NY-4369]

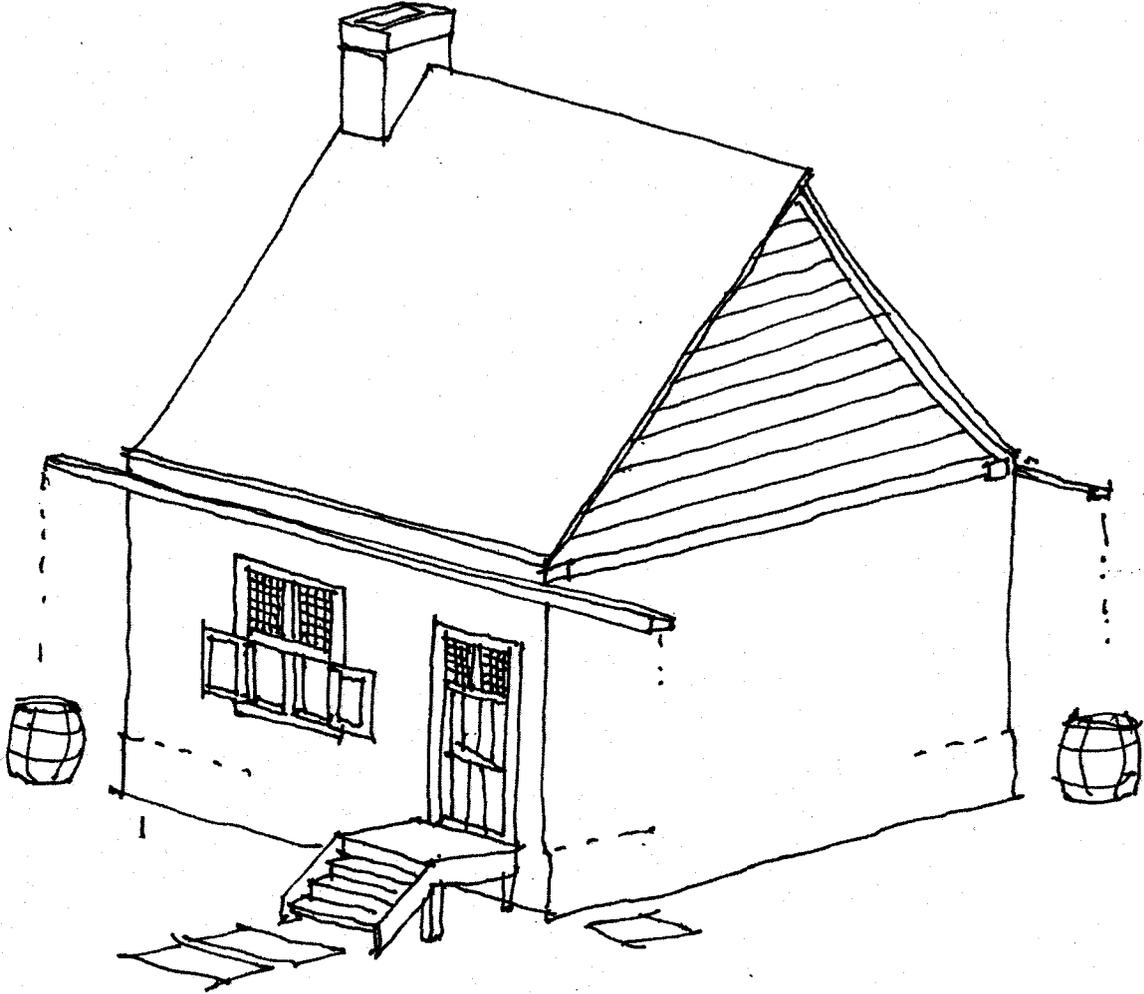
fig. 6: Schematic isometric drawing of Phase I of Abraham Hasbrouck House, c1721

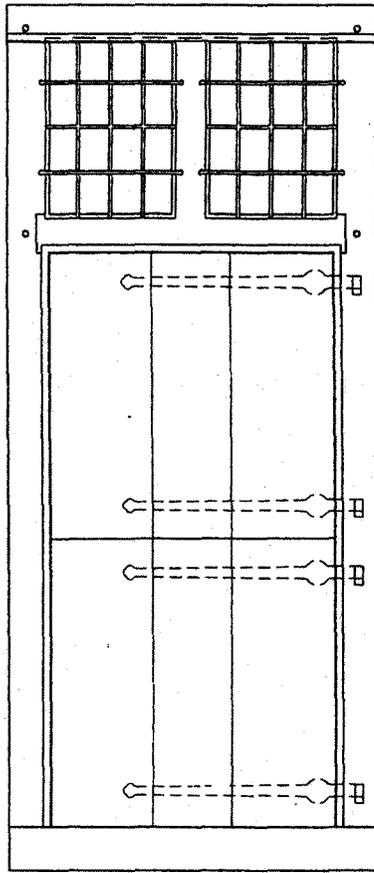
<sup>6</sup>fig. 7: Schematic drawing of doorway, Phase I of Abraham Hasbrouck House, c1721

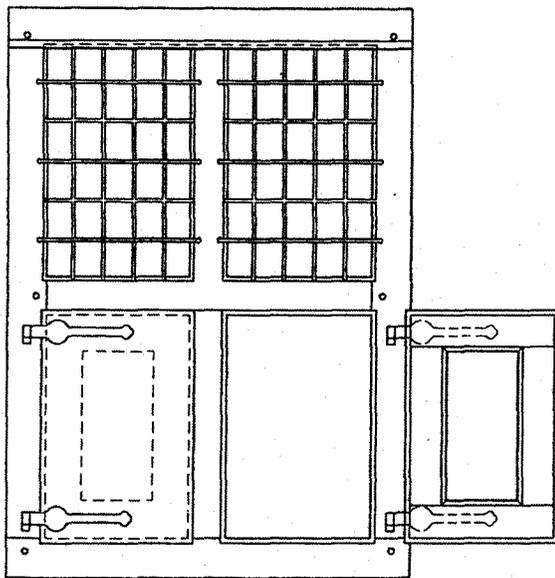
<sup>7</sup>fig. 8: Schematic drawing of *cruiscoszyn*, Phase I of Abraham Hasbrouck House, c1721

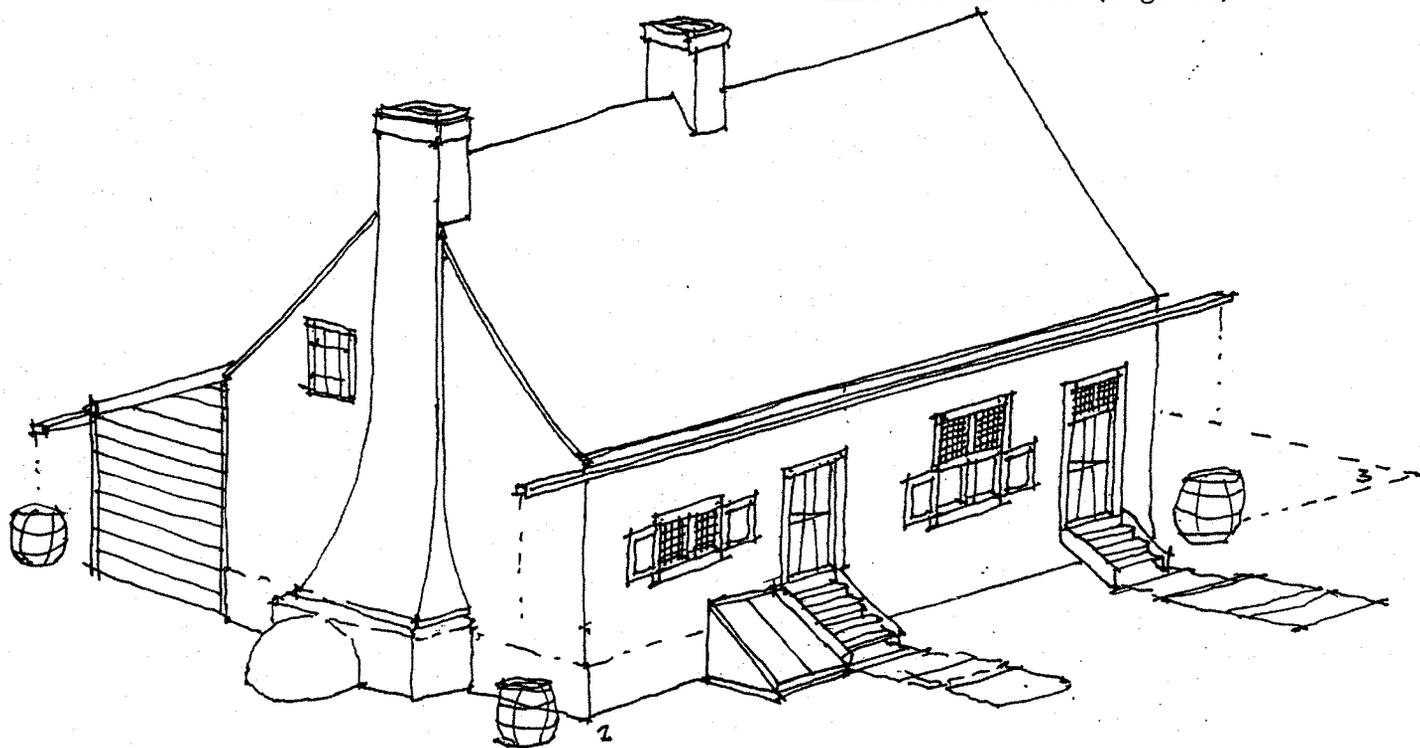
fig. 10: Schematic isometric drawing of Phase II of Abraham Hasbrouck House, c1728

The north wall displayed the exterior of the brick chimney that bisected the stone wall in distinctive fashion. It was flanked by windows to illuminate the kitchen at its base and at least a door and possibly a shuttered window at the attic level. If an outlet was present on the rear of the Phase I house, it could have been extended across the east wall of Phase II, although no openings were present in the stone wall. Ground level would have been nearly three feet below its present wall in this phase. The front entrances into the expanded house would have needed tall wood stoops. (fig. 8)

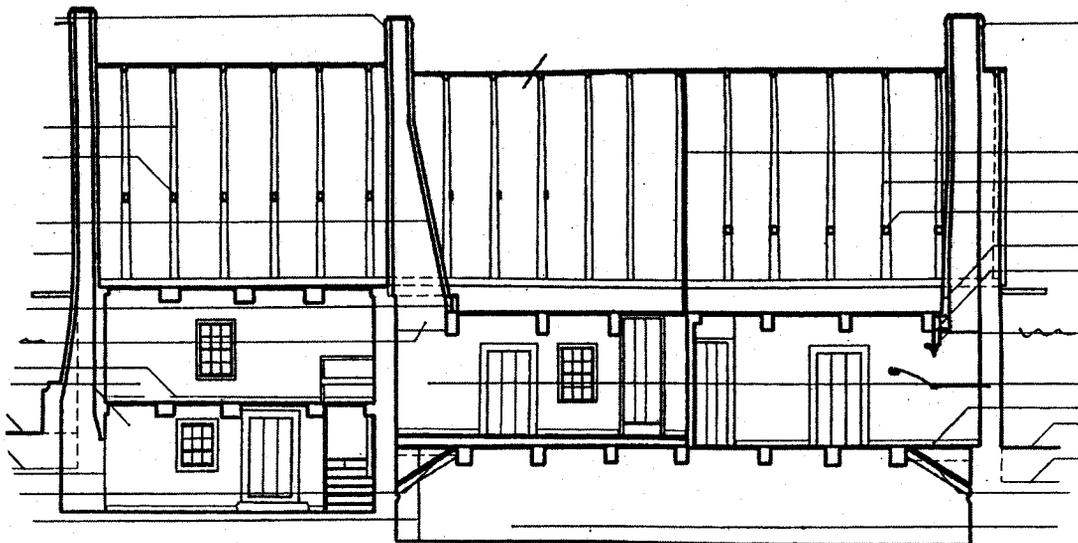
fig. 11: Longitudinal section of Abraham Hasbrouck House, kitchen and opkamer on left

The street façade of the *opkamer* would have contained a door and a window as it now does. The present door is a nineteenth-century replacement; and even though it does not contain any fragments of earlier material, an exterior entrance into this room would have been consistent with Dutch tradition in the region.<sup>31</sup> With rooms aligned end-to-end and with no internal connecting passageways, as was the rare case in the Jean Hasbrouck House, eighteenth-century stone houses typically had separate entrances into each room. Based on the dimensions of the opening, it does not appear that this door had a transom like the entrance into the first phase of the house. The window adjacent to the door was, based on its dimensions, a *bolcoszyn*, which paired two openings side-by-side in a heavy oak frame. This window was constructed with moveable leaded-glass windows with wood frames that would have allowed for both openings to have been glazed and shuttered. Later, perhaps as soon as in the next phase of construction, these leaded-glass casements were replaced with wood-muntin windows. (fig. 11)

This shift in levels was also conveyed to the exterior appearance of the house through the varying window levels and the indication of two stories in the kitchen portion. (fig. 11) The distinction of this stage of development is that the kitchen was still contained within the mass of the whole house; that is, that the stone walls of the kitchen were the same height as the main part of the house, and a single ridgeline was preserved on the roof. In ensuing stages of evolution after the turn of the nineteenth century, the kitchen became an appendage that clearly indicated the separation of the private family and public working sections of the farmhouse. (fig. 12) By then, the development of the Ulster County farmhouse type, stone or otherwise, was complete, and the old Dutch townhouse was merely a remnant of the colonial past.

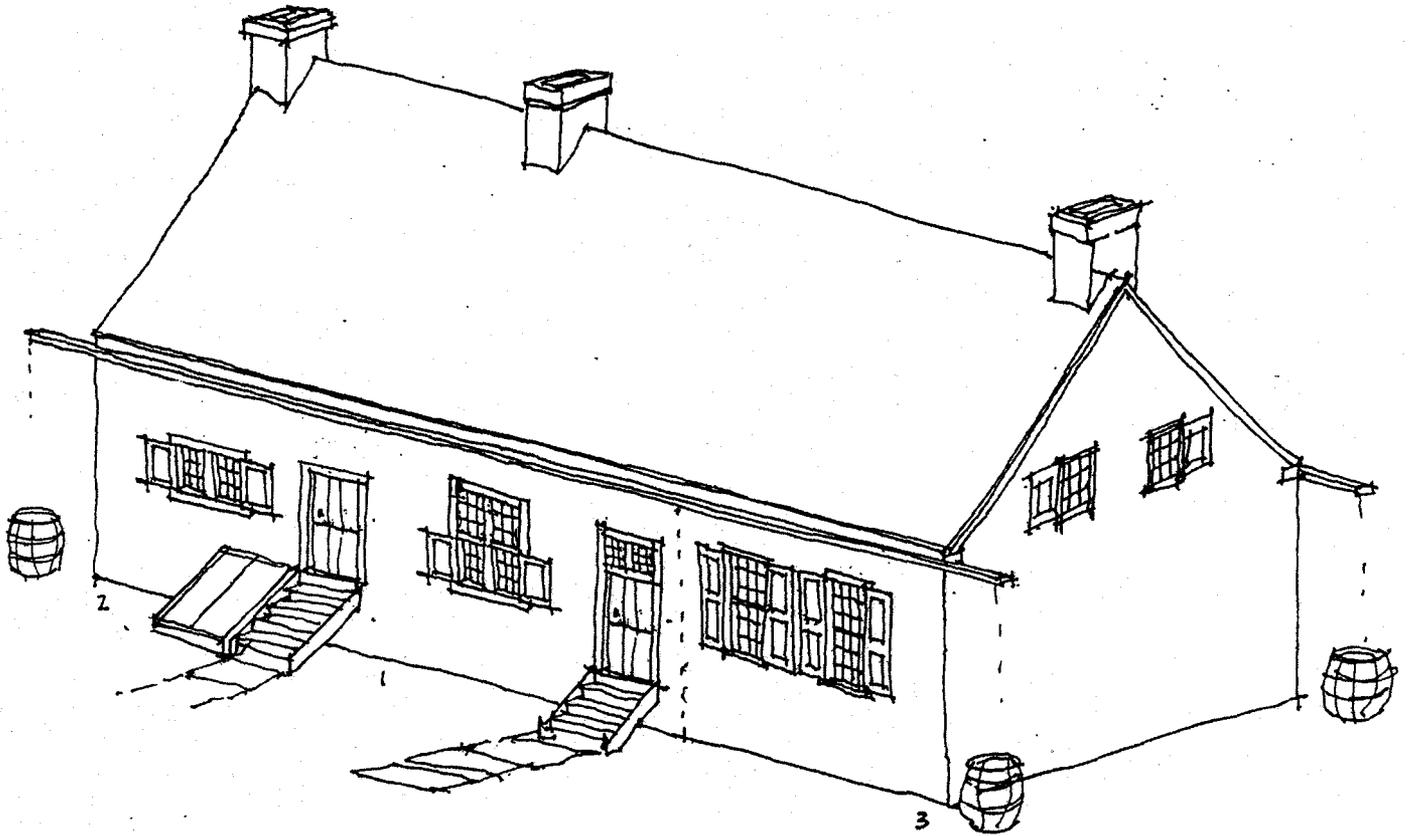
fig. 17. Schematic isometric drawing of Phase III of Abraham Hasbrouck House,  
1734-1741

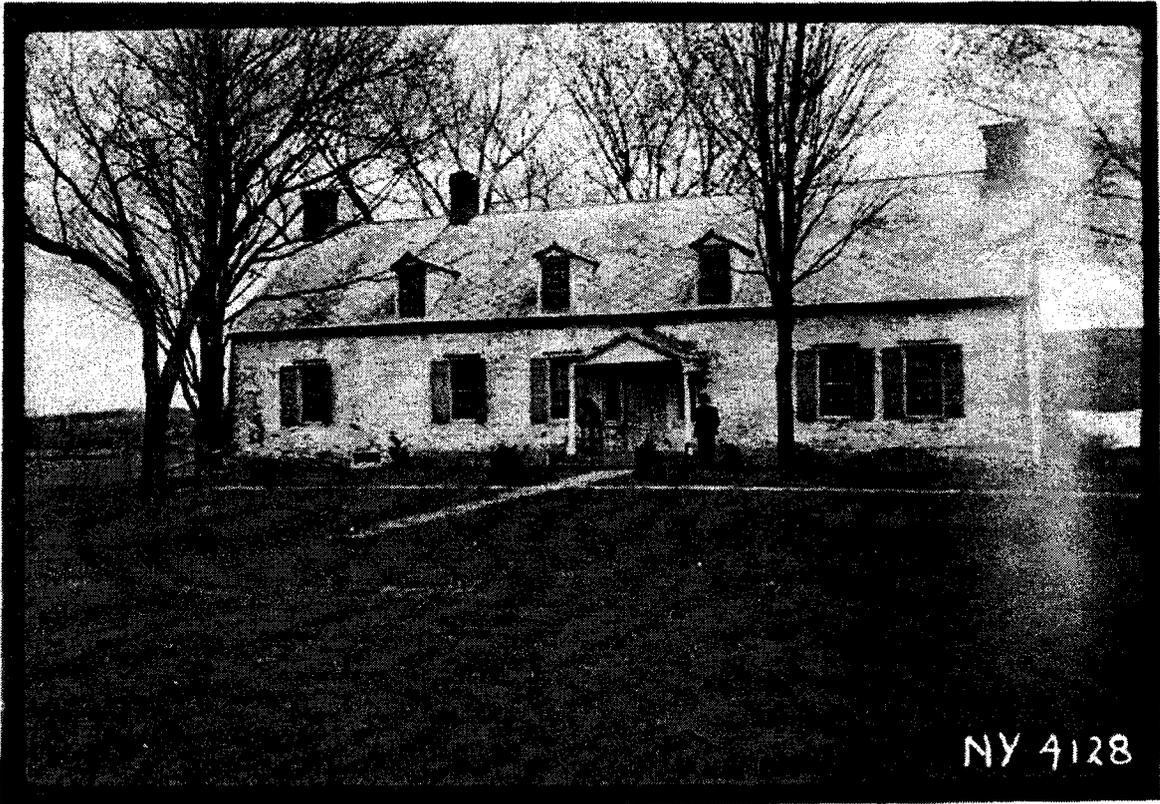
15

fig. 19: Bruyn House, Wawarsing NY, c1740 [from HABS NY-4128]

On the west wall was a pair of twelve-over-twelve sash windows that conveyed the status of the room by their modernity. In 1734, or even 1741, these windows would have been quite an innovation, which positions the house on the cutting edge of the developing stone house architecture once again.<sup>32</sup> It would not be until many years later that this new window type became common in the village. And although it has been impossible to interpret the window counts and measurements contained in the assessment lists for the 1798 U.S. Direct Tax, there is every indication that the old casement windows were still in use in many of the stone houses, including the Abraham Hasbrouck House, at this late date.<sup>33</sup> The pairing of these windows on the exterior of the building introduced an element of Classical symmetry to the otherwise organic fenestration of the façade. It did not seem to concern the builder that these windows and their relationship to each other were not in correspondence with the rest of the house. It apparently was sufficient to demonstrate that this particular component was up-to-date, while the earlier phases of the house remained in their own style context. Perhaps it was important to document the elements of continuity and change in this transitional period. This is a phenomenon that repeated itself frequently during Daniel Hasbrouck's generation as old stone houses were enlarged and modernized. (figs. 14 & 15)

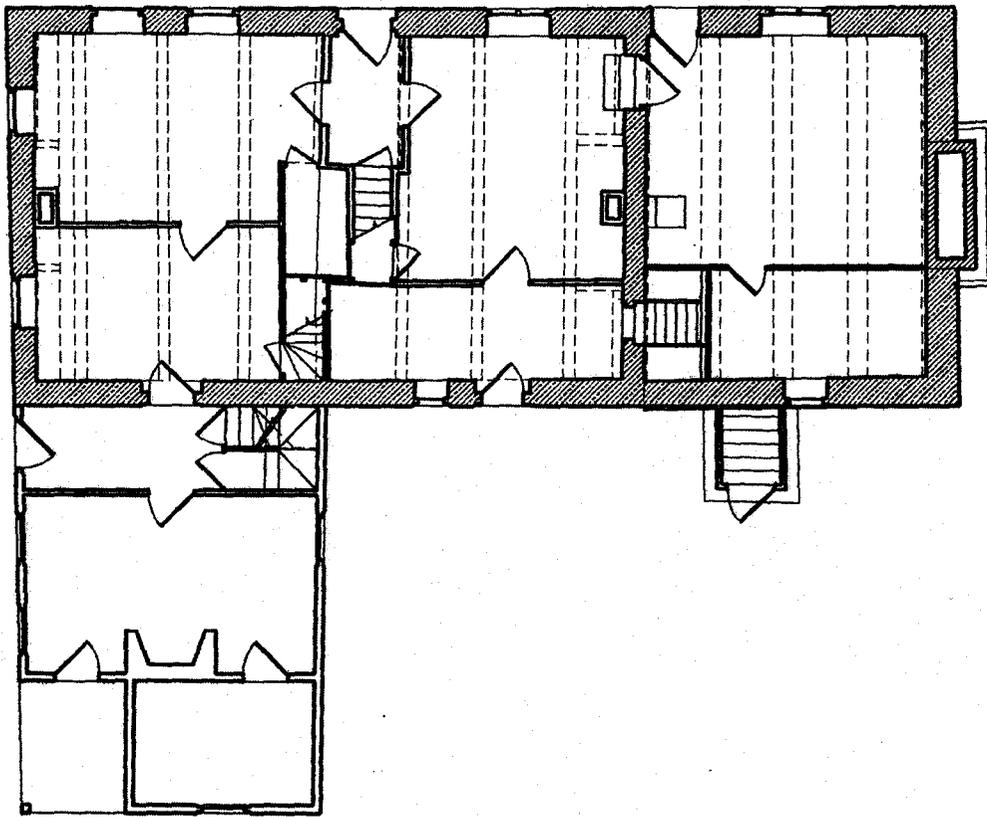
fig. <sup>116</sup>21: Schematic floorplan of Phase IV of Abraham Hasbrouck House, c1830

With the jambless fireplaces removed and the floor work completed, the center and southern rooms were partitioned into two spaces.<sup>43</sup> (fig. 16) New windows were cut through the stone walls on the south wall of the house to provide more light, and a window was cut in the east wall of the center section to illuminate the new room there. In fact, all the existing windows were refitted with new window sashes and frames, possibly over an extended period of time. It was in Phase IV that the exterior stone walls of the house likely received their first coats of whitewash. The east wall was repaired, old casement window spaces were built in and made smaller, and new windows were cut through creating a jumble of new seams and patchwork. The whitewash would have concealed these imperfections and refreshed the appearance of the house. By the early
