3 Winding Way (House)
West side of Winding Way
Binghamton
Broome County
New York

HABS No. NY-5507

HISTORIC AMERICAN BUILDINGS SURVEY

3 WINDING WAY (House)

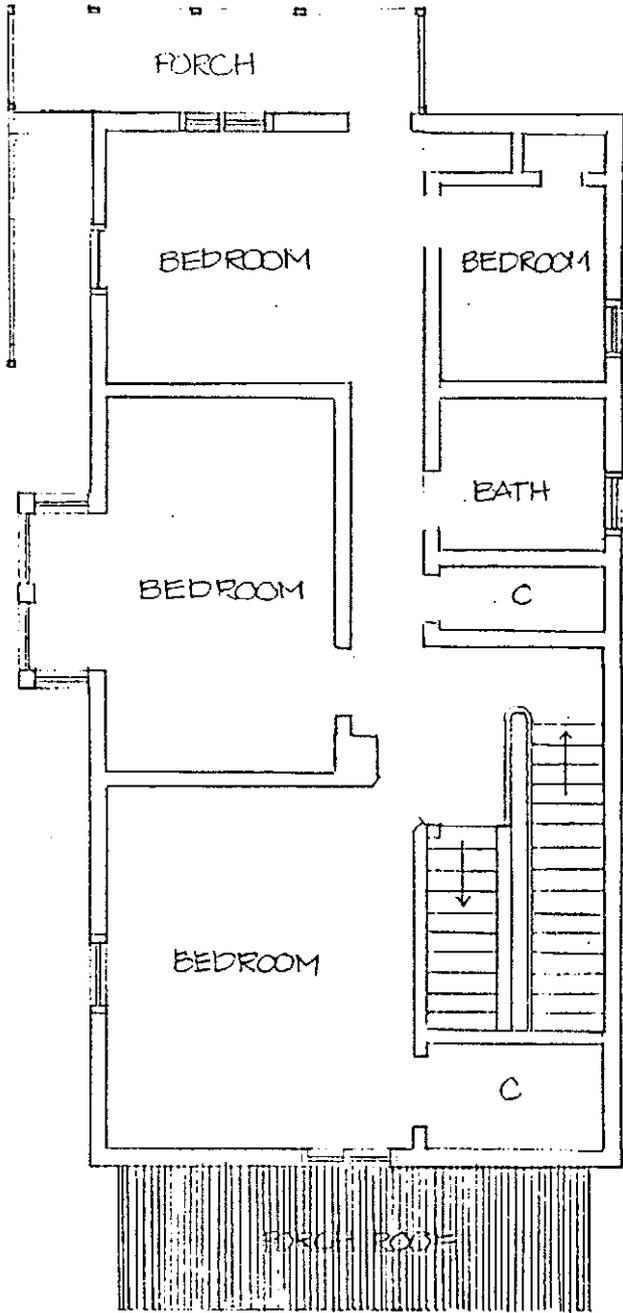
Second Floor Plan
Scale: 1/8" = 1'0"
3 Winding Way
Drawn by Laurie Kimball
Date: 6/27/86

1. Floor Plans: Refer to Drawings 1-4 for room dimensions and original uses.
2. Stairways: There are two stairways in this structure: front entry and attic (refer to Drawings 1-4 for locations). The front entry stairs are hardwood in construction and include a complete spindle bannister, the stairway has been painted several times and steps show extreme wear. The attic stairs are pine with a narrow pine railing, they are unpainted and worn. Access to the basement is through a ground level door in the rear of the building.

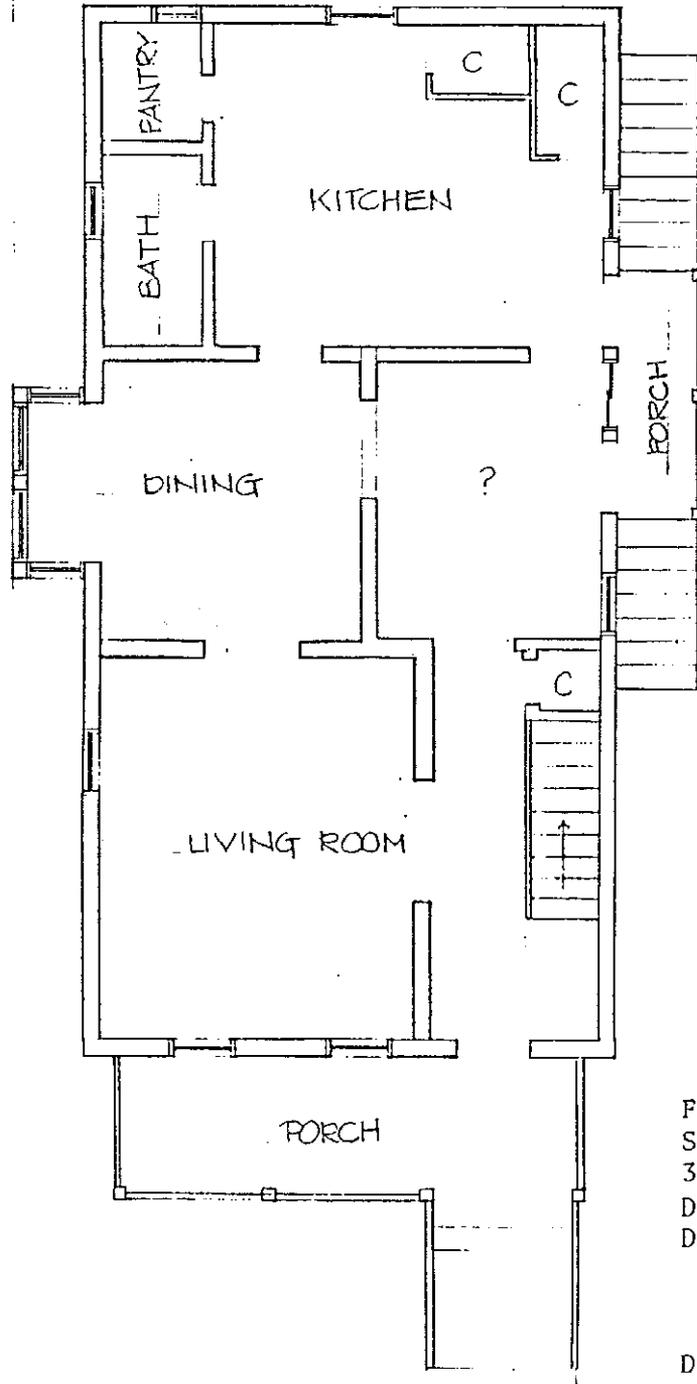
First Floor Plan
Scale: 1/8" = 1'0"
3 Winding Way
Drawn by Laurie Kimball
Date: 6/27/86

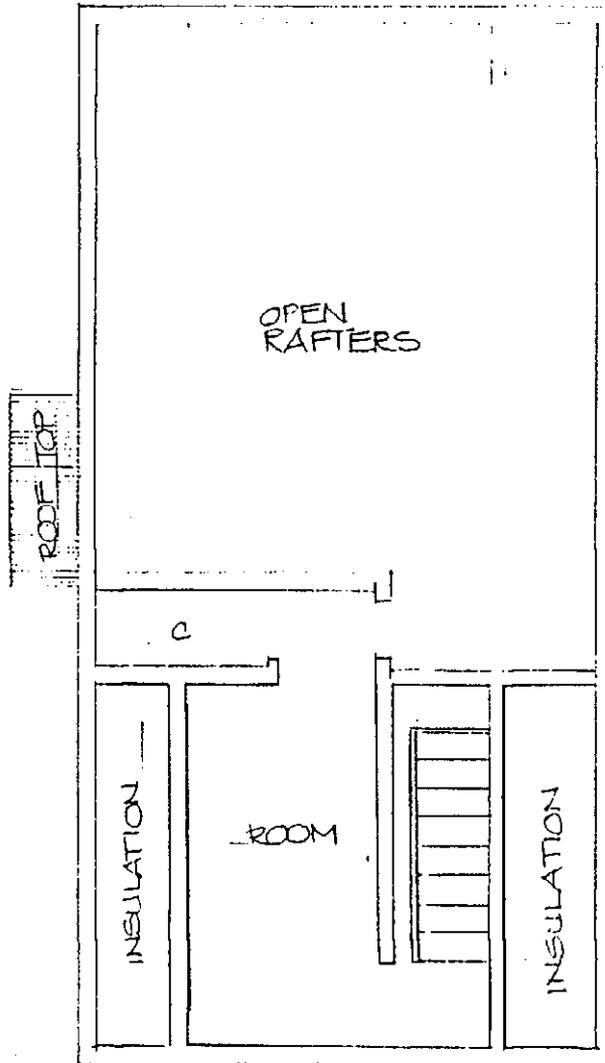
Attic Plan
Scale: 1/8" = 1'00"
3 Winding Way
Drawn by Laurie Kimball
Date: 6/27/86

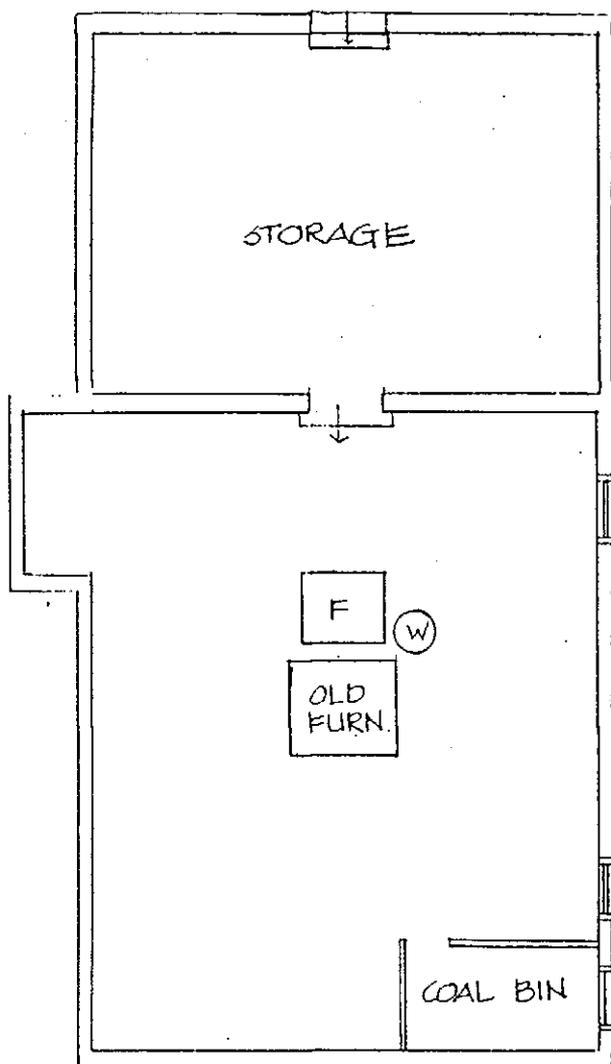
Basement Plan
Scale 1/8" = 1'00"
3 Winding Way
Drawn by Laurie Kimball
Date: 6/27/86
