ANDERSON HOUSE  
(Dankworth House)  
3678 Belmont Street  
Bellaire  
Belmont County  
Ohio

HABS No. OH-2324

WRITTEN HISTORICAL AND DESCRIPTIVE DATA

Anderson House (Dankworth House)

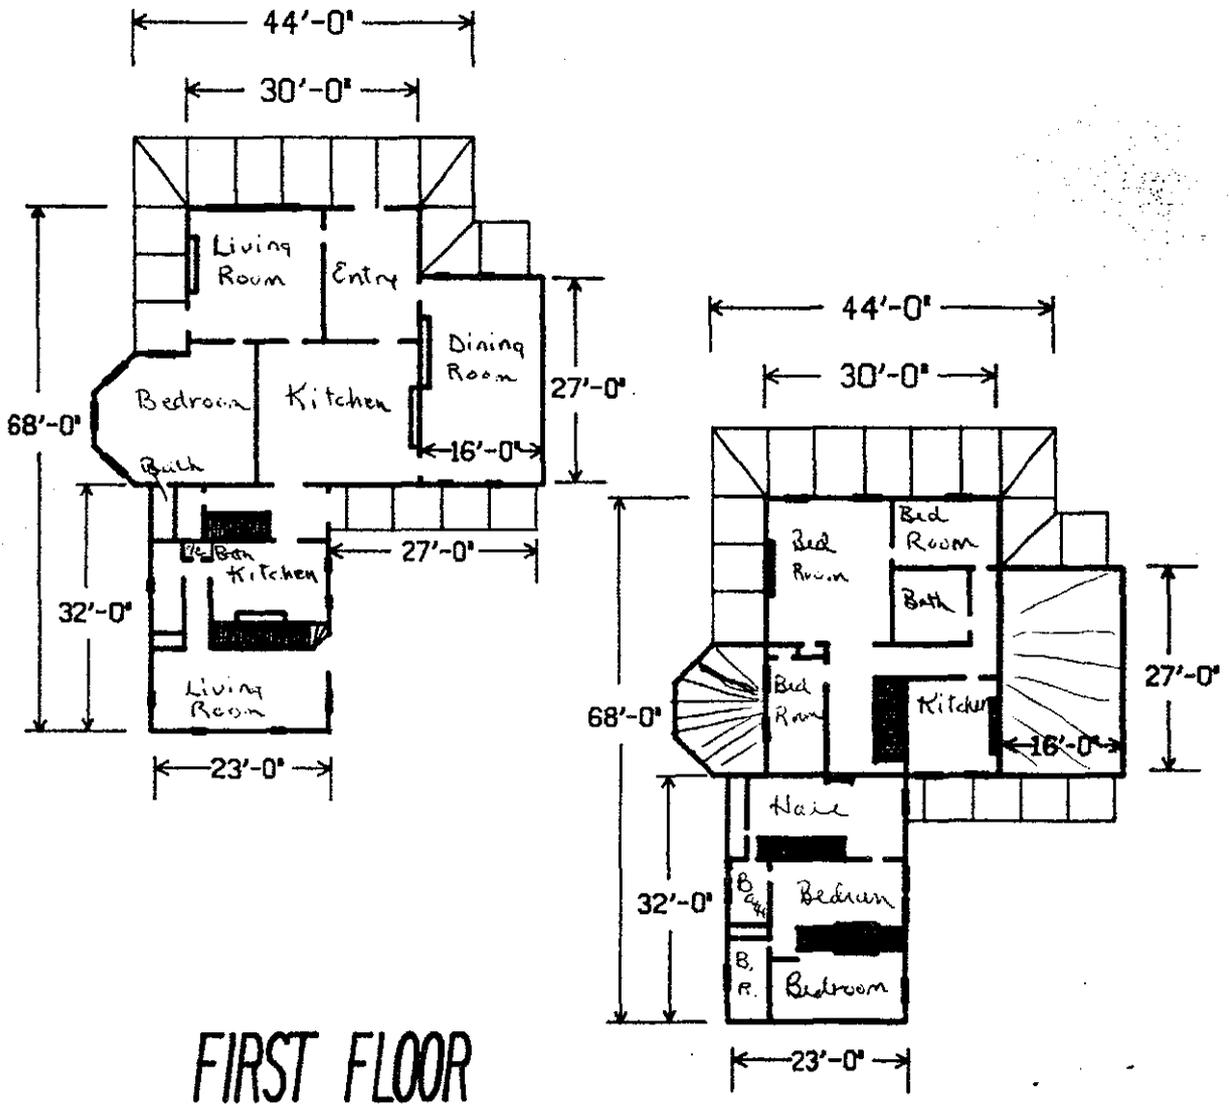
ANDERSON HOUSE (DANKWORTH HOUSE)  
HABS NO. OH-2324 (PAGE 17)

FIRST FLOOR

SECOND FLOOR

1. Overall dimensions: The two story brick house is irregular in massing, 49'x86'. This measurement is inclusive of a one story addition (16'x27'), a two story addition (23'x32'), front frame porch (58'x28' at longest points), bay window addition (12'x17'). The facade features a full width frame porch, added circa 1910, and elliptical arched opening for front door.
2. Foundations: The foundation is random stone. The foundation for core structure is random stone 19" thick. The rear addition is random stone topped with cut sandstone 19" thick. The south and north sides contain a
