Andrews Stone House
Harney County Road 201,
approximately 13 miles north of Oregon 205 at Fields, Oregon
Andrews, Harney County
Oregon

HABS No. OR-172

Andrews Stone House HABS No. OR-172

Significance: Part of a small townsite associated with ranching, a prominent
industry in this region, the Stone House exemplifies a
vernacular style of architecture typical of rural late 19th and
early 20th century southeastern and south central Oregon.

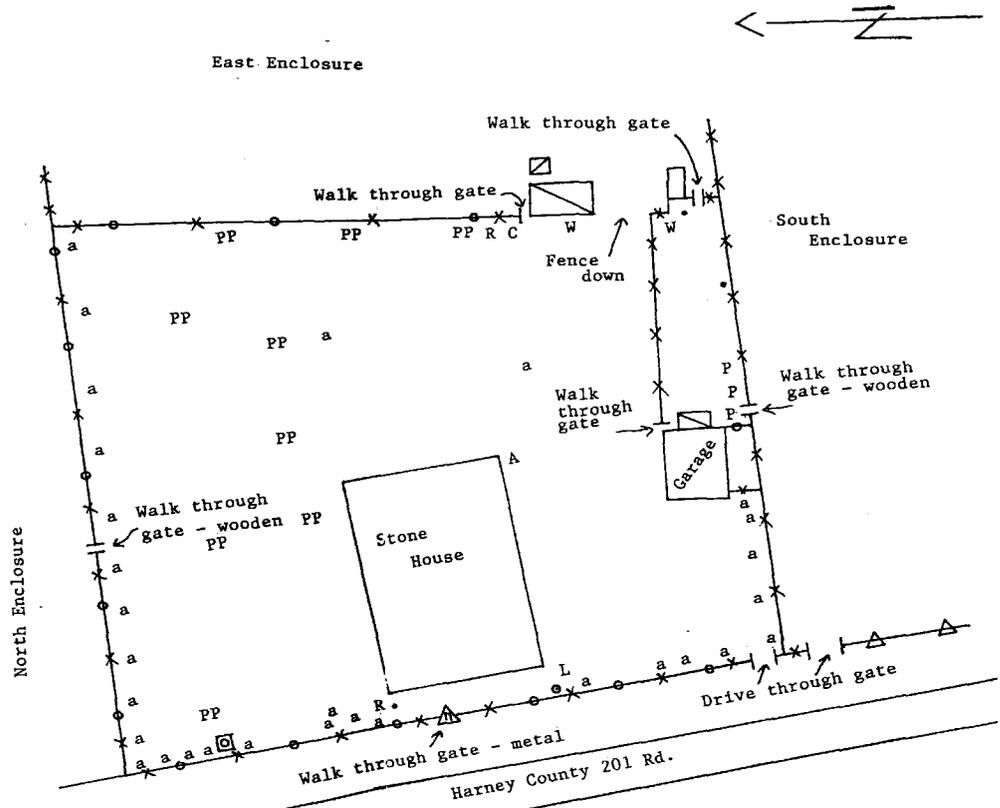
Andrews Stone House Main Enclosure Legend		
△	- Datum	Plant spp.:
⊙	- Utility pole	a - Poplars
⊕	- Water tower	A - Ash
⊠	- Privy	W - Walnut
⊡	- Chicken coop	R - Wild rose
□	- Shed	PP - Apple
—○—	- Hogwire fence	L - Lilac
—x—	- Hogwire fence w/ barbwire	C - Cherry
△△	- Post fence	P - Ponderosa pine
xx	- Barbwire fence	. - Unknown plant

Stone House Andrews, Oregon
Sketch Map
1/4"=3m

The yard is enclosed with a post and wire fence, with the front gate located in front of the house, facing the gravel road.

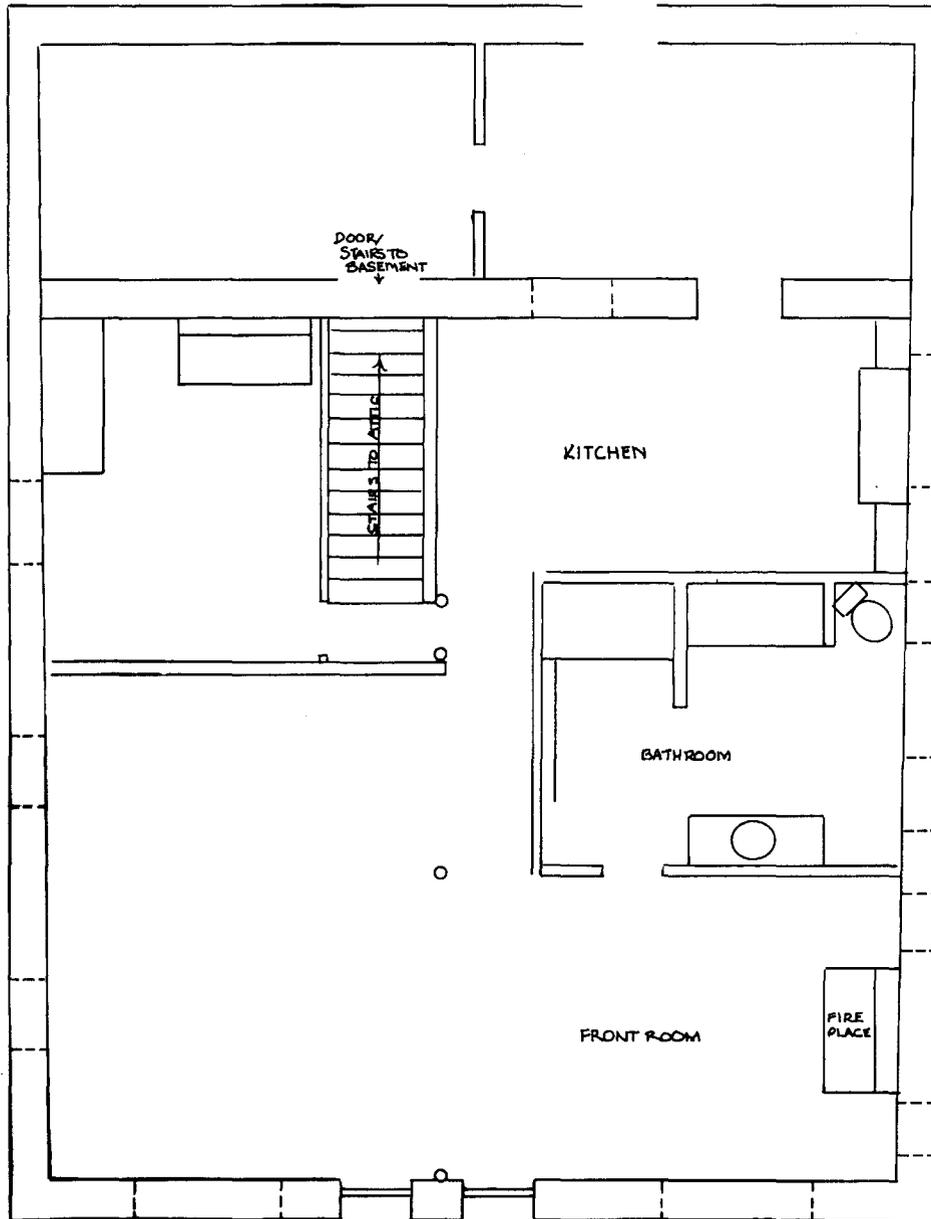
Stone House Andrews, Oregon
Sketch of Floor Plan (Meas. Approx.)
1/8"=1'0"

2. Foundations: Foundation of same dressed field stone as building walls, approximately 20" thick. Basement under the north half of the building, approximately 20 feet by 39 feet, and estimated nine feet deep. Basement was filled with water up to about three feet deep at the time building was recorded, precise measurements could not be obtained.

3. Flooring. Floors throughout are 1 x 6" wood planks, plain stained in front room, covered with circa 1970's linoleum floor covering in other rooms, cut pile carpet in bathroom.

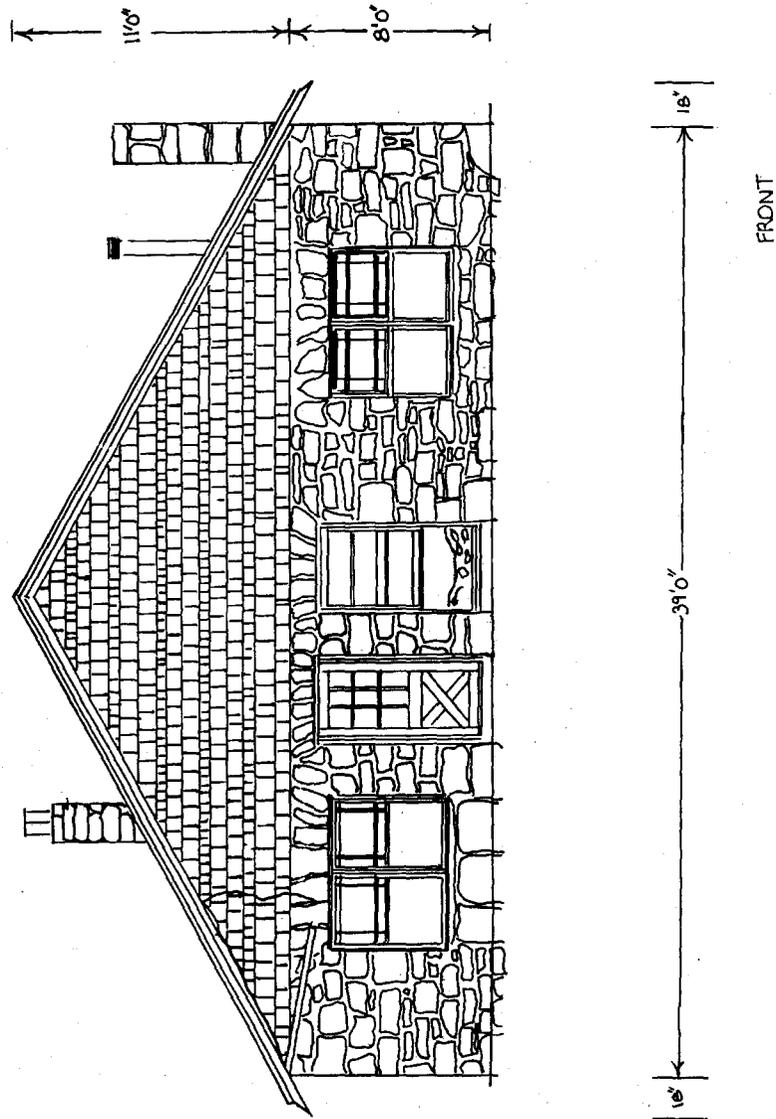
Stone House Andrews, Oregon
Sketch, Front
1/8"=1'0"

a. Two doorways on front facade - one originally opened to living quarters, and other one to the store. Doorway on the south half has been replaced with a window and partially filled with loose rock and mortar. Door on north half is circa 1970 wood panel door with nine light window and decorative cross brace over panel. East facade has a wood panel door, with top opening covered with screen. All doors have wood frames and moldings. Front doors are set in to rock approximately 12 inches from front of rock wall.

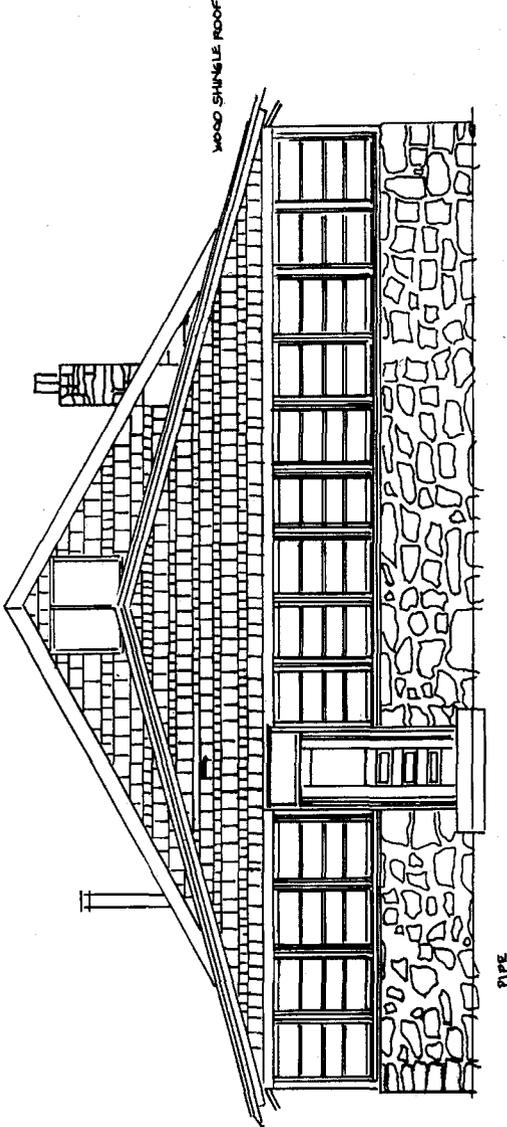
EAST FACADE

Stone House Andrews, Oregon
Sketch, East Facade
1/8"=1'0"

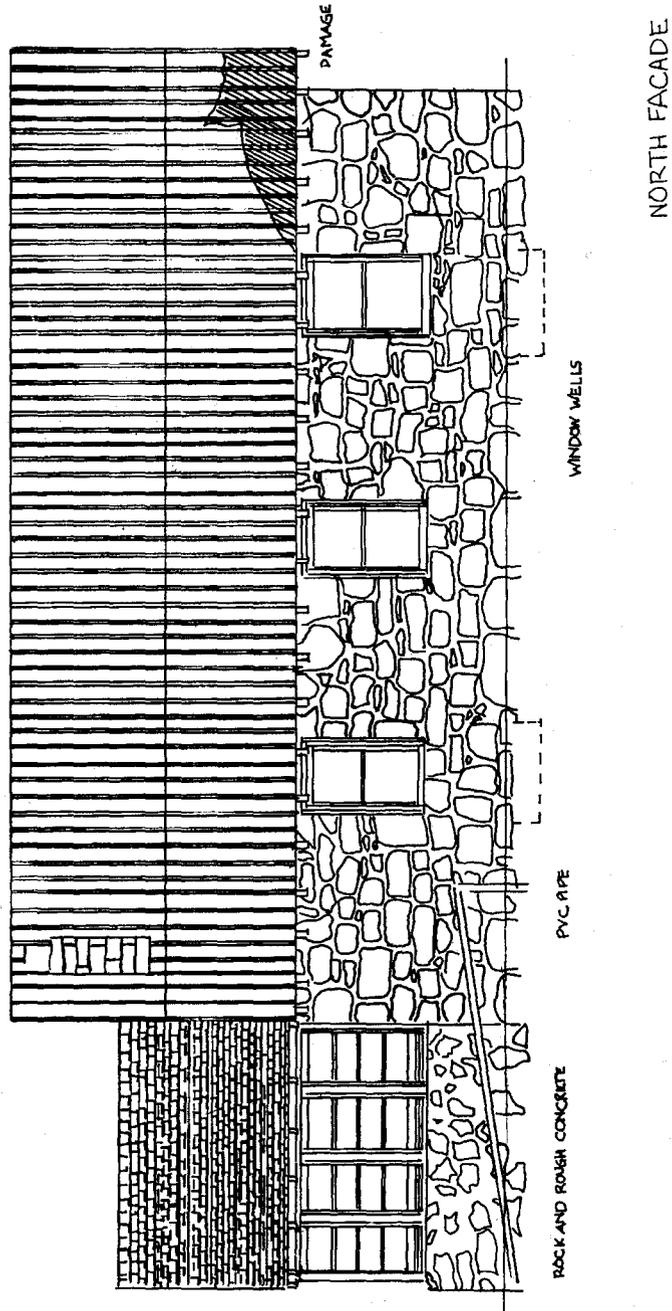
Stone House Andrews, Oregon
Sketch, North Facade
1/8"=1'0"

b. 18" overhang, rafter ends exposed. Painted barge boards with trimmed ends. Damage from fallen tree on northwest corner of roof and trim. North and south facades have cable tie downs connecting rafters to ground.

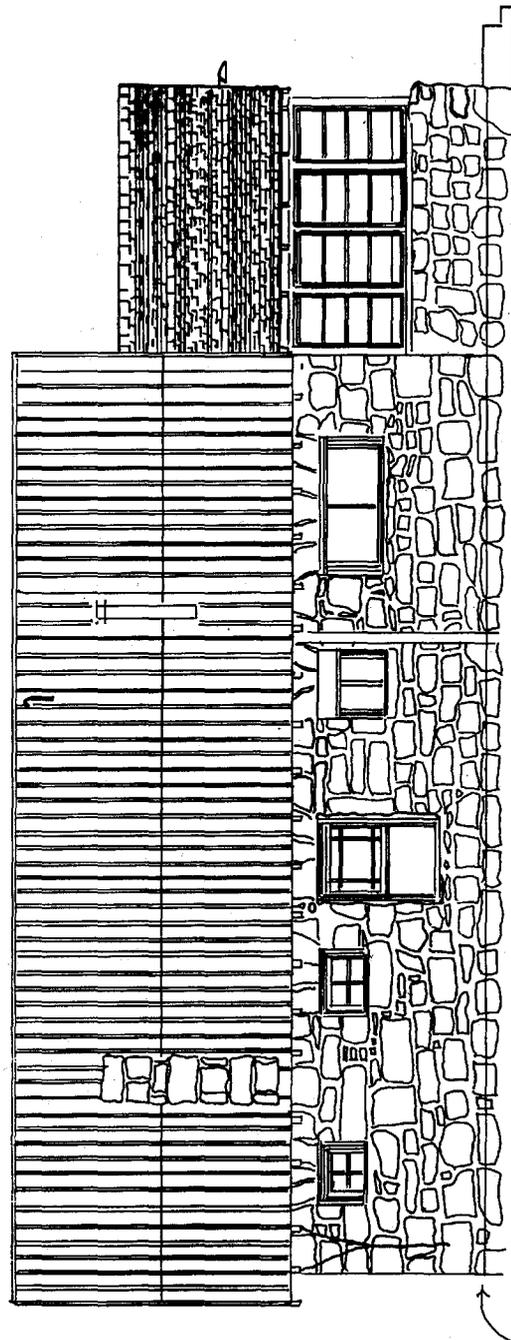
SOUTH FACADE

Stone House Andrews, Oregon
Sketch, South Facade
1/8"=1'0"

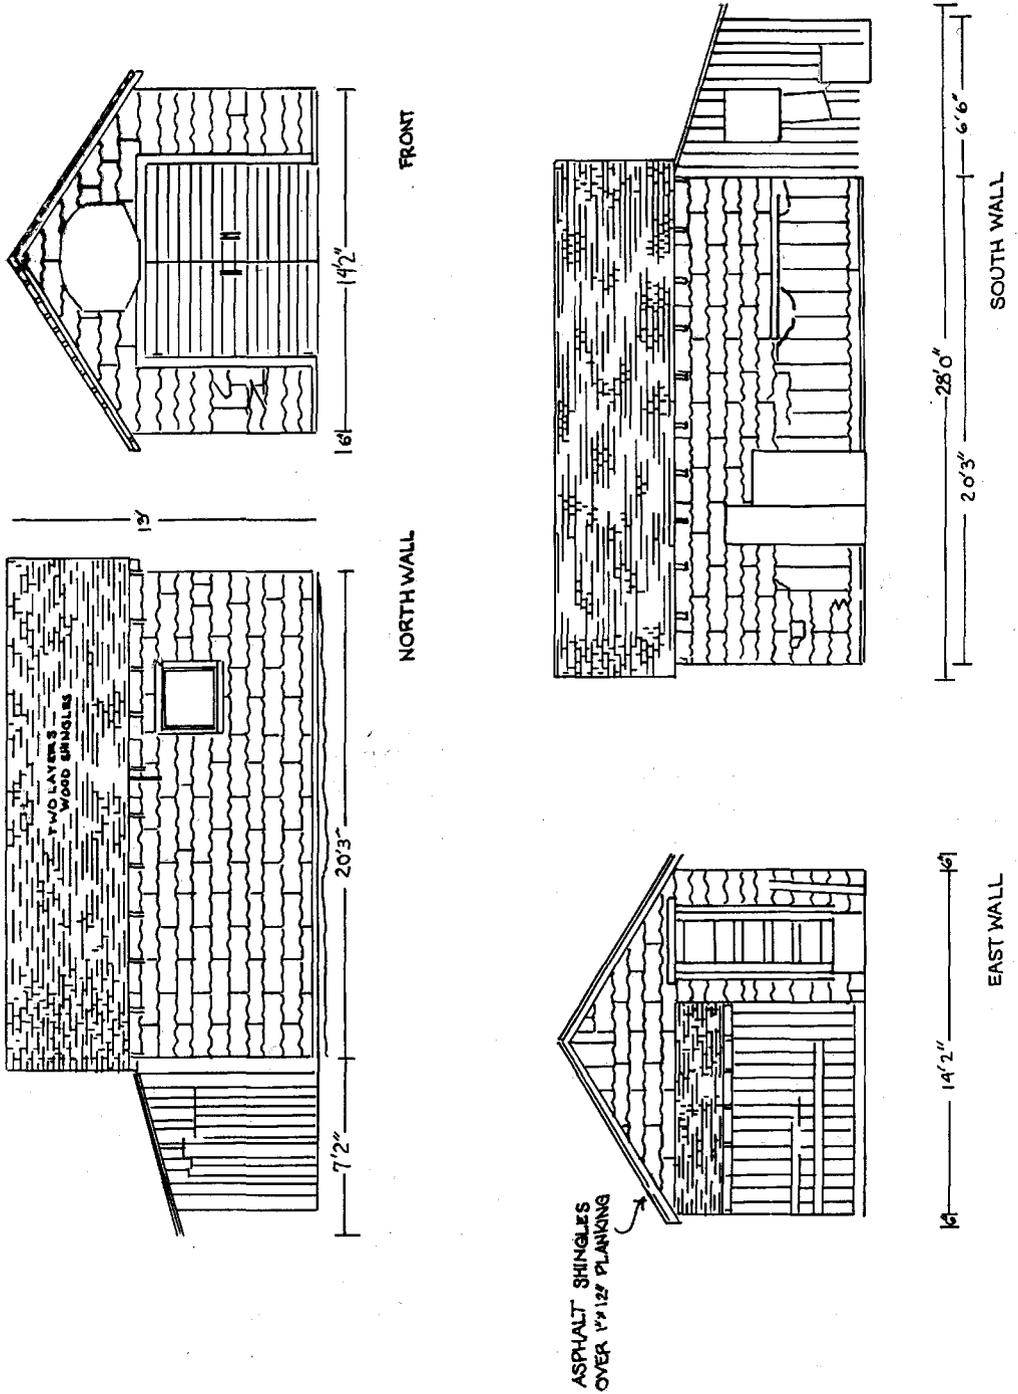
Stone House Andrews, Oregon
 Sketches, Garage
 1/8"=1'0"
