WILLIAM HANNA HOUSE

HABS No. PA- 5526

Location: Township Route 359, approximately 2,500 feet west of Water Street, Lock Haven Vicinity, Clinton County, Pennsylvania

Significance: The late-nineteenth-century William Hanna House is significant for its association with the Hanna family and for its distinctive architecture. The Hanna family was the principal landowning family throughout the nineteenth century in the Upper Lockport and Monseytown Flats areas of Woodward Township. John Hanna, an early settler, purchased 6,800 acres in 1801 and built the John Hanna House (HABS No. PA-5525). His ancestors continued to occupy the land for approximately 150 years. The William Hanna House was built circa 1880 by Hanna's grandson, William Hanna.

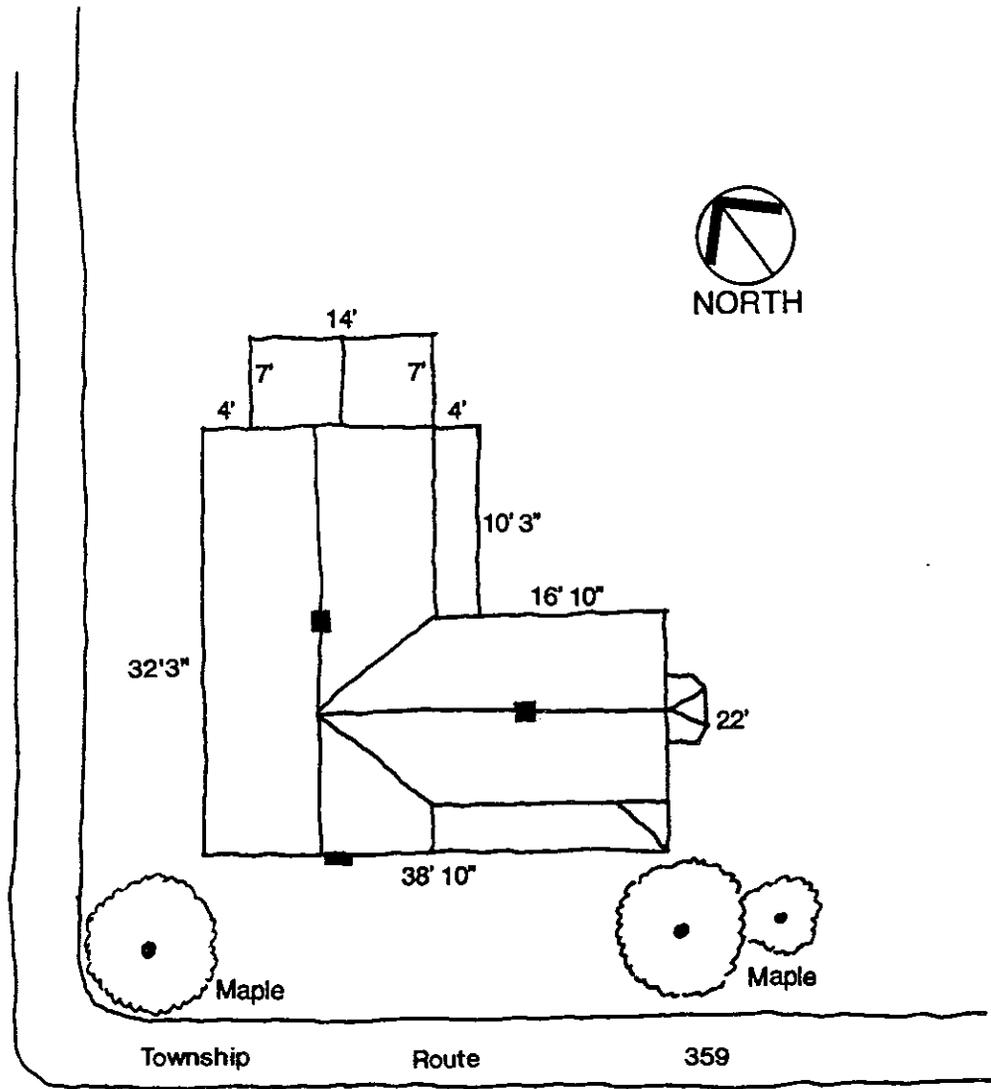
Site Plan  
(Not to Scale)

↑  
Route 18011

West Branch Susquehanna River

Date Drawn: 1992  
Prepared By: Jill Cremer

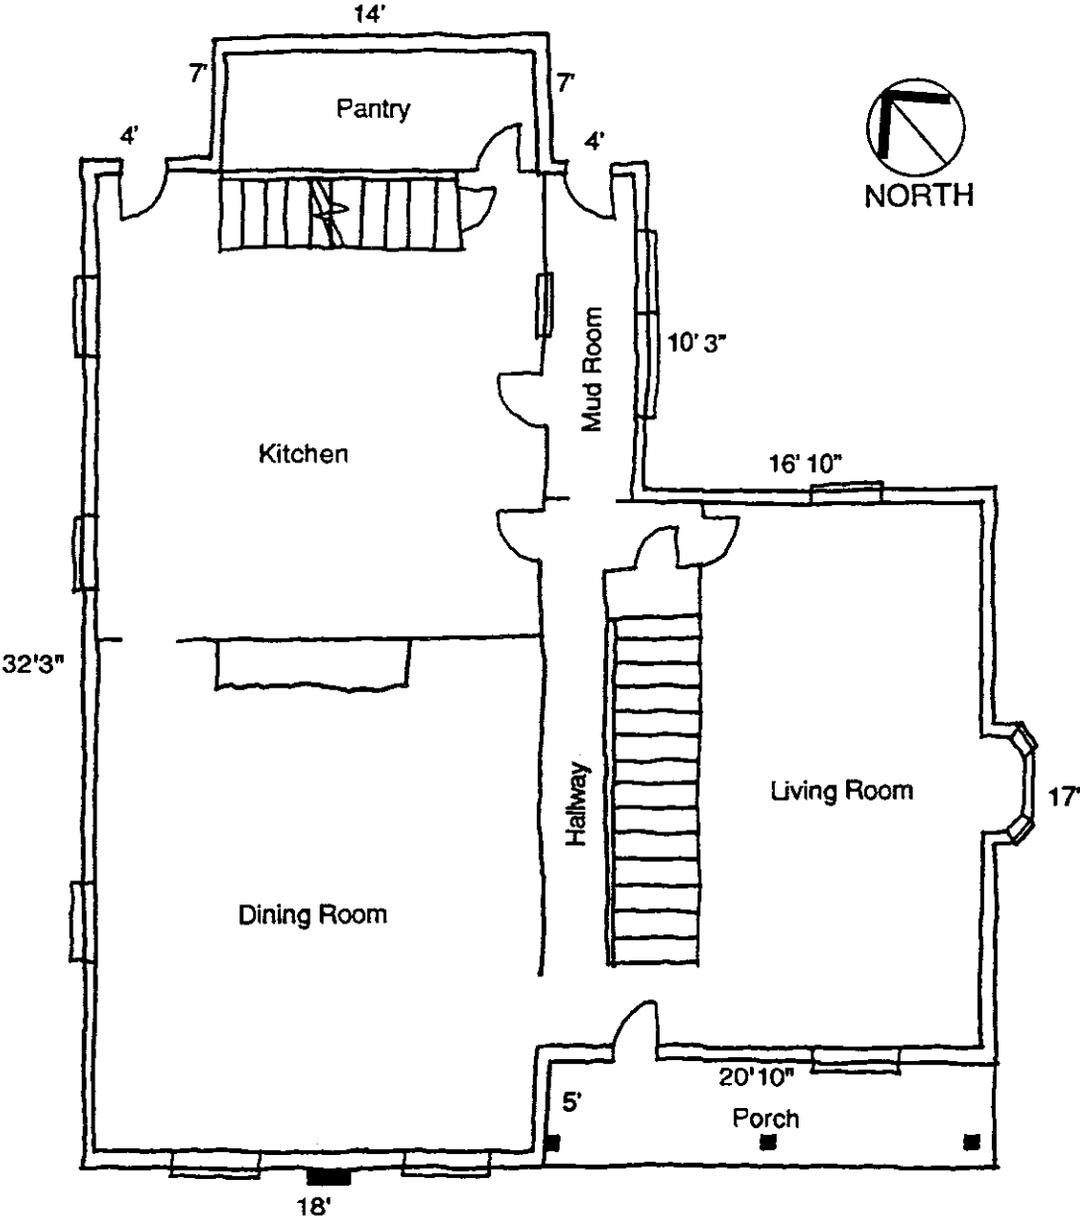
First Floor Plan  
(Not to Scale)

Date Drawn: 1992  
Prepared By: Jill Cremer

1. Floor plans: See accompanying sketch plans.
2. Stairways: The main, central hall stairway is in a deteriorated state and consists of a turned post balustrade, extended treads, and a newel post, lacking a newel cap. The stairway railing is missing, and the wall has a beaded stringcourse. The stairway has a landing, and the balustrade returns on the second floor, forming an overlook in the second floor hallway. A rear staircase is enclosed and has no ornamentation.

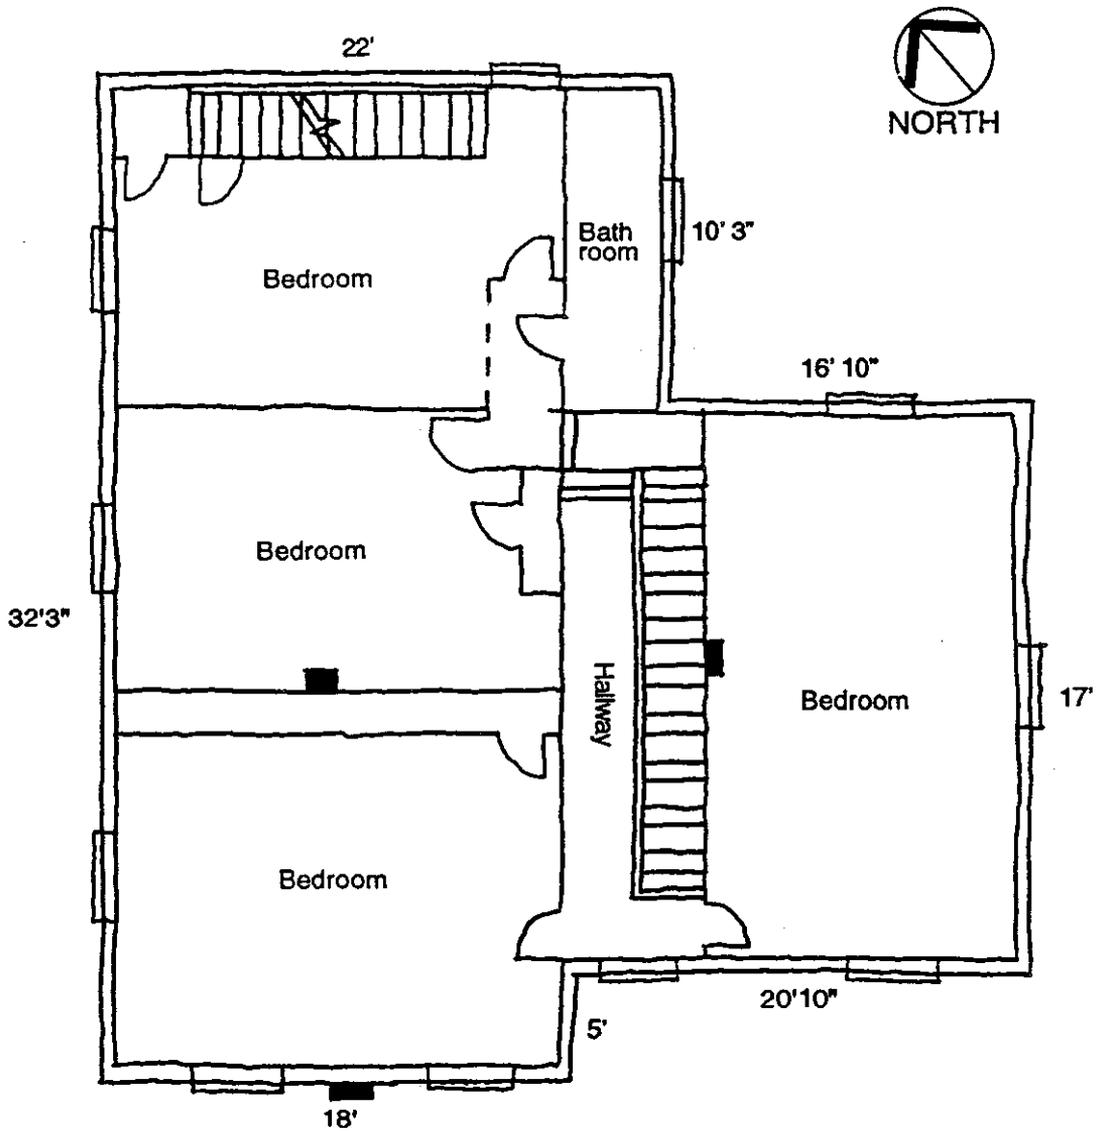
Second Floor Plan  
(Not to Scale)

Date Drawn: 1992  
Prepared By: Jill Cremer
