FIRST NATIONAL BANK BUILDING
125-129 West Crawford Avenue
City of Connellsville
Fayette County
Pennsylvania

HABS No. PA-6208

FIRST NATIONAL BANK BUILDING

EXISTING CONDITIONS of the
FIRST NATIONAL BANK BUILDING
125 Crawford Avenue
Connellsville, Pennsylvania
PREPARED for CONNELLSVILLE REDEVELOPMENT AUTHORITY

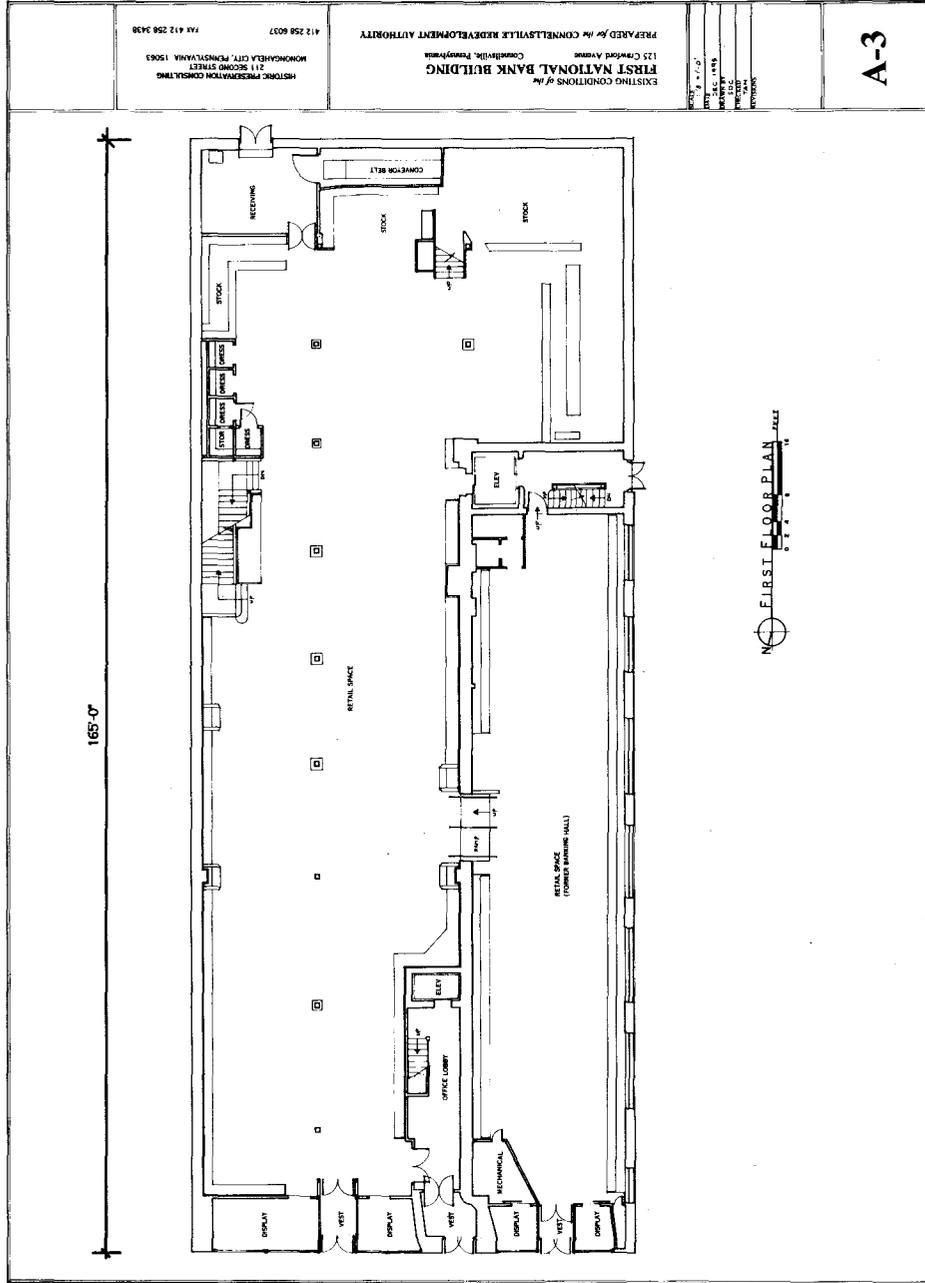
A-3

EXISTING CONDITIONS OF
FIRST NATIONAL BANK BUILDING
 122 Crawford Avenue
 Conowingo, Maryland
 PREPARED FOR: MARYLAND REDEVELOPMENT AUTHORITY
 HISTORIC PRESERVATION CONSULTING
 211 MONROE STREET
 MONOWHETA CITY, PENNSYLVANIA 15063
 412 258 6037
 FAX 412 258 3430

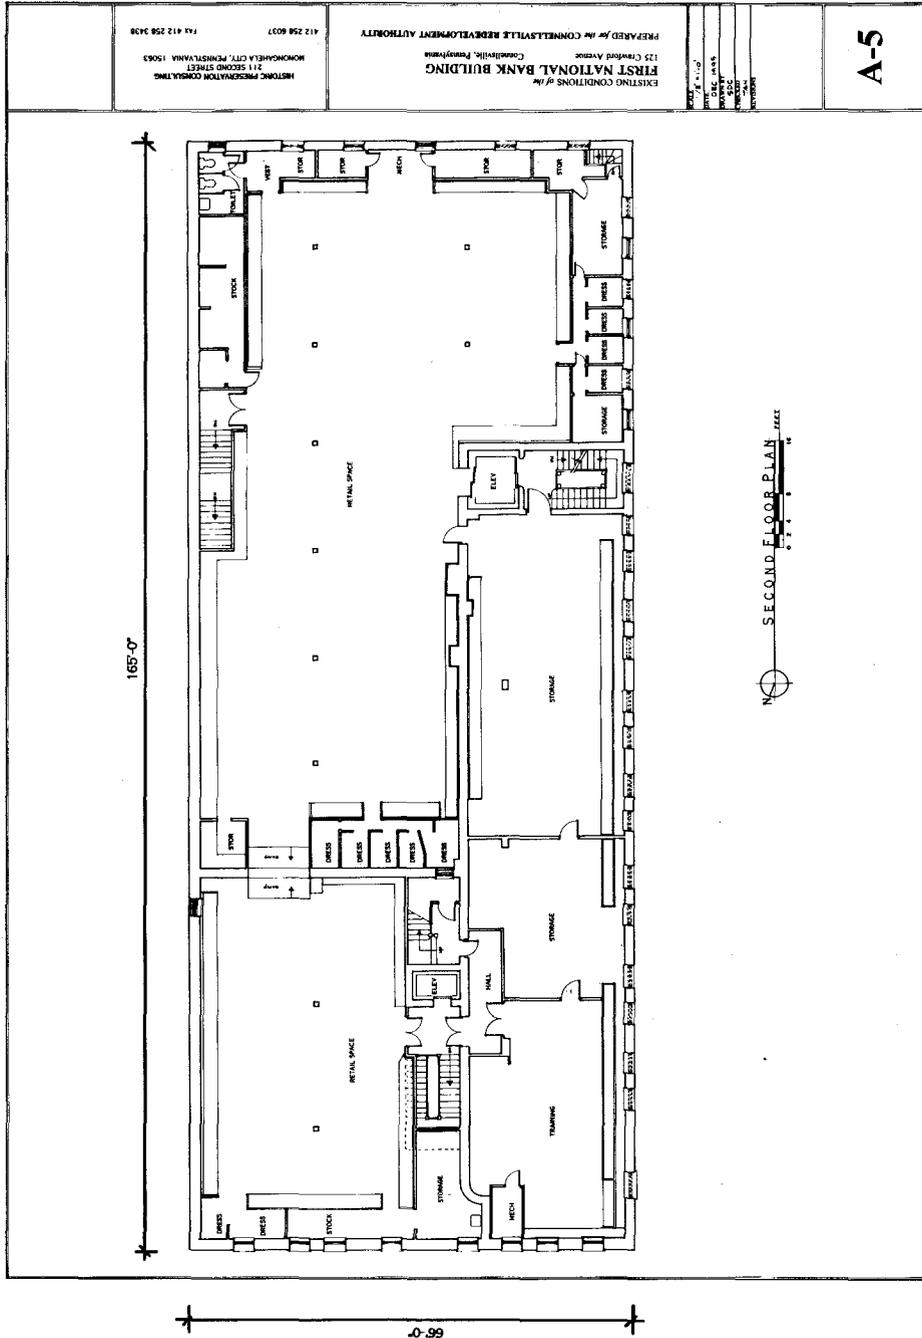
A-5

EXISTING CONDITIONS OF
FIRST NATIONAL BANK BUILDING
Connellsville, Pennsylvania
125 Crawford Avenue
PREPARED FOR CONNELLSVILLE REDEVELOPMENT AUTHORITY
