CEDAR PASS LODGE, CABIN 1-2  
Badlands National Park  
20681 South Dakota Highway 240  
Interior  
Jackson County  
South Dakota

HABS SD-25-A  
*HABS SD-25-A*

### CEDAR PASS LODGE, CABIN 1-2

HABS No. SD-25-A

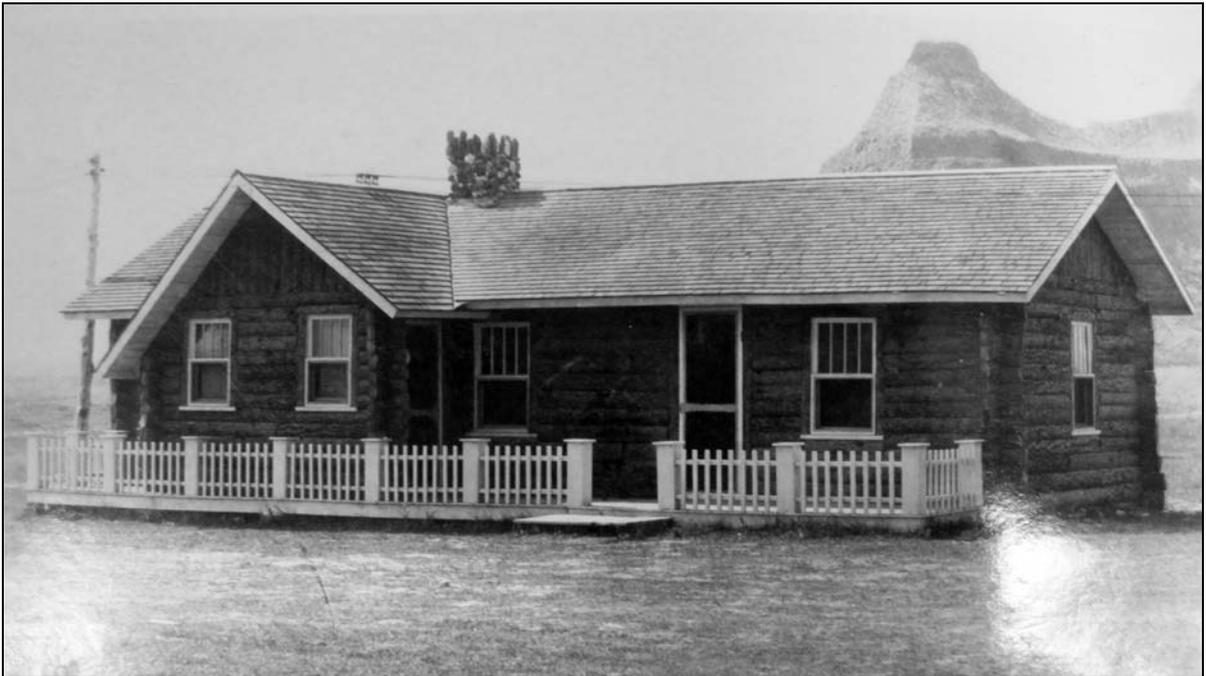
Figure 1: Cabin (now Cabin 1-2), Cedar Pass Camp, c. 1935.  
Source: Mary (nee Allburn) Aggergaard Scrapbook, BADL Archives.

3. Builder, contractor, suppliers: Unknown.
4. Original plans and construction: A photograph from c. 1935 indicates Cabin 1-2's form is largely the same (Figure 1). This photograph shows log-faced siding and four over one wood sash windows. An original entrance porch with an asymmetrical front gable is located on the main elevation. The original interior form of this duplex cabin is unknown. The rear ell contains older building material that may be repurposed.

B. Early Views: The earliest photograph of Cabin 1-2 is from c. 1935, showing the wood timber sheathing and original windows (see Figure 1). Views from the 1960s show alteration of the exterior with stucco and simulated masonry veneer (see Figures 2, 3, and 4).

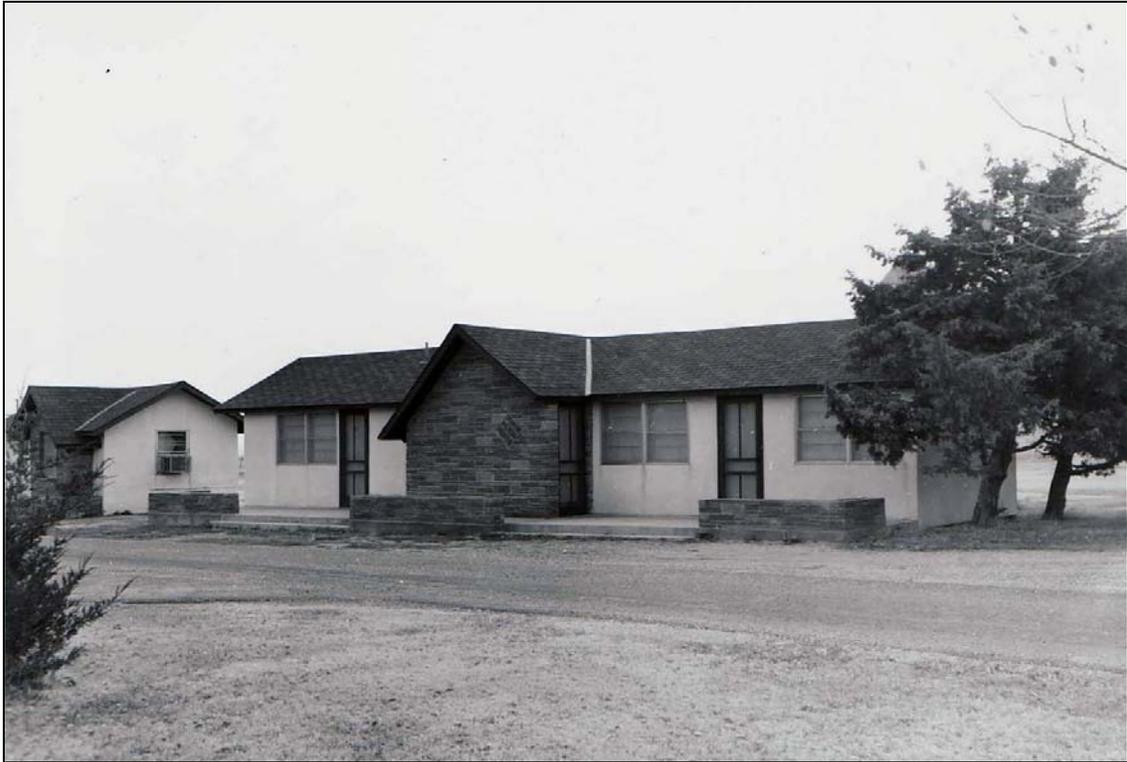
Figure 2: Cabin 1-2 (November 1965). Note Cabin 3 at left.  
Source: "Concessions Buildings, Badlands," (19 November 1965), Box 830, Entry P 11, RG 79, NARA II.

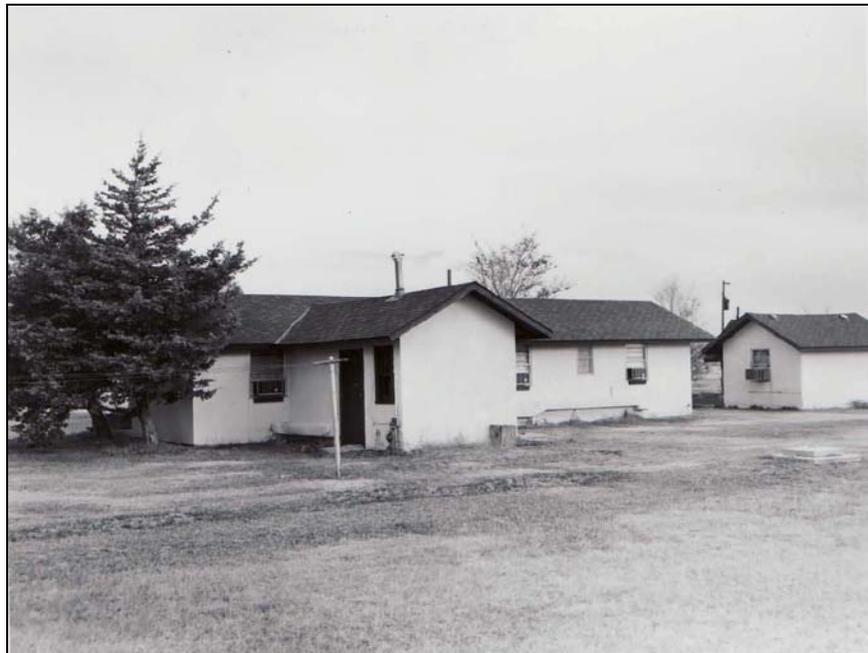
Figure 3: Cabin 1-2, Rear View from Northwest (November 1965). Note Cabin 3 at right.  
Source: "Concessions Buildings, Badlands," (19 November 1965), Box 830, Entry P 11, RG 79, NARA II

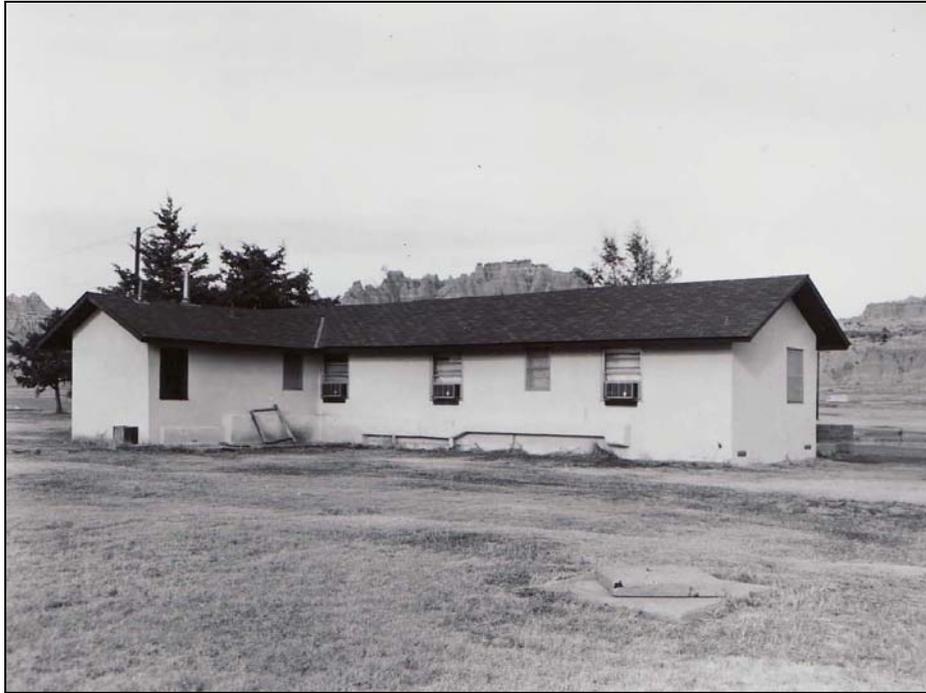
Figure 4: Cabin 1-2, Rear View from Southwest (November 1965). Note Cabin 3 at left.  
Source: "Concessions Buildings, Badlands," (19 November 1965), Box 830, Entry P 11, RG 79, NARA II
