CEDAR PASS LODGE, CABIN 22  
Badlands National Park  
20681 South Dakota Highway 240  
Interior  
Jackson County  
South Dakota

HABS SD-25-Q  
*HABS SD-25-Q*

### CEDAR PASS LODGE, CABIN 22

HABS No. SD-25-Q

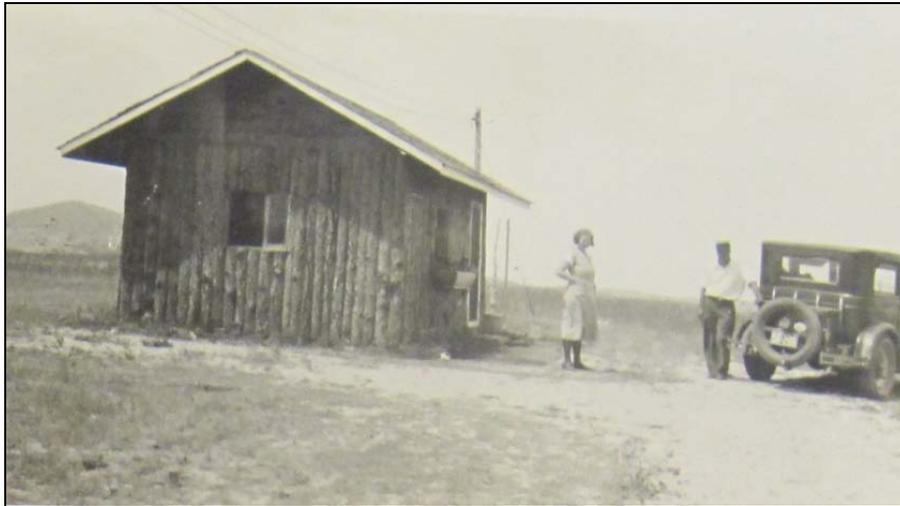
Figure 1: Cabin, Cedar Pass Camp, c. 1935.  
Source: Mary (nee Allburn) Aggergaard Scrapbook, BADL Archives.

B. Early Views: A cabin similar to Cabin 22 appears in a c. 1935 photograph, showing the wood timber sheathing and original windows (see Figure 1). Views from the 1960s show alteration of the exterior with stucco (Figure 2).

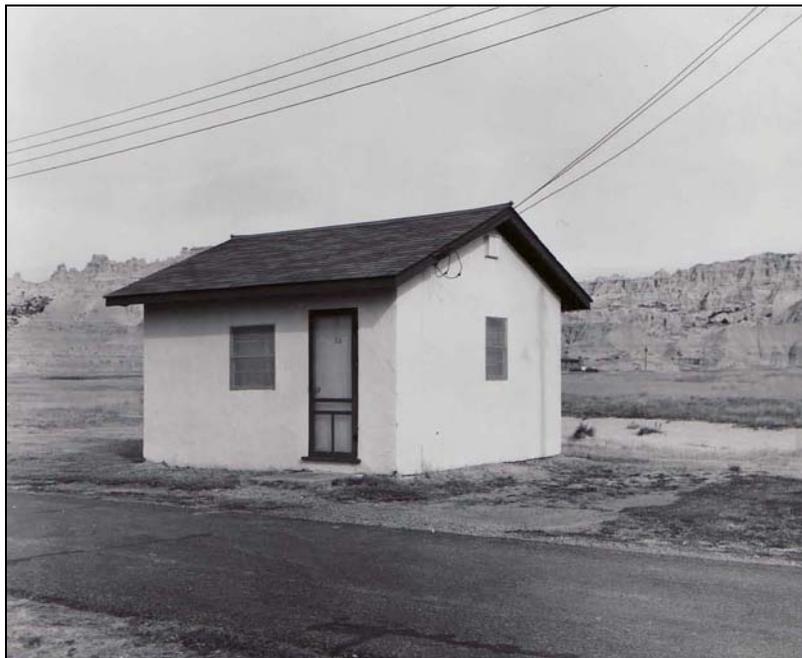
Figure 2: Cabin 22 (November 1965).  
Source: "Concessions Buildings, Badlands," (19 November 1965), Box 830, Entry P 11, RG 79, NARA II.
