MISSION NUESTRA SEÑORA DEL CARMEN
Ysleta, El Paso County, Texas.

Mision de San Antonio
de la Isleta del Sur

HABS No. TX-3104
(page 14)

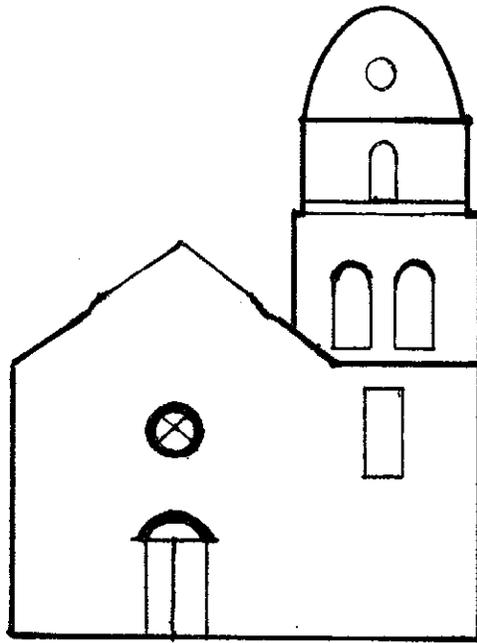
IV. 1901 (OR LATER)

EAST
FACADE DEVELOPMENT OF YSLETA CHURCH
EL PASO, TEXAS 1881 - 1980

Also, about this time the double hung sash window, above the main doors on the east facade, was replaced by a four part circular window. Sometime after 1901, the arched gable openings were filled in. The church continued this appearance until the 1907 fire. There are no known photographs of the pre-fire interior and the only known account of it was a brief newspaper description after the fire. ⁶

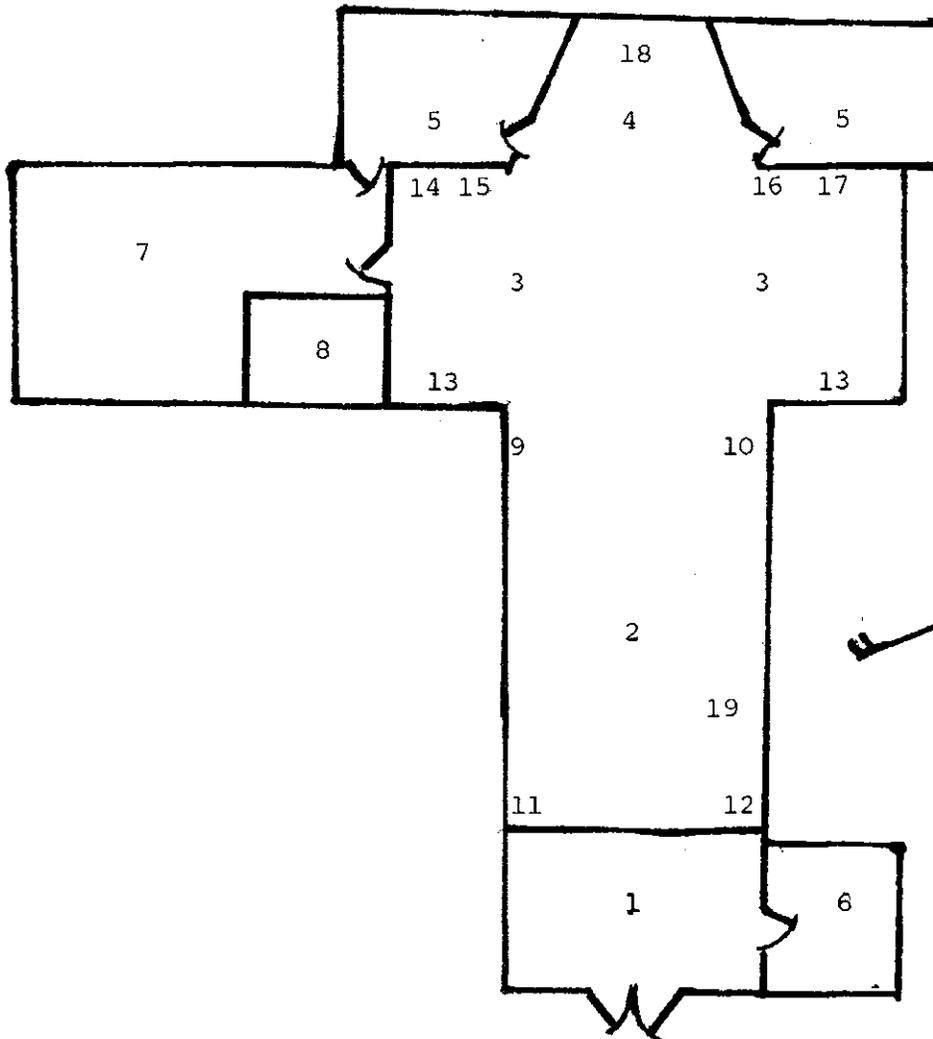
OUR LADY OF MOUNT CARMEL CHURCH, EL PASO, TEXAS
JULY 31, 1980

1. Choir Loft
2. Nave
3. Transcept
4. Apse
5. Sacristy
6. Tower
7. Old Rectory
8. Baptistery
9. St. Aloysius
10. St. Martin
11. St. Isidore
12. St. Monica
13. Confession Booths
14. Altar of St. Anthony above the statue of The Body Of Jesus
15. Our Lady of the Lourdes
16. Little Flower of the Carmelite Order
17. Altar of Our Lady of Guadalupe
18. Main Altar to Our Lady of Mount Carmel
19. Shrine to Our Lady of Fatima
