WELL HOUSE  
(Brightwood Farms)  
1009 Monroe Street  
Herndon  
Fairfax County  
Virginia

HABS No. VA-1386

WRITTEN HISTORICAL AND DESCRIPTIVE DATA  
REDUCED COPIES OF MEASURED DRAWINGS

### WELL HOUSE

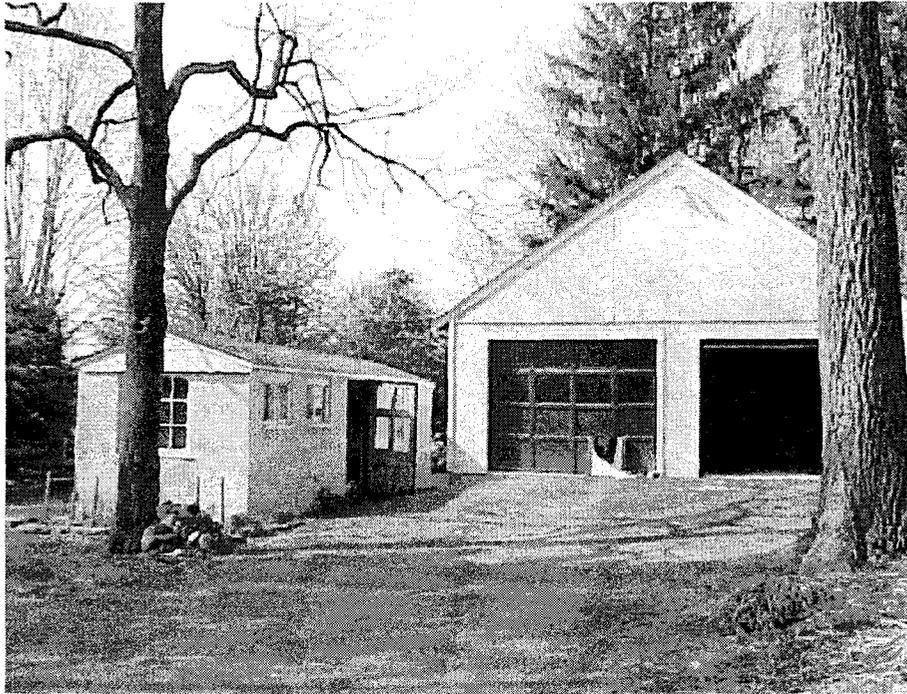
*Below: A closer view of the well house itself, showing south elevation 12-pane awning window, two fixed windows on the east elevation, and main entry door.*

Exterior: The well house at 1009 Monroe Street, occupying a rectangular footprint measuring 24'8" x 8'6", is a humble brick structure that sits on a brick foundation. It is oriented longitudinally on a north-south axis, with the main door in the center of its east elevation and an opposing door on the west elevation. While the present one-acre property's western boundary lies just several feet beyond the well house, its earlier agricultural incarnation as part of a twenty-acre farm until subdivision in 1970 hints at the logic behind the building's plan. Because the narrow property stretched back from the road and house, most of it would have sat behind the well house, necessitating fenestration on the west elevation to allow for irrigation pipe or hand-hauling of water without having to pass back and around the structure.

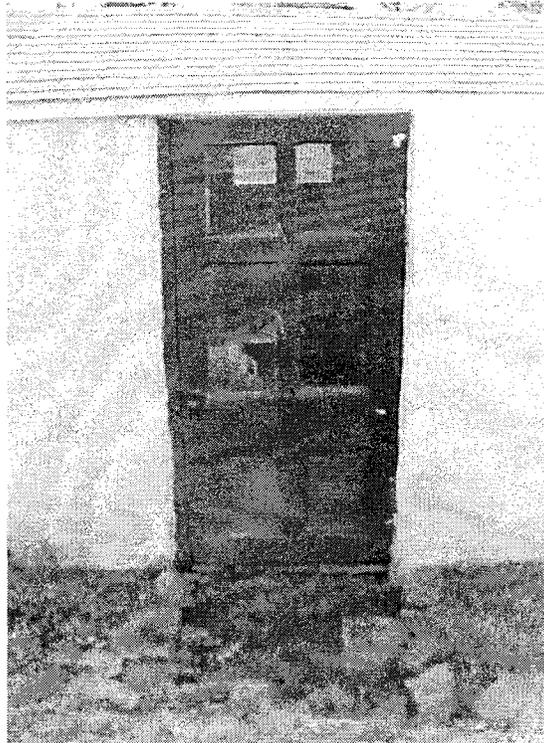
*Above: Main door to structure, located in the center of the east elevation. Note the change in surrounding grade, resulting in step-down entrance with small stone retaining barrier. Below: Looking through the main door (open) to the opposing door on the west elevation.*

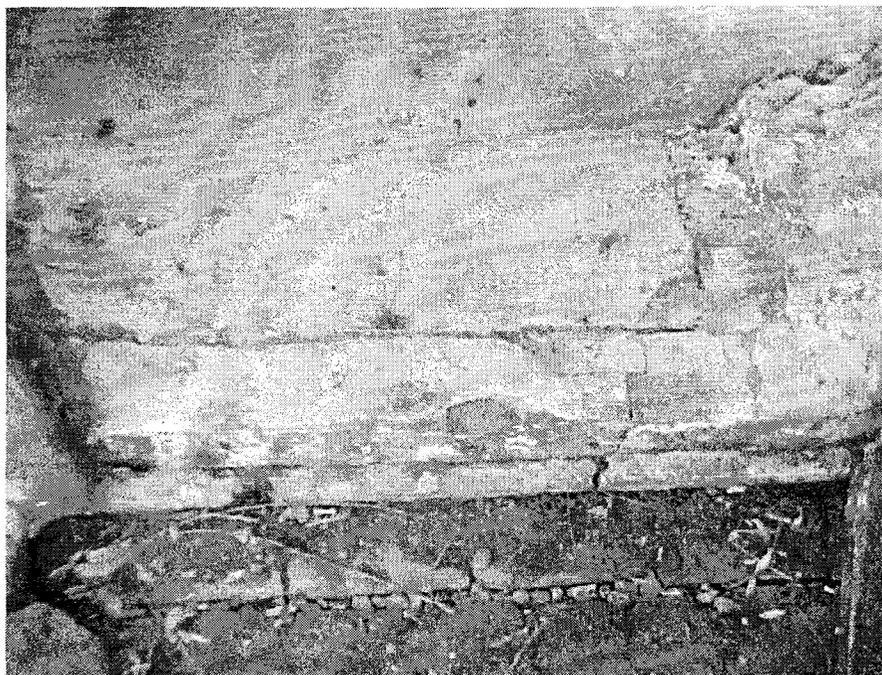
*Above: Threshold at main door, revealing poured concrete floor and brick foundation.*

Close examination of the foundation around the perimeter also reveals a small section of *c.m.u.* block, suggesting foundation repairs around the time the floor was poured.

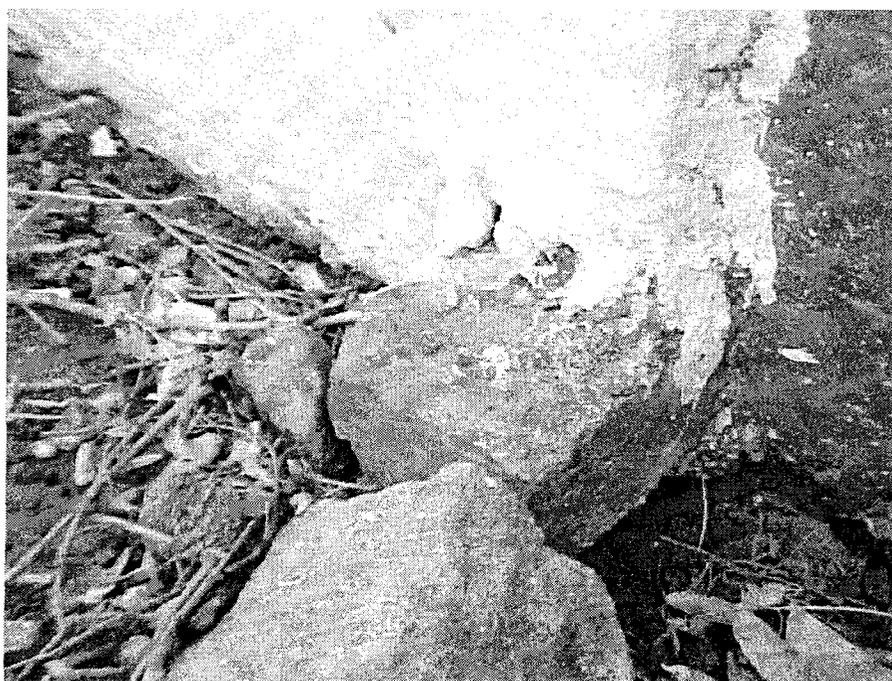
*Below: Detail at lower left-hand corner of main entry door, with concrete parge over exterior brick wall and evidence of brick foundation beneath.*

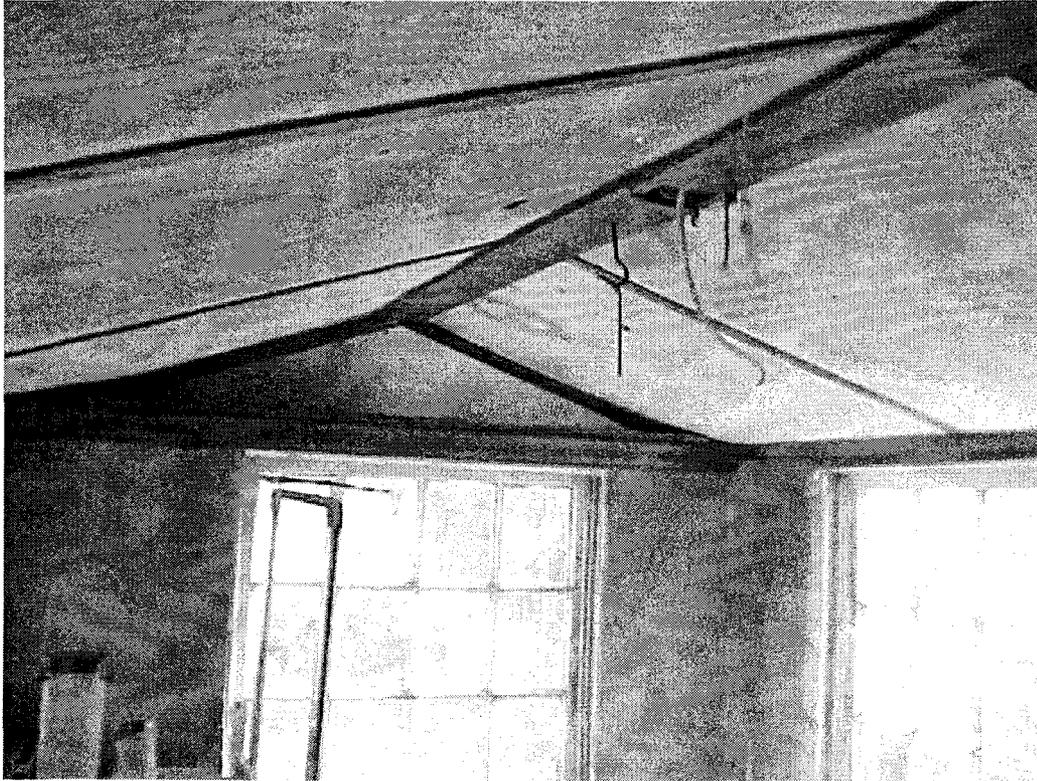
*Above: Interior shot of roof and ceiling system, consisting of common rafters covered with sheetrock. Joints and nail holes are hidden with 1/4" thick screen bead trim pieces.*

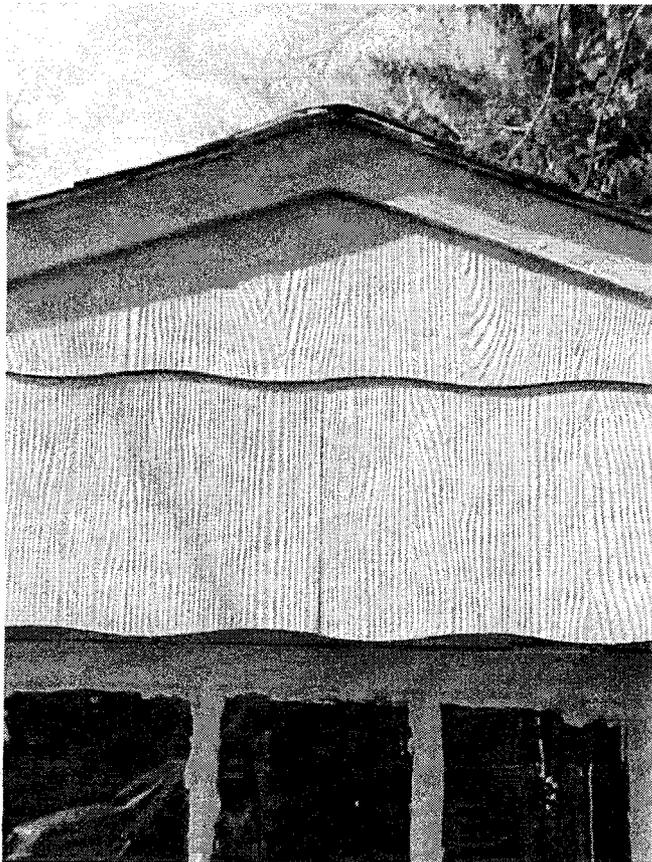
*Left: South elevation eave detail. Asbestos shingles ornament the gable beneath the rake boards on this shallow-sloped (4/12) roof.*

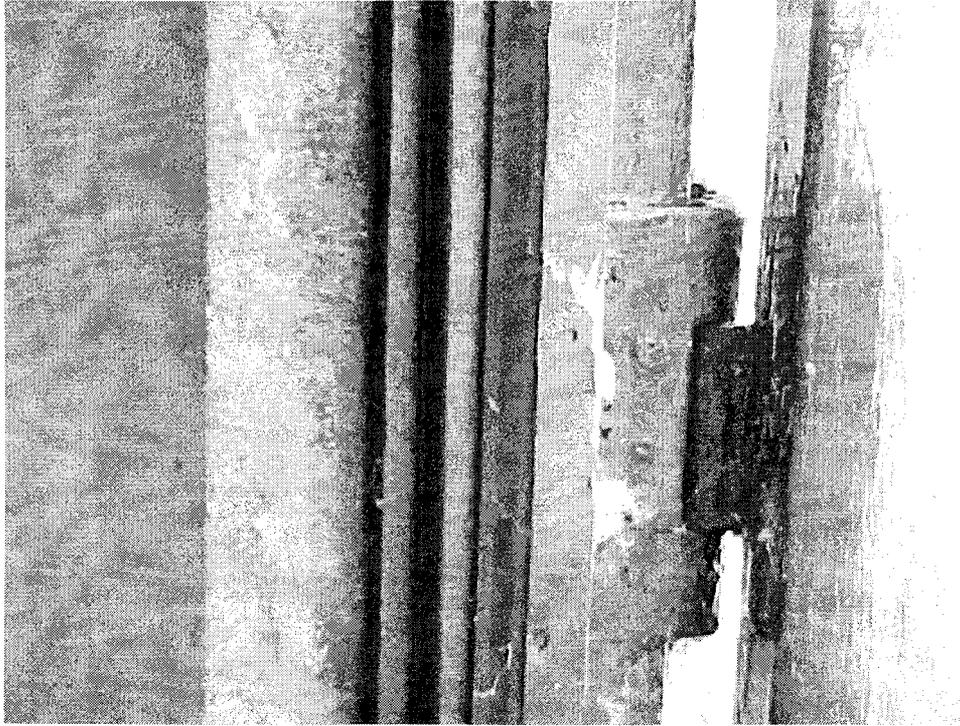
***Door details.***

***Above: Interior hinge and jam detail from front door.***

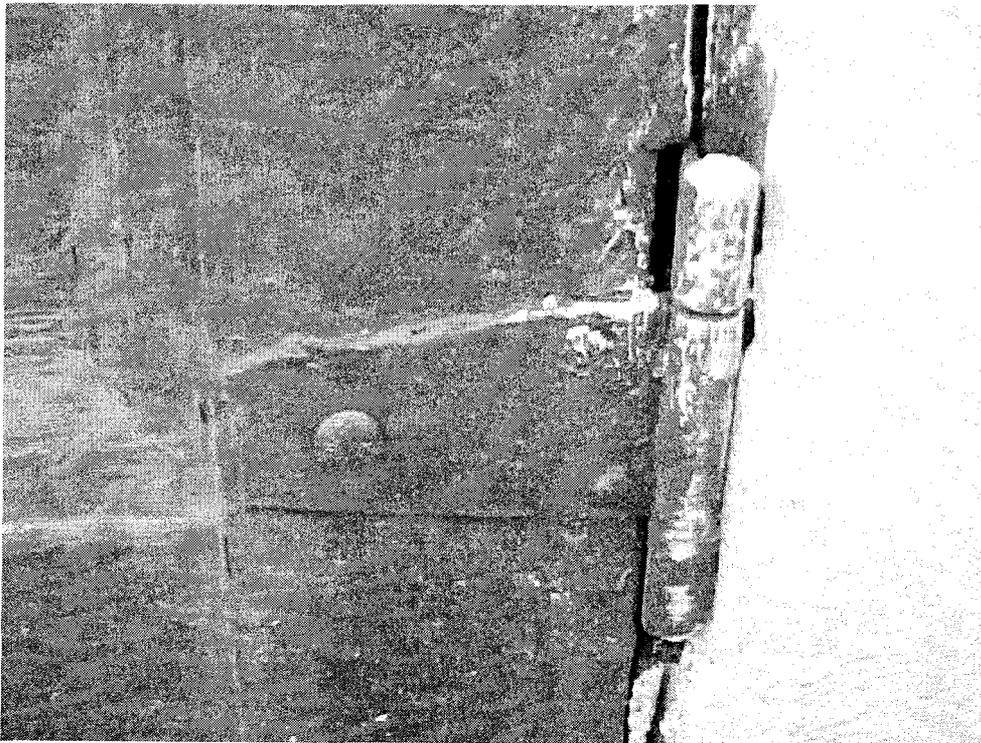
***Below: Exterior hinge detail from front door.***
