Boone ~~Truly~~ Ranch, Hay Barn
11119 NE 185th Street
Bothell
King County
Washington

HABS No. WA-218-J

THE BOONE/TRULY RANCH
HAY BARN

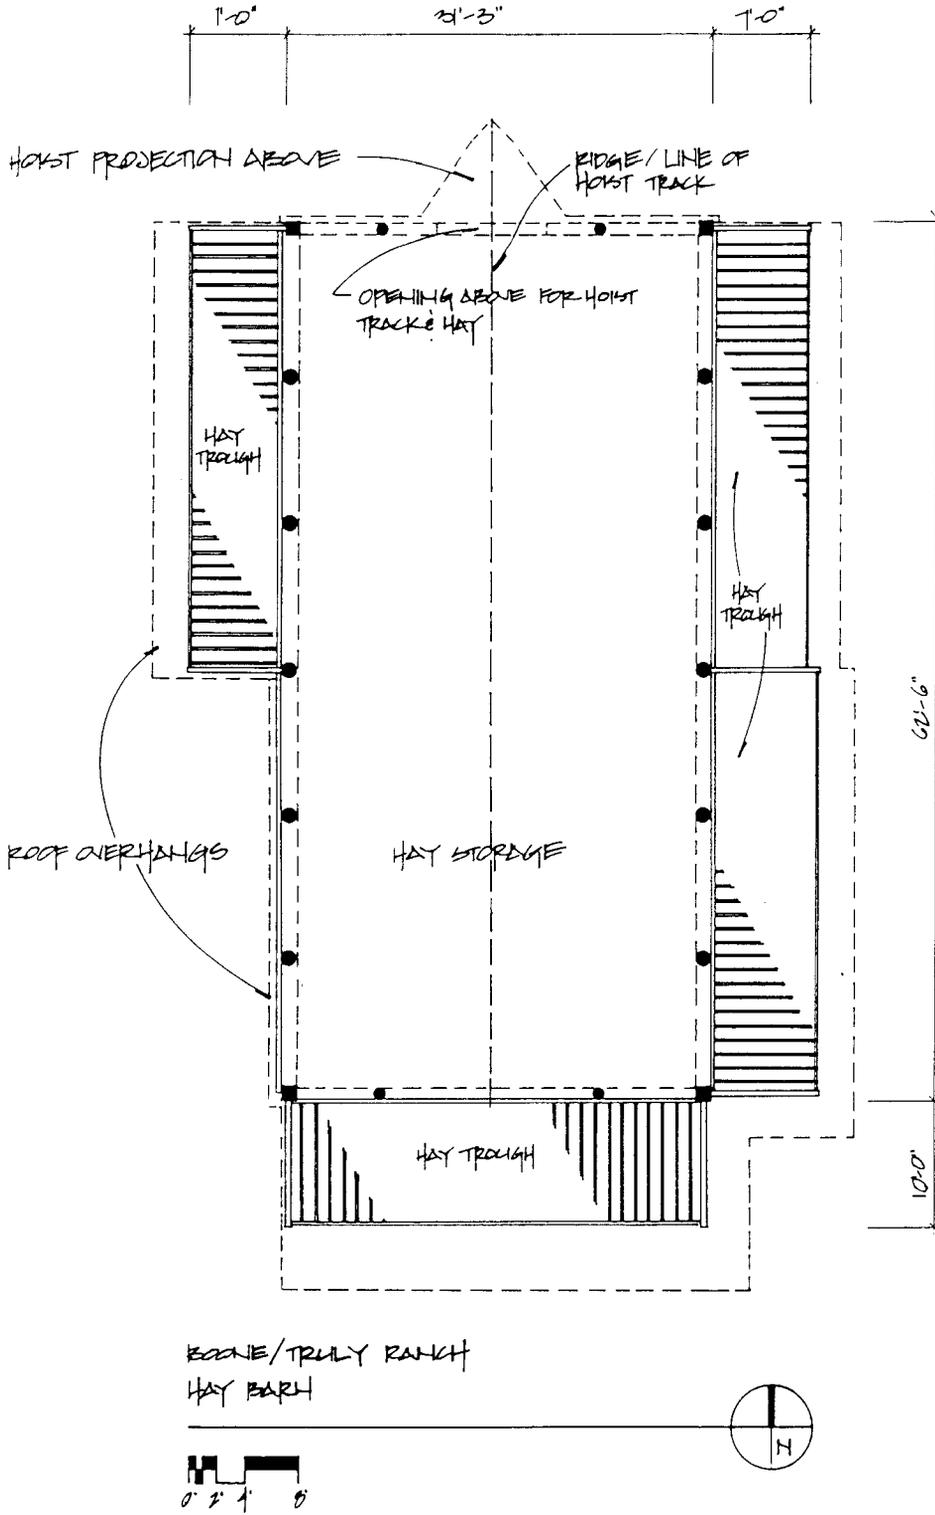
Figure 1. The Hay Barn, Plan. Source: Boyle • Wagoner Architects, January 1997.

The north facade is open from ground level to approximately one-half the height of the facade. Originally two large doors closed off the interior from the elements. There is no evidence that a loft existed in the structure. A hoist track runs the length of the building; it is attached to the rafters and projects through an opening centered above the main door. The hoist was used with a block and tackle and tong assembly to lift loose hay from a cart into the south end of the barn. Exterior walls are constructed of 2x6 slats spaced 8" apart to 4' height, facilitating ventilation for stacked hay.

The east and west facades are with identical. Hay racks constructed of debarked saplings canted outward from the foundation at an angle of 45 degrees, from the lower portion of the exterior side walls. Saplings were used, as opposed to 2x4 or similar lumber, due to their weathering properties. They also reduced the possibility of injury to the muzzles of cattle. The racks were used to create an ease on the daily routine of the ranch. A ranch hand would fill the racks with hay, then the cattle could feed themselves. The hay racks are covered by shed roofs of corrugated iron which connect to the main building frame under the eaves of the main roof. The steep pitched main roof is sheathed in corrugated metal sheets.

The south facade has similar hay racks. The upper half of the gable on this end is clad with painted board and batten siding. A small square ventilation opening appears in the peak of the gable.
