Fort Vancouver, Visitor Center  
Fort Vancouver National Historic Site  
Vancouver National Historic Reserve Historic District  
1501 East Evergreen Boulevard  
Vancouver  
Clark County  
Washington

HABS No. WA-41-H

## HISTORIC AMERICAN BUILDINGS SURVEY

### FORT VANCOUVER VISITOR CENTER

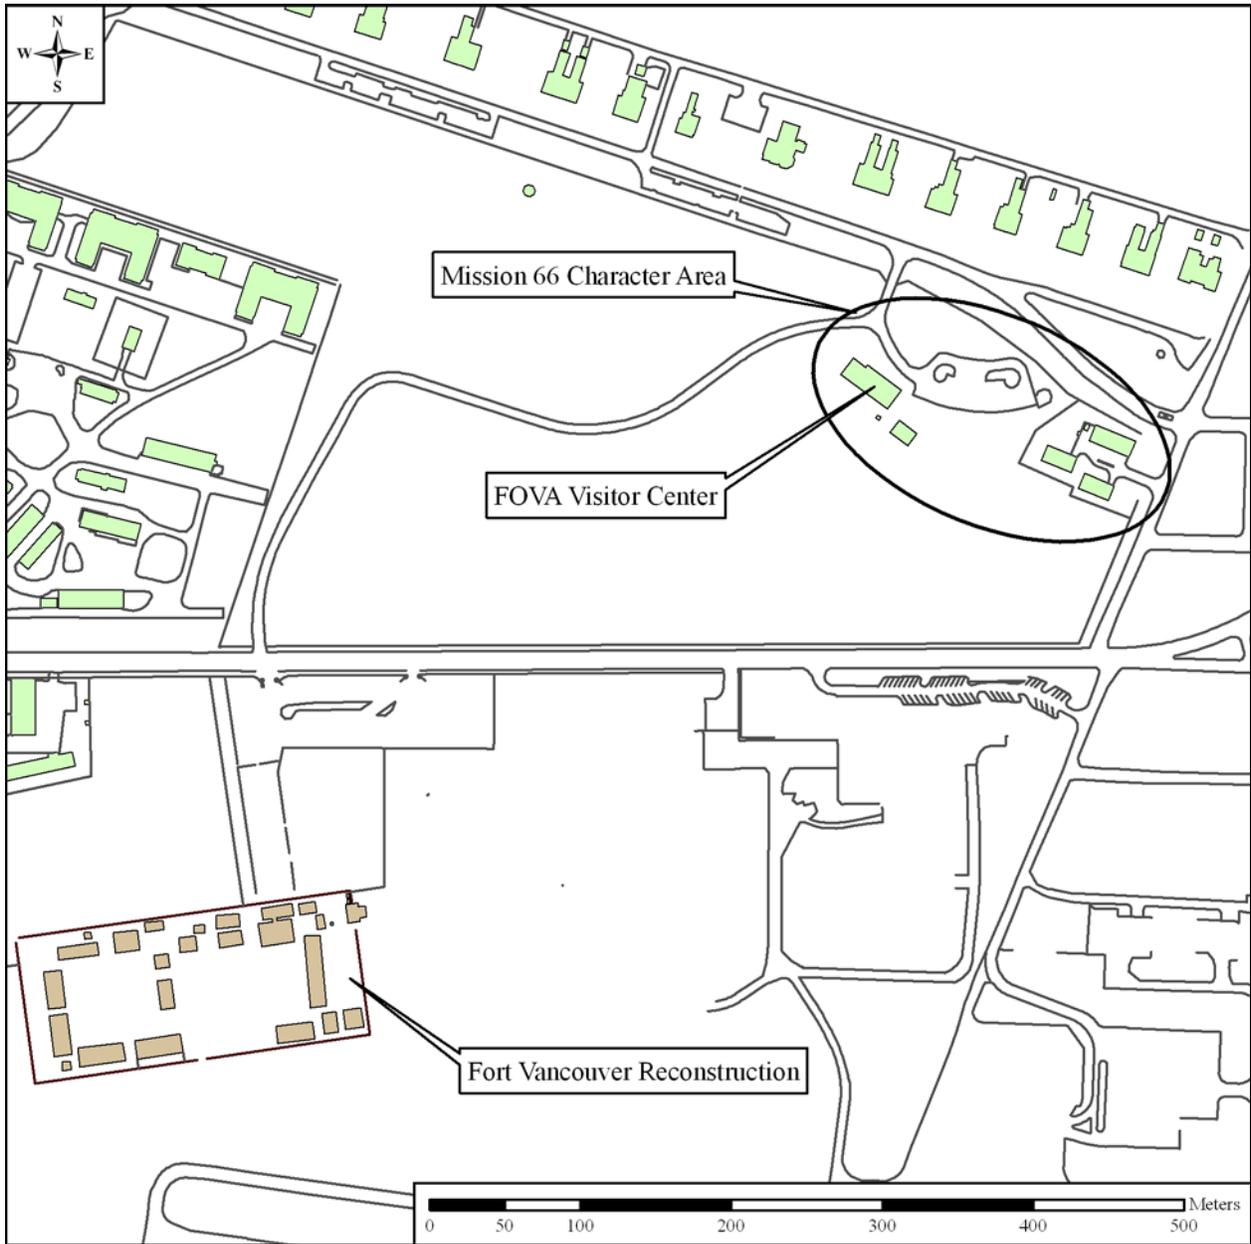
Figure 2. Location of Visitor Center within the Mission 66 Character Area at Fort Vancouver National Historic Site.

**Significance:** The Fort Vancouver National Historic Site Visitor Center is a contributing building to the Vancouver National Historic Reserve (VNHR) Historic District in Vancouver, Washington. Built in 1960-1961, the Visitor Center is a component of the Mission 66 Character Area (Figure 2).

- 2. Associated Buildings:** the Visitor Center is closely associated with three additional structures, all built in 1961, which together comprise the Mission 66 Character Area. These buildings, an employee residence, an administrative headquarters building (formerly a second employee residence), and a maintenance building, are located east of the Visitor Center and are accessed through a separate driveway from East Reserve Street (Figure 2).

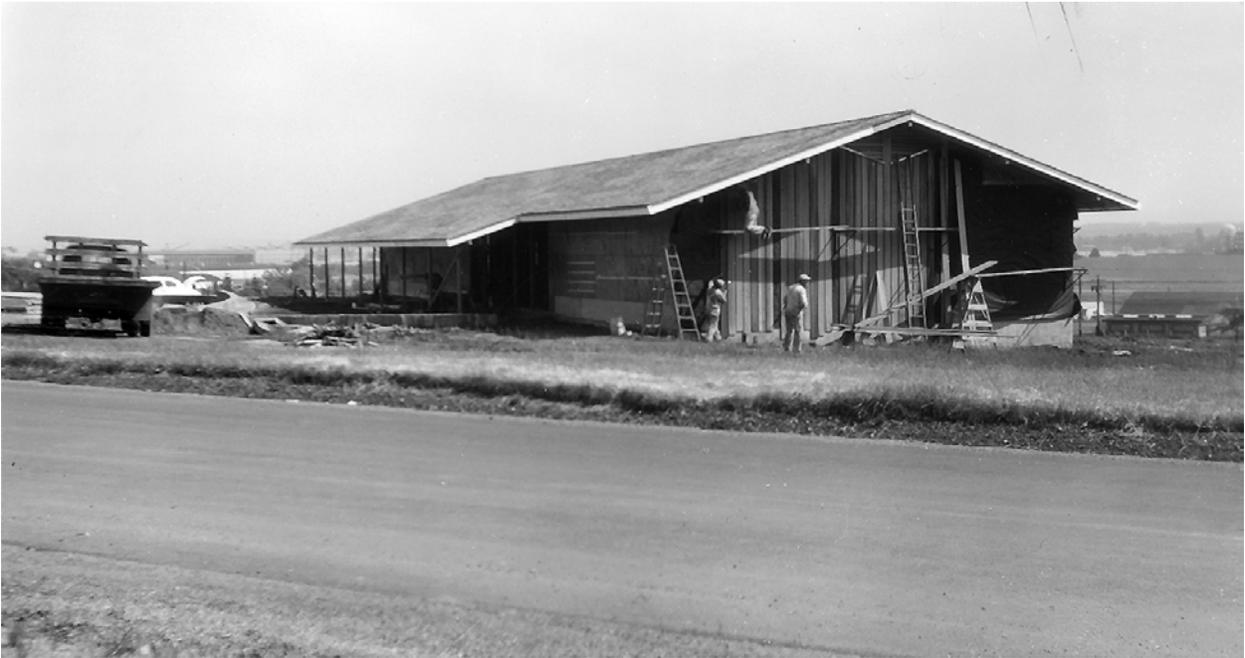
Figure 3. View of the construction of the Visitor Center, facing southeast. Photograph FOVA 1723, 5/25/1961.

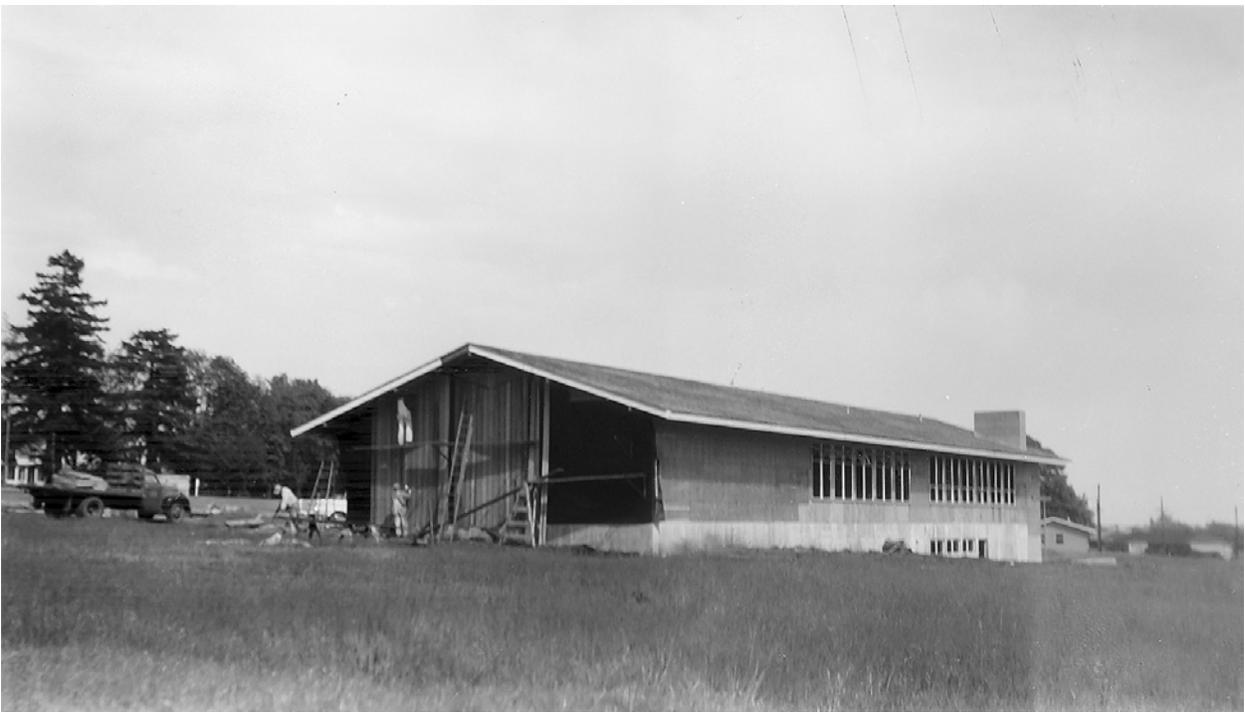
Figure 4. View of the construction of the Visitor Center, facing northeast. Photograph FOVA 1722, 5/25/1961.

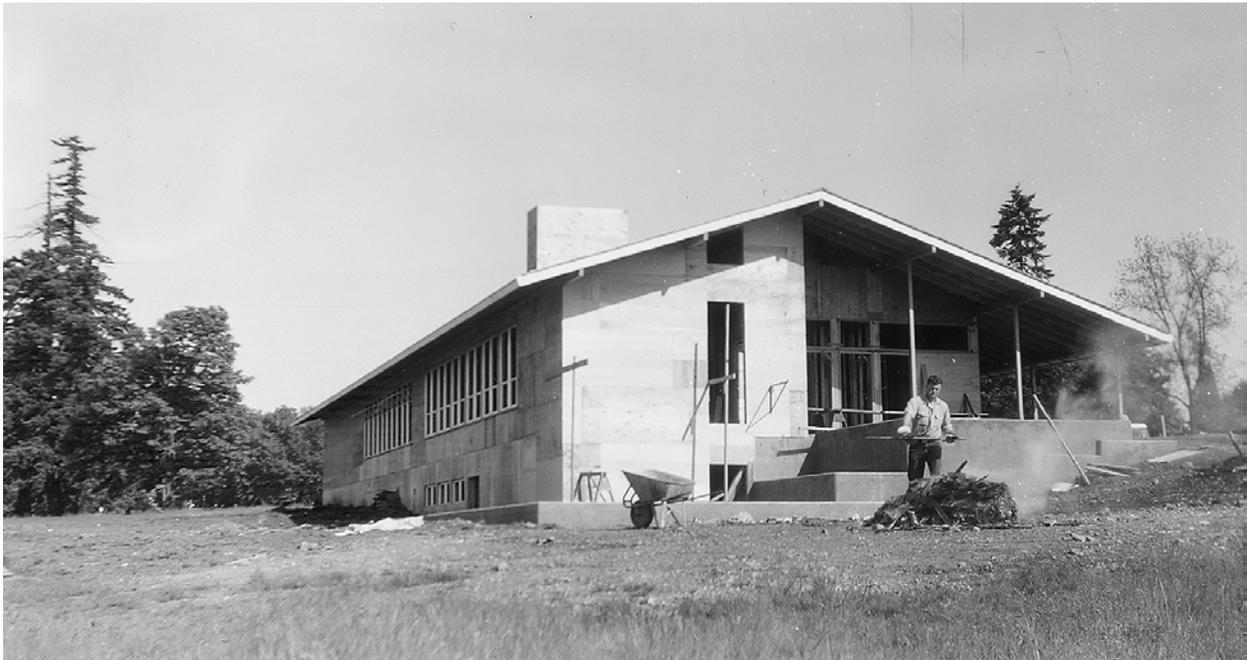
Figure 5. View of the construction of the Visitor Center, facing northwest. Photograph FOVA 1720, 5/25/1961.

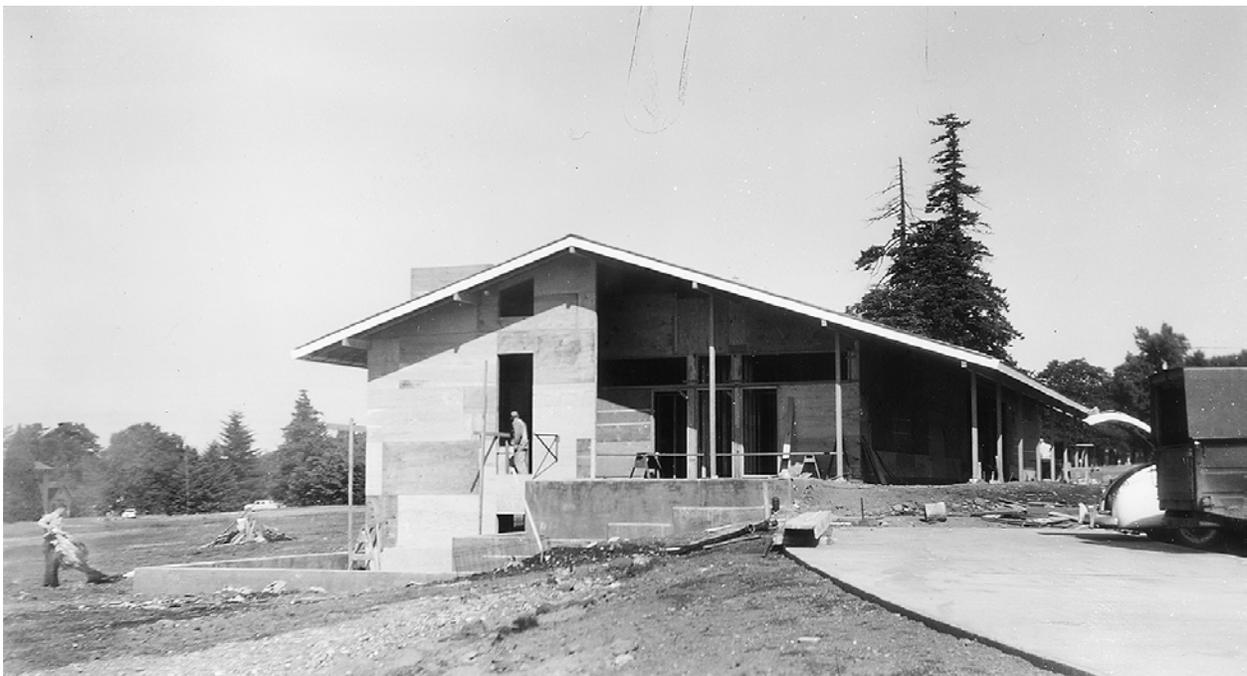
Figure 6. View of the construction of the Visitor Center, facing west. Photograph FOVA 1721, 5/25/1961.

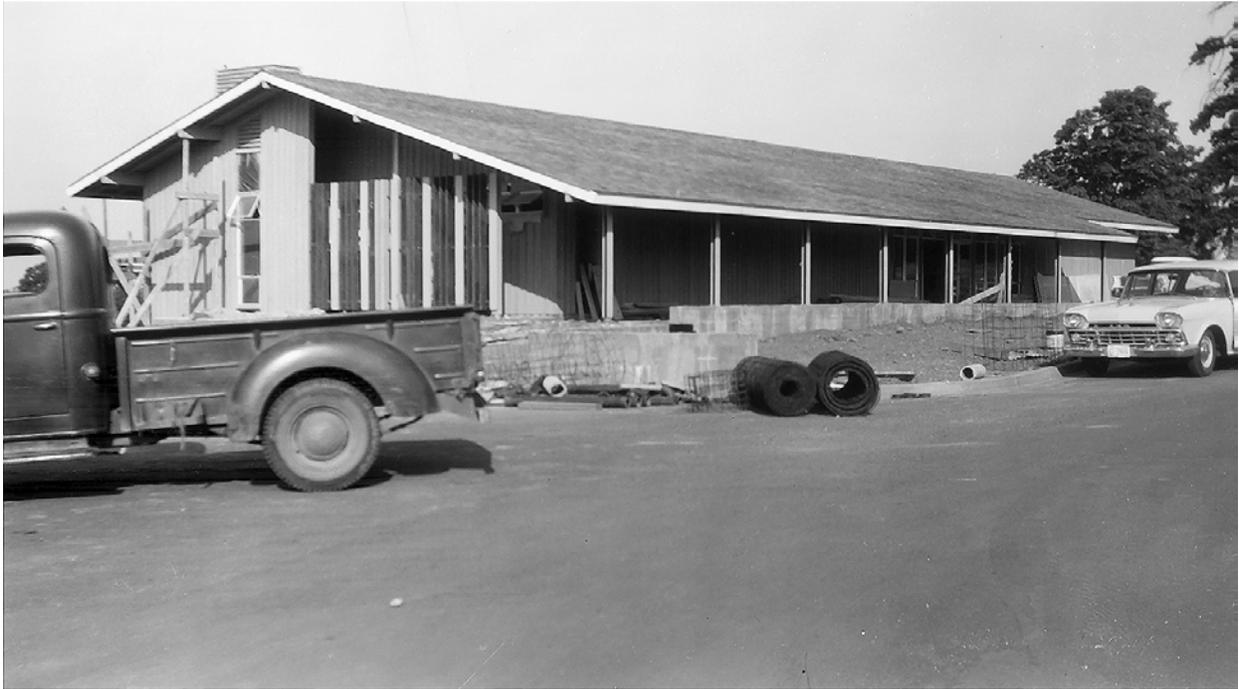
Figure 7. View of the construction of the Visitor Center, facing southwest. Photograph FOVA 1724, 7/11/1961.

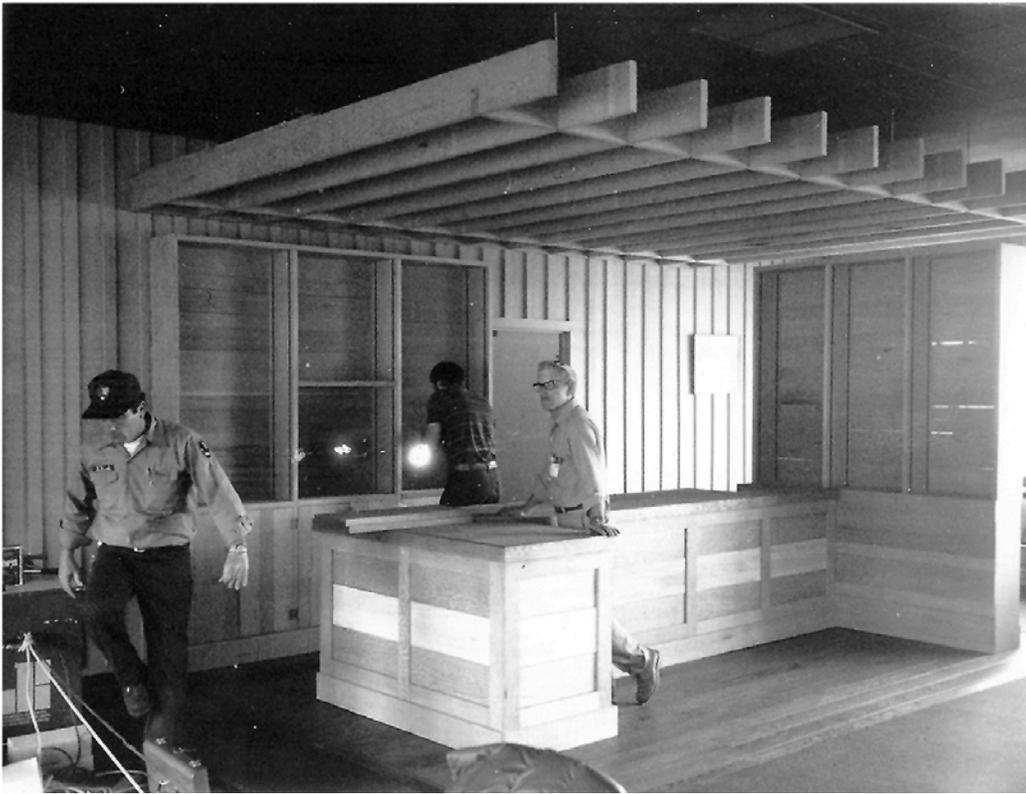
Figure 8. View of the interior remodeling of the Visitor Center. Photograph FOVA 1716, 2/16/1977.

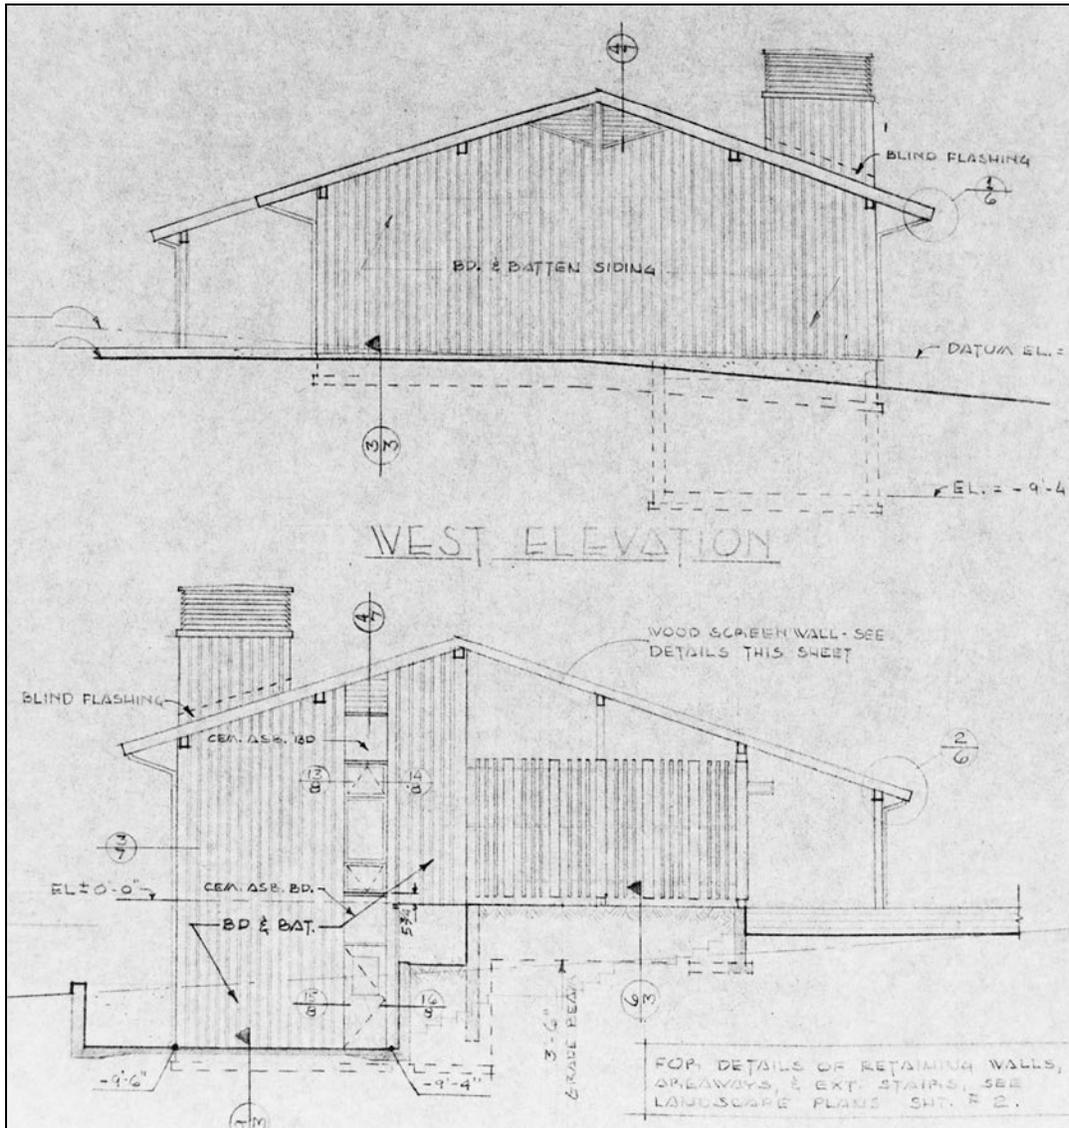
Figure 10. West and east elevations of the Visitor Center, photographed from the original blueprints on file in the Fort Vancouver National Historic Site Archives.

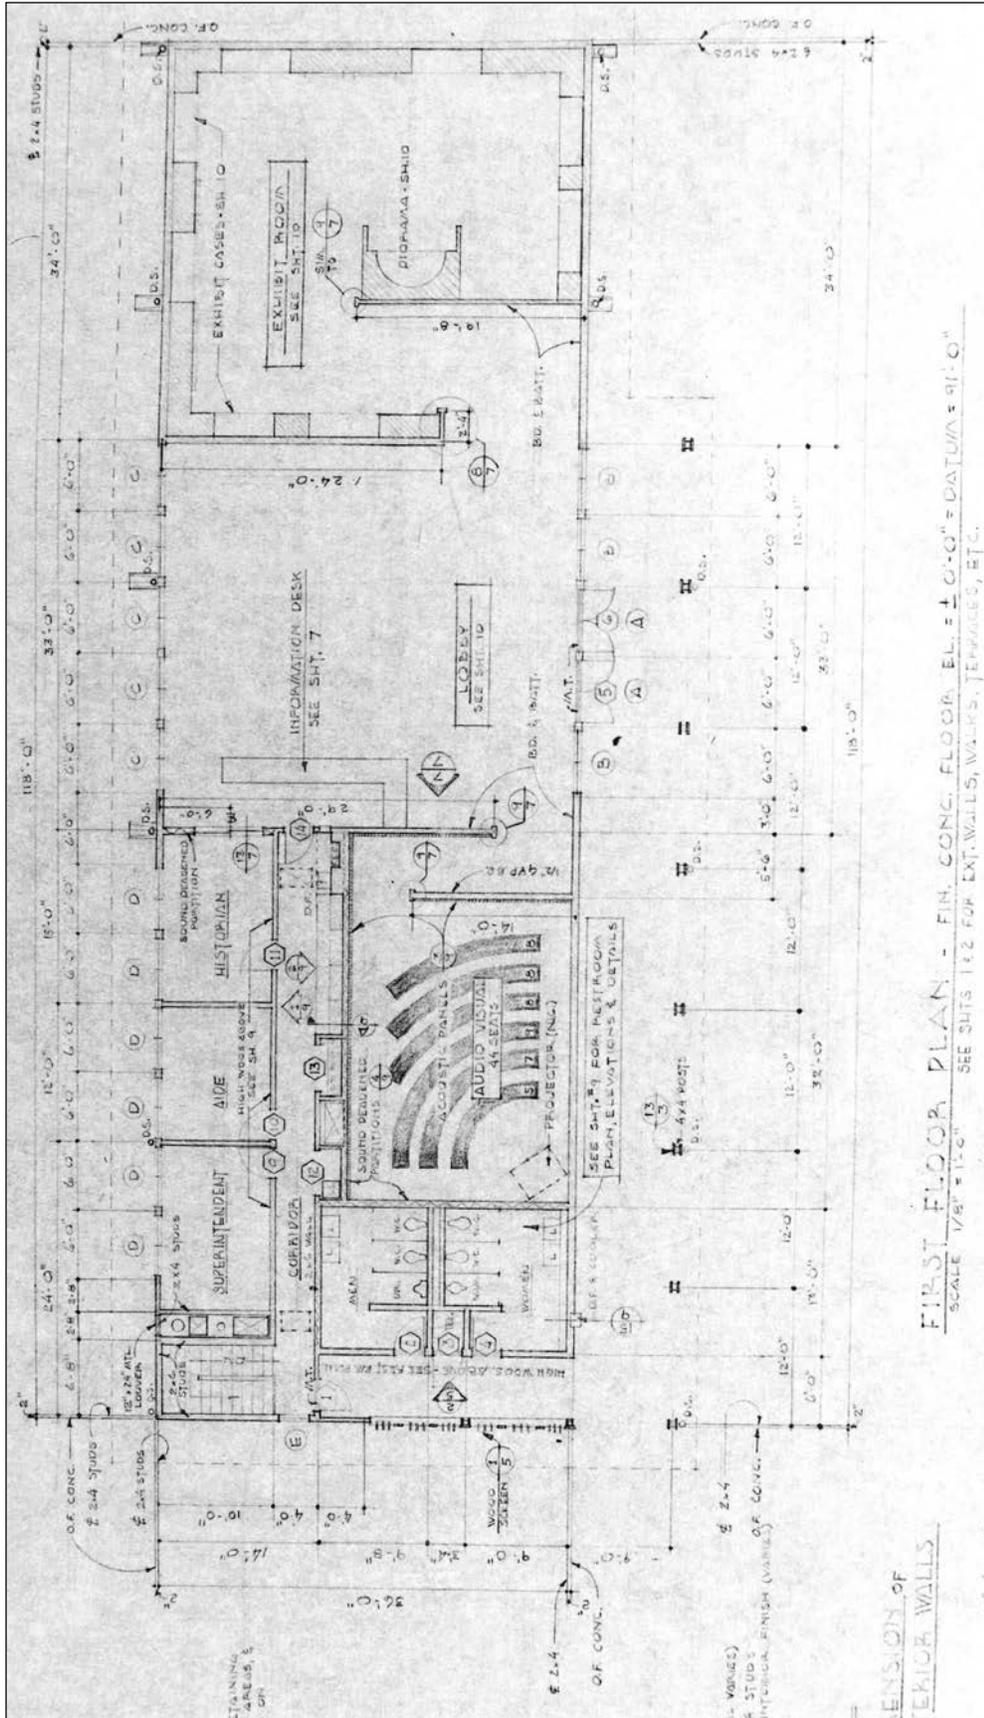
Figure 12. Main floor plan of the Visitor Center, photographed from the original blueprints on file in the Fort Vancouver National Historic Site Archives.

- 1. Overall Dimensions:** The main floor of the Visitor Center measures 36 x 118 ft. (Figure 12) with 9 ft. tall walls. The main floor height to the peak of the roof is approximately 16 ft. The basement measures 14 x 90 ft. (Figure 13).
- 2. Foundations:** The Visitor Center is located on a gentle slope to the south. The east, south, and west walls are supported by a 4 in. thick concrete foundation, which forms the walls of the partial daylight basement. The concrete slab basement with steel foundation joists underlies the south 14 ft. and east 90 ft. of the Visitor Center (Figure 14). The remainder of the building is supported on subsurface concrete slabs and

- a. Main Floor:** The main floor of the Visitor Center contains a lobby/gift shop (33 x 36 ft.), an exhibit room (34 x 36 ft.), an audiovisual room (20 x 32 ft.), three offices (10 ft. x 14 ft. 8 in., 10 x 12 ft., and 10 x 15 ft.), a connecting corridor with cabinets, counter, shelves, clothes closet, and janitor closet (30 x 27 in.), and restrooms (13 x 22 ft.) (Figure 12).

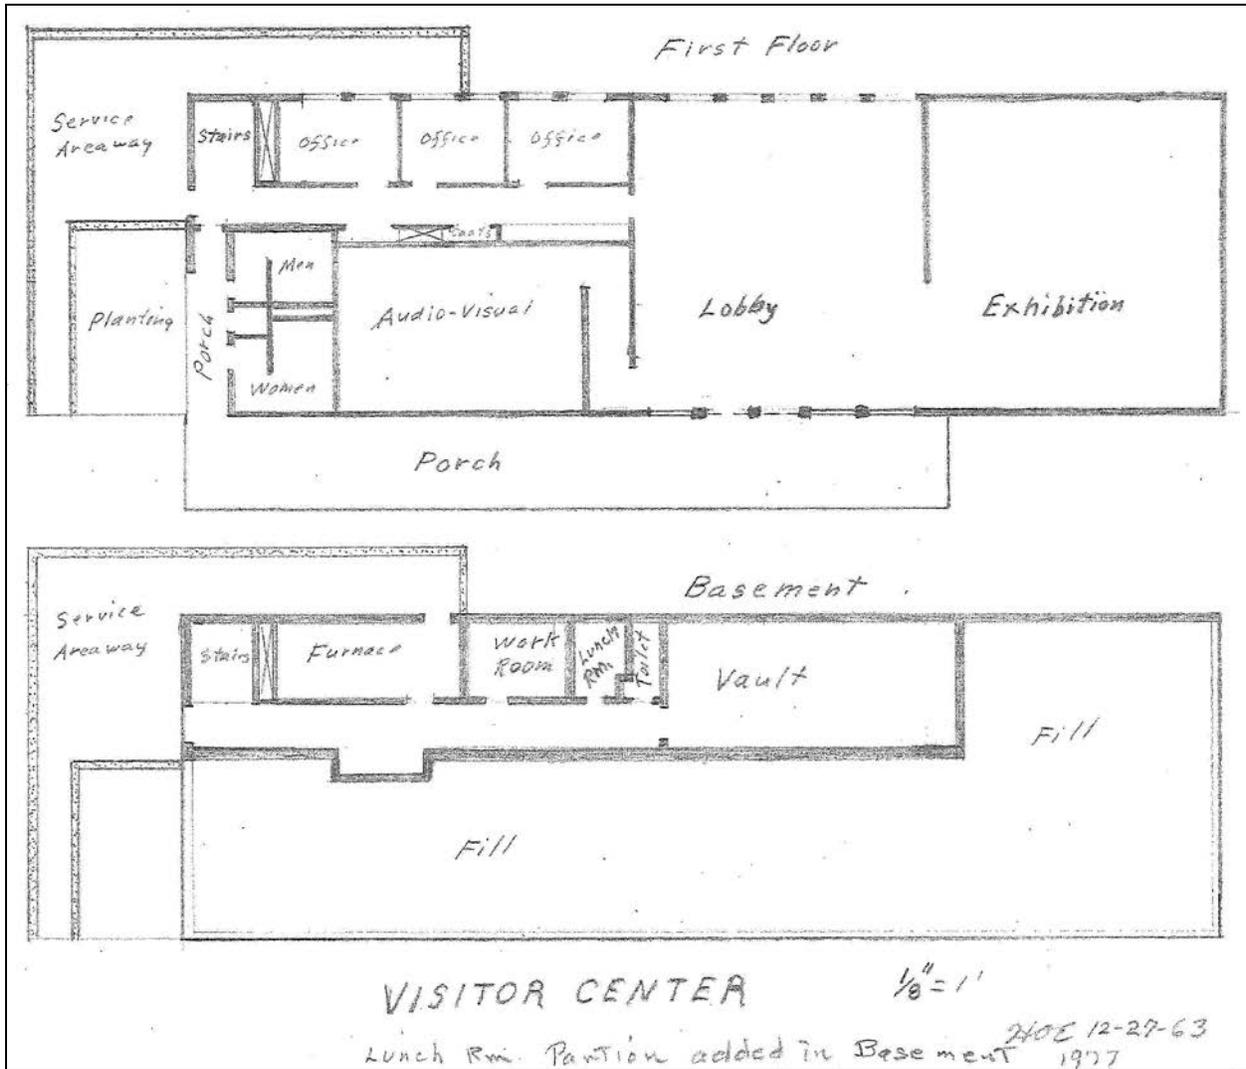
Figure 15. 1977 Visitor Center floor plan, after the lunch room partition was added to the work room in the basement. Drawing on file in the Fort Vancouver National Historic Site Archives.

- b. Basement:** The basement includes a furnace room (10 ft. 6 in. x 23 ft. 4 in.), a work room (10 ft. 6 in. x 21 ft.), an artifact vault (14 ft. x 35 ft. 8 in.), a small restroom, and a connecting corridor (3ft. 6 in. x 54 ft.) (Figure 13). In 1978, the west 9 ft. of the work room was partitioned to create a lunch room (Figure 15). The corridor has a small alcove that houses a water heater.
