Fort Mason (Quarters No. 1) Commanding General's House  
San Francisco County  
San Francisco, California

ADDENDUM TO:  
FORT MASON, QUARTERS NO. 1, COMMANDING GENERAL'S  
HOUSE  
(Officer's Club)  
(McDowell Hall)  
Golden Gate National Recreation Area  
Franklin Street  
San Francisco  
San Francisco County  
California

Addendum to:  
Fort Mason, Quarters No. 1, Commanding General's House  
(Officers' Club)  
(McDowell Hall) HABS No. CA-1877

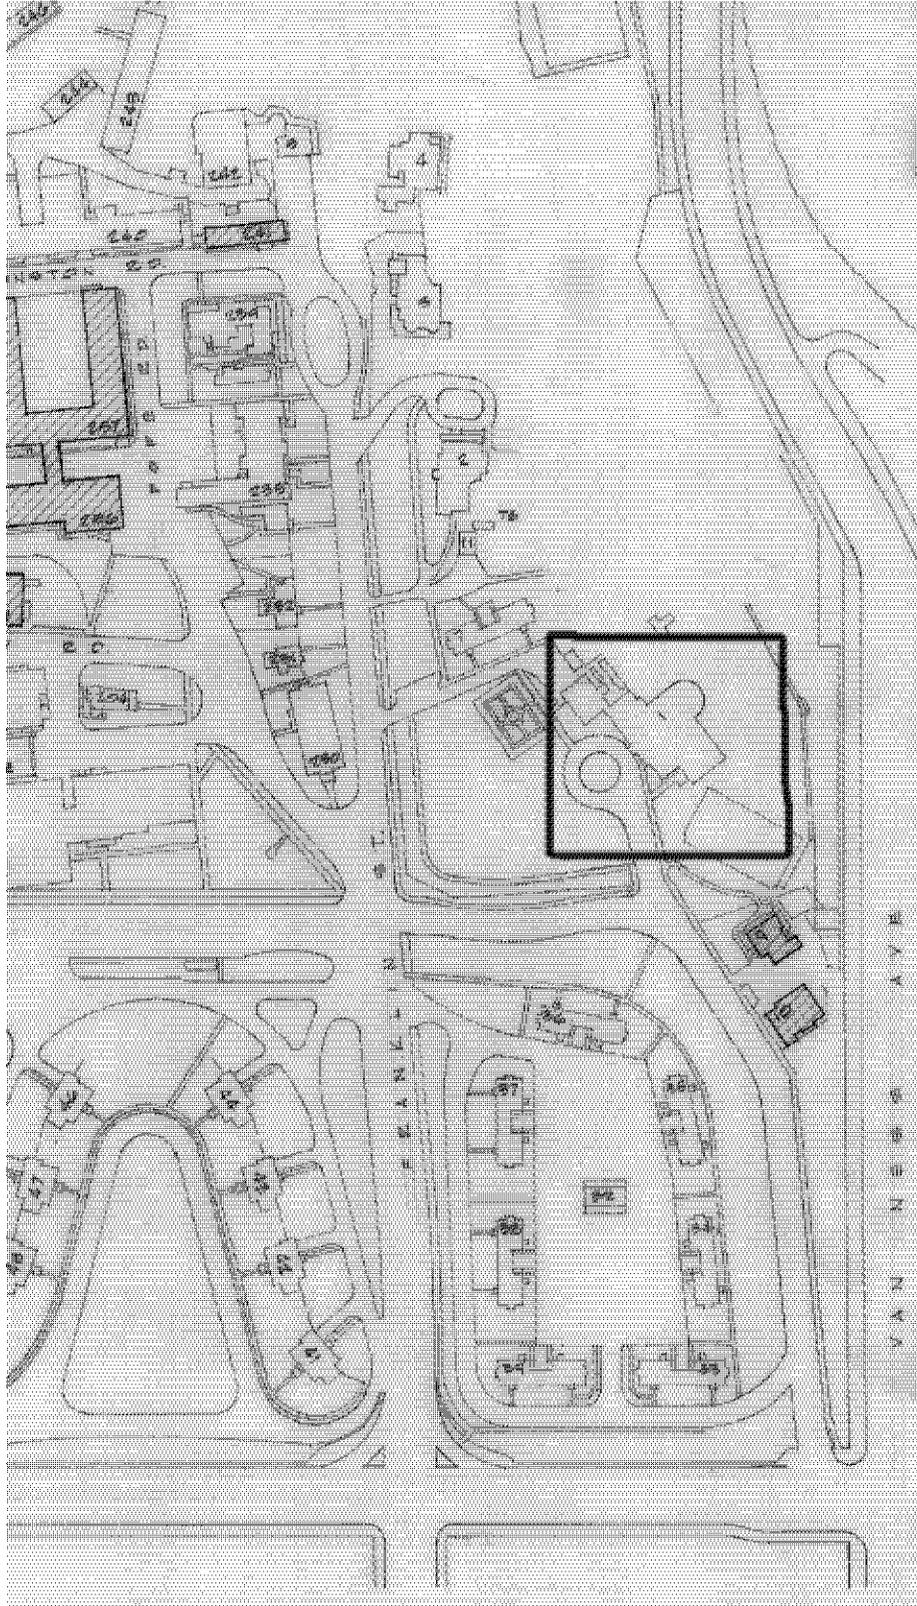
Site Plan: Detail from a 1960 Fort Mason roofing contract site plan  
7. Site

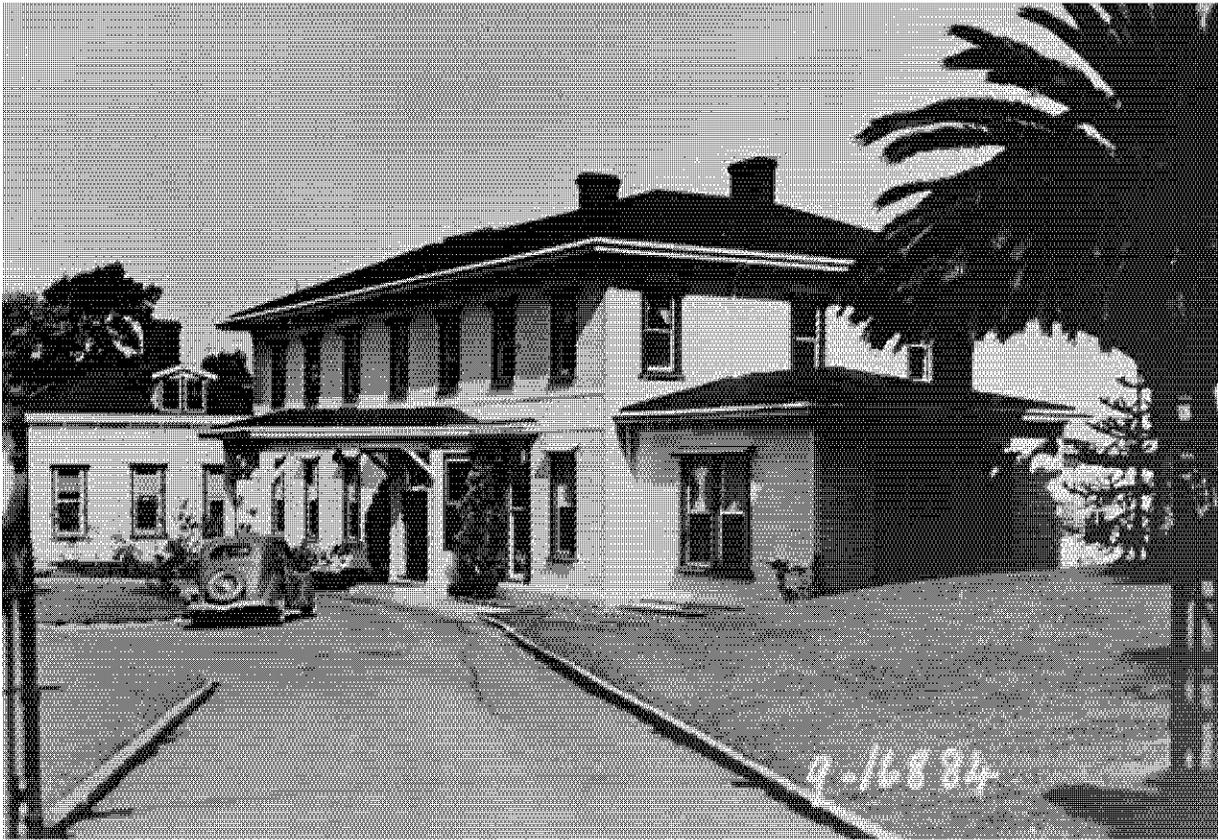
View of Fort Mason, Quarters No. 1, Commanding General's House in 1938. View looking north.
