CAMP REYNOLDS, OFFICERS' QUARTERS
(Building No. 48-49)
Angel Island State Park
Angel Island
Marin County
California

HABS CA-1841-D
CA-1841-D

CAMP REYNOLDS, OFFICERS' QUARTERS
(Fort McDowell - West Garrison, Building No. 48-49)

HABS No. CA-1841-D

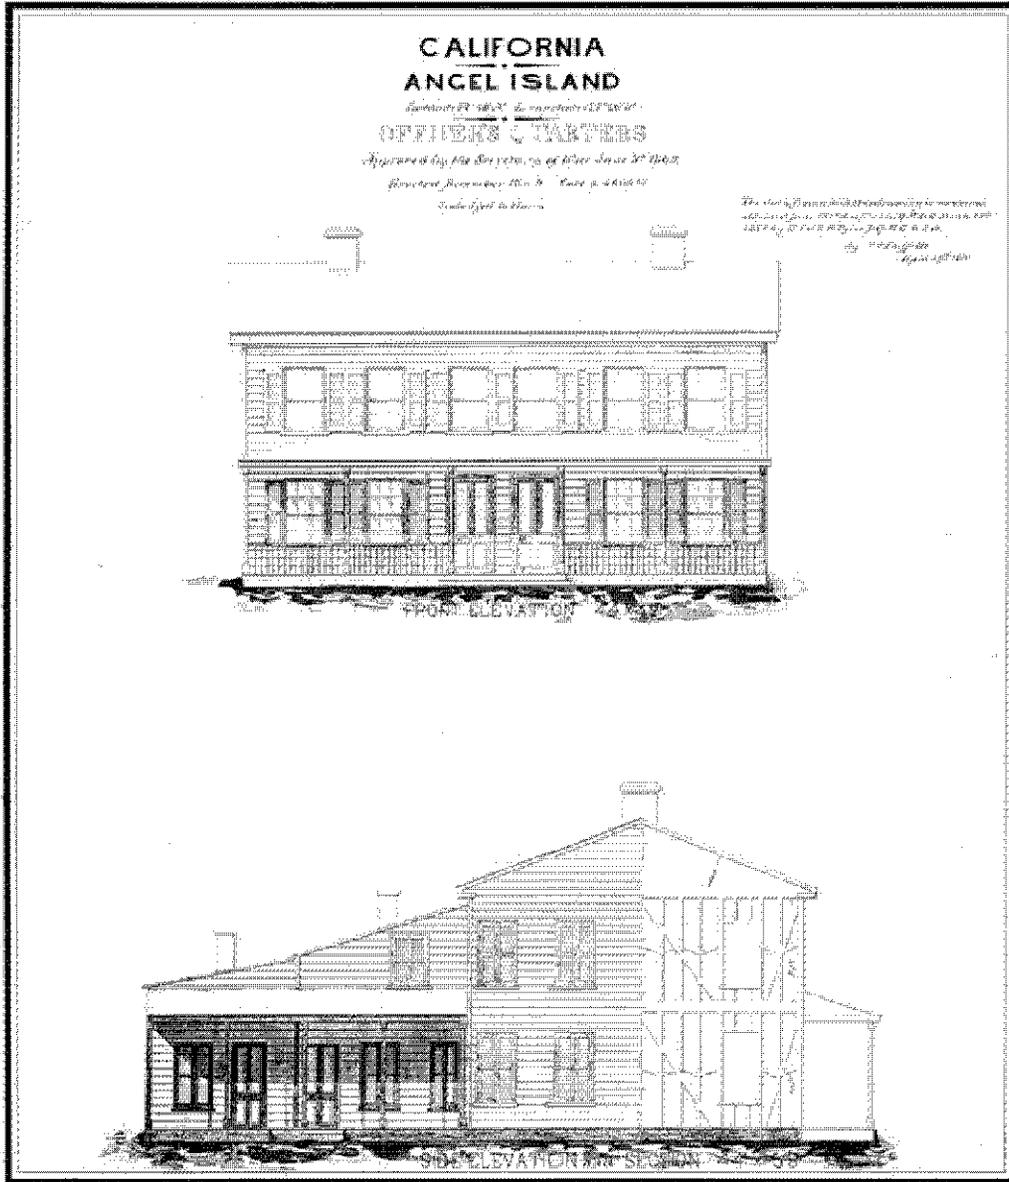
Figure 1: Officers' Quarters, Elevations, (built December 1869)
Source: Map 42-7, "Angel Island," RG 92 Post and Reservation File,
National Archives, Cartographic and Architectural Branch (College Park, Maryland)

This officers' quarters was built as a double structure housing two sets of officers and their families in largely mirror-image plan dwellings. A set of as-built plans was filed with the Quartermaster General's office in spring 1871 (Figure 1). These plans specify that the building was constructed in December 1869 at a cost of \$4,000. The original form of a two-story, six-bay, side gable structure with an one-and-a-half-story shed roof kitchen ell is still largely intact, although an one-story section at the back of the kitchen ell is no longer extant. The 1871 floor plans illustrate the rectangular footprint of the main section of the dwelling and the square kitchen ell, with each unit divided into four rooms and an entrance hall on the first floor, and three rooms and stair hall with a small room to the north on the second floor (Figure 2). Several spaces in the kitchen ell are labeled on the plan; the rear of the kitchen ell was a "back kitchen," while a sink and pantry in the other first floor room indicate another kitchen space. The second story part of the kitchen ell is labeled "servant's room."¹ In addition to the family spaces, having a servants' room in an officers' quarters would not have been unusual during the late nineteenth century. Officers' wives could hire civilian servants - often Chinese at Angel Island - or soldiers could serve as domestic help, even after this practice was outlawed in 1870.²

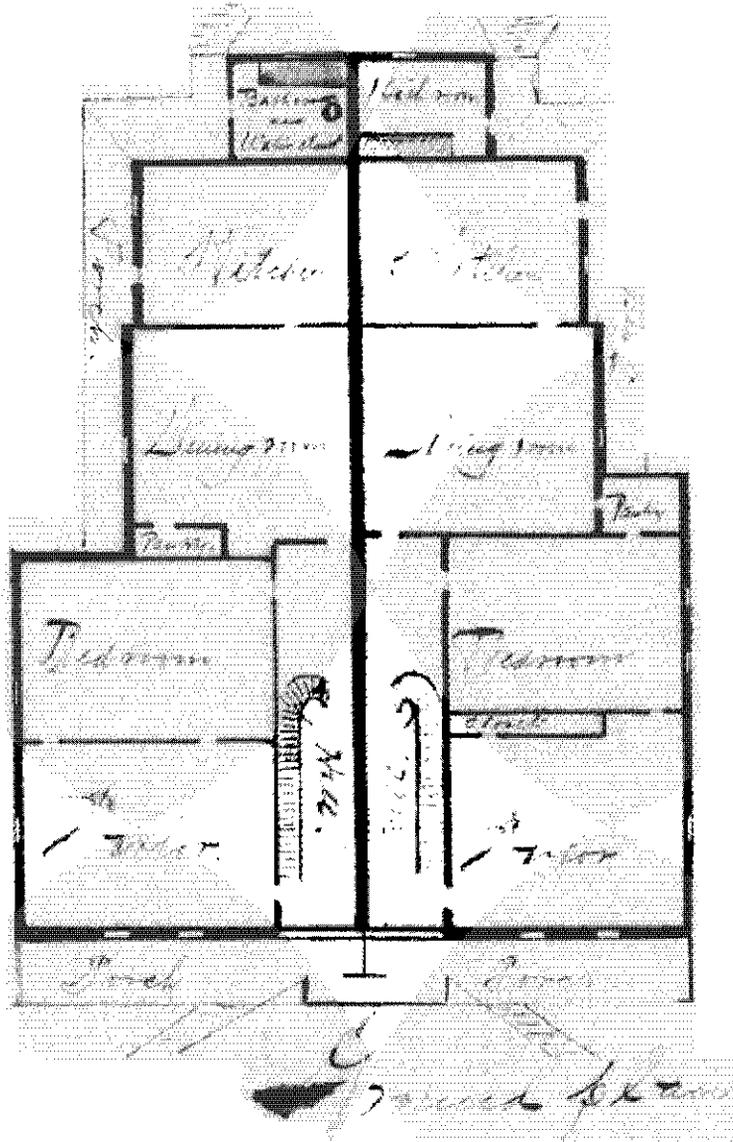
Figure 3: First Floor Plan, 1893, Officers' Quarters
Source: Enclosure to Special Sanitary Report, (30 June 1893),
National Archives, RG 112 - Office of the Surgeon General, Entry 41, Box 2

both a series of changes since the original plans and differences between the two units (Figures 3 & 4). The first floor of each unit had, front to back, a parlor, bedroom, dining room, kitchen, and small bathroom. The side porches wrapped around to the back of the kitchen. In Building No. 49 a closet in the dining room was labeled pantry while this closet was removed in Building No. 48. Instead a small pantry addition was added to the side of the kitchen ell. Above this added pantry was the outside closet referred to above. On the second floor each unit had a stair hall, two bedrooms and a large closet in the main section. The ell room in No. 49 was one large bathroom while in No. 48 this area was divided into three small spaces - a hall, bathroom, and servant's room.⁸

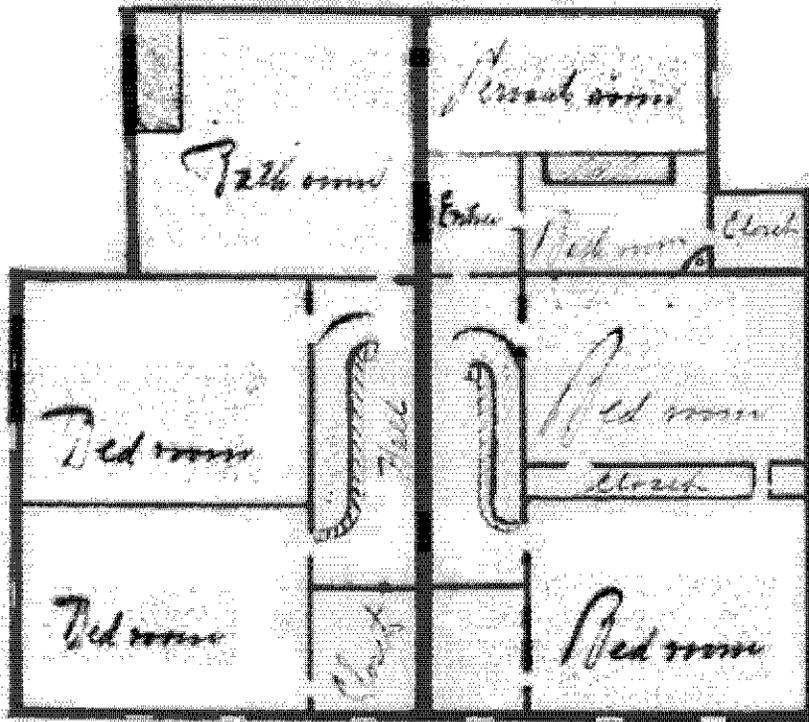
Plan of second story.

Figure 4: Second Floor Plan, 1893, Officers' Quarters
Source: Enclosure to Special Sanitary Report, (30 June 1893),
National Archives, RG 112 - Office of the Surgeon General, Entry 41, Box 2
