Indian Leap Pedestrian Bridge
Yantic St
Norwich
New London County
Connecticut

HAER No. CT-4

MONOGRAPH
FOR
HISTORICAL AMERICAN ENGINEERING RECORD
INDIAN LEAP RECREATIONAL AREA
PEDESTRIAN BRIDGE
OVER
YANTIC RIVER
IN
NORWICH, CONNECTICUT
MAY 1979

PREPARED BY: C-E MAGUIRE, INC.

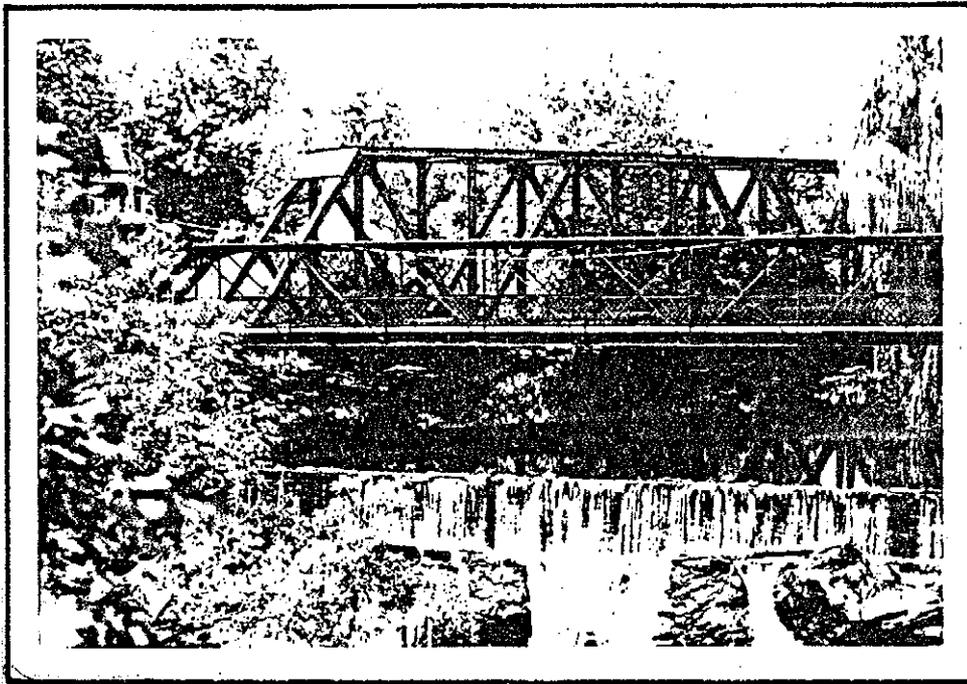
LOOKING WEST

PEDESTRIAN BRIDGE OVER YANTIC RIVER IN FOREGROUND
RAILROAD BRIDGE OVER YANTIC RIVER IN BACKGROUND

It will be noted that the construction of this pedestrian bridge followed the design of the existing railroad bridge nearby.

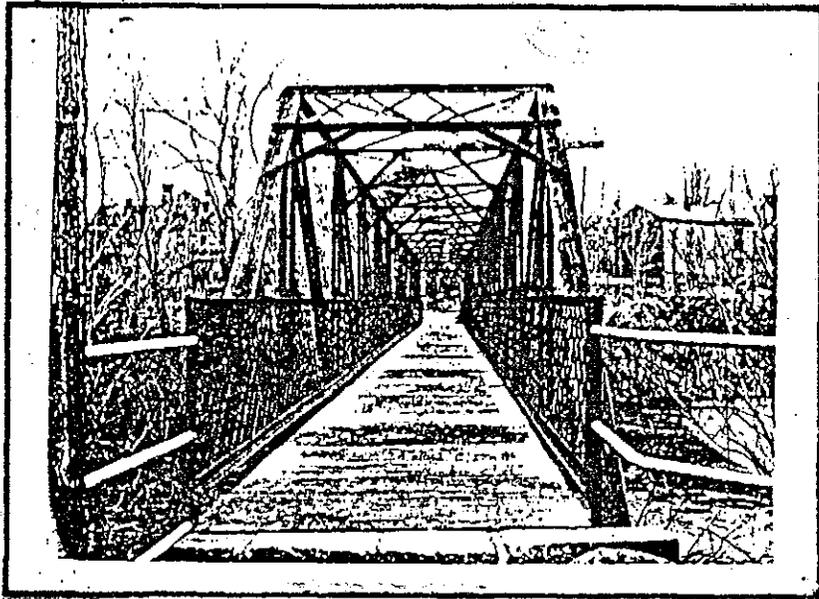
SOUTH END OF BRIDGE

The stone masonry abutment at the East end of the bridge was observed to be in good condition, however, excessive dirt accumulated behind the bearing plates and the extensive corrosion in the bearing area probably restrains proper thermal movement of the structure. The stone masonry abutment at the West end of the bridge was observed to be in fair condition. The mortar joints were observed to be cracking and spalling with tree branches and foliage growing out from between the stones.

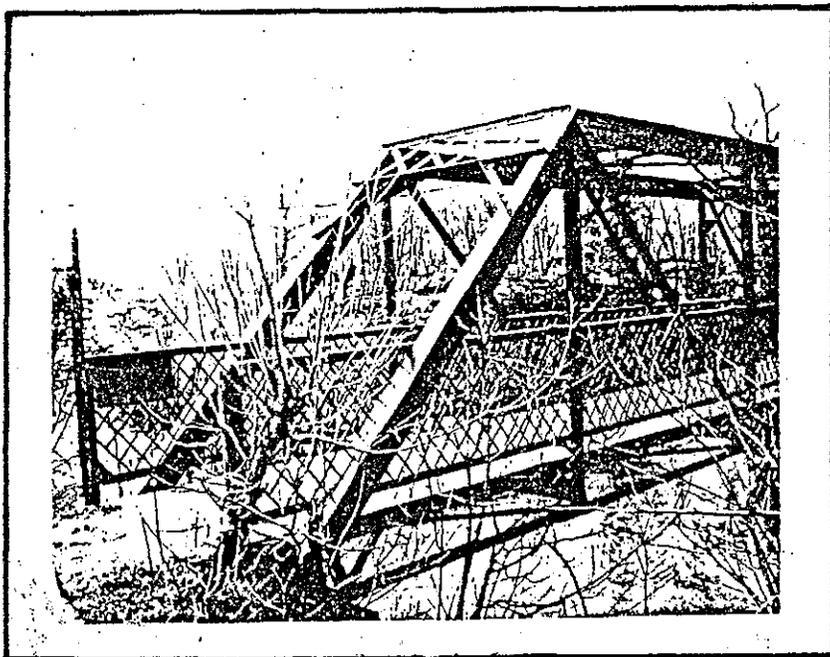
NORTH END OF BRIDGE

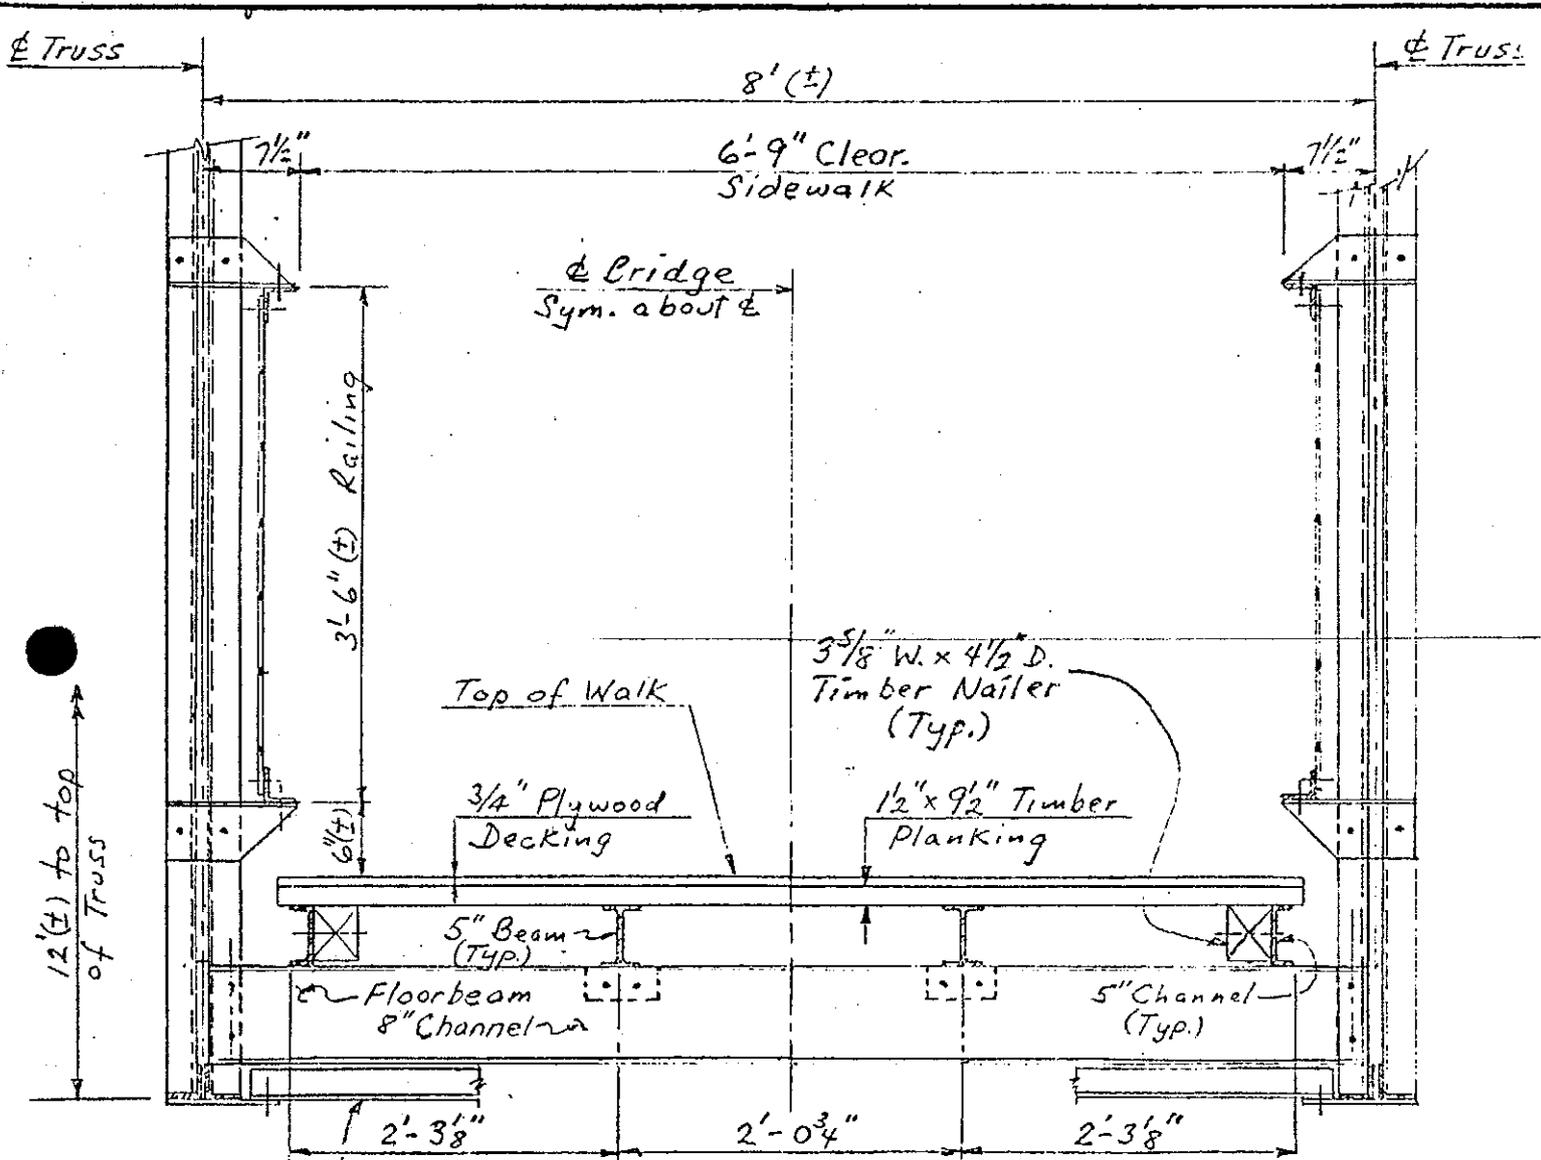
INDIAN LEAP FOOT BRIDGE

TYPICAL BRIDGE SECTION
 Scale: 3/4" = 1'-0"

L 2 1/2 x 2 1/2 x 4
 Lat. Bracing
 (Typ.)

The bottom lateral bracing angles were observed to be generally in fair condition. The lateral bracing connection plate, however, at the Southwest corner of the bridge was completely rusted through. The top lateral bracing angles, sway bracing and portal members appeared to be in good condition. Several of the top lateral struts were observed to be rusted through at the connection plates.

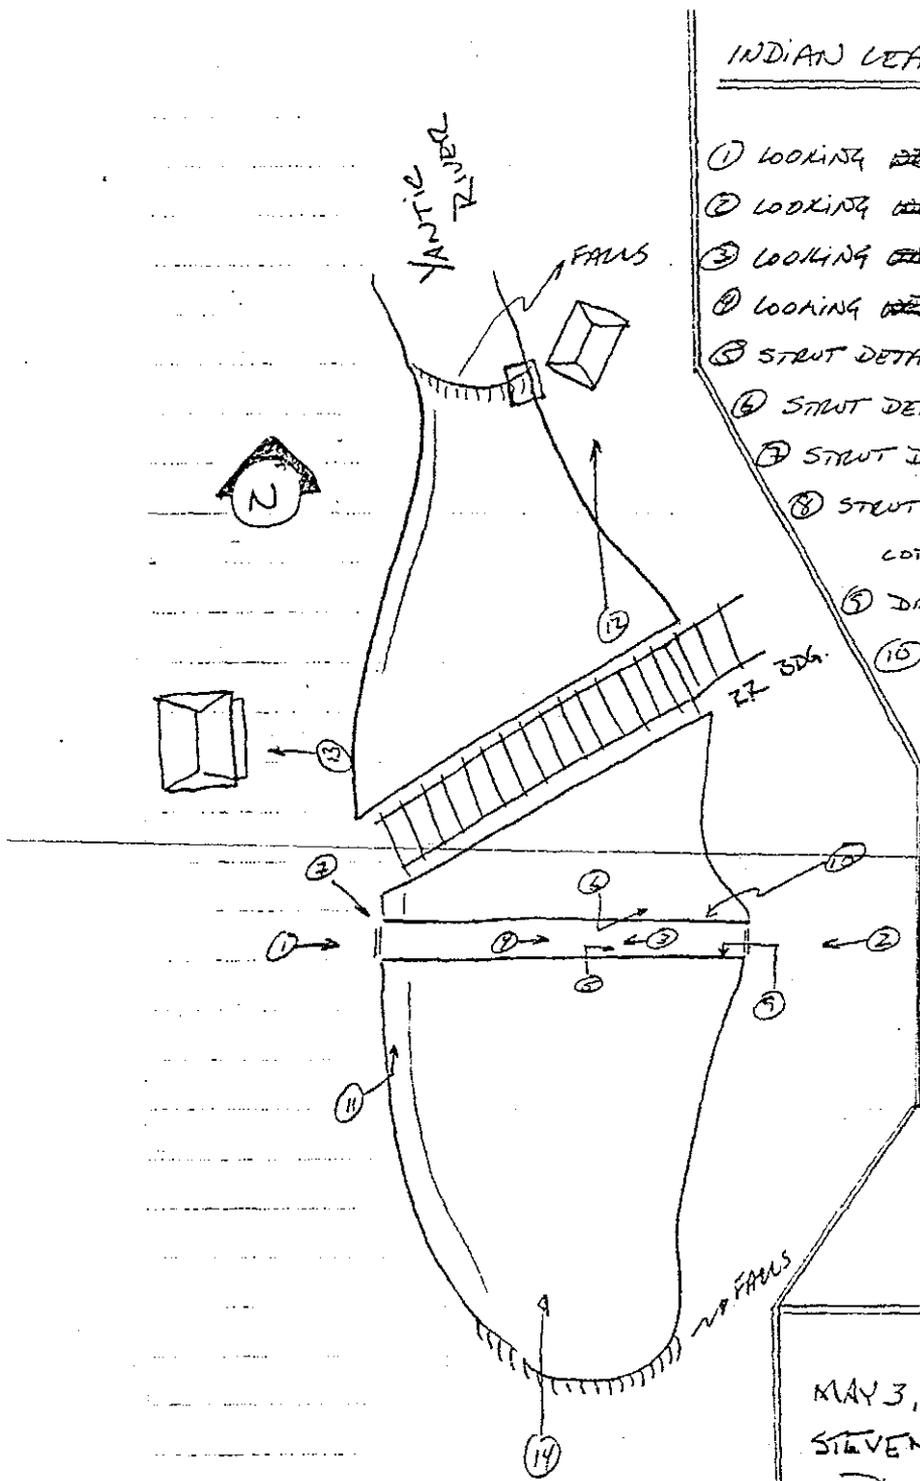
- ① LOOKING ~~WEST~~ EAST
- ② LOOKING ~~WEST~~ WEST
- ③ LOOKING ~~WEST~~ WEST
- ④ LOOKING ~~WEST~~ EAST
- ⑤ STRUT DETAIL LKG. EAST
- ⑥ STRUT DETAIL LOOKING N.E.
- ⑦ STRUT DETAIL N.W. CORNER
- ⑧ STRUT & FENCE DETAIL N.W. CORNER. (SEE LOC. 7)
- ⑨ DATE PLATE
- ⑩ UNDERSIDE OF PIERL DETAIL
- ⑪ DETAIL - STONE CLEATS
- ⑫ POWDL. HSE & MILL RACE
- ⑬ FARM HSE
- ⑭ GENERAL VIEW NORTH...
