ST. ELIZABETHS HOSPITAL, GARFIELD  
(Building No. 5)  
539-559 Cedar Drive, Southeast  
Washington  
District of Columbia

HABS DC-349-Z  
*HABS DC-349-Z*

### ST. ELIZABETHS HOSPITAL, GARFIELD (BUILDING 5)

HABS NO. DC-349-Z

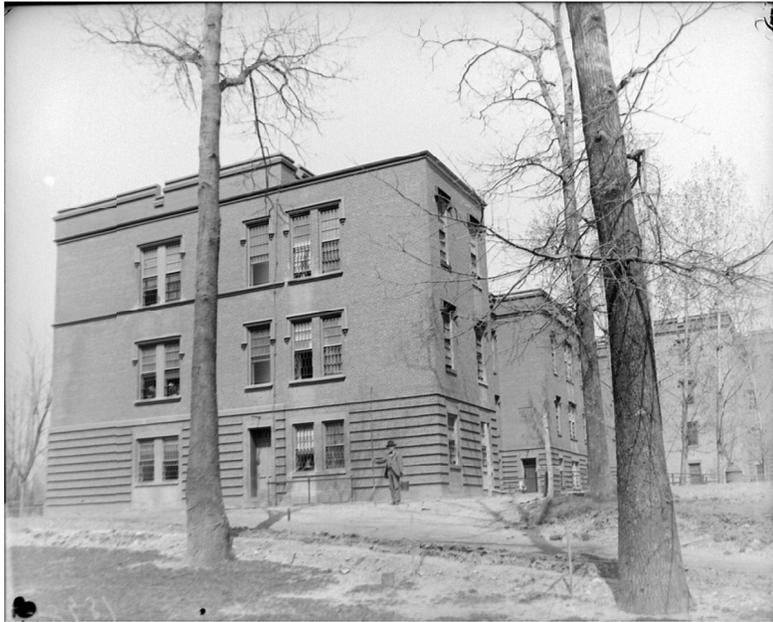
*Figure 1. Lavatory addition to the Garfield Building, 1898. Source: GSA archives, image DC1441SE0P003.*

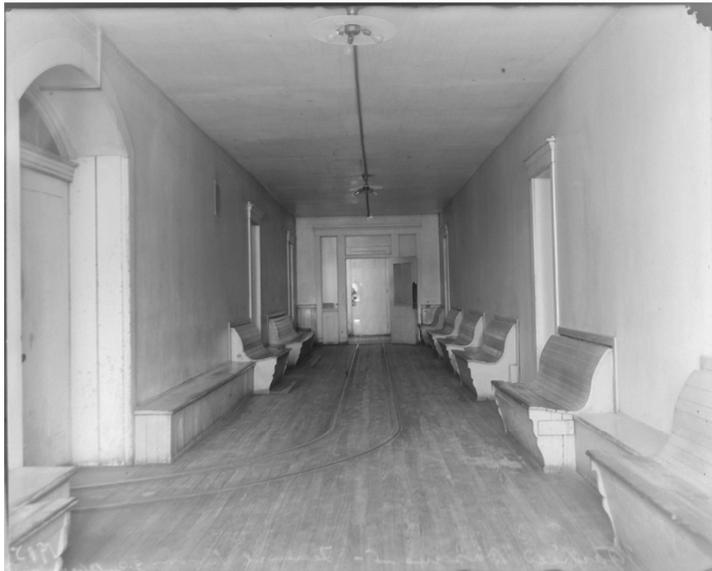
*Figure 2. First floor of the Garfield Building along the north-south corridor looking toward the West Wing vestibule, 1905. Source: GSA archives, image DC1441SE0P006.*

The east-west and north-south corridors are divided by a plaster elliptical arch with plaster pilaster trim at the spring line and a steel bullnose at the wall corners. The alcoves off the east-west corridor are defined by similar arches. The connecting corridor to the bathroom wing is defined by a semicircular plaster arch with bullnose trim at the wall corners. In the south alcove off the east-west corridor, there is a rectangular plastered opening in the wall leading to the dayroom; this opening replaced a typical paired window opening at this location when the dayroom addition was constructed.

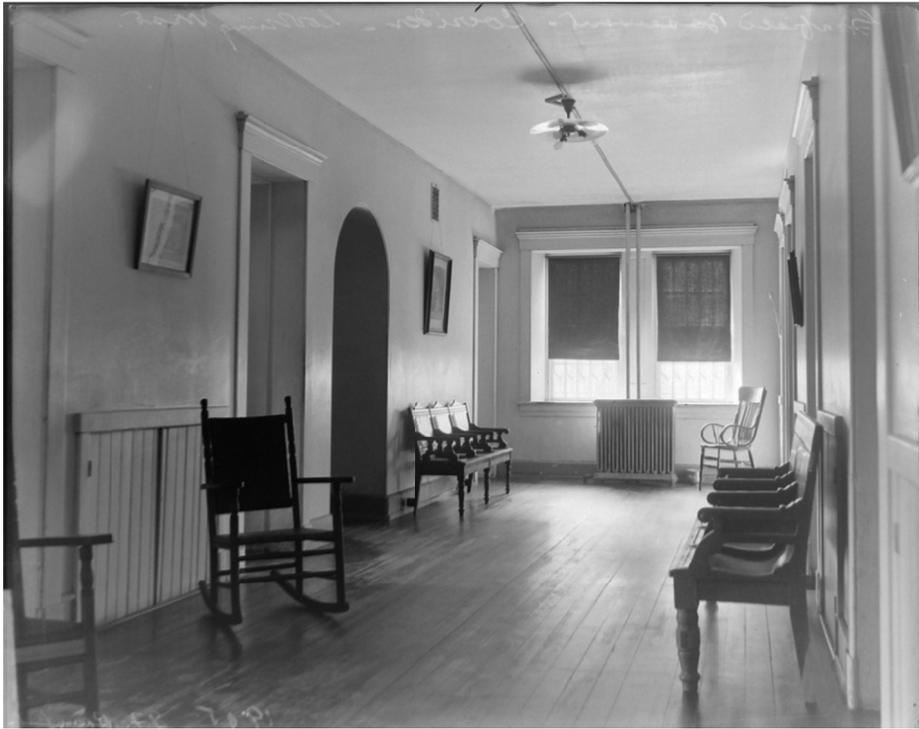
Figure 3. First floor of the Garfield Building along the east-west corridor, 1905. Arched opening on the left leads to the lavatory addition. Source: GSA archives, image DC1441SE0P007.

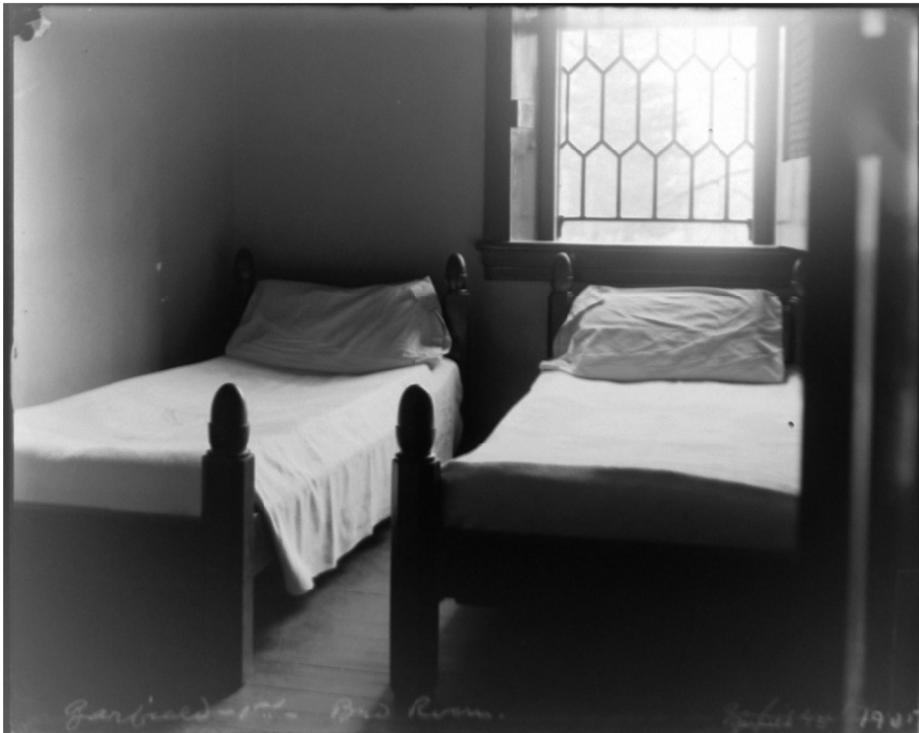
Figure 4. Patient bedroom in the Garfield Building, 1905. Source GSA archives, image DC1441SE0P004.

- b. Windows: In addition to the exterior iron security grille at the lower sash, most ground floor and first floor bedroom windows have original interior inward-swinging wood-framed security grilles with heavy-gauge diagonal woven wire screening; no such grilles are present at the second floor, although traces of hardware for screens of this type were observed.

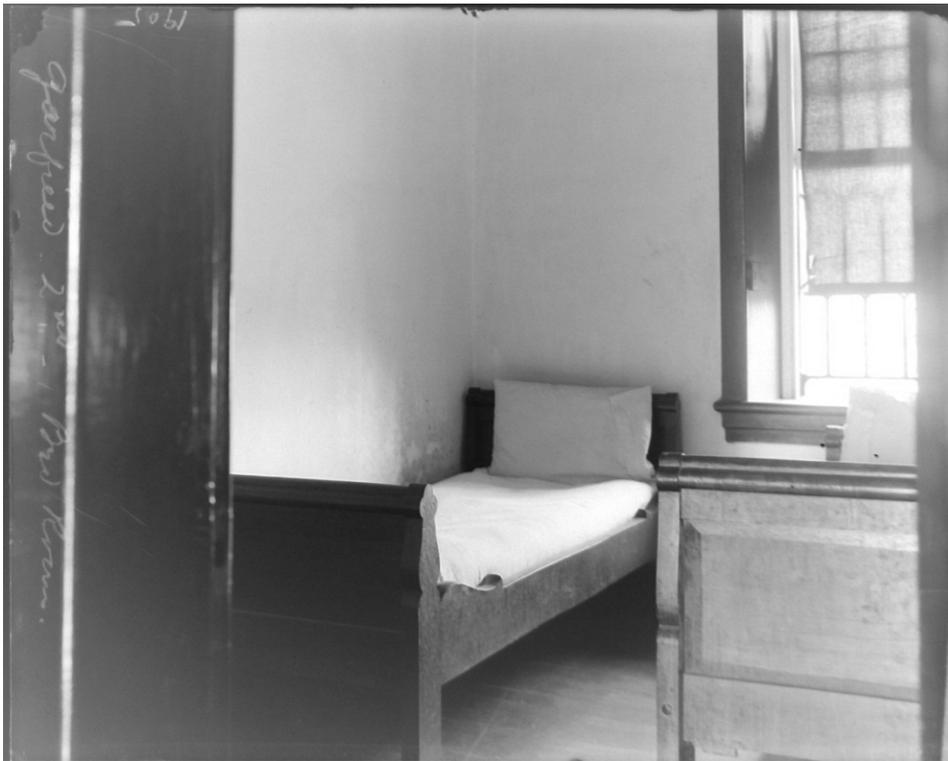
Figure 5. Patient bedroom in the Garfield Building, 1905. Source GSA archives, image DC1441SE0P005.

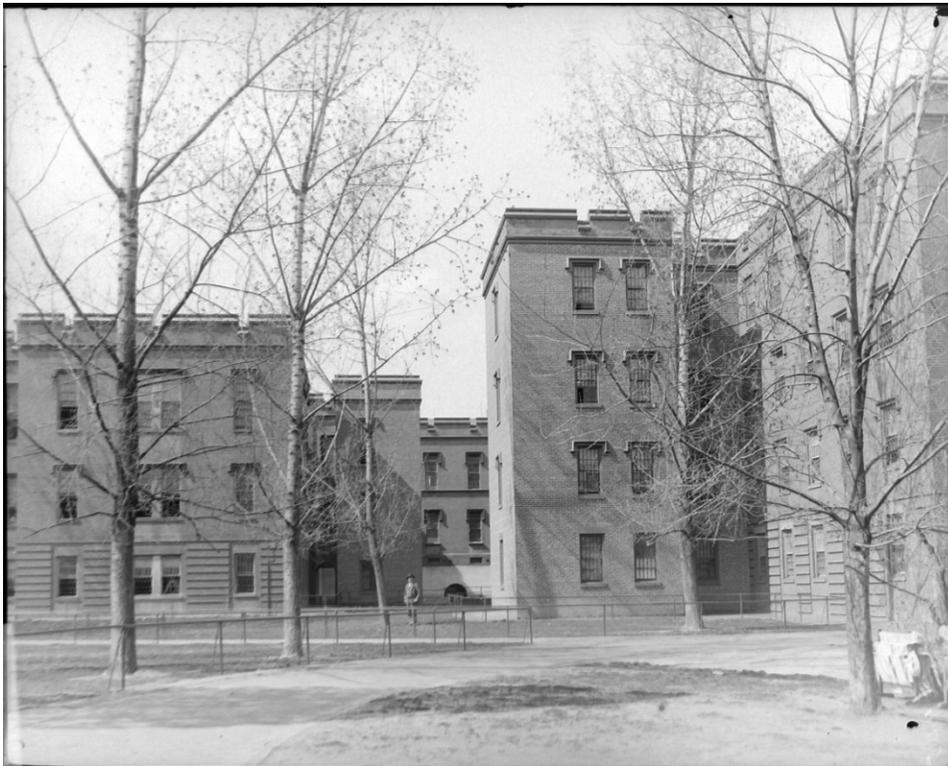
Figure 6. View from the south of the Center Building; Garfield on the left side of the image, the West Wing in the distance, and Dawes (no longer extant) on the right, 1905. Source GSA archives, image DC1347SE0P005.

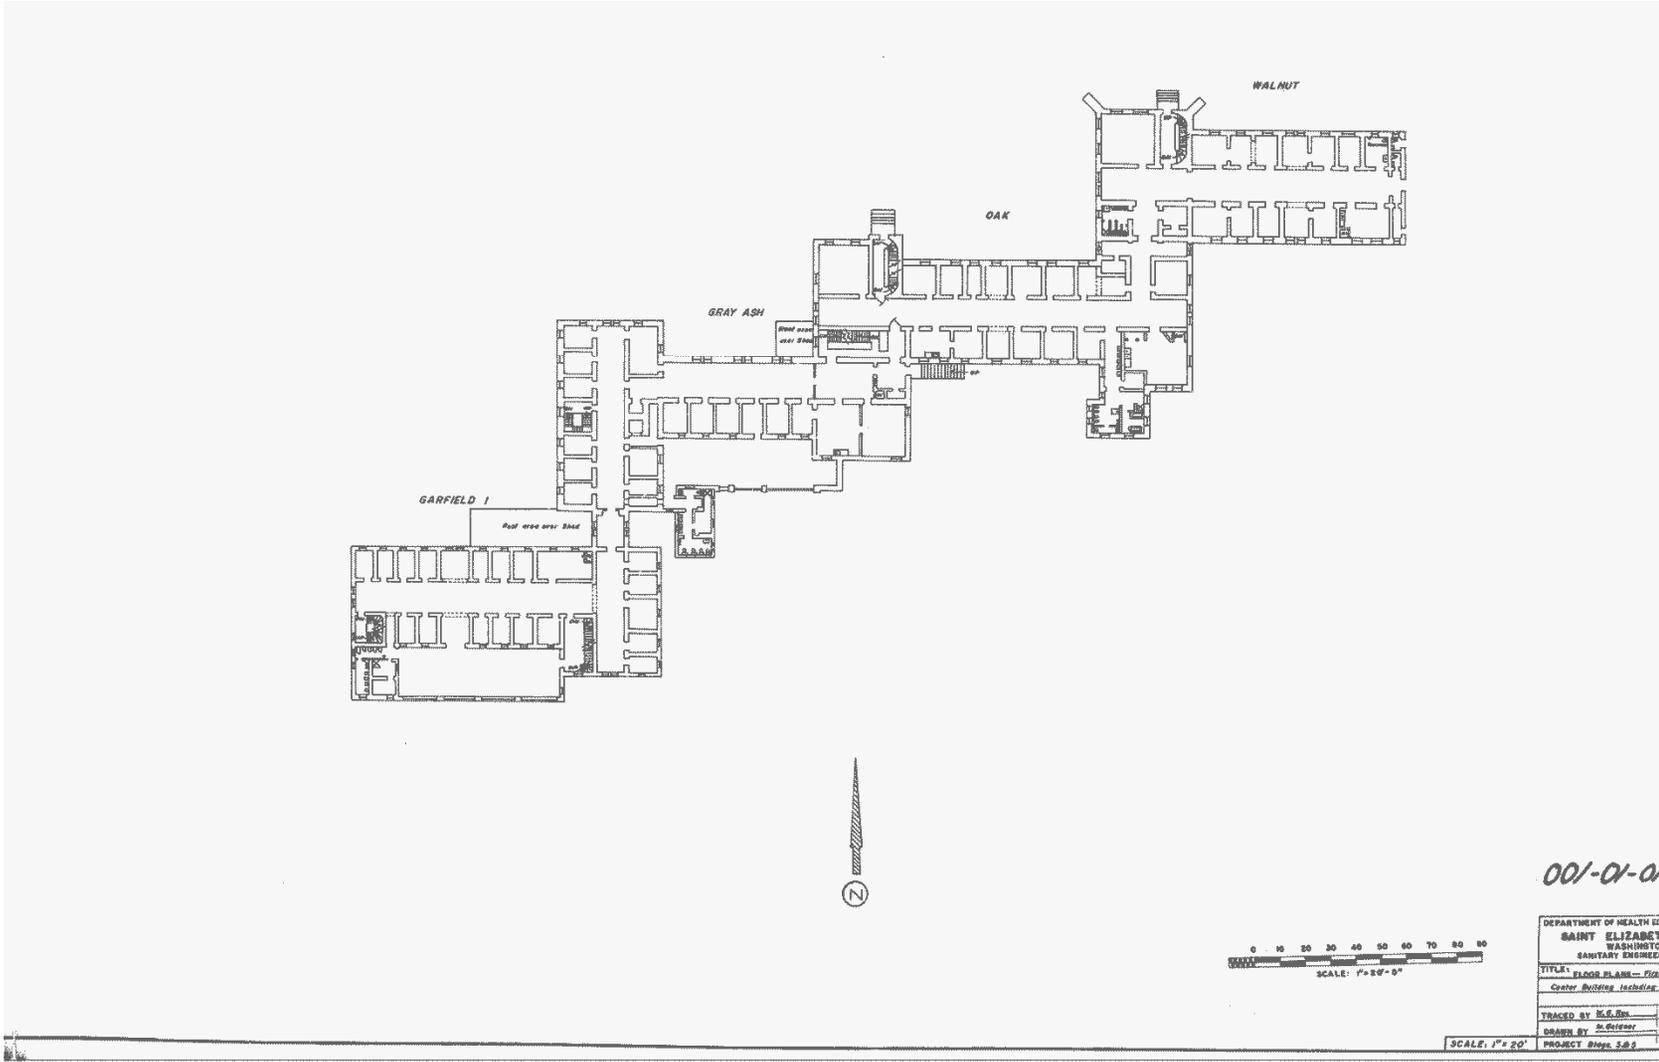
Figure 7. First floor plan of West Wing and Garfield Building, 1966. Source GSA archives, image DC0070SE0102.

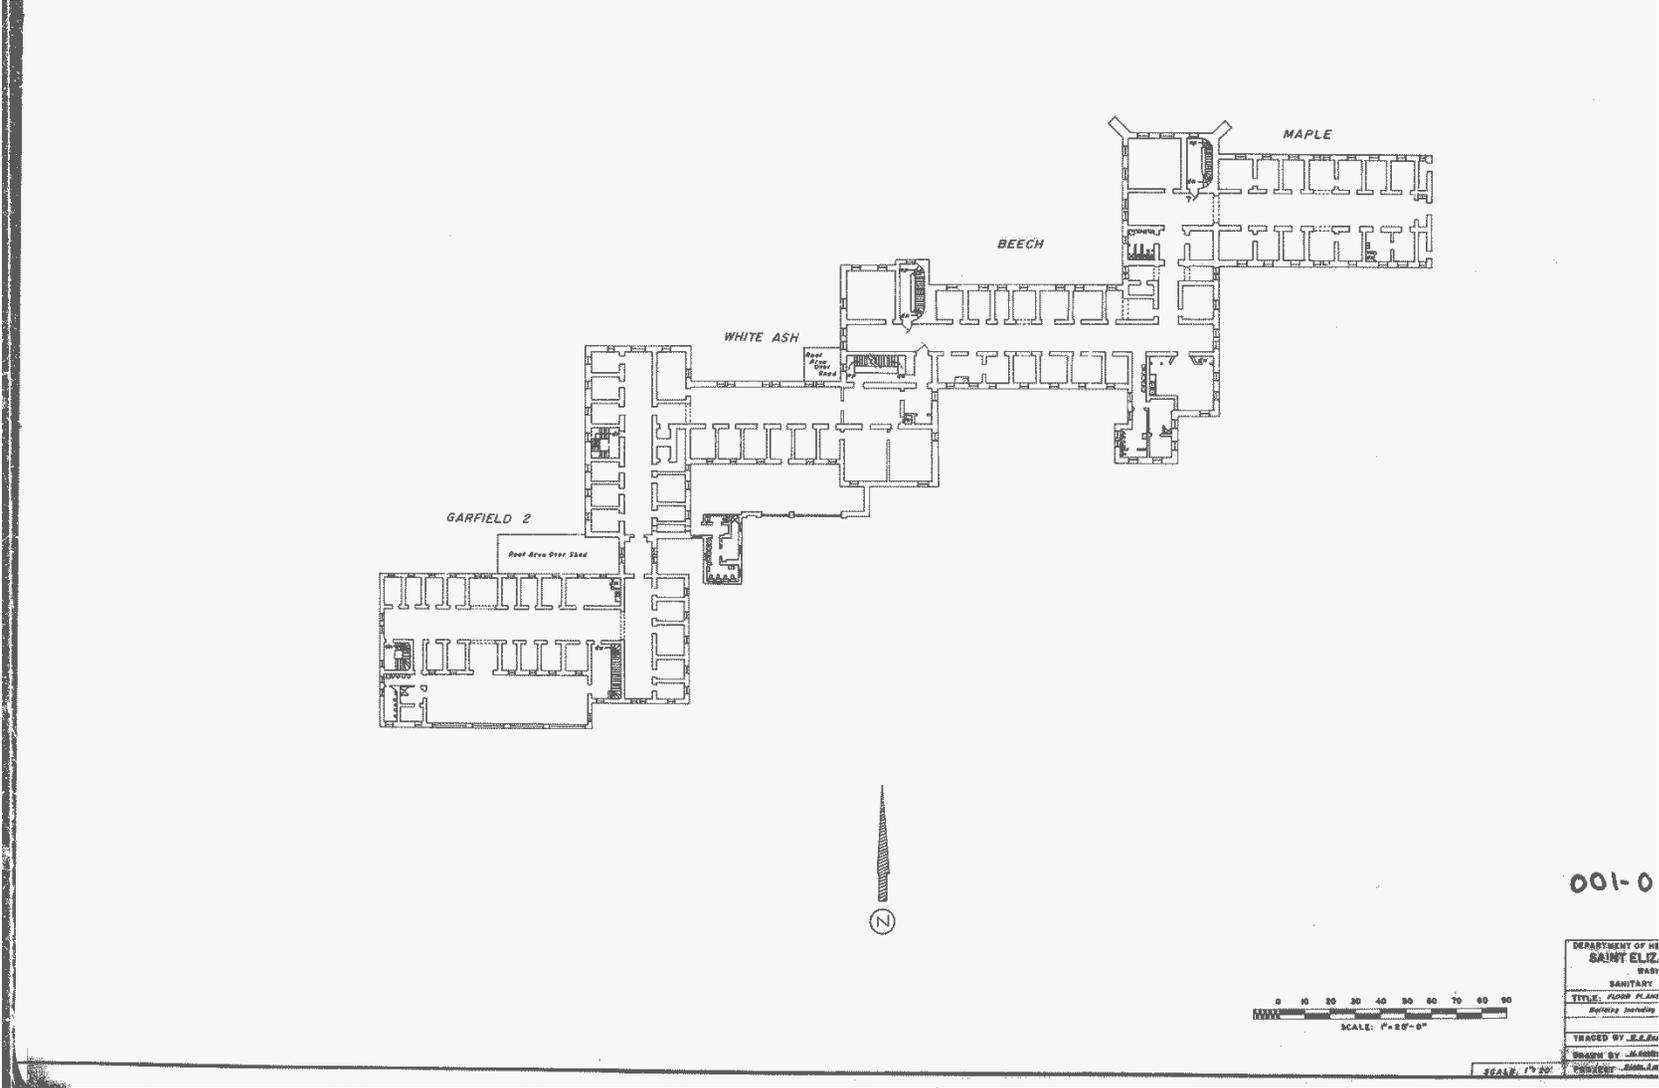
Figure 8. Second floor plan of West Wing and Garfield Building, 1966. Source GSA archives, image DC0070SE0103.

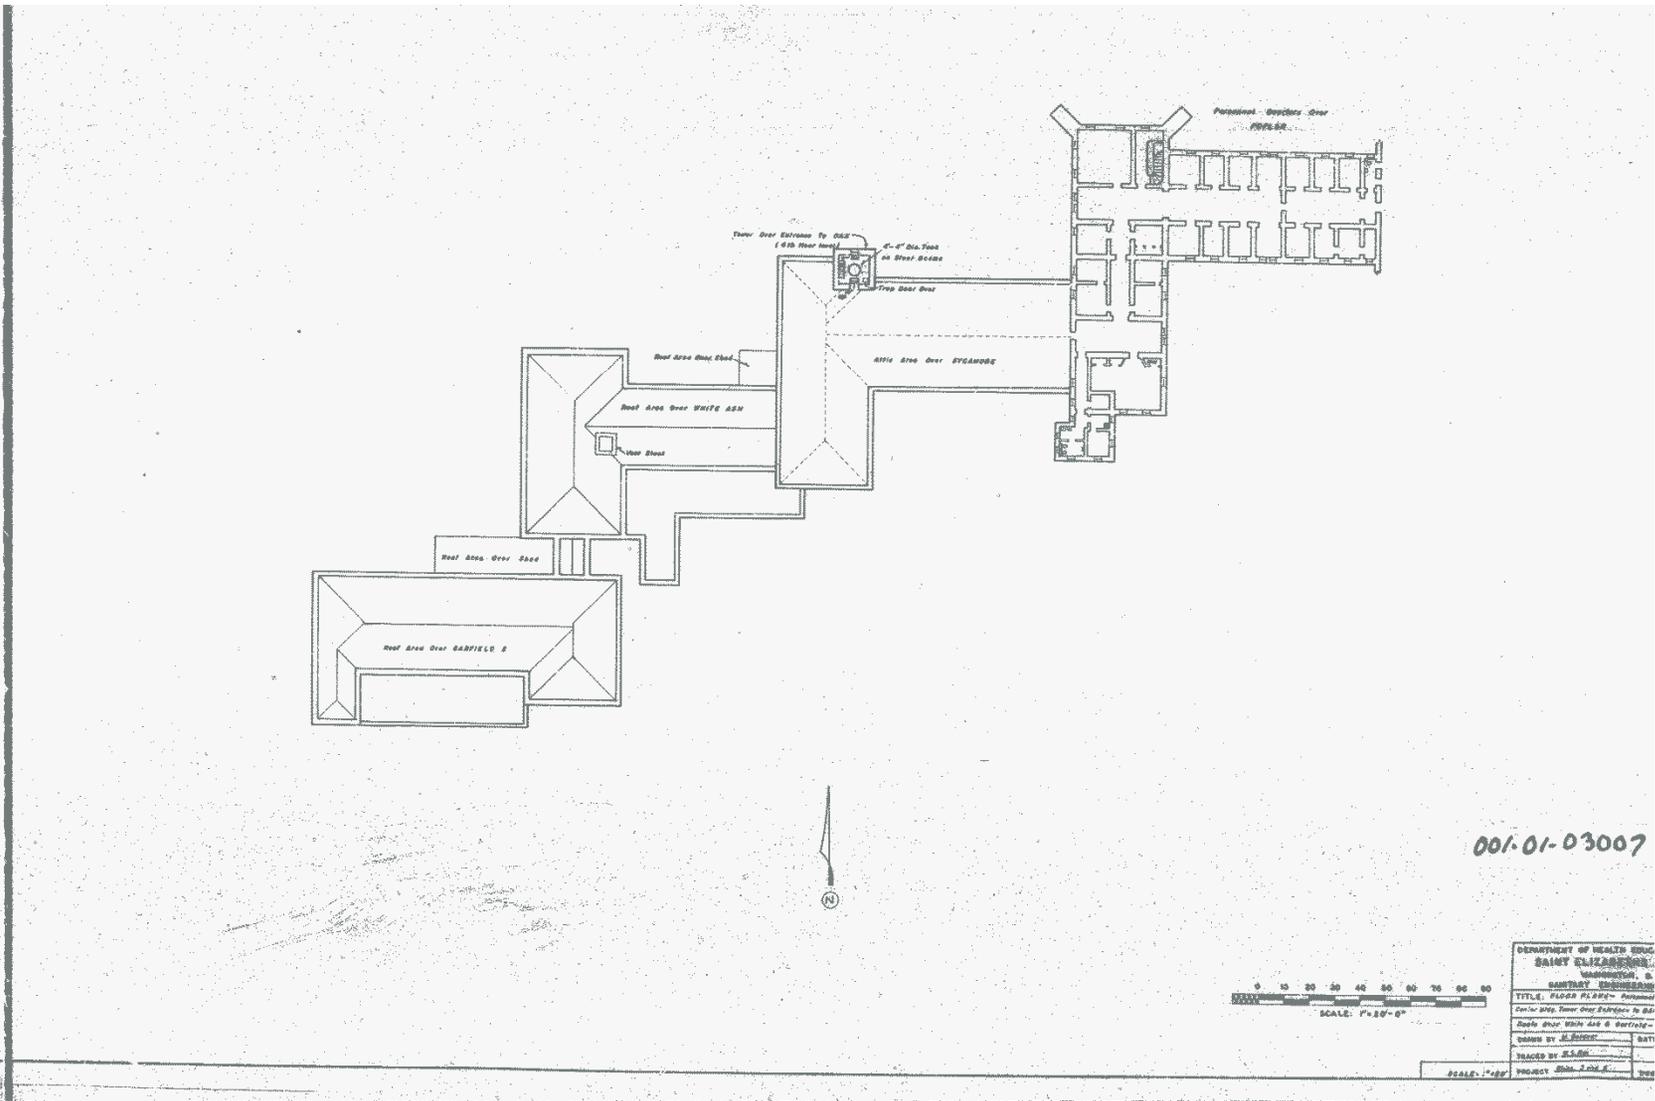
Figure 9. Roof plan of West Wing and Garfield Building, 1966. Source GSA archives, image DC0070SE0104.

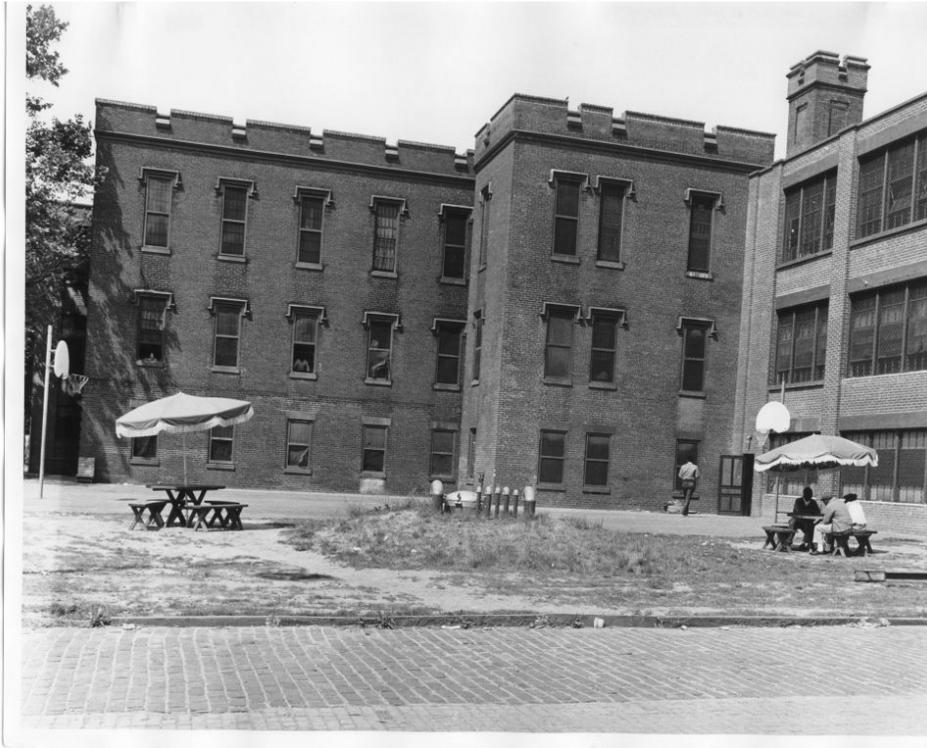
*Figure 10. A view of the east elevation of the Garfield Building and the West Wing, 1968. Source: GSA archives, image DC1441SE0P001.*

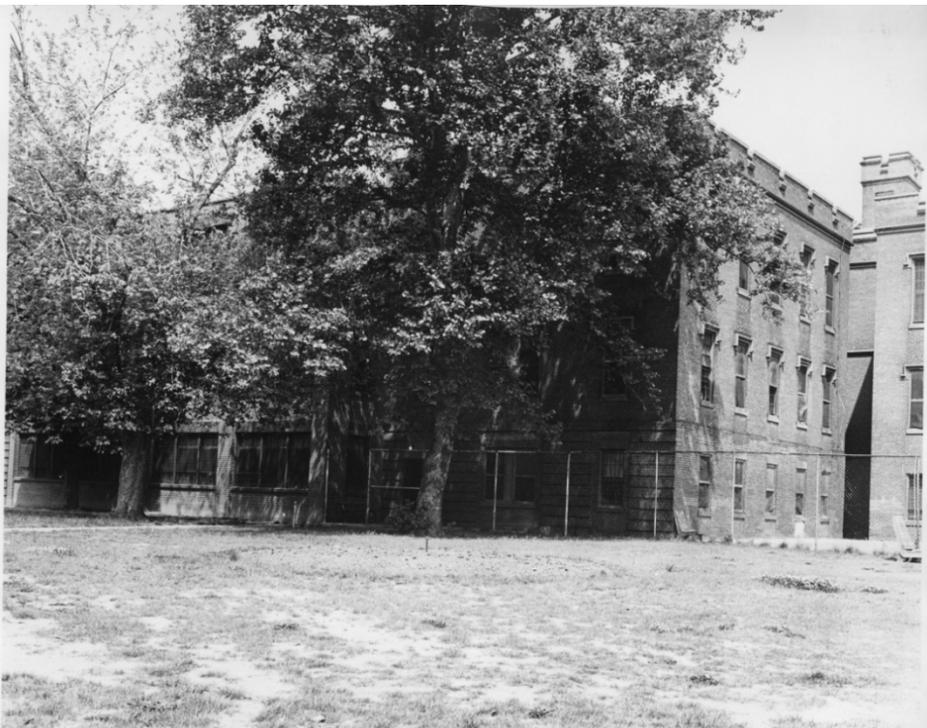
*Figure 11. South elevation of Garfield with the dayroom porch addition, 1968. Source GSA archives, image DC1441SE0P002.*
