Del Rio Federal Building  
(Del Rio Courthouse and Post Office)  
100 Broadway, corner of Main Street  
Del Rio  
Val Verde County  
Texas

HABS No. TX-3394

HISTORIC AMERICAN BUILDINGS SURVEY

DEL RIO FEDERAL BUILDING

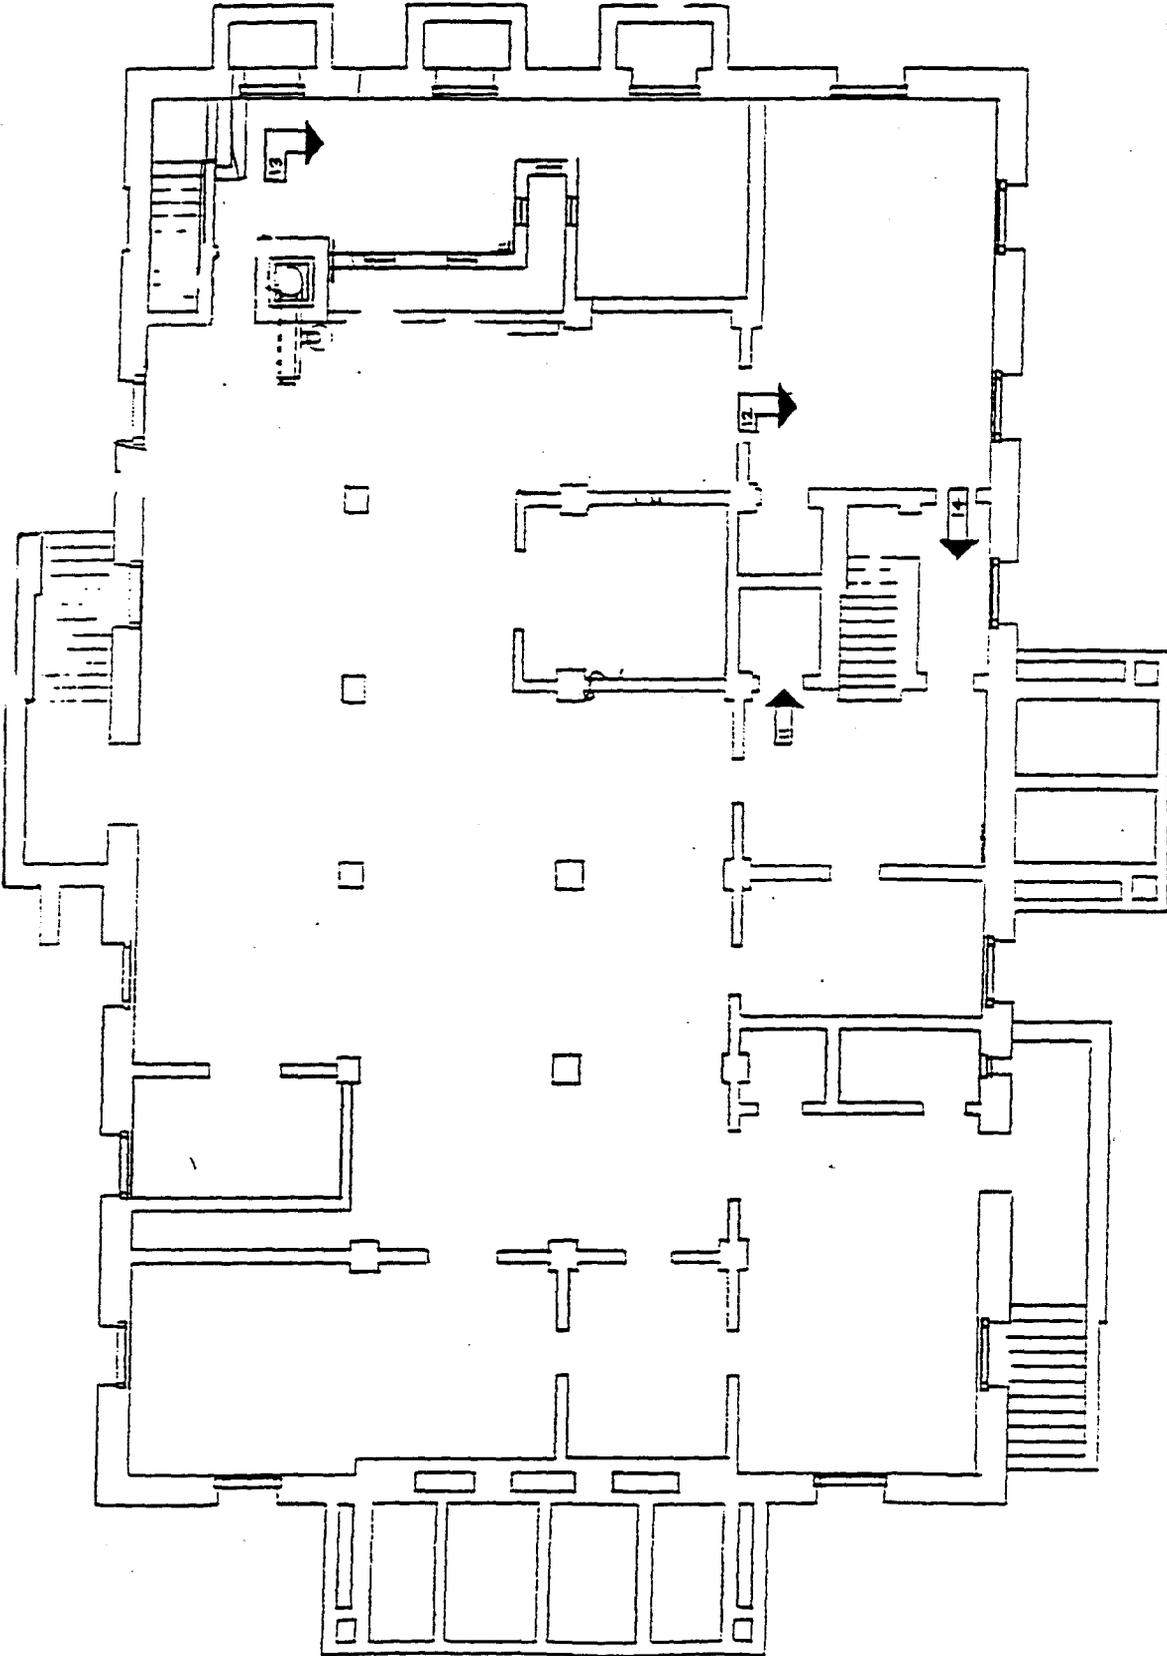
*BASEMENT PART PLAN*

OLD DEL RIO FEDERAL BUILDING  
100 EAST BROADWAY  
DEL RIO , TEXAS

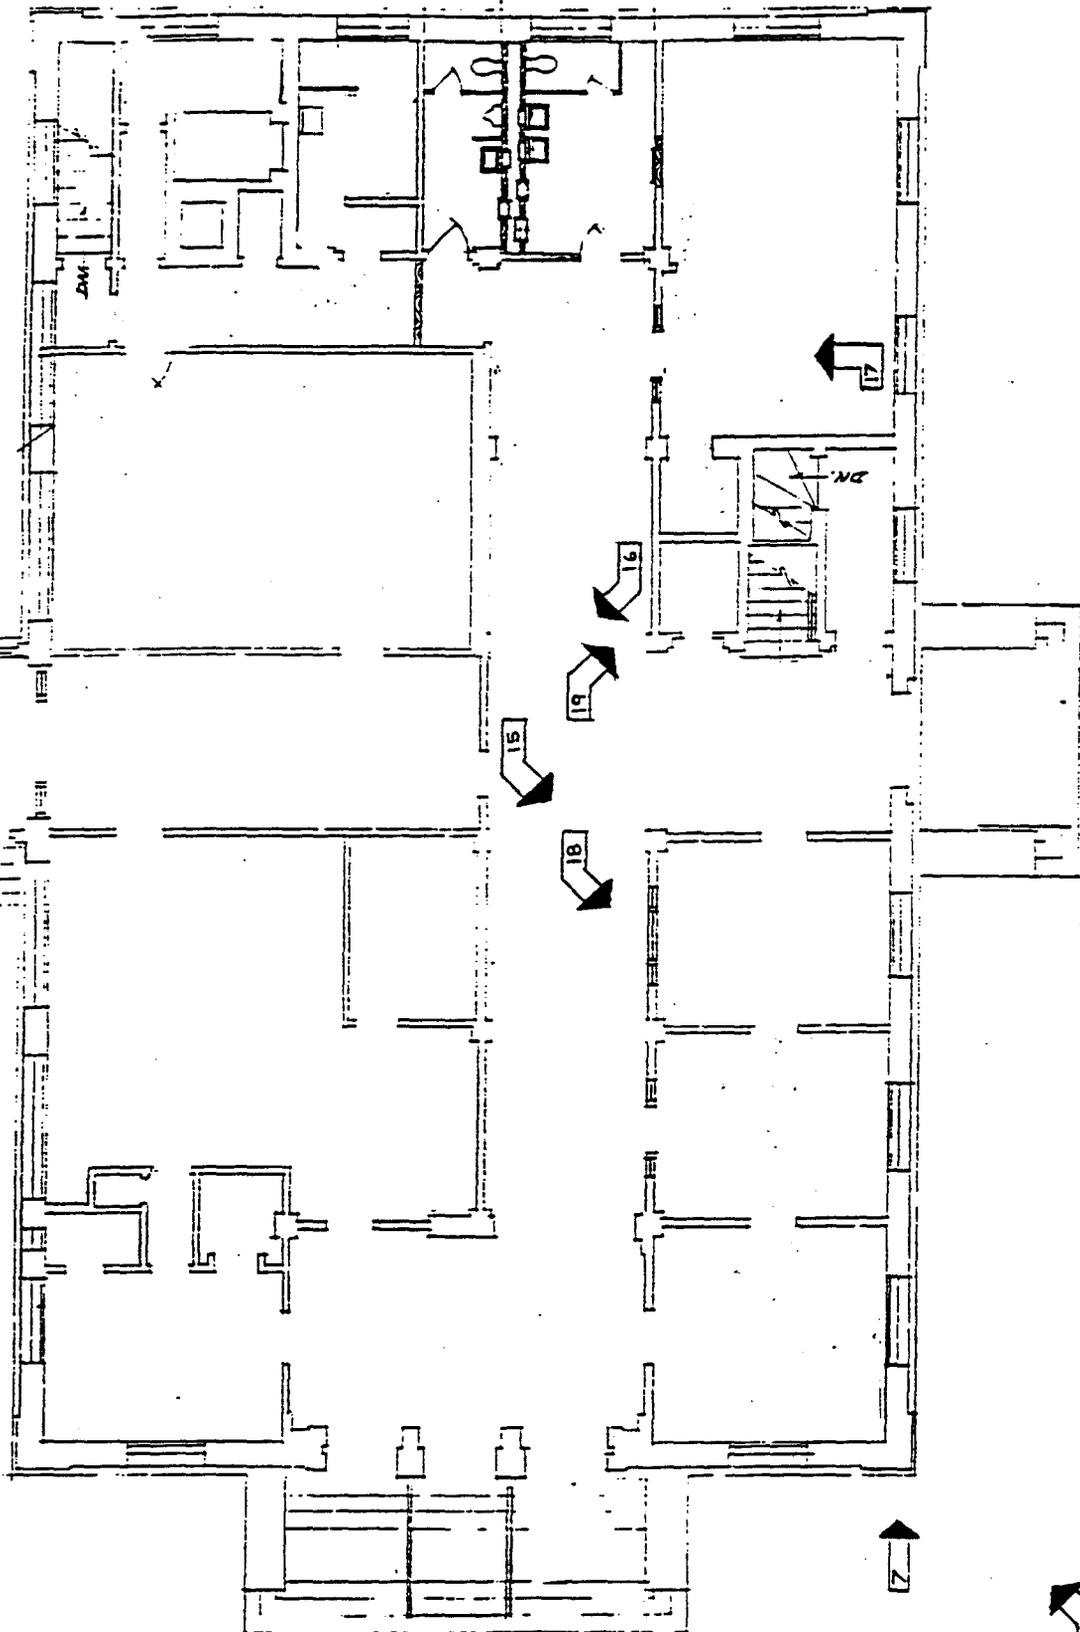
*PLAN - FIRST FLOOR*

OLD DEL RIO FEDERAL BUILDING  
100 EAST BROADWAY  
DEL RIO, TEXAS

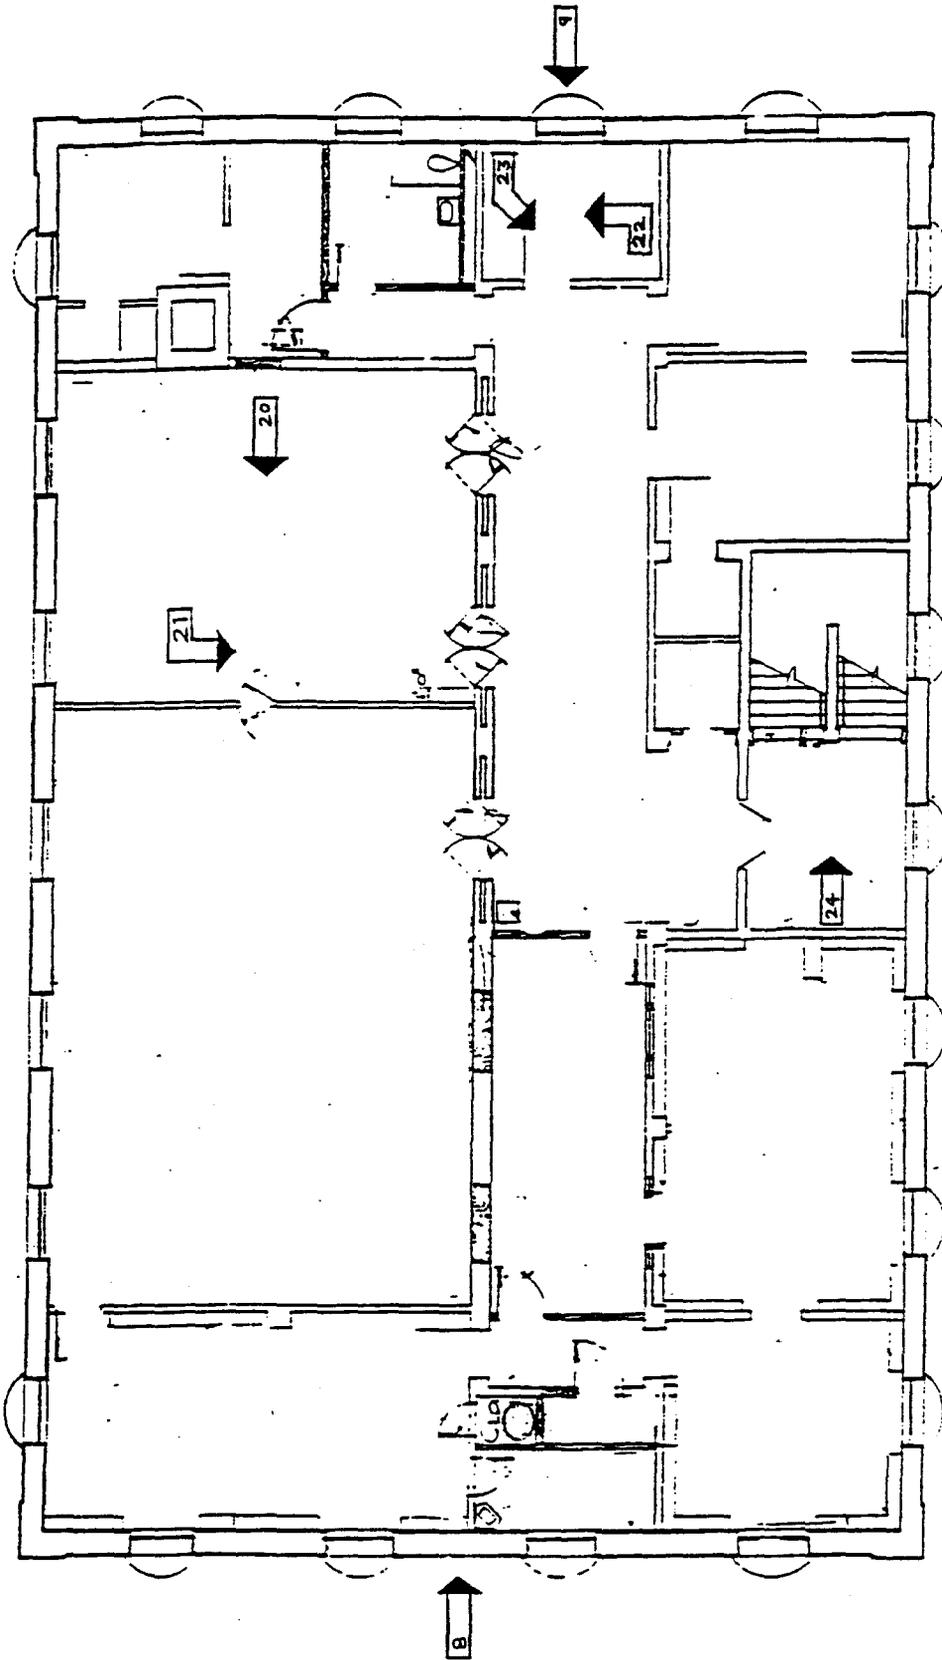
SECOND FLOOR PLAN

4" x 5" PHOTO  
LOCATIONS

OLD DEL RIO FEDERAL BUILDING  
100 EAST BROADWAY  
DEL RIO , TEXAS

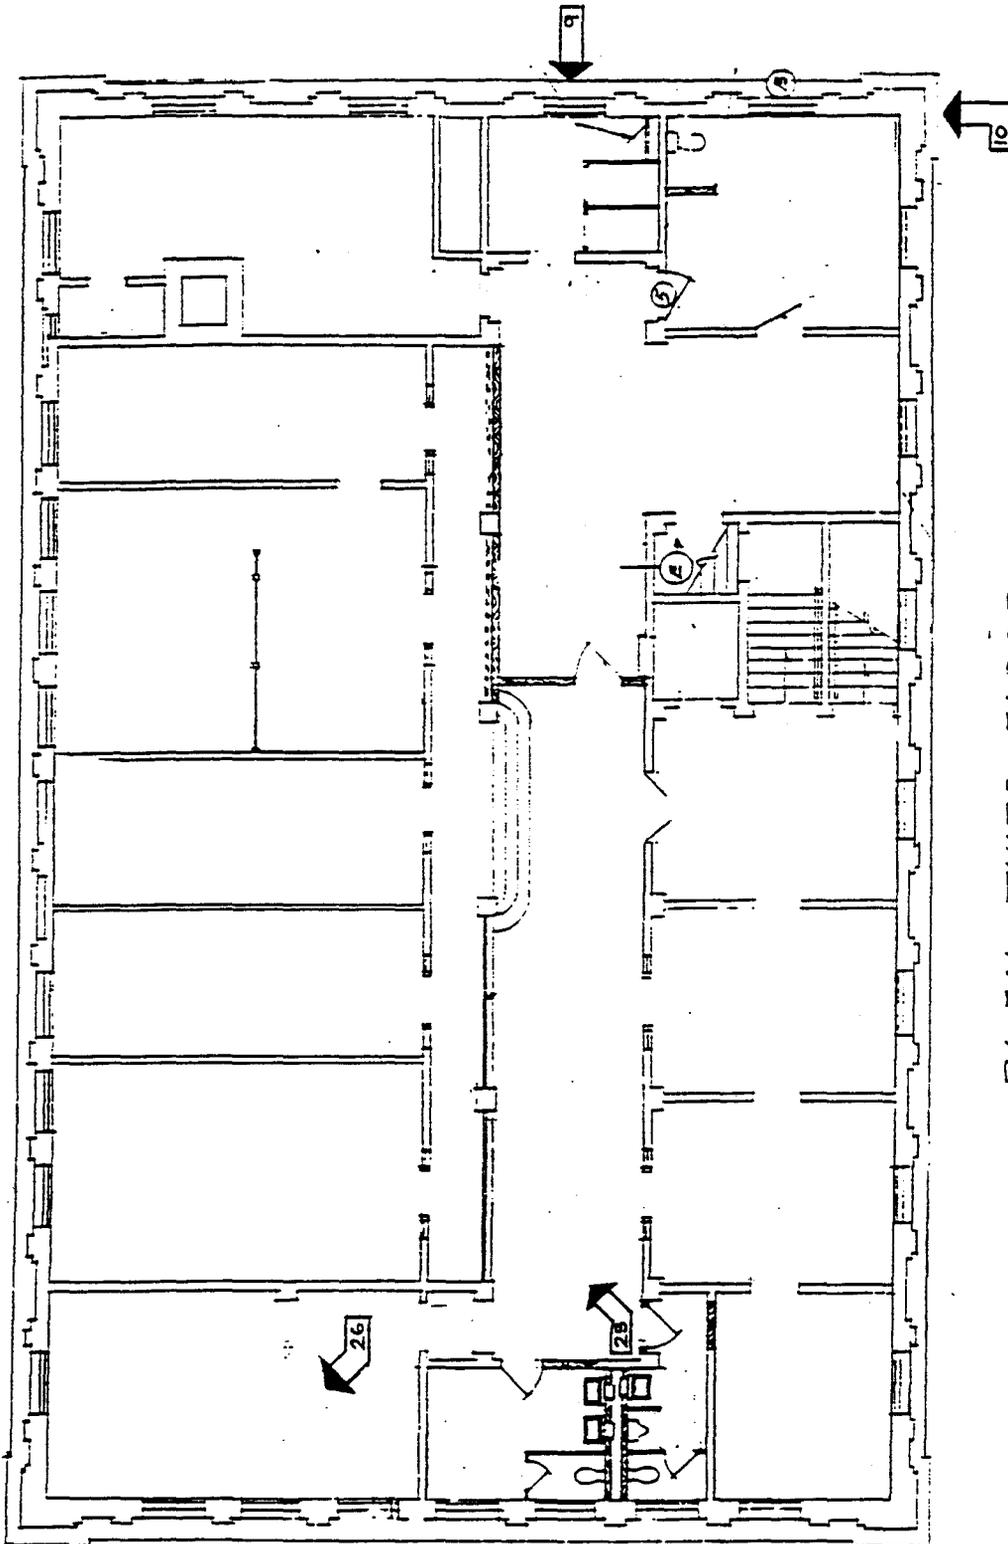
*PLAN - THIRD FLOOR*

4"x5" PHOTO  
LOCATIONS

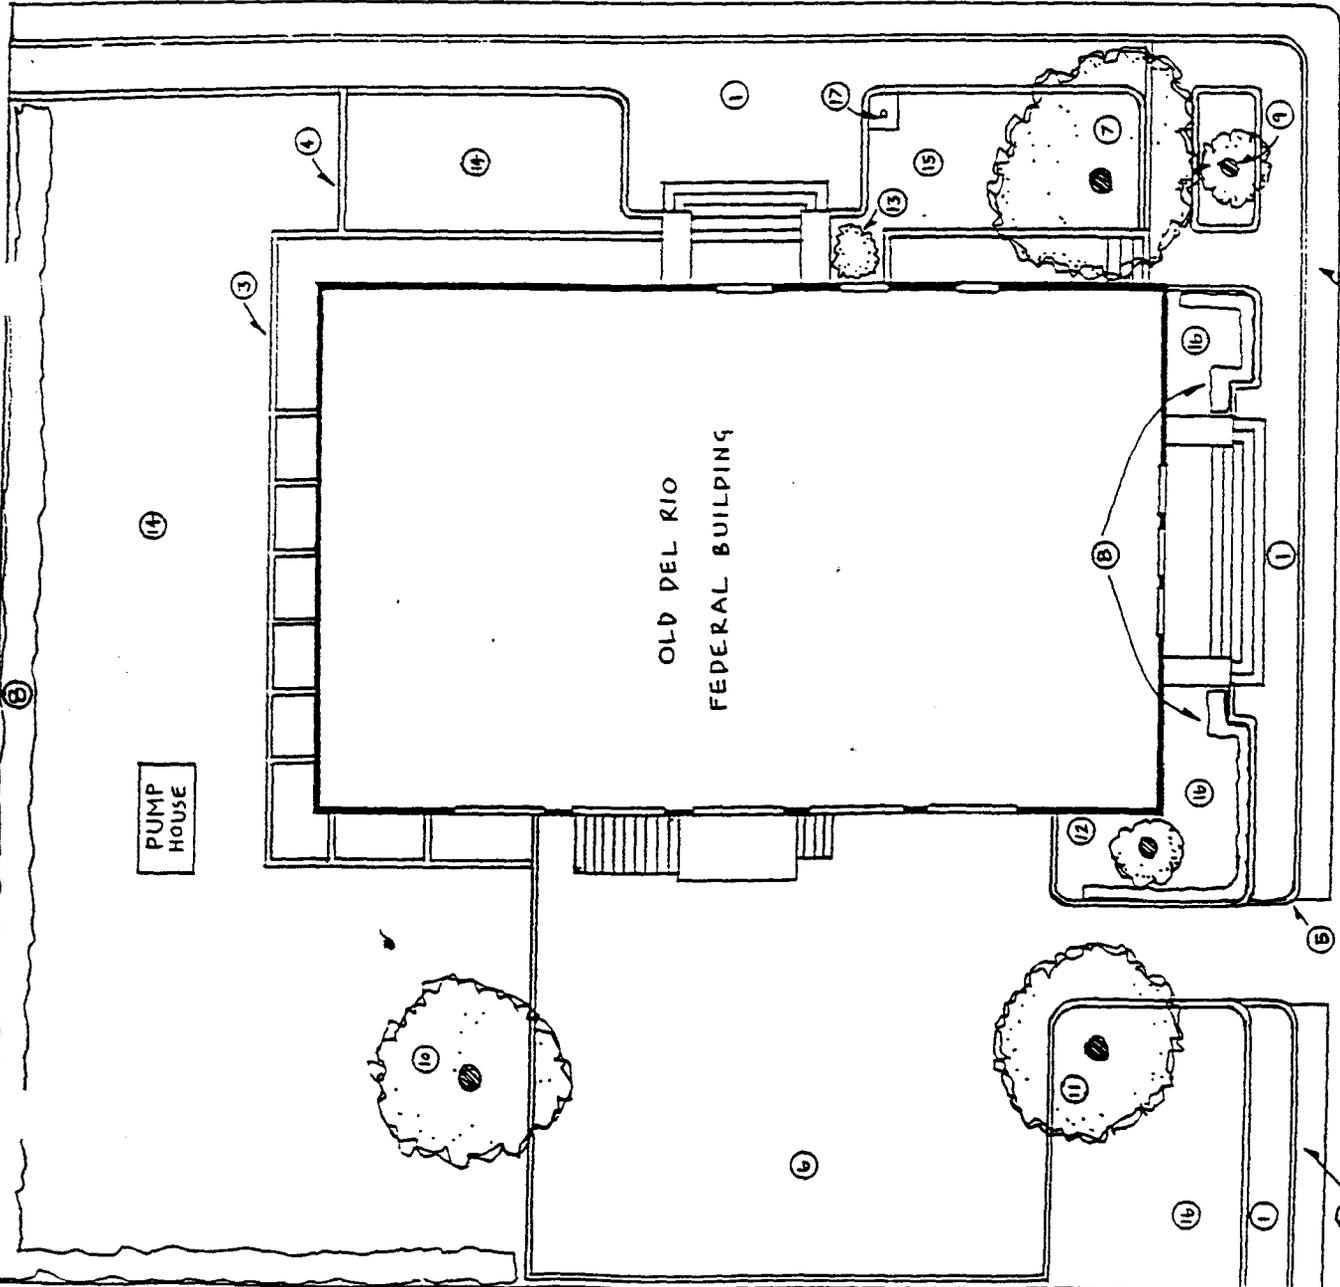
LANDSCAPE SIGHT PLAN & FIELD NOTES

MAIN STREET

OLD DEL RIO FEDERAL BUILDING

1. The building is sited on two lots and part of a third lot at the corner of two major downtown streets, its two primary facades facing southwest (Main, formerly First, Street) and southeast (Broadway Street).
2. The two primary facades are bordered by original pink stained concrete side walks with low curbed retaining walls to provide a level lawn up to the building. A molded concrete drainage system around the building perimeter which appears on the 1930s landscape plan has been altered by the addition of a drain line that cuts through the original curb at the Broadway side (Photo #1 and landscape sketch field plan). The property is delineated by an original continuous concrete curb (Photo # 38).
