FALCON VILLAGE, ADMINISTRATION BUILDING
1 Reservoir Road
Falcon Heights Vicinity
Starr County
Texas

HABS TX-3557-A

FALCON VILLAGE, ADMINISTRATION BUILDING

HABS No. TX-3557-A

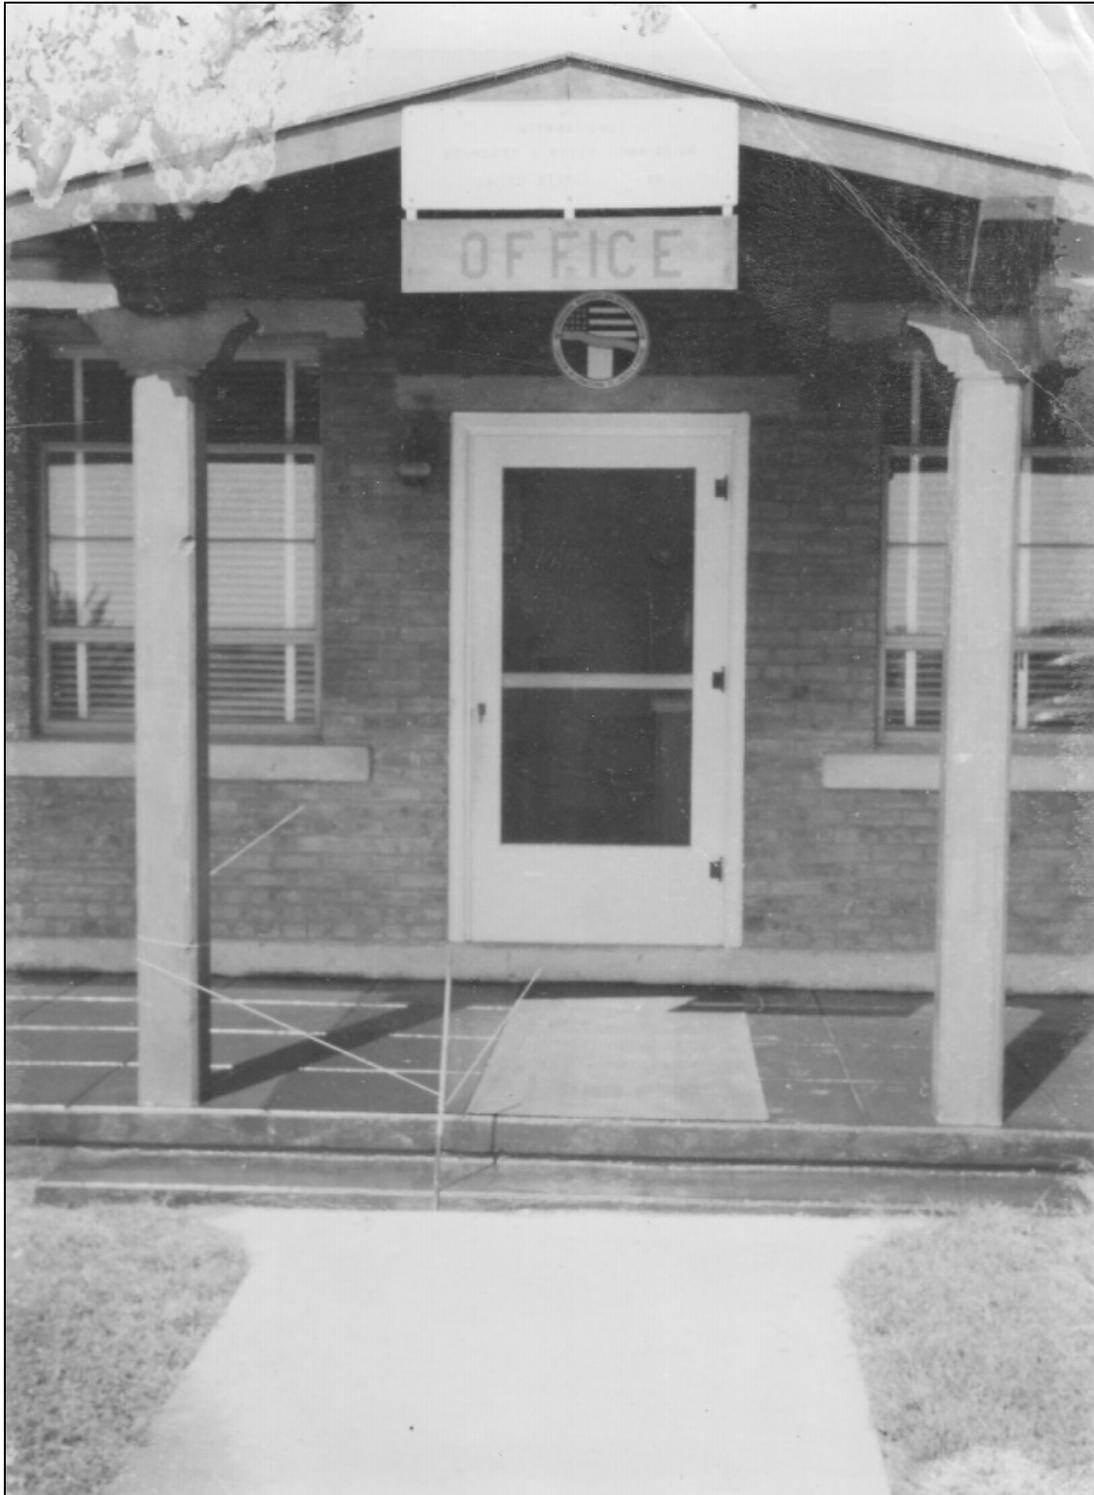
Photo 3. Photo of unknown date of the entrance to the Administration Building (photo in possession of Mr. Alberto Hinojosa, Falcon Dam Operations Manager).

A photograph of unknown date in the possession of Mr. Alberto Hinojosa, current Dam Operations Manager, shows the front of the building (PHOTO 3).⁹ It appears that the front porch was being painted at the time. The details of the plans from 1950 seem to all be intact in this photograph and constructed to specifications. A photograph from 1957 that accompanies the project completion report shows the landscaping around the building (PHOTO 4).¹⁰ Finally, a photograph showing utility work near the garage building in 1962 shows the east side of the administration building in the background (PHOTO 5).¹¹ In all of these photos, the original design of the porch and roof appear to be intact.

- a. **Doorways and doors:** The primary entrance is on the center of the south facade, with a single-leaf, wood-and-glass door that replaced the original single glass panel door at an unknown date. A screen door was also removed at an unknown date based on the original plans and a historic photograph of unknown date (PHOTO 3). Above the entrance is a concrete lintel to which is affixed a metal sign lettered with OFFICE. Above the lintel is a round metal sign with the USIBWC logo. A metal exterior light with glass panes is to the west of this door. A secondary entrance is on the west side of the north ell with a concrete sill and lintel. It has a single-leaf wood door with metal handle.

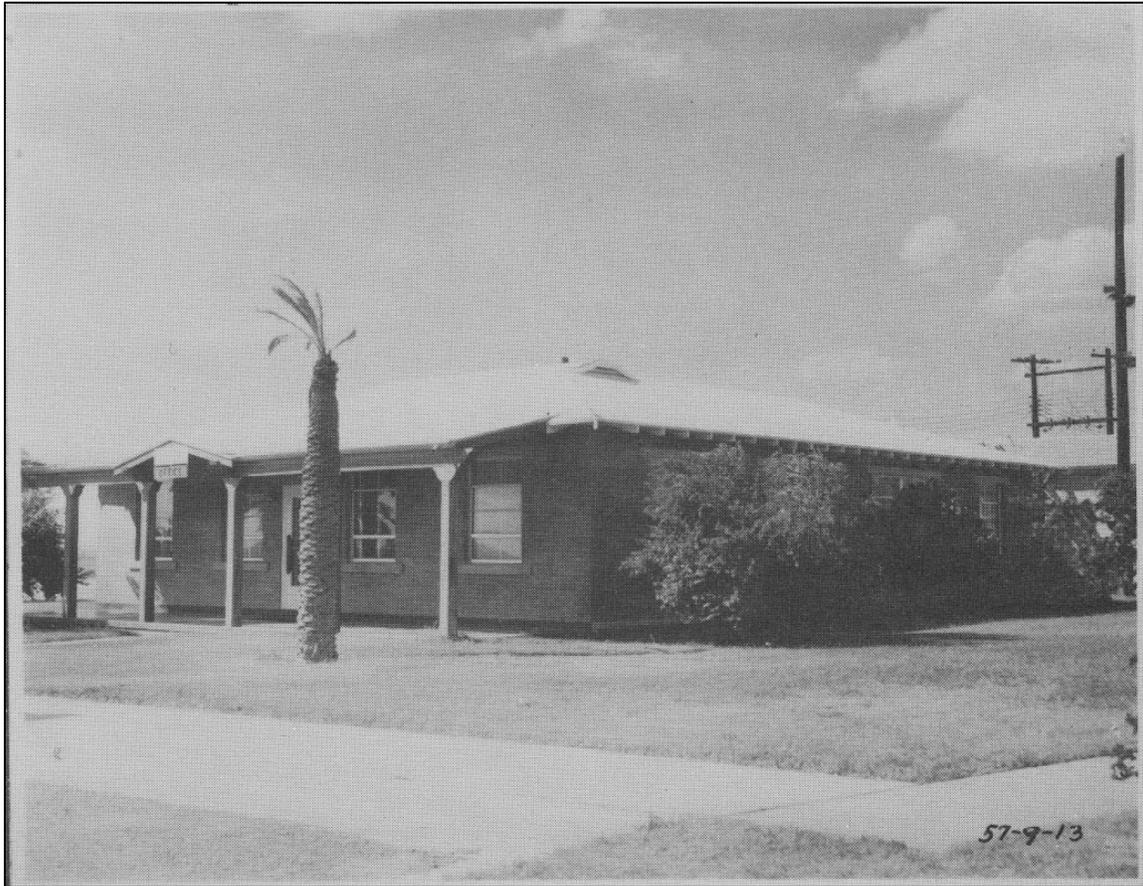
Photo 4. View of the south and east sides of the Administration Building, 12 September 1957
(photo from *Report on Construction of Falcon Dam*, 1958[?]).

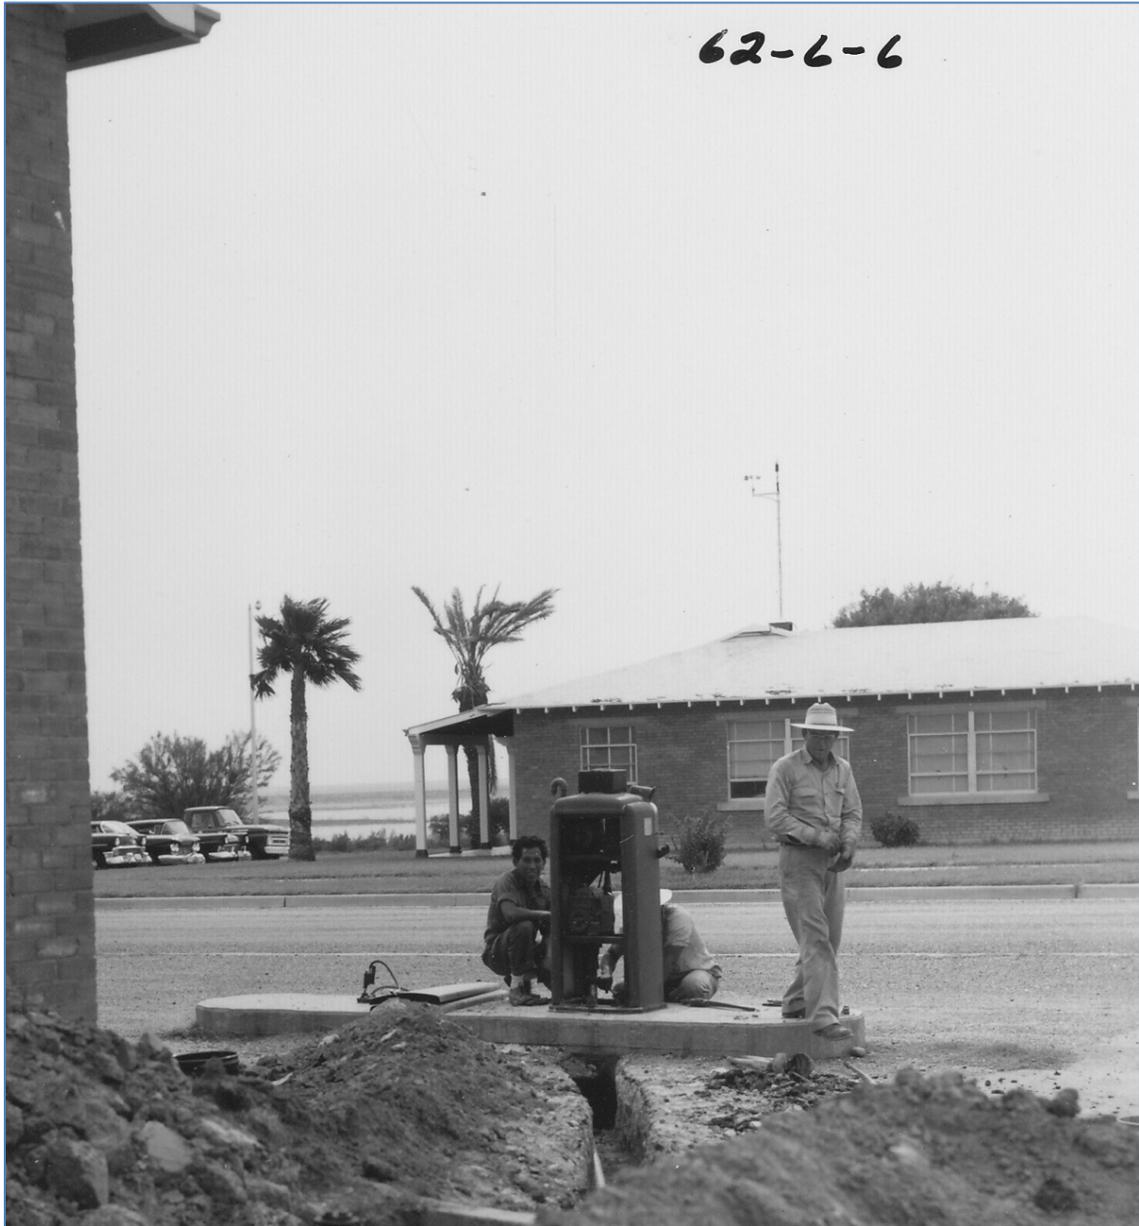
Photo 5. View of utility construction with Administration Building in background, 6 June 1962
(photo from Administration Building Vault).

No structural additions have been made to the building. A patio in the rear ell covered by a metal shed roof was added at an unknown date. The porch supports and some porch details were replaced sometime after 1962 based on the photo of that date that shows original porch supports in place (PHOTO 5).

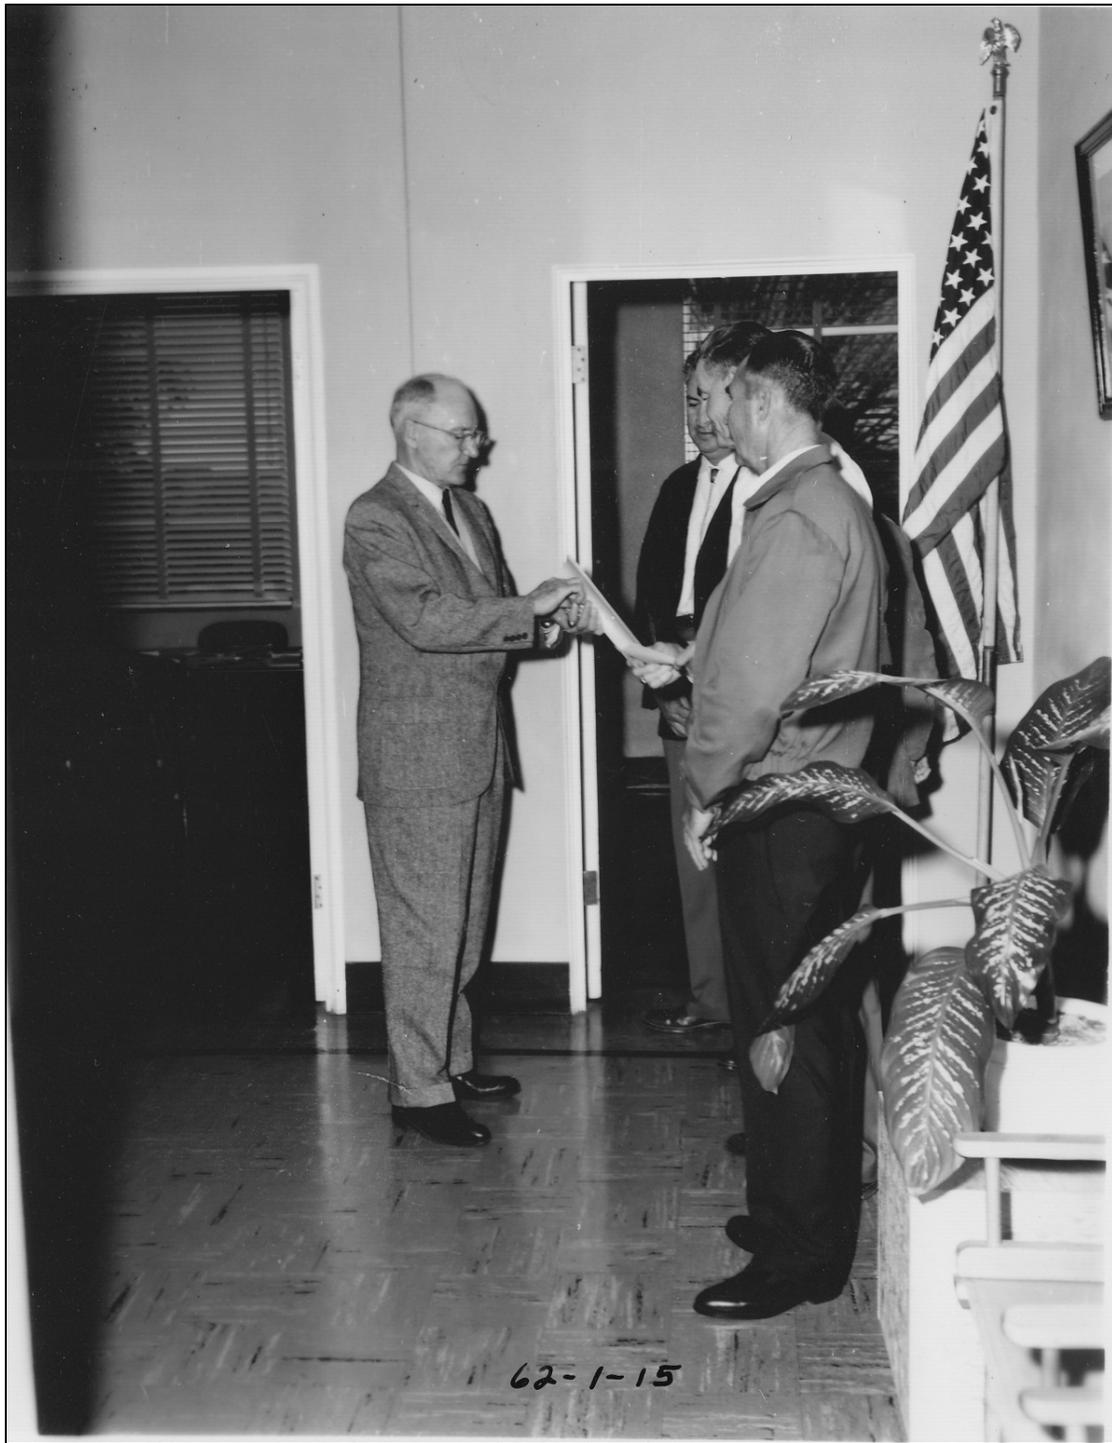
Photo 6. USIBWC employees receiving their 10-year service pins in the lobby of the Administration Building, 15 January 1962 (photo from Administration Building Vault).

A picture of several employees receiving 10-year service awards in January 1962 appears to have been taken in Administration Building lobby and is the only historic view of the building interior that was located (PHOTO 6).¹² It indicates that the wood paneling was added after that date and that the 9-inch-square asphalt tile floor was replaced after that date with a similar, but not identical, 12-inch square tile.

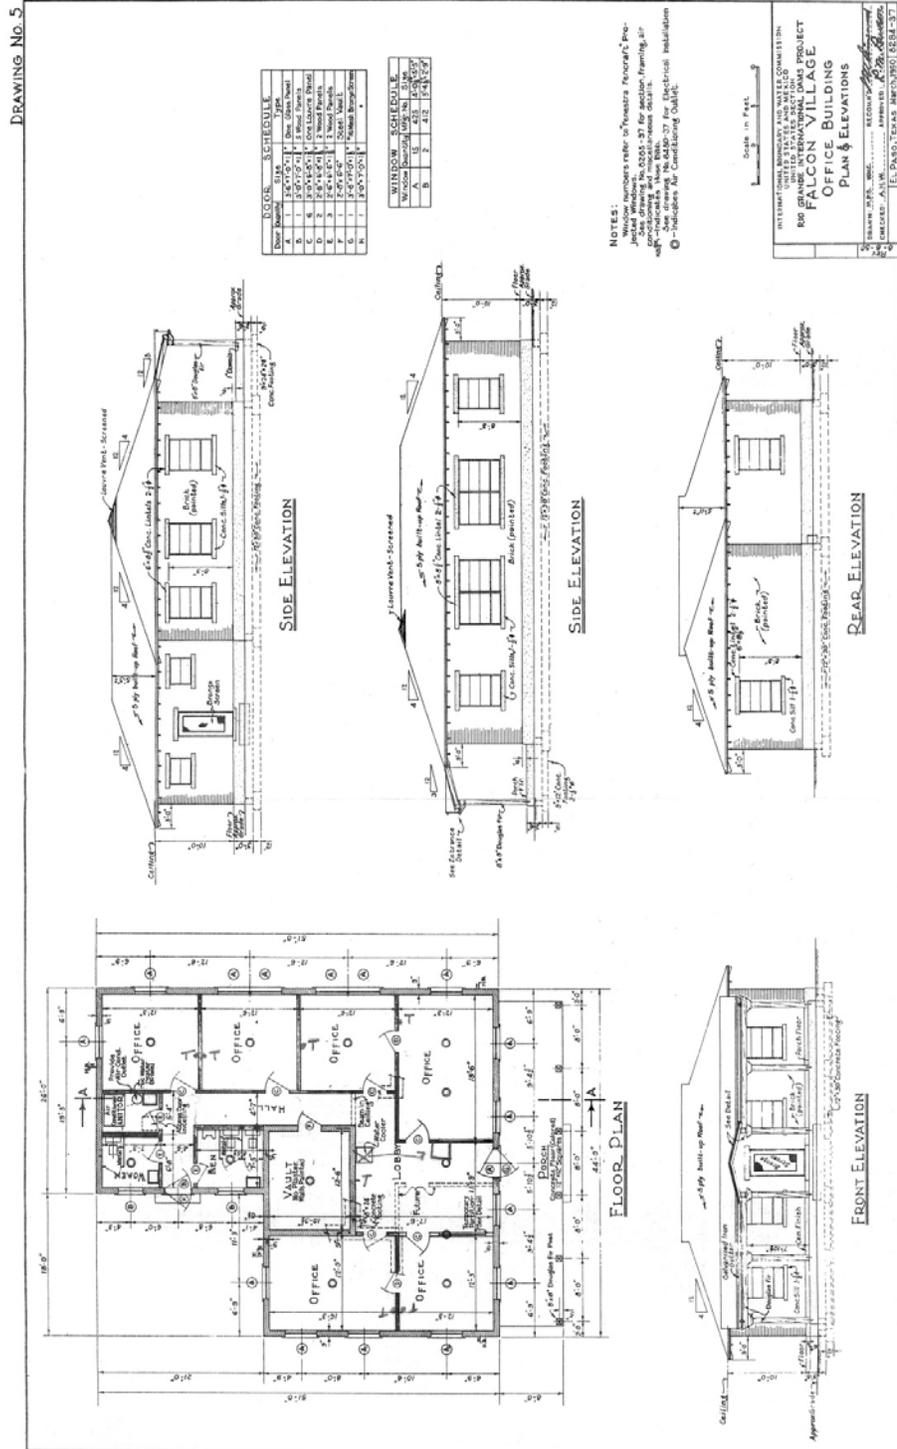
Figure 1. Original plan and elevations for Falcon Village Administration Building.

- A. **Architectural Drawings:** Original plans for the Falcon Village Administration Building were located in the vault room of the building and will likely be transferred to the National Archives and Records Administration Region Branch in Fort Worth, Texas before demolition. They were photographed as part of the documentation and are reproduced in Figures 1–4. Larger copies of these plans are included in the Field Records.

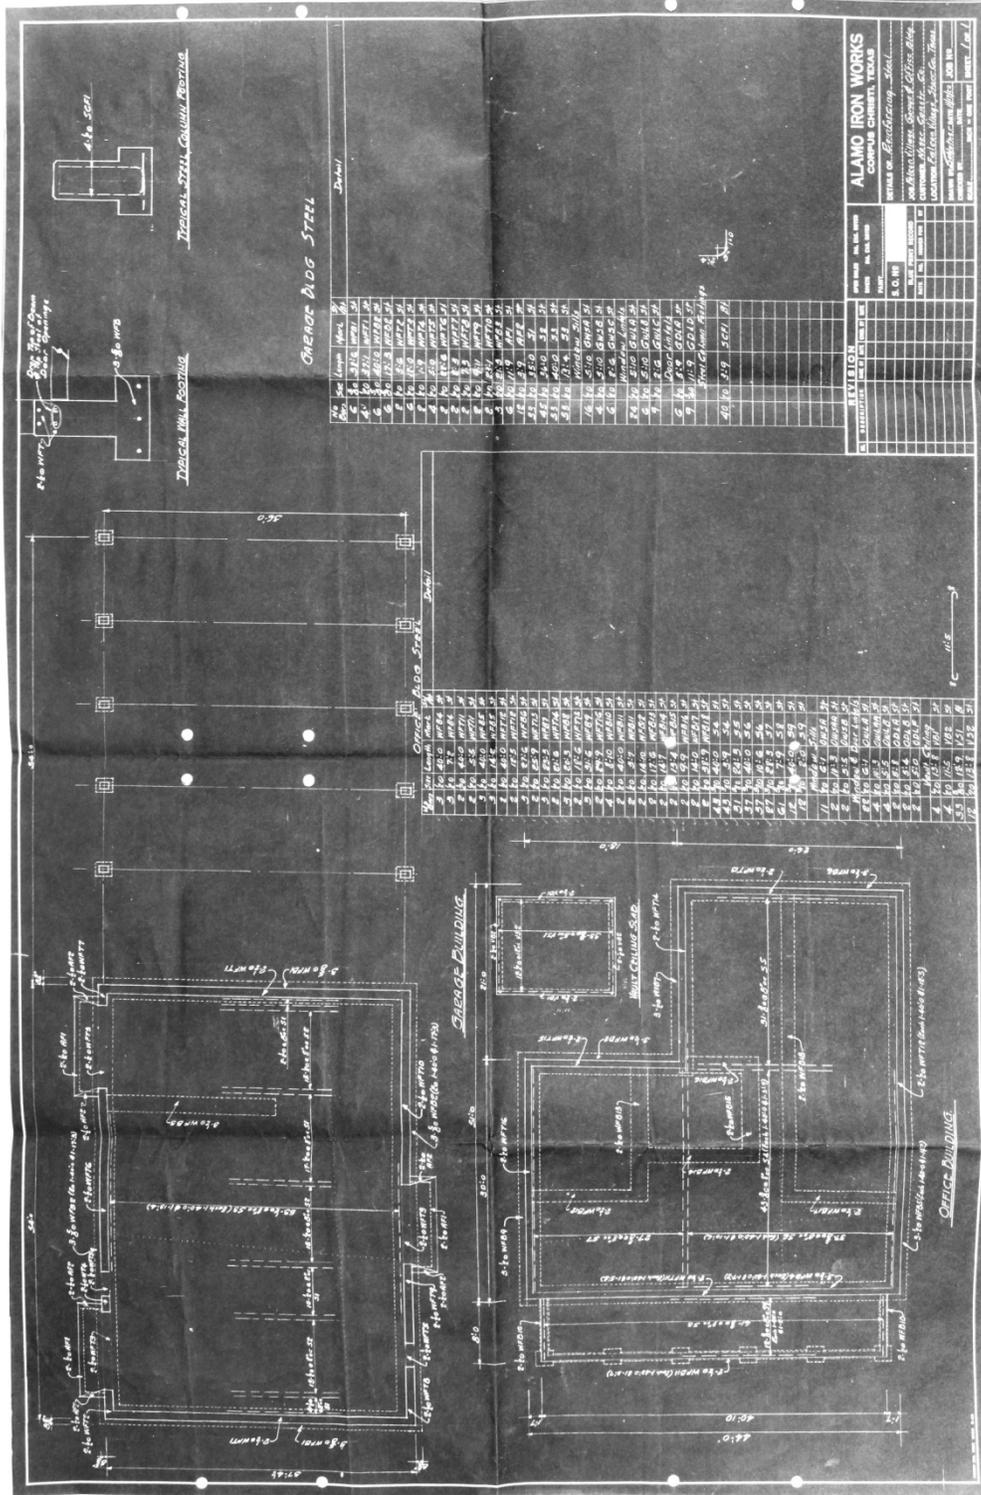
Figure 4. Original details of structural steel for Falcon Village Administration Building.
