3111 GROVE AVENUE (HOUSE)  
1009 Monroe Street  
Richmond  
Independent City County  
Virginia

HABS No. VA-1387

### 3111 GROVE AVENUE (HOUSE)

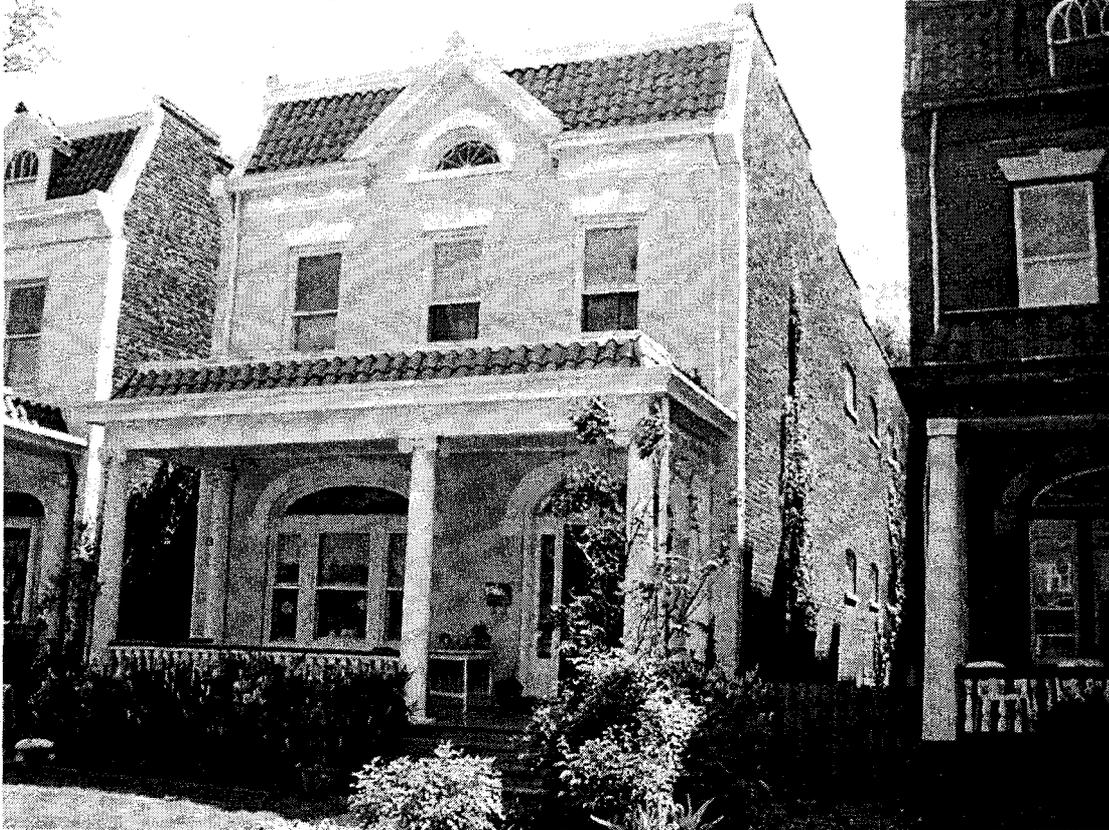
Figure 1:  
Primary north façade and  
west alley façade as viewed  
from Grove Avenue sidewalk.  
Neighboring houses of similar  
design partially visible.

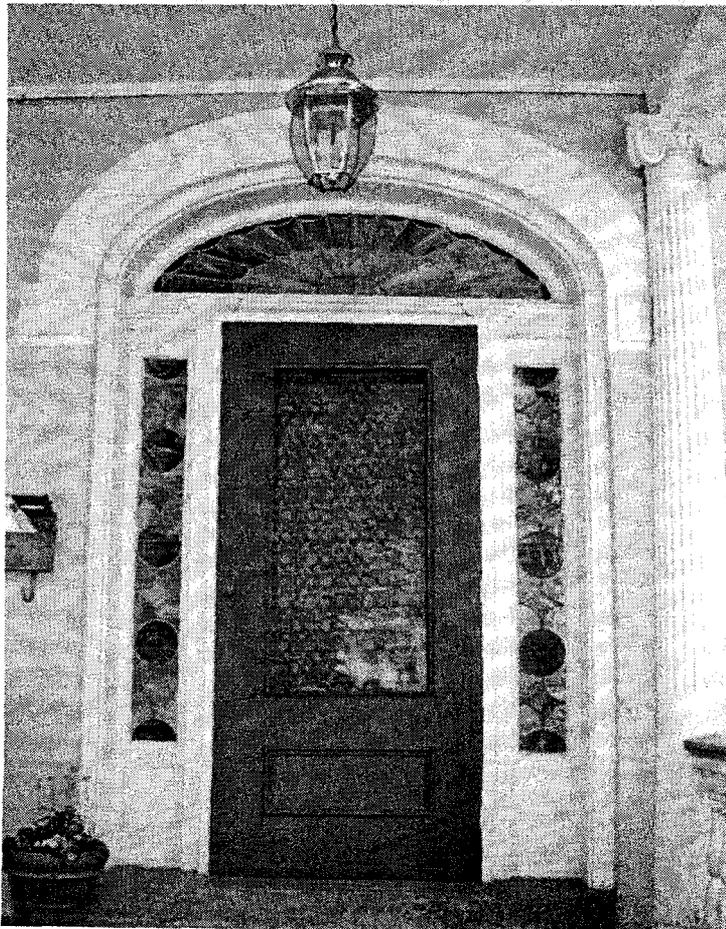
Figure 2:  
North façade entrance.

Two other variations of fanlights adorn the facade. All three fanlights are framed by stone corner blocks, arches, and keystones which are dressed with machine-tooled grooves. The glazed front door and stained-glass sidelights are capped by an elliptical stained-glass fanlight (fig. 2). A similar one also tops the tripartite double-hung windows (glazed with one-over-one lights) on the first floor. Engaged entablatures ornament the mullions between these three windows. Flat arches with keystones cap the three second-story windows.

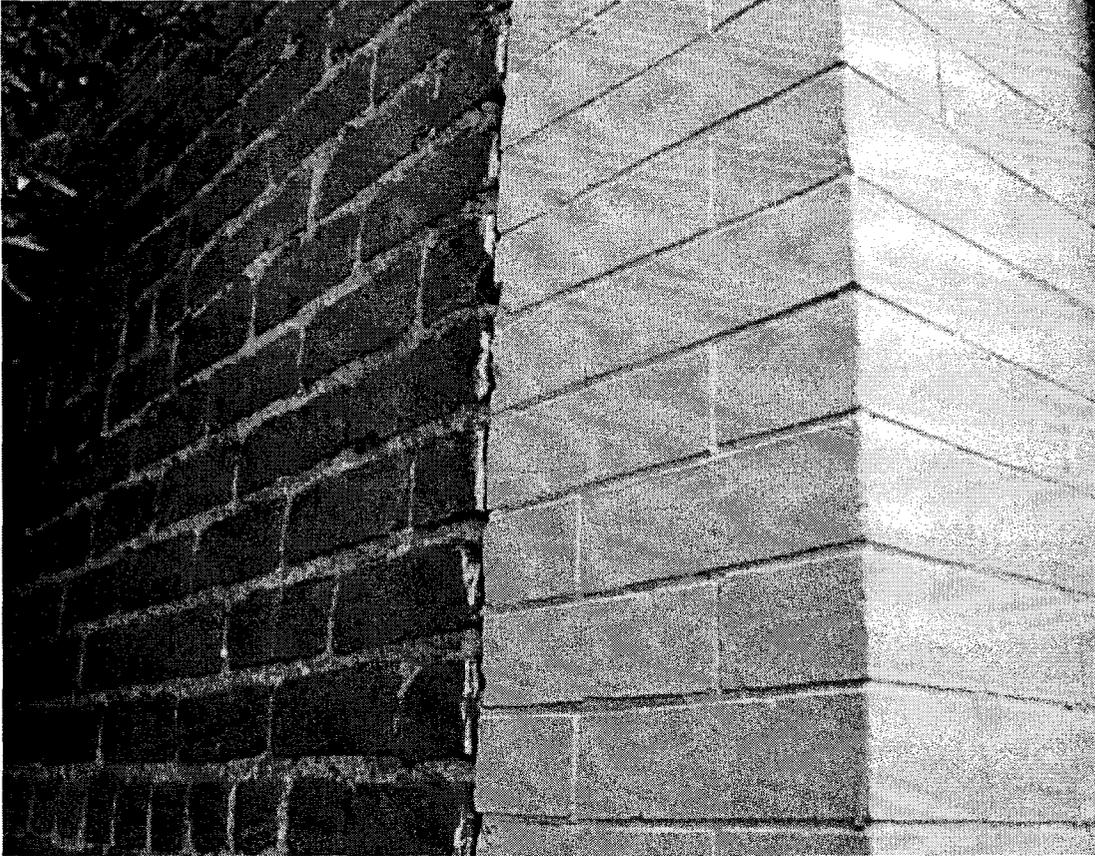
Figure 3: Transition from public façade to alley façade on northeast corner.

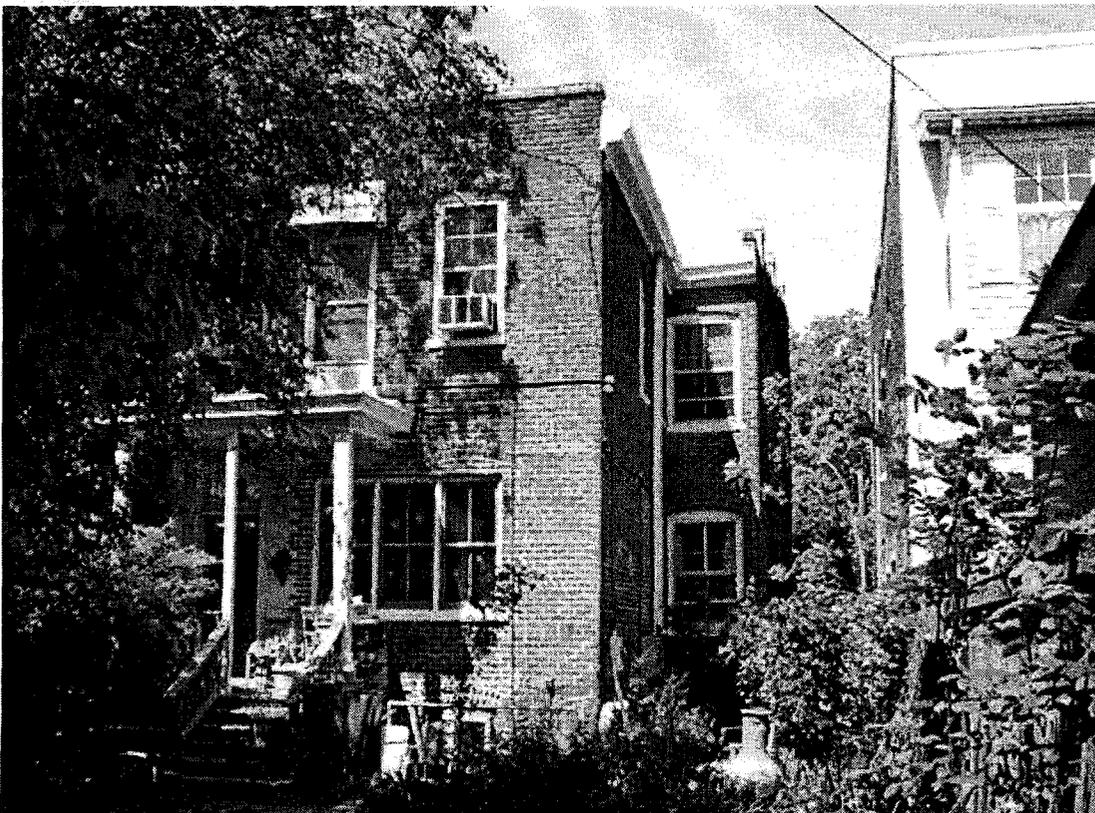
Figure 4: South façade as viewed from alleyway.

In phase three, new molding and baseboards were added to the kitchen. Interestingly, with the enclosing of phase one windows and the addition of new ones, the contractor matched the new frames to the old; yet, concerning the base and crown moldings, a pattern incongruent to the rest of the house was chosen. New windows and door frames though matched to the original, lack the layers paint, have cleaner edges, and visible nail heads. Remnants of two segmental arches on the exterior south elevation where there are now three windows, and one segmental arch on the east facade completely filled in, also reveal that the kitchen windows are phase three (fig. 4).

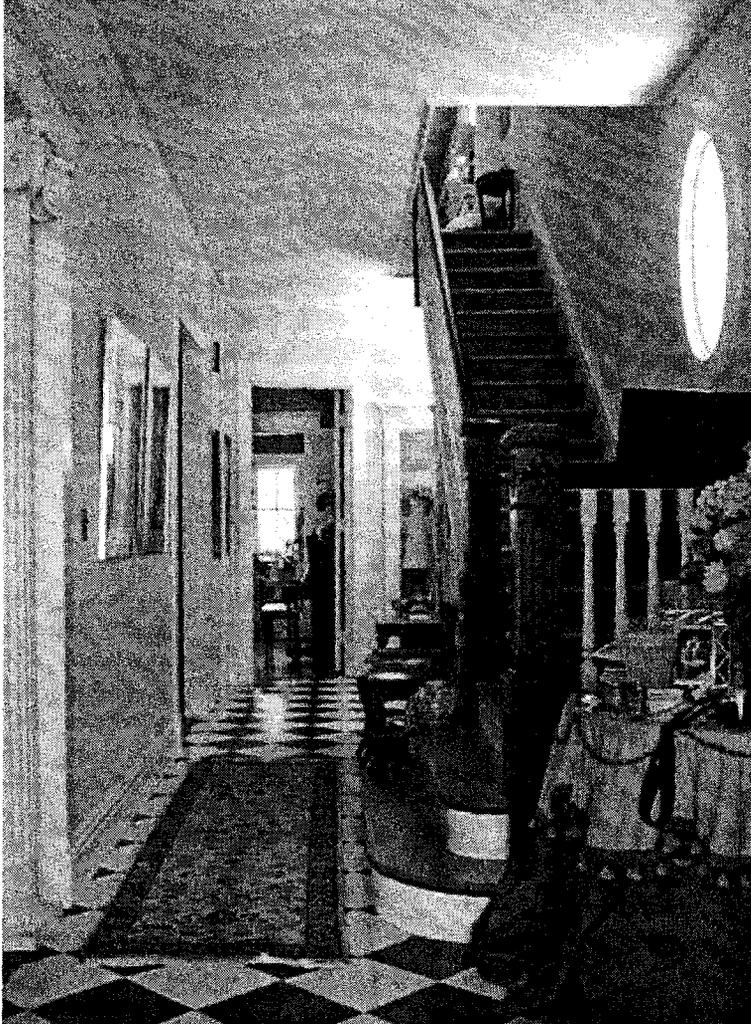
Figure 5:  
Looking south from front  
foyer.

Interior: Upon entering the foyer from the front door situated on the west end of the north elevation, one can view the entire depth of the house to the south elevation windows (fig. 5). The entire house consists of narrow strip wood flooring except in the bathrooms, where second and third phase ceramic tiles have been laid. Stairs against the west wall have decorative newel posts and balustrade with a turned platform three steps up from the main floor. In contrast, the newel at the back of the house on what was likely the servant stairs is not quite as elaborate, nor is the stair as wide.

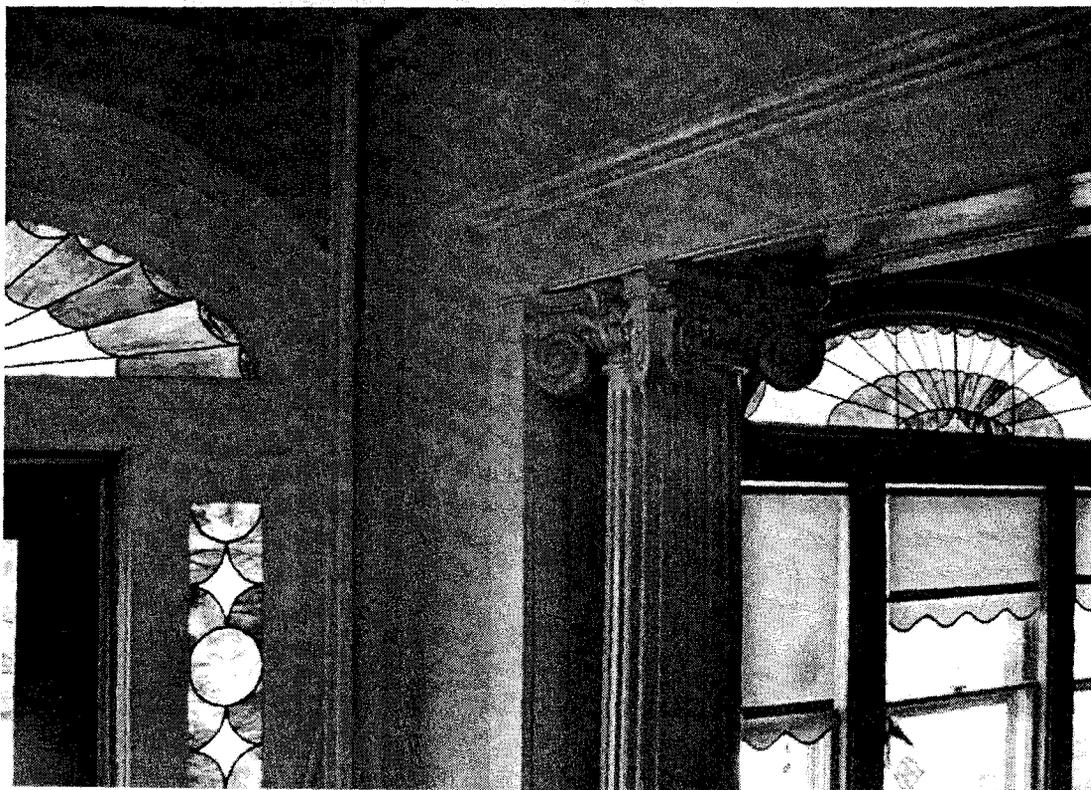
Figure 6:  
Looking toward northern  
interior wall from front  
stair platform.

Turning east from the foyer is a wide opening flanked by Ionic columns to the parlor. Fig. 6 illustrates the detail with which the capitals were produced as well as the stained-glass fanlights within the front facade. The house is four chambers deep, the first three of which flow into one another through double pocket doors. Identical mantelpieces and tile hearths along the east wall surround the fireplaces in these three rooms. They are rather simple, yet elegant in design and characteristic of mass-produced features of the early twentieth century. Beveled mirrors, a more affordable luxury by this time, fit within the mantelpieces. The fireplace in the front room has a decorative metal screen (fig. 7).

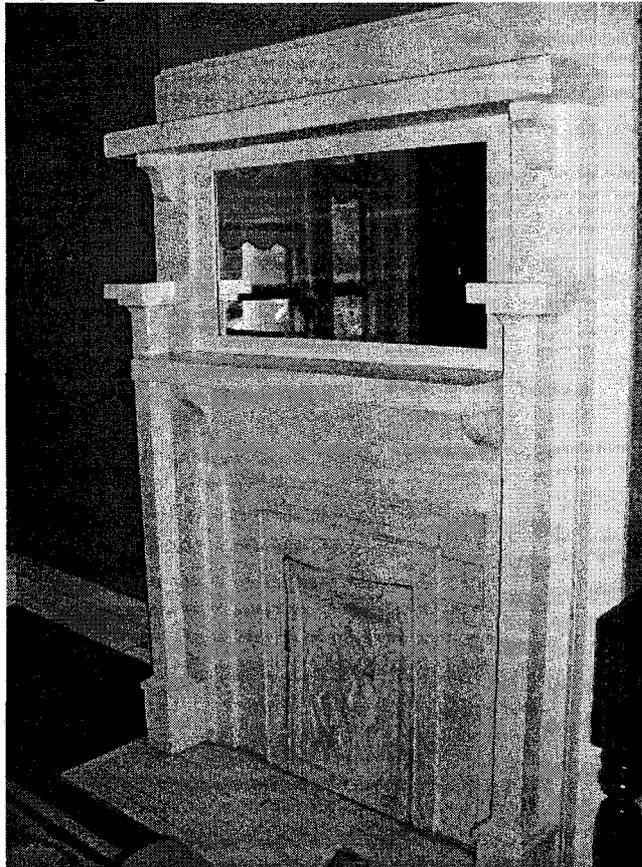
Figure 7: First-chamber mantelpiece on east wall.

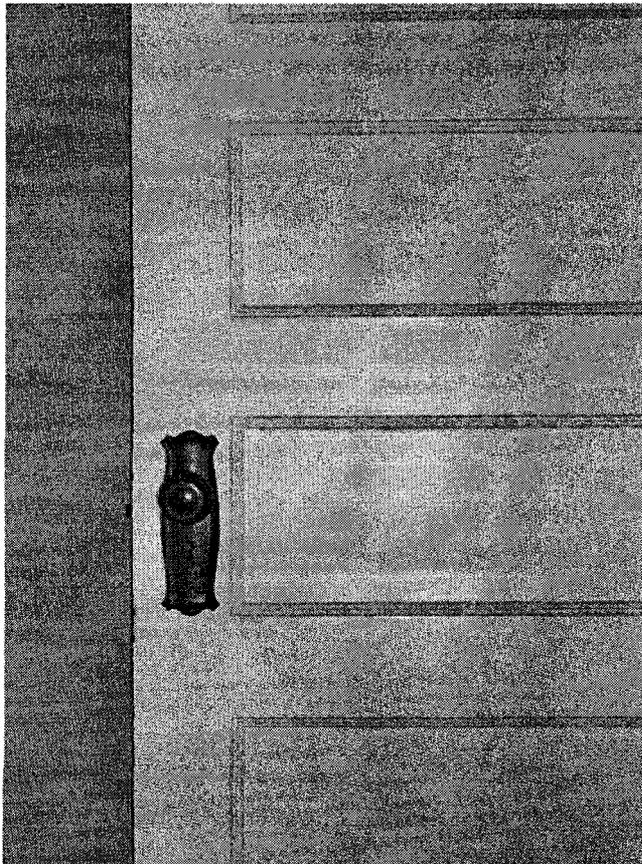
Figure 8: Door detail, used throughout the house, on the door between the hallway and the third chamber.

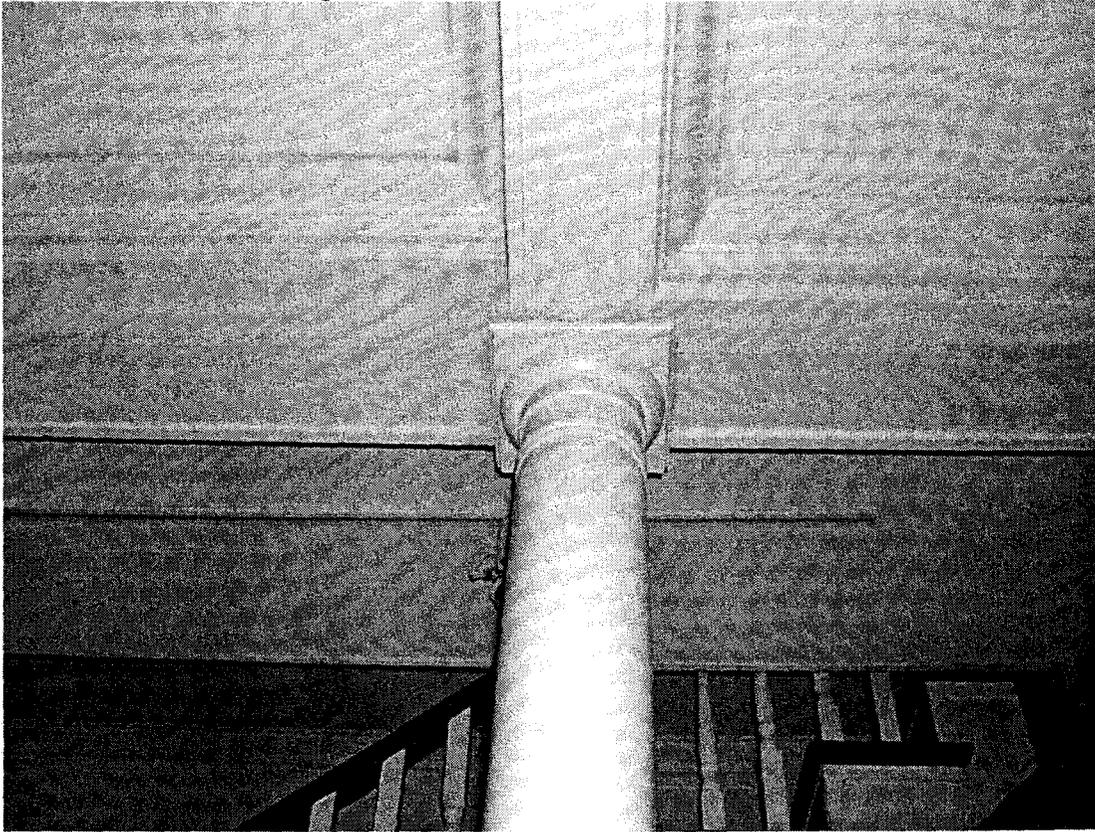
Figure 9: Structural Tuscan column, which replaced the support of two load-bearing walls removed during Phase III.

Approaching the rear of the house, No. 3111 has undergone two visible interior alteration phases since its construction. Possibly in the 1960s, phase two occurred, evidenced by a hollow flush door at the top of the basement stairwell in the kitchen and faux paneling over the interior walls of the stairwell. Indicative of a third phase, stains and nail holes scar the wood flooring in the kitchen. The third-phase kitchen renovation created these scars and an overhead reflection of where the dividing walls once stood (fig. 9). The removal of the load-bearing wall that had divided the kitchen from the back stair hall required the addition of

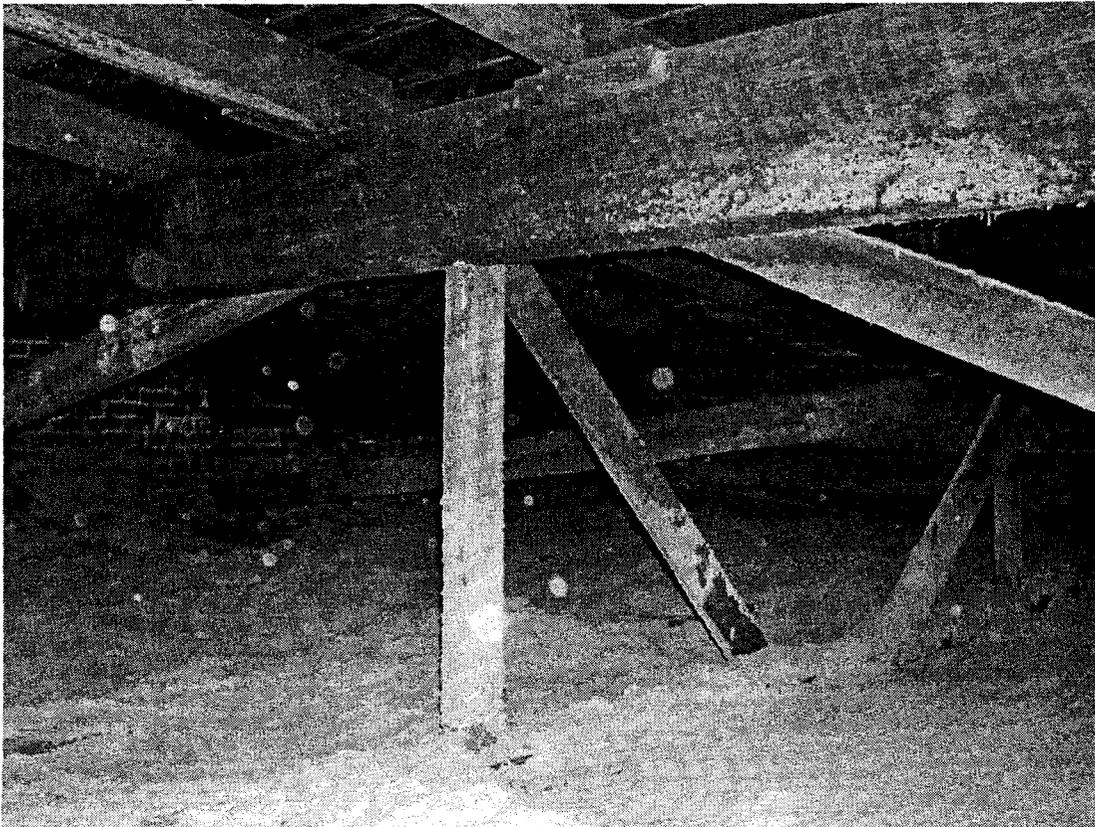
Figure 10: Looking toward the southeast corner of the attic (sawmill pattern visible on the boards).

Accessed either from the backyard or the kitchen, the basement is only as large as the room above. The underside of the house can be viewed via a crawlspace of packed earth. The foundation of the walls is concrete mixed with small stones and common bricks laid approximately nine bricks high on top of that. Other than the exterior walls, the foundation supports exist beneath the wall dividing the hallway from the living chambers and the wall dividing the third chamber from the kitchen. The regular and circular pattern of grooves on the wood in floor and roof supports seen in the crawlspace and attic confirm that the boards were produced in a twentieth-century saw mill. The pattern of saw marks can clearly be seen in the attic (fig. 10), which is accessed through a hall closet on the second floor. The framing structure within the attic confirms how the roof was described from the exterior. It consists of boards with a variety of dimensions nailed together and situated in a crude truss fashion extending back
