NAVAL TRAINING STATION, SENIOR OFFICERS' QUARTERS
DISTRICT, QUARTERS NO. 1
(Nimitz House)
(Naval Station Treasure Island, Commander's Quarters)
Naval Station Treasure Island, 1 Whiting Way, Yerba Buena Island
San Francisco
San Francisco County
California

HABS CA-1793-B
CA-1793-B

HISTORIC AMERICAN BUILDINGS SURVEY

NAVAL TRAINING STATION, SENIOR OFFICERS'
QUARTERS DISTRICT, QUARTERS NO. 1
(Naval Training Station, Nimitz House)
(Naval Station Treasure Island, Commander's Quarters)

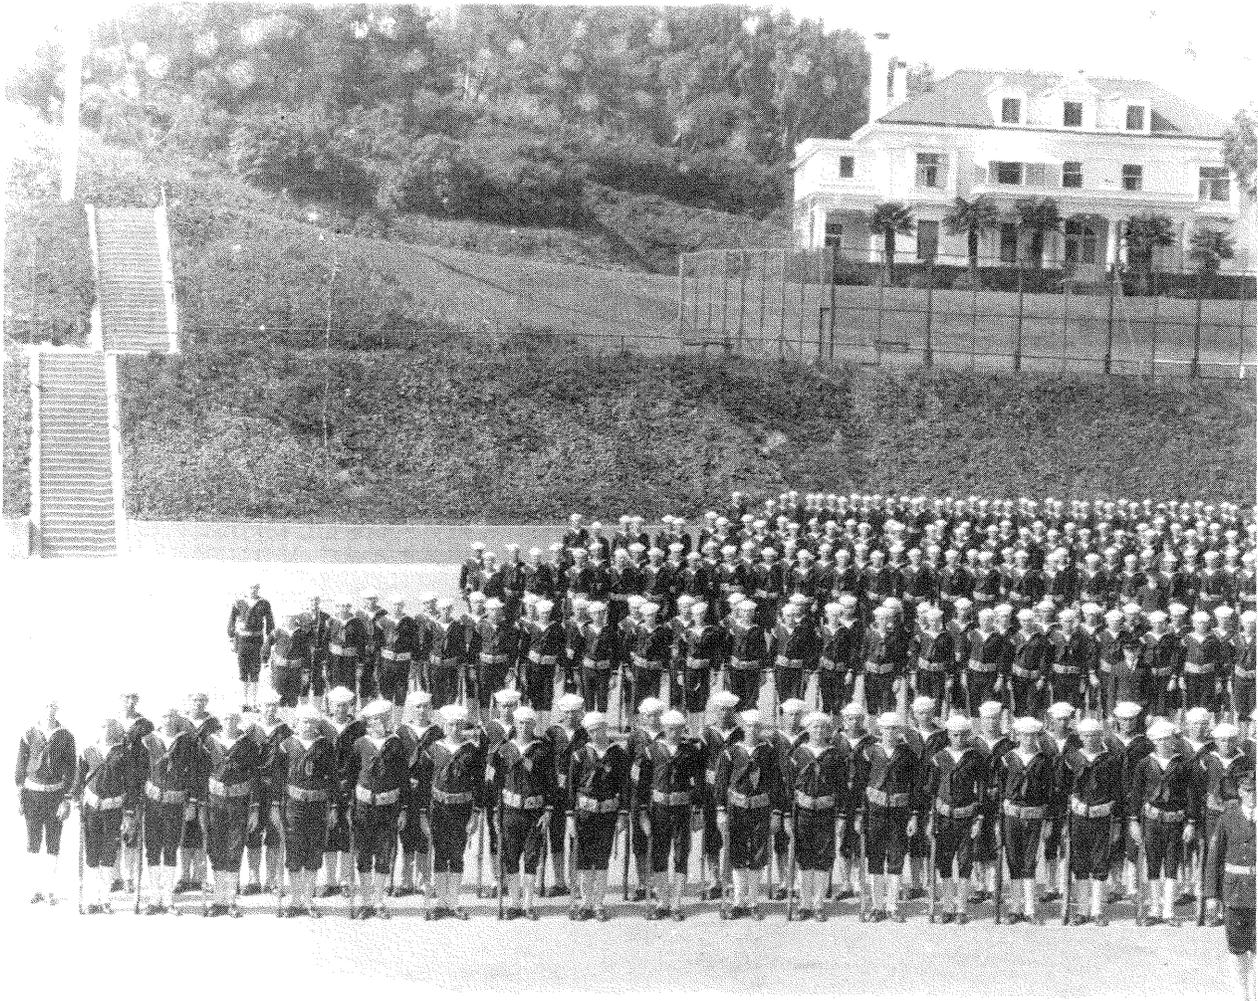
Figure 1. U.S. Navy photograph showing naval recruits in front of Quarters 1 (upper right corner). This photograph shows the front side of Quarters 1 before the fire of 1934. Treasure Island Museum Collection, Unit 1, Shelf A, Yerba Buena Island Folder.

View of Quarters 1 with naval recruits. This photograph shows the front side of the building before the fire of 1934. Treasure Island Museum Collection, Unit 1, Shelf A, Yerba Buena Island Folder.

1. Figure 1 which shows a view of Quarters 1 with naval recruits, n.d. This photograph shows the front side of the building before the fire of 1934. From the Treasure Island Museum Collection, Unit 1, Shelf A, Yerba Buena Island Folder.
2. Figure 2 illustrates Quarters 1 as it appeared after the 1934 fire and subsequent reconstruction, May 1935. Treasure Island Museum Collection, Yerba Buena Island folder.
3. Location map showing Quarters 1 in relation to other buildings in the Senior Officers' Quarters District.
4. Floor plans of Quarters 1, including the basement, first floor, and second floor.

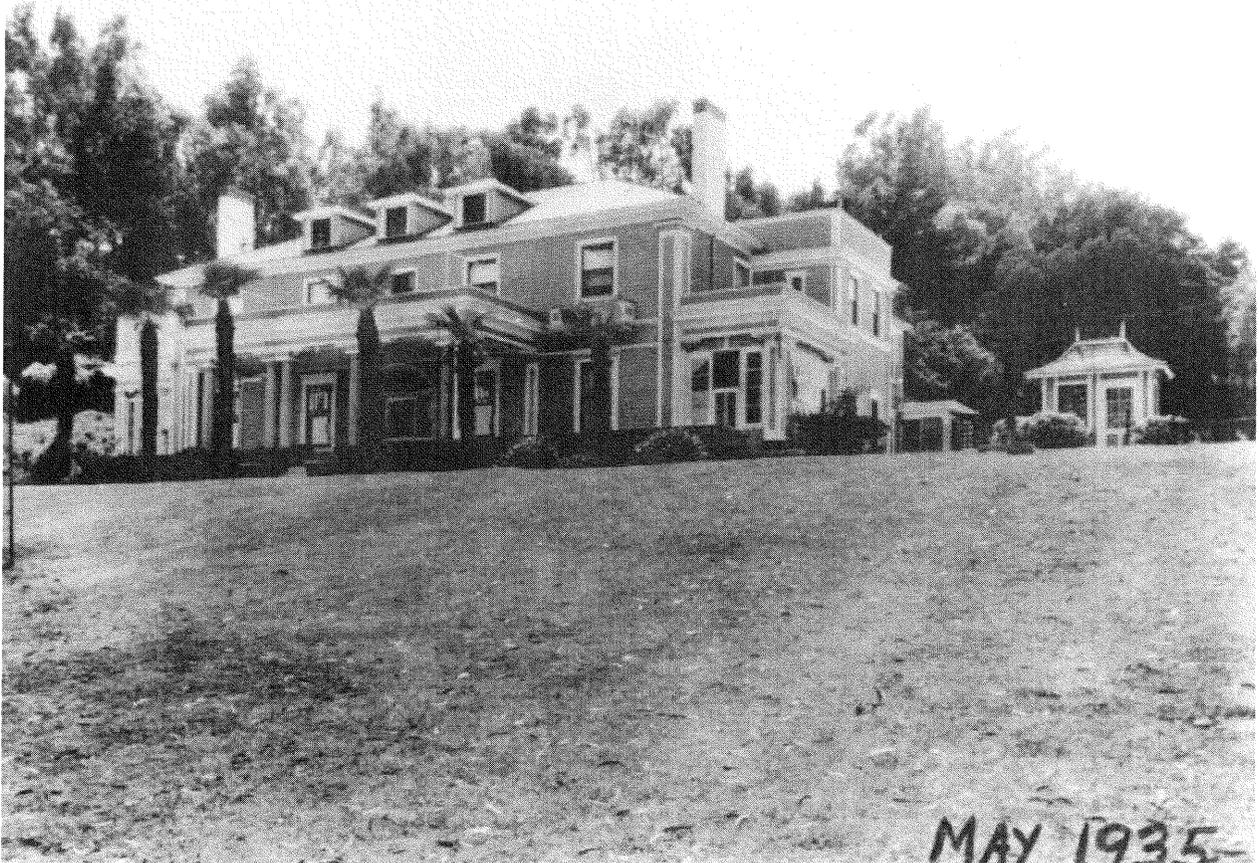
Figure 2. U.S. Navy photograph showing Quarters 1 as it appeared after the 1934 fire and subsequent reconstruction, May 1935. Treasure Island Museum Collection, Yerba Buena Island folder.

5. Porches, stoops, balconies: A one-story portico is located on the east side of main facade and is three bays wide. A prominent flat roof is supported by paired columns, which rest on a low wall that runs the length of the porch and wraps around the sides. Two attached porches are located on the north and south sides. On the north side, the porch is one-story and enclosed with glazing. Columns similar to those found on the main portico are located at the corners of the enclosed porch. The porch on the south side is two stories and also enclosed with glazing. Both the north and south side were enclosed after 1934. On the rear side, there is a brick stoop covered with a canvas awning.

Quarters 1 as it appeared after the 1934 fire and subsequent reconstruction, May 1935. Treasure Island Museum Collection, Yerba Buena Island folder.

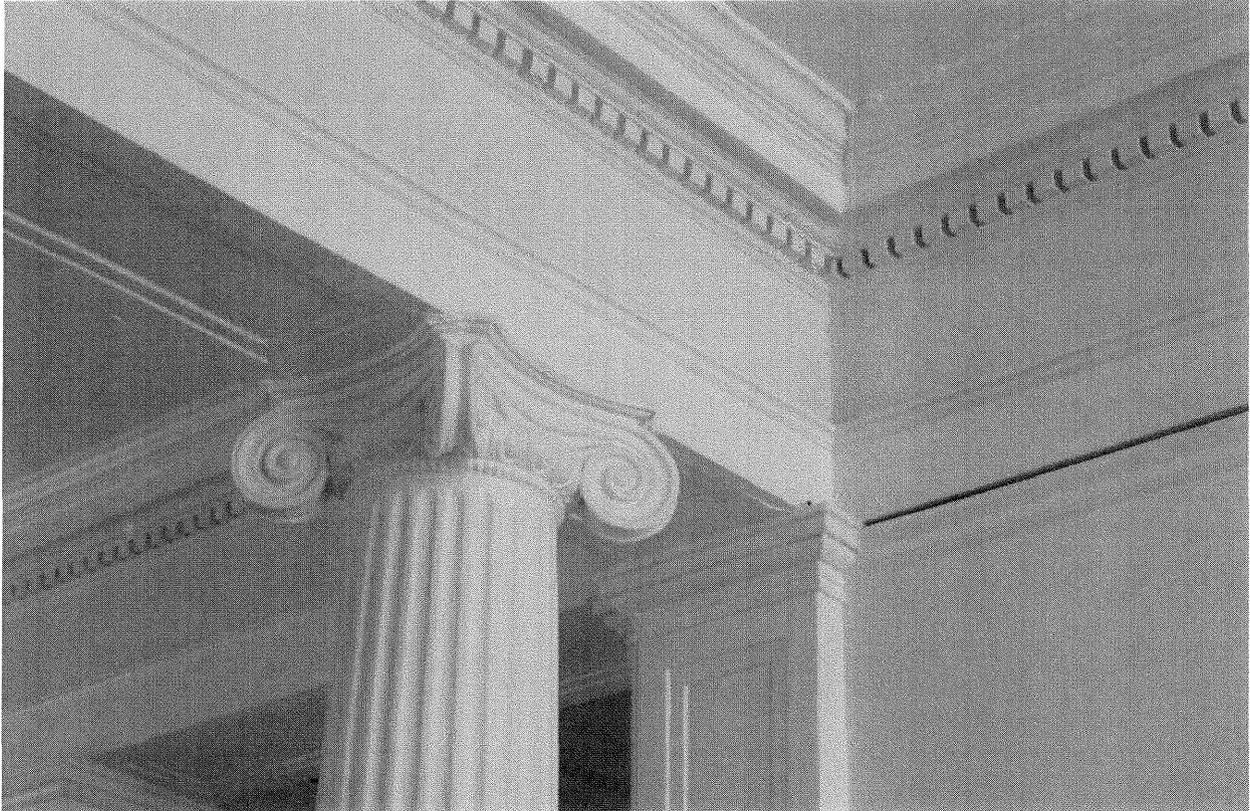
Figure 3. Detail of crown molding and fluted column separating the entry and reception halls.
[Source: JRP Historical Consulting]

6. Decorative features and trim: The front portion of the entry-hall features paneled wainscoting and a molded chair rail. Picture molding and an elaborate crown molding which are more elaborate than in other rooms, complete the decorative finishes in this room. Also notable in the hall is the plaster medallion that surrounds the light fixture on the ceiling.
7. Hardware: A combination of thumb latches and brass handles are used throughout the residence. Simple brass finger holds are used on the wood panel doors. Without plans prior to the 1950s, it is difficult to tell which hardware is original.

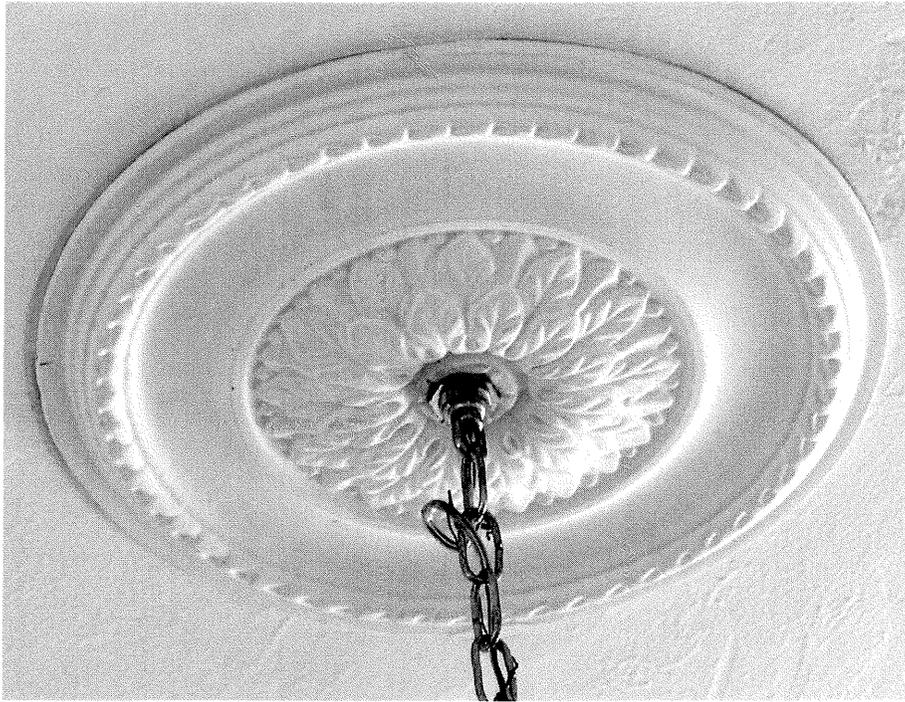
Figure 4. Detail of plaster medallion in the entry hall.
[Source: JRP Historical Consulting]

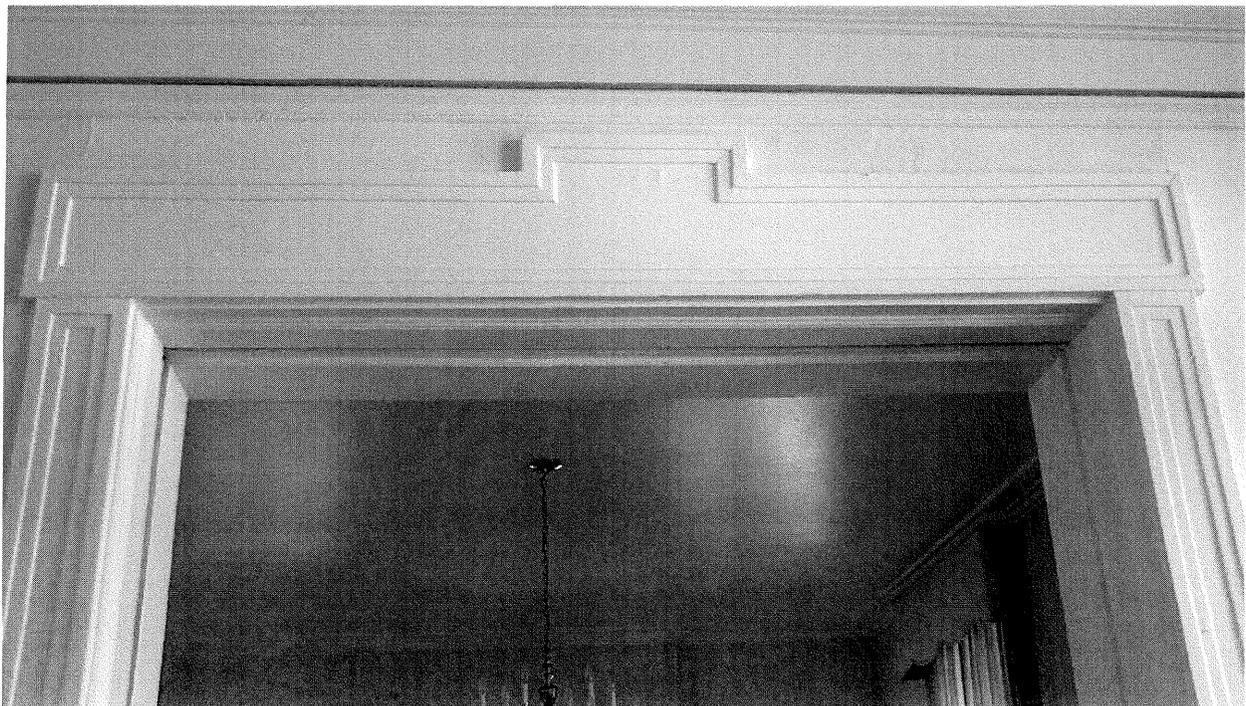
Figure 5. Detail of paneled architrave framing pocket doors that lead to the dining room.
[Source: JRP Historical Consulting]

5. Openings:
 - a. Doorways and doors: Large pocket doors separate the living and dining rooms from the hall and are framed by paneled architraves. Each opening contains one door panel that slides the entire length of the opening. The doors are inset wood panel doors. Multi-light doors flank the fireplace, separating the living and dining room from the solarium. Paneled wood doors are used throughout the second floor.
