WESTERNPORT PUBLIC SCHOOL  
(Hammond Street School)  
West side, Hammond Street, south of Division Street  
Westernport  
Allegany County  
Maryland

HABS. NO. MD-1049

HISTORIC AMERICAN BUILDINGS SURVEY  
Northeast Region  
National Park Service  
200 Chestnut Street  
Philadelphia, PA 19106

WESTERNPORT PUBLIC SCHOOL  
(Hammond Street School)

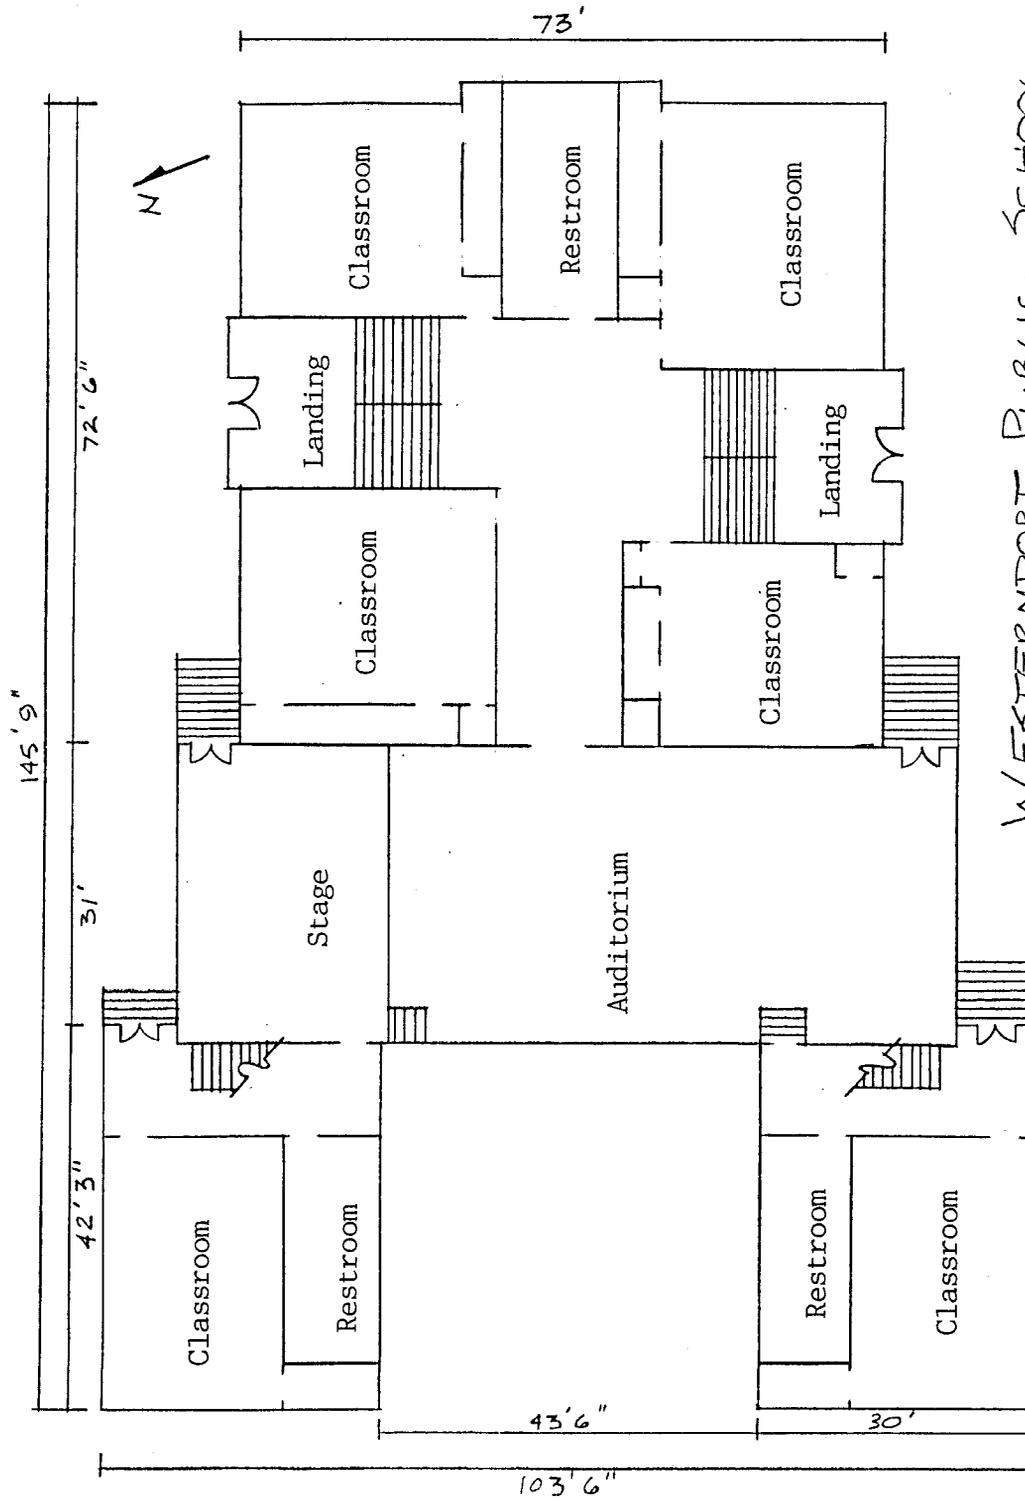
First Floor Plan

WESTERNPORT PUBLIC SCHOOL  
FIRST FLOOR PLAN

Rooms at the main stories are reached by a T-shaped corridor with slightly off-set arms. The corridor extends from the rear (west) of the 1891 section forward toward Hammond Street where it intersects with a stairwell on each side (north and south) forming the top of the T. From the main classroom level, the staircases lead down to landings into which opened doors from the outside. At the second story level, the stairs lead upward to a landing area and an enclosed office. The Principal's office was at the top of the south stairwell and the assistant principal's office in the north stairwell.

The placement of the corridor and stairwells creates classroom space in each of the four corners of the building. The area at the head or top of the T at the central sections of the front (south) of the building became a restroom at each of the two main levels. The girls' restroom was at the first story, the boys at the second.

Since the two stairwells are not exactly opposite one another, two diagonally opposed classrooms are smaller than the other diagonal pair, one pair being 30' by 25' and the other 24' by 25'.

The west end of the corridor opens into the 1911 addition. At the first story level this area is one large room, an auditorium with an elevated stage across its north side. The second story level of this addition contains three classrooms, two arranged along the north and south walls of the addition and the third between them with its long side being the west exterior wall of the addition. A seven foot wide corridor running
