WILSON ESTATE, BUILDING 15A
9100 Rockville Pike
Bethesda
Montgomery County
Maryland

HABS No. MD-1105-D

WRITTEN HISTORICAL AND DESCRIPTIVE DATA

WILSON ESTATE, BUILDING 15A

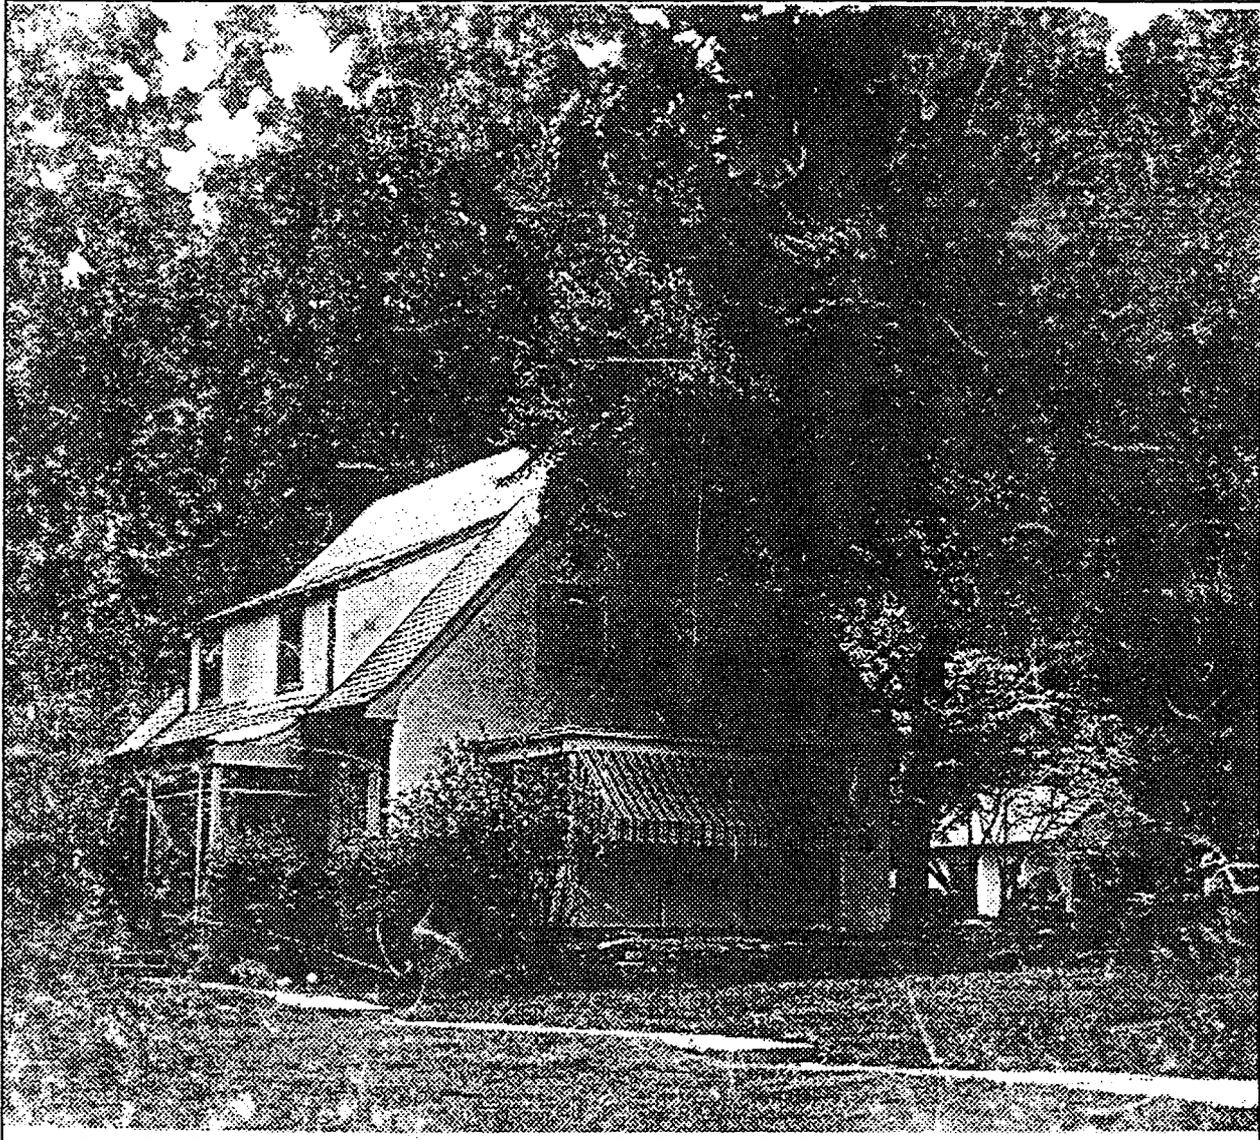
Building 15A, southwest view, late 1950s. Source: NIH Division of Space and Facility Management, Deed and Land Records, Building Maintenance Records.
