ALLEN PARK VETERANS ADMINISTRATION HOSPITAL, BUILDING NO. 1
(Allen Park Veterans Administration Hospital, Hospital)
Southfield Expressway & Outer Drive
Allen Park
Wayne County
Michigan

HABS No. MI-427-A

ALLEN PARK VETERANS ADMINISTRATION HOSPITAL BUILDING 1 (Hospital Building)

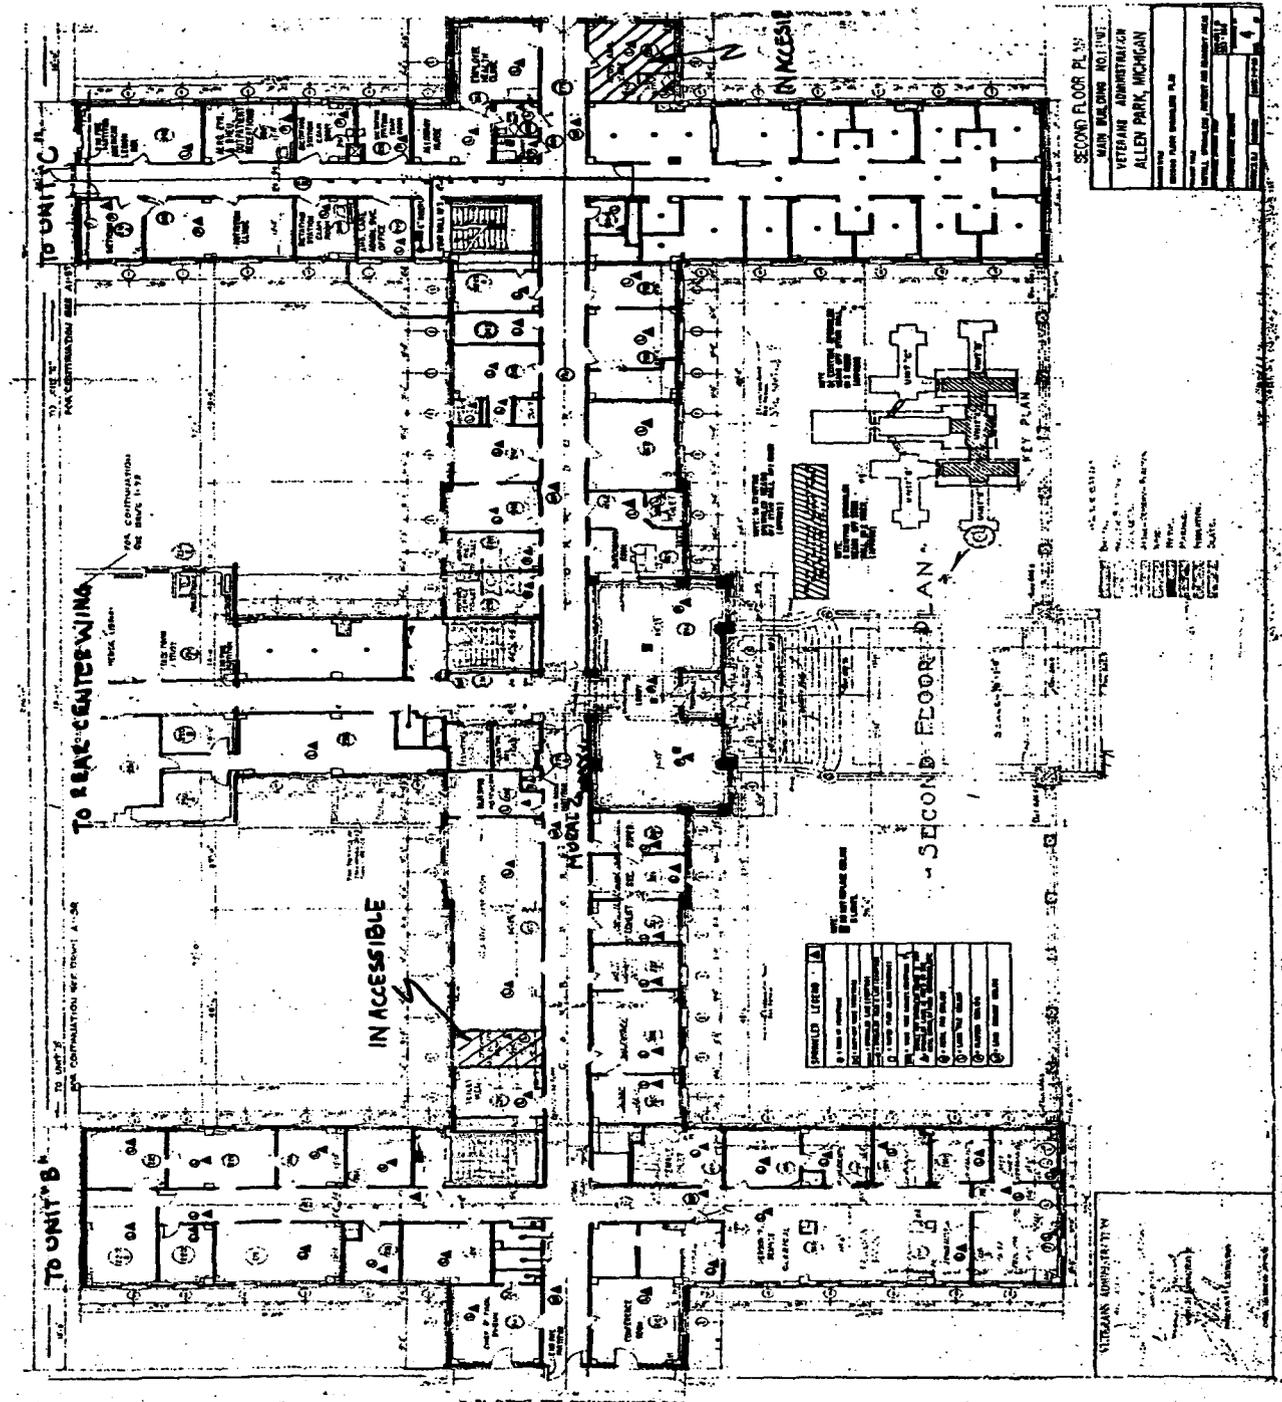
Reduced Copy of Current Plan, February 2002
 Unit A, Second Floor

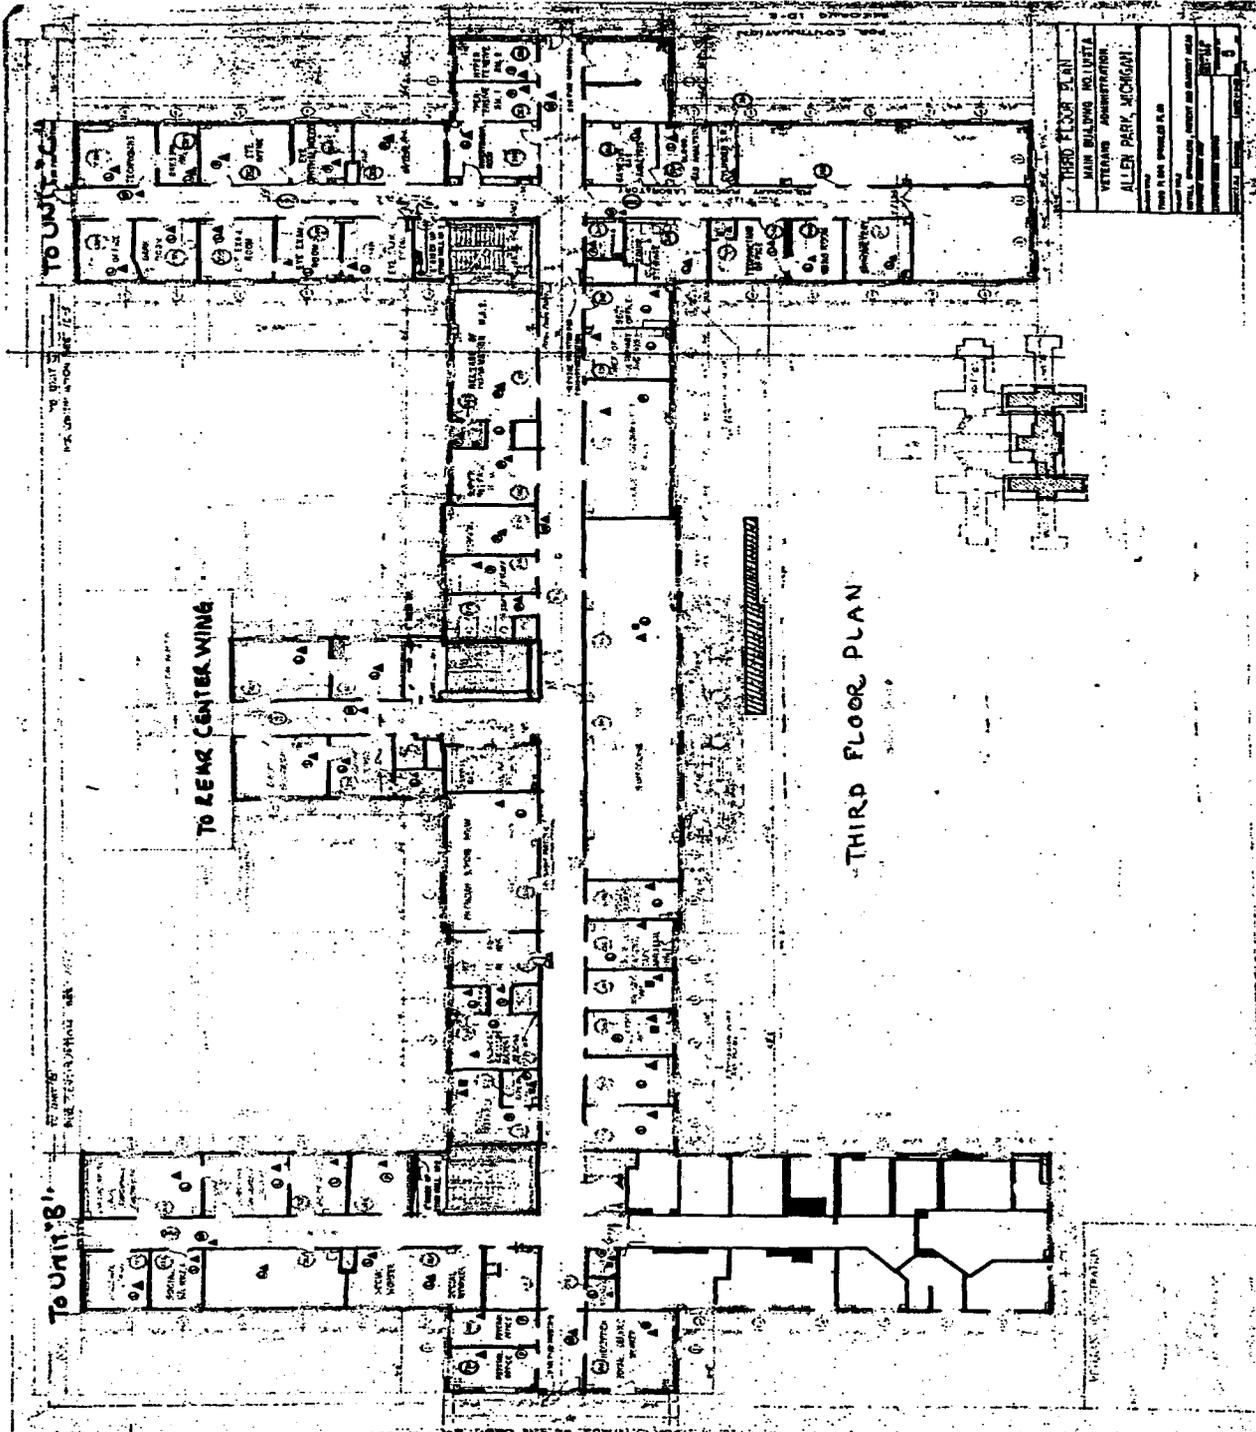
Reduced Copy of Current Plan, February 2002
Unit A, Third Floor

- (4) **Third Floor:** The earliest available floorplans for the third floor date to ca. 1968 and show the floor as occupied by a large transcribing unit and other records management offices in the hyphen, labs in the northwest wing, social workers' offices in the northeast, spirometry facilities in the southwest, and eye care facilities in the southeast. Dietetic offices had moved up from the second floor to the central rear extension of the hyphen. In the 1980s, the laboratories were replaced with offices. An exercise room that had been located at the end of the southwest wing was converted into an office.

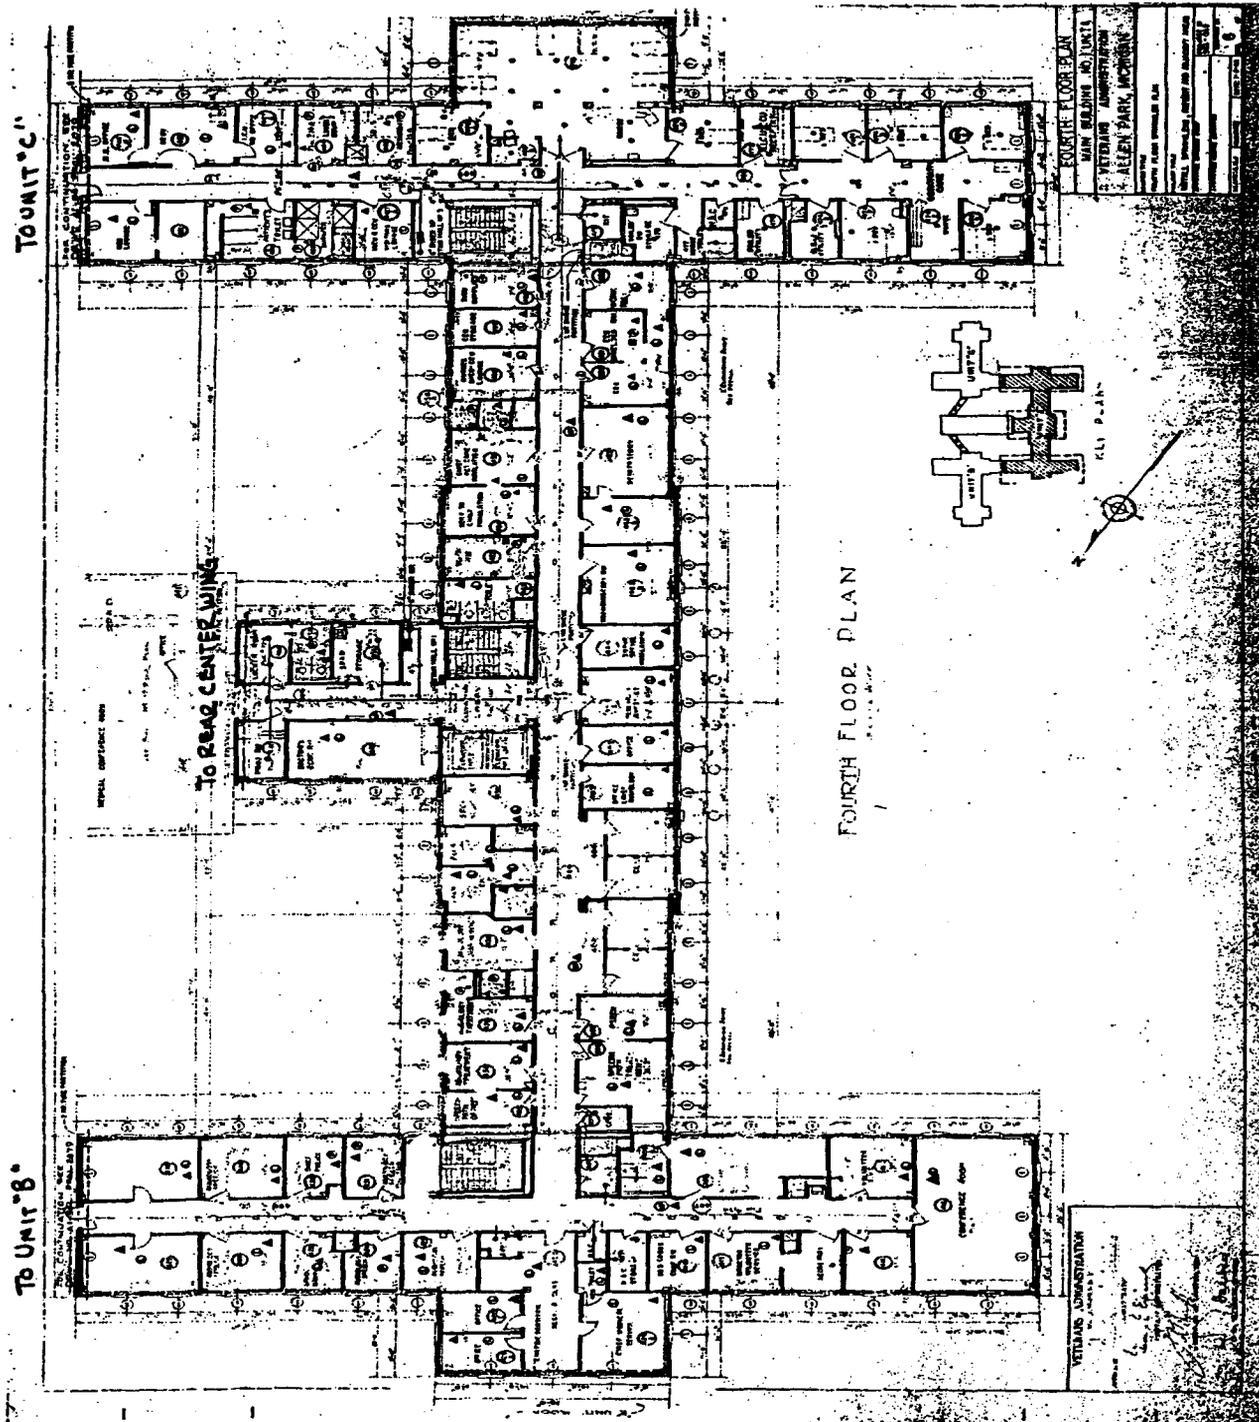
Reduced Copy of Current Plan, February 2002
Unit A, Fourth Floor

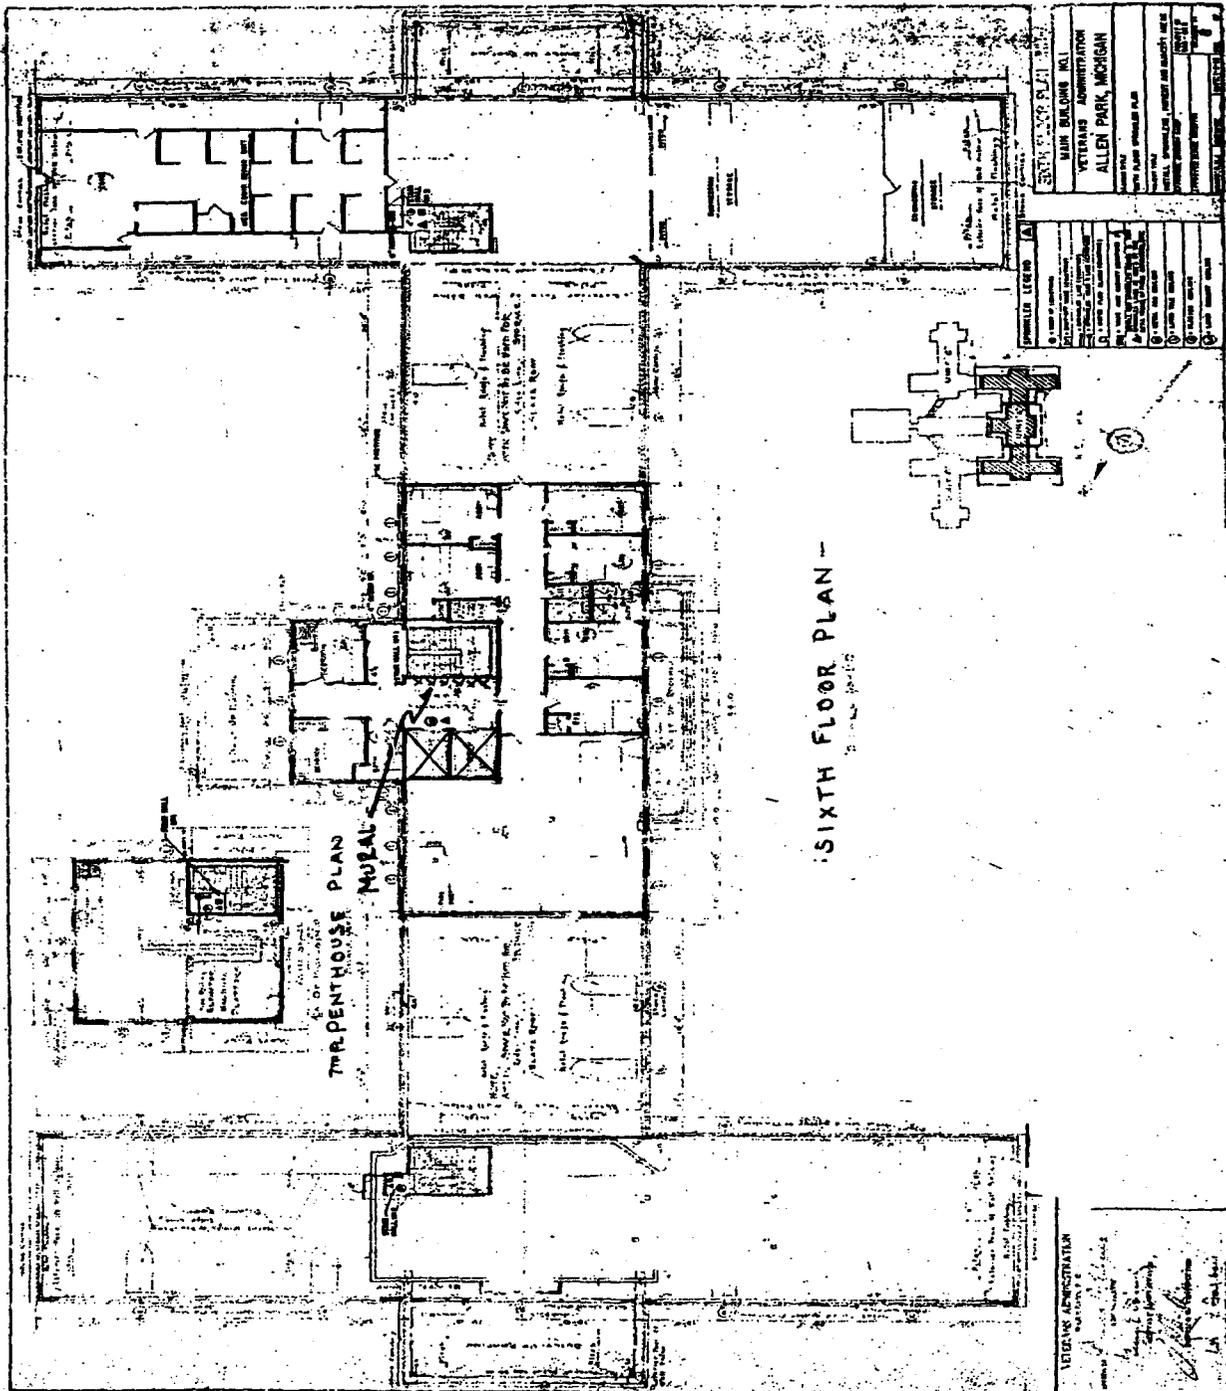
Reduced Copy of Current Plan, February 2002
Unit A, Sixth Floor

- (7) **Sixth Floor (Attic):** No original plans were located for the sixth floor, or attic, but it is believed that the space was unfinished and vacant. However, finished rooms in the center of the hyphen were in place at least as early as 1947. At this time, these six rooms provided two-bed quarters for resident interns. Also present are a toilet and shower room, and a lounge. A large room for air conditioning equipment is located to the north of these finished rooms. In ca. 1968, a multi-room Medical Equipment Repair Unit was added in the formerly unfinished

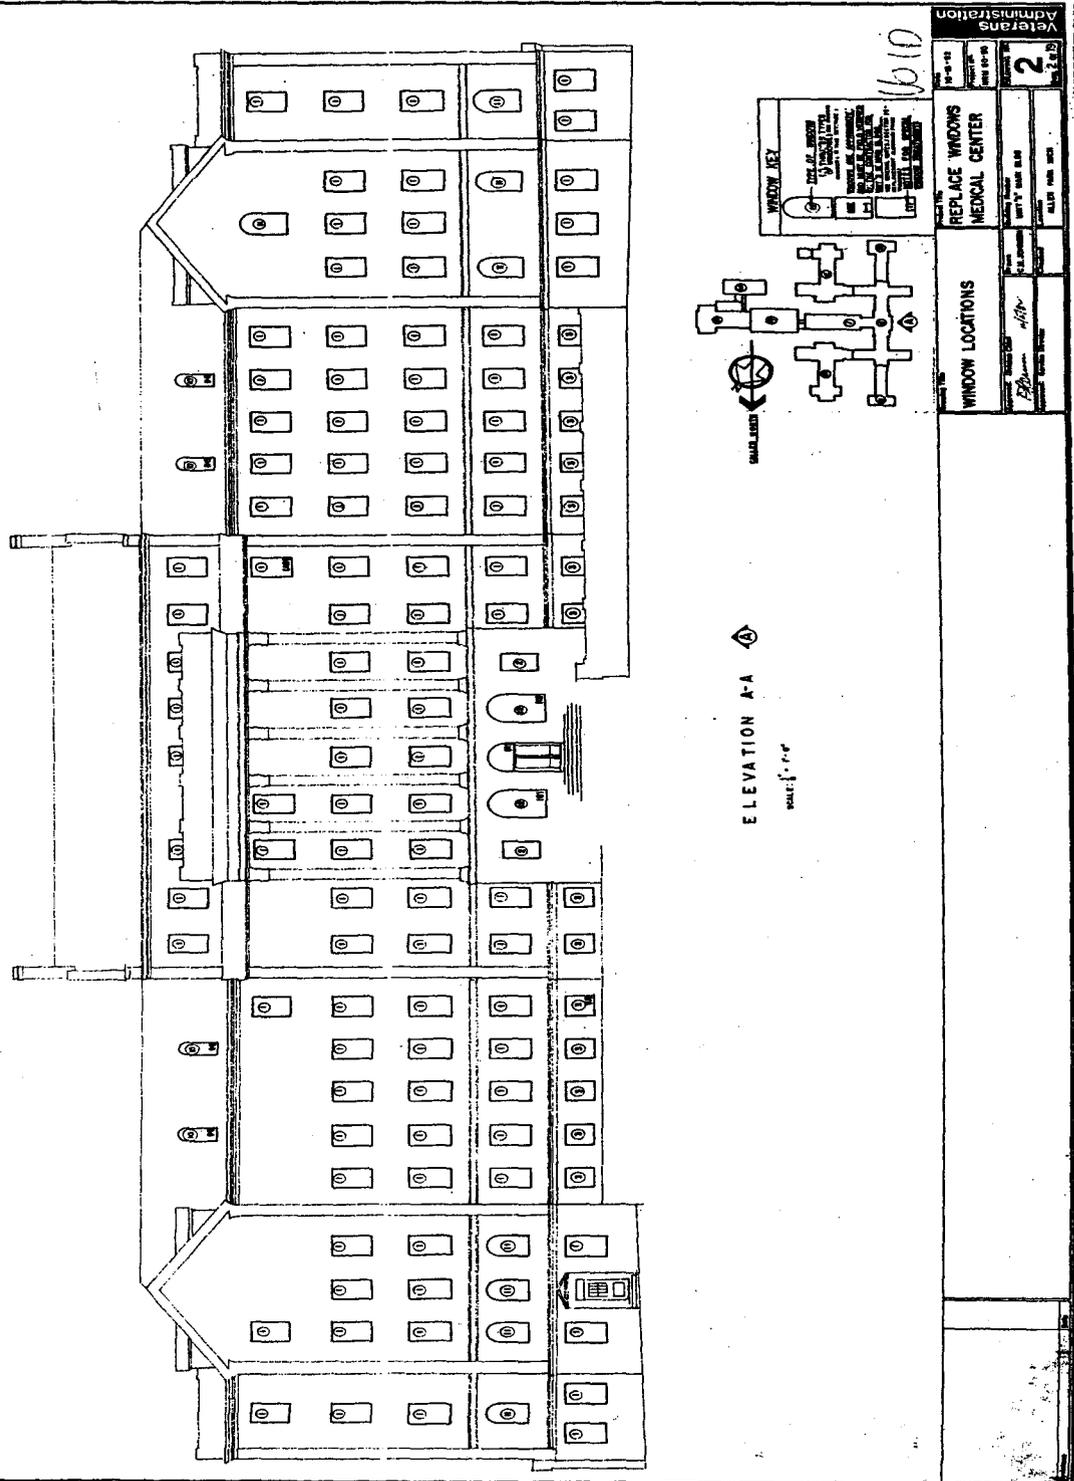
Reduced Copy of Current Elevation, February 2002
 Unit A

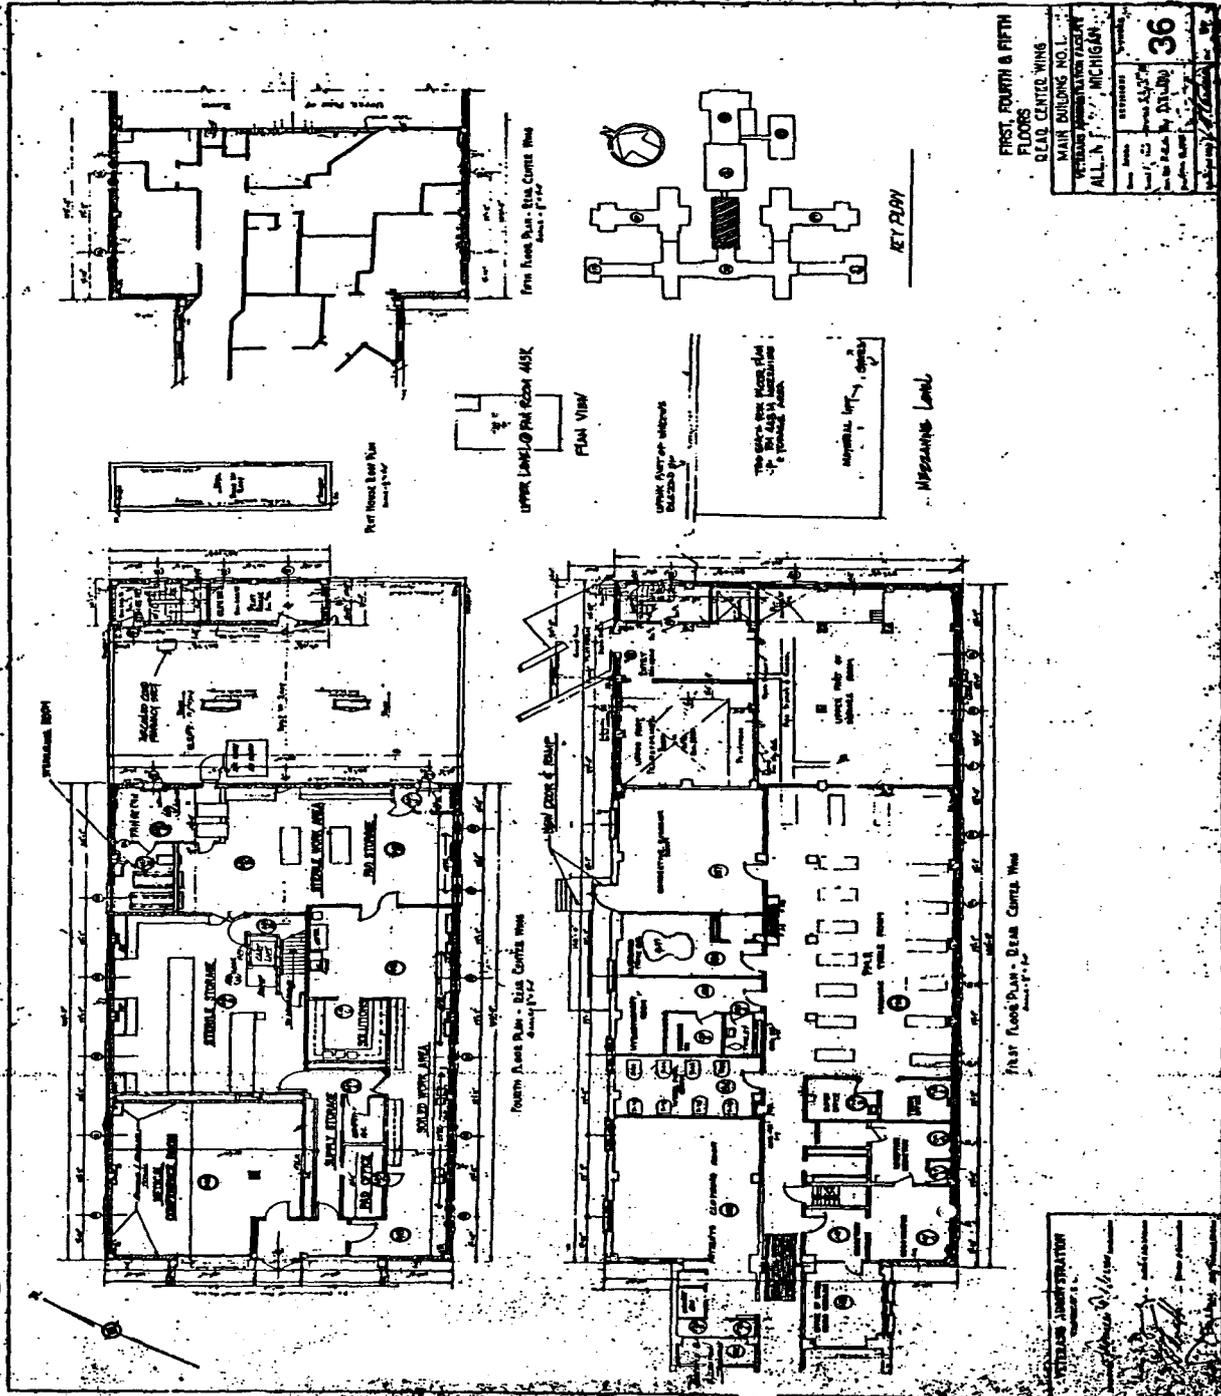
Reduced Copy of Current Plan, February 2002
 Rear Center Wing, First, Fourth, and Fifth Floors

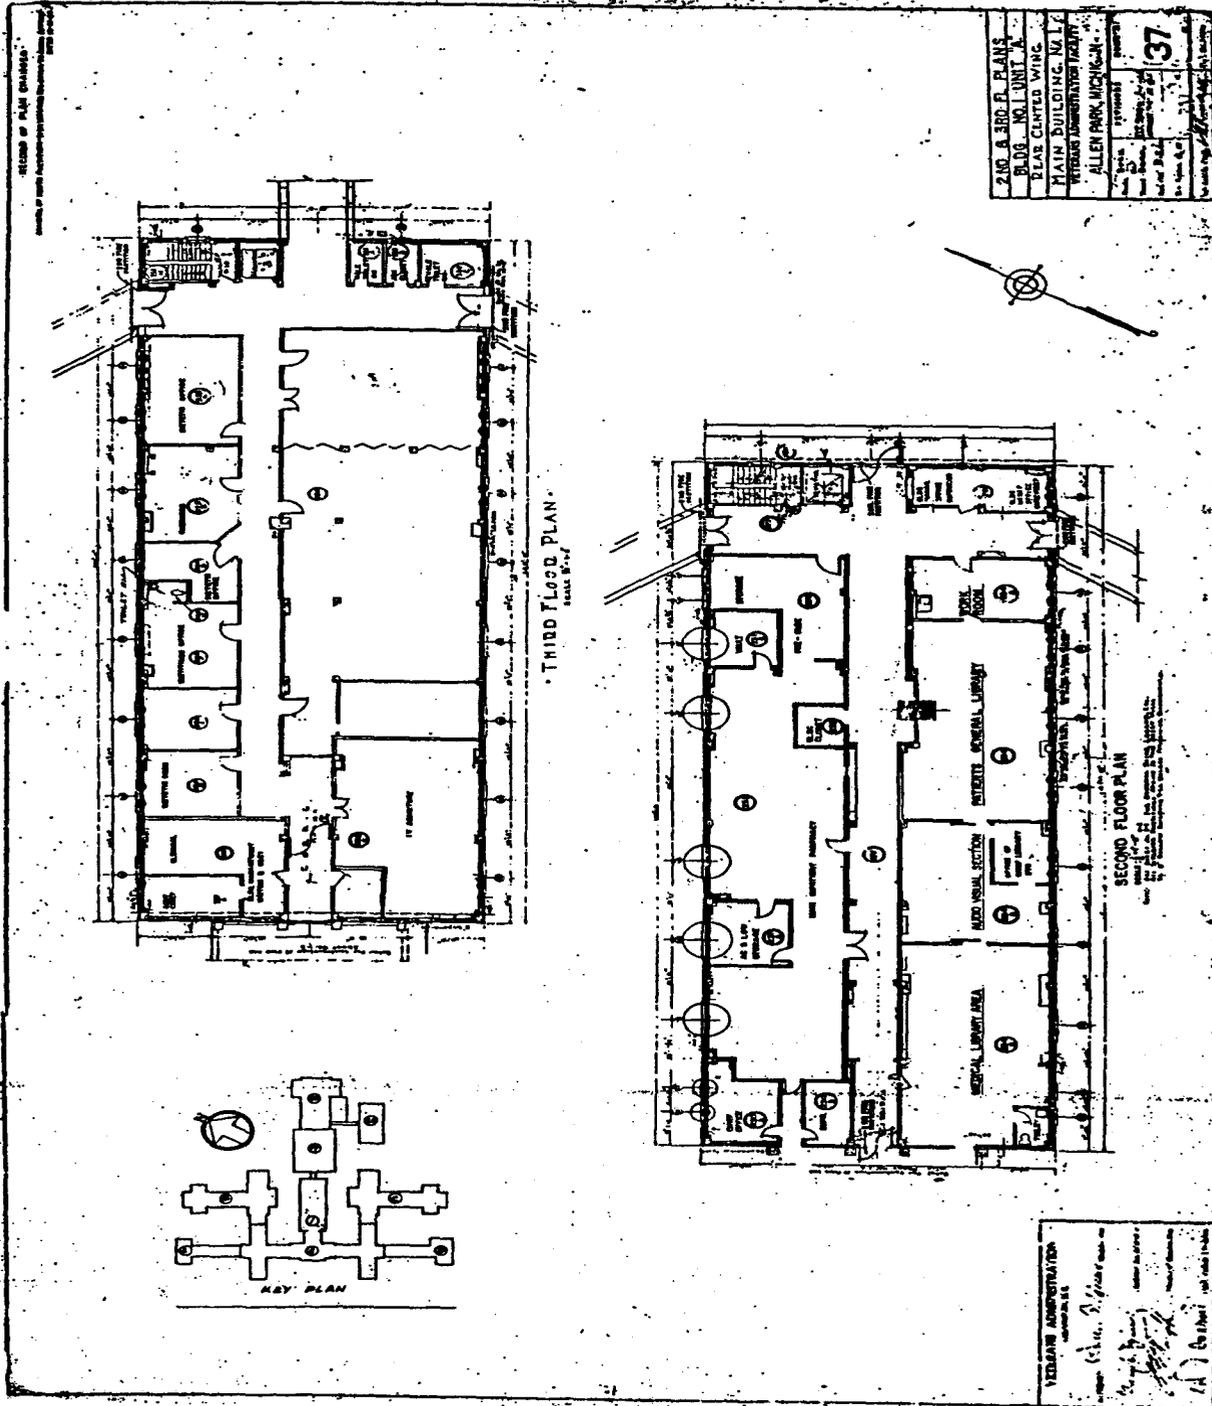
Reduced Copy of Current Plan, February 2002
 Rear Center Wing, Second and Third Floors

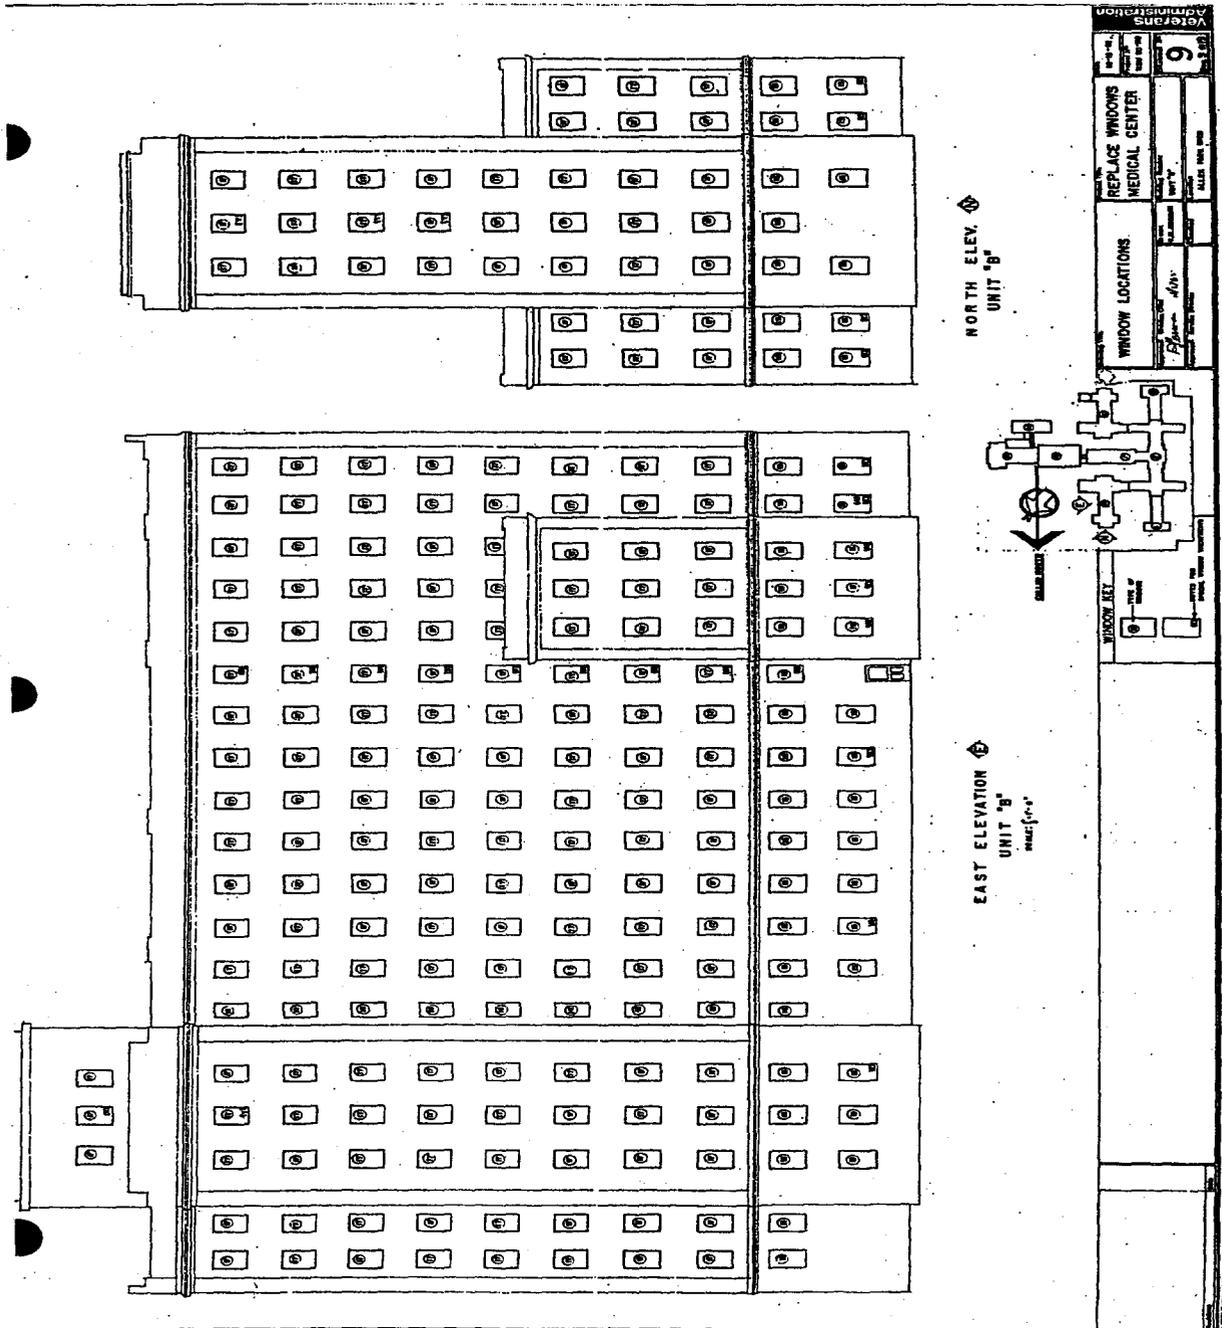
Reduced Copy of Current Elevation, February 2002
Unit B

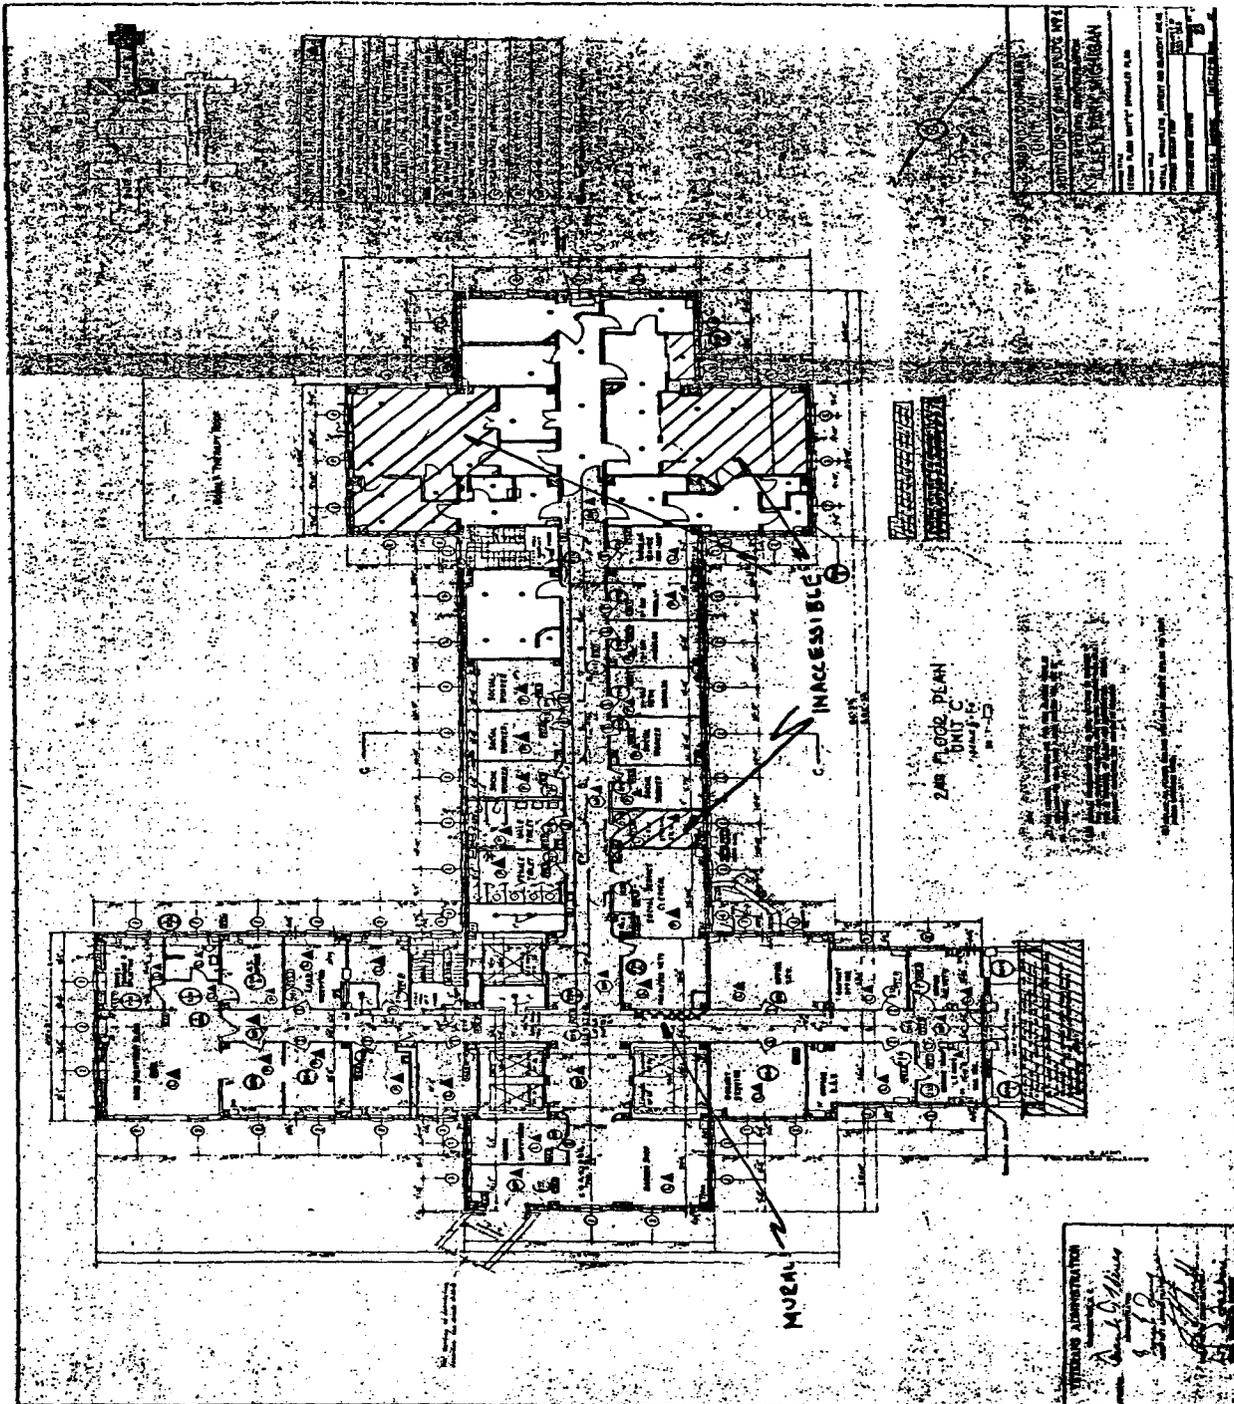
Reduced Copy of Current Plan, February 2002
Unit C, Second Floor

- (3) Second Floor:** This floor originally mirrored the patient room configuration found in Unit B. Plans dated 1985 show that wards had been converted to use as offices for various service organizations, such as Disabled American Veterans, Veterans of Foreign Wars, and the Marine Corps League. A barber shop was installed in a former four-bed ward at the north end. Although partition walls were not removed, the former main hall wards were now occupied almost exclusively by social workers' offices. The south end of the building was completely reconfigured to convert the large open eleven-bed wards to an office suite.

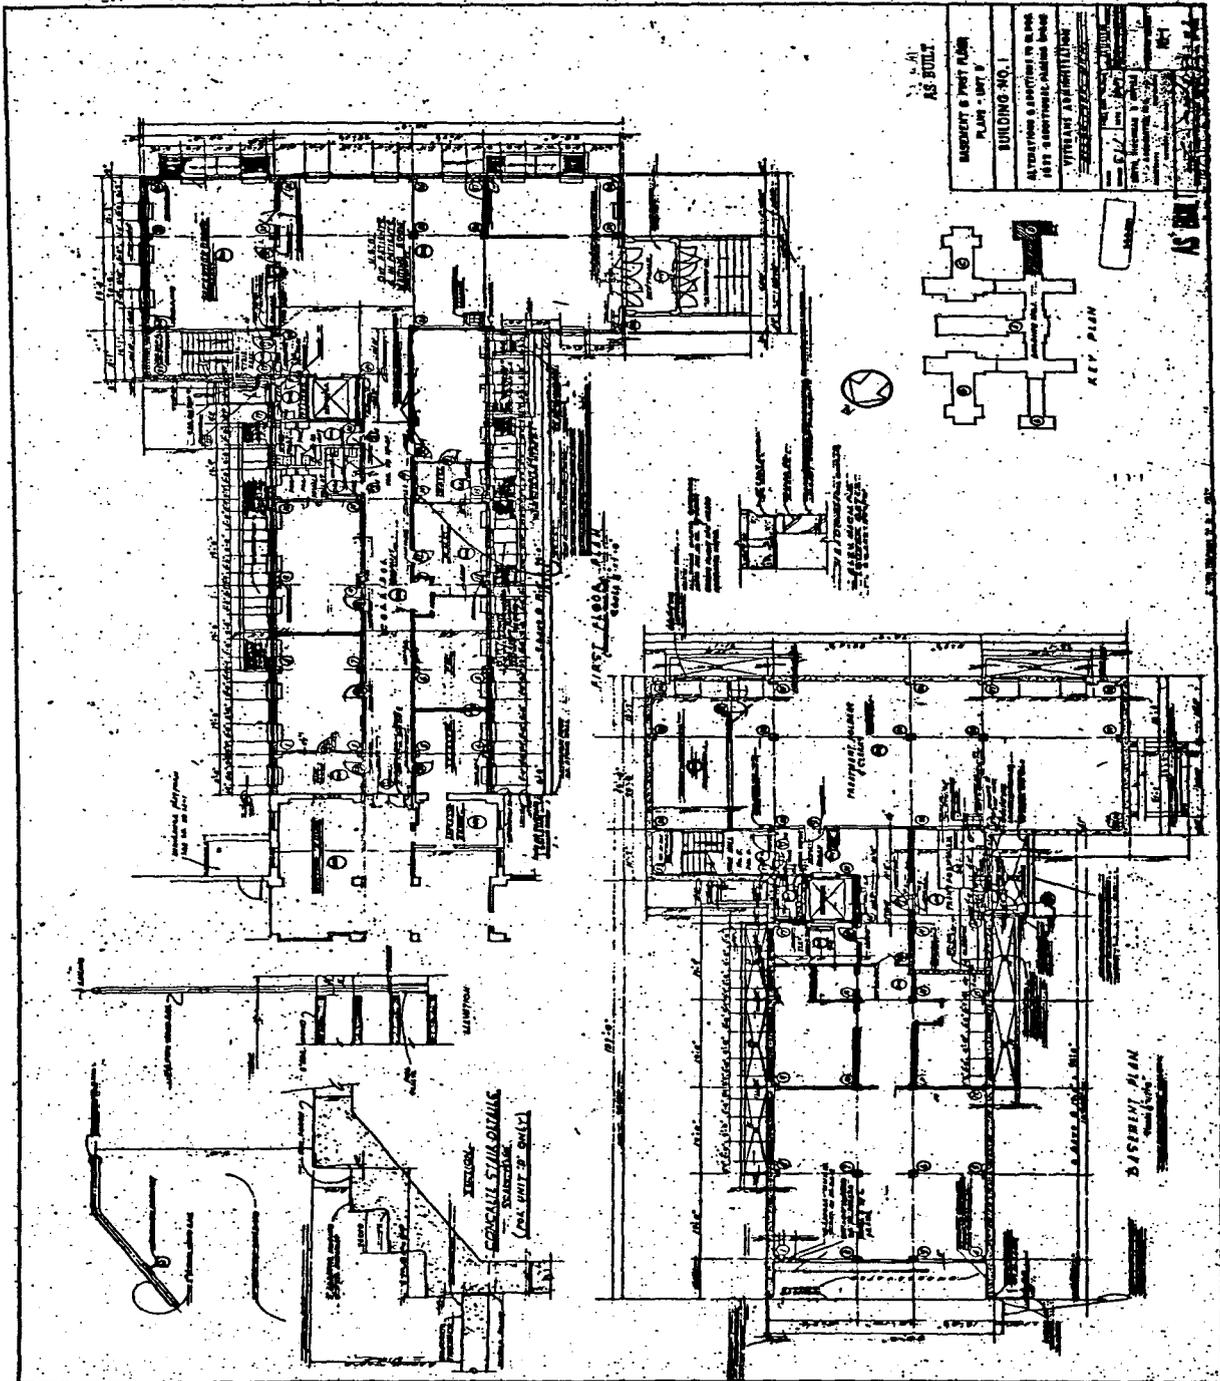
Reduced Copy of Current Plan, February 2002
 Unit D, Basement and First Floor

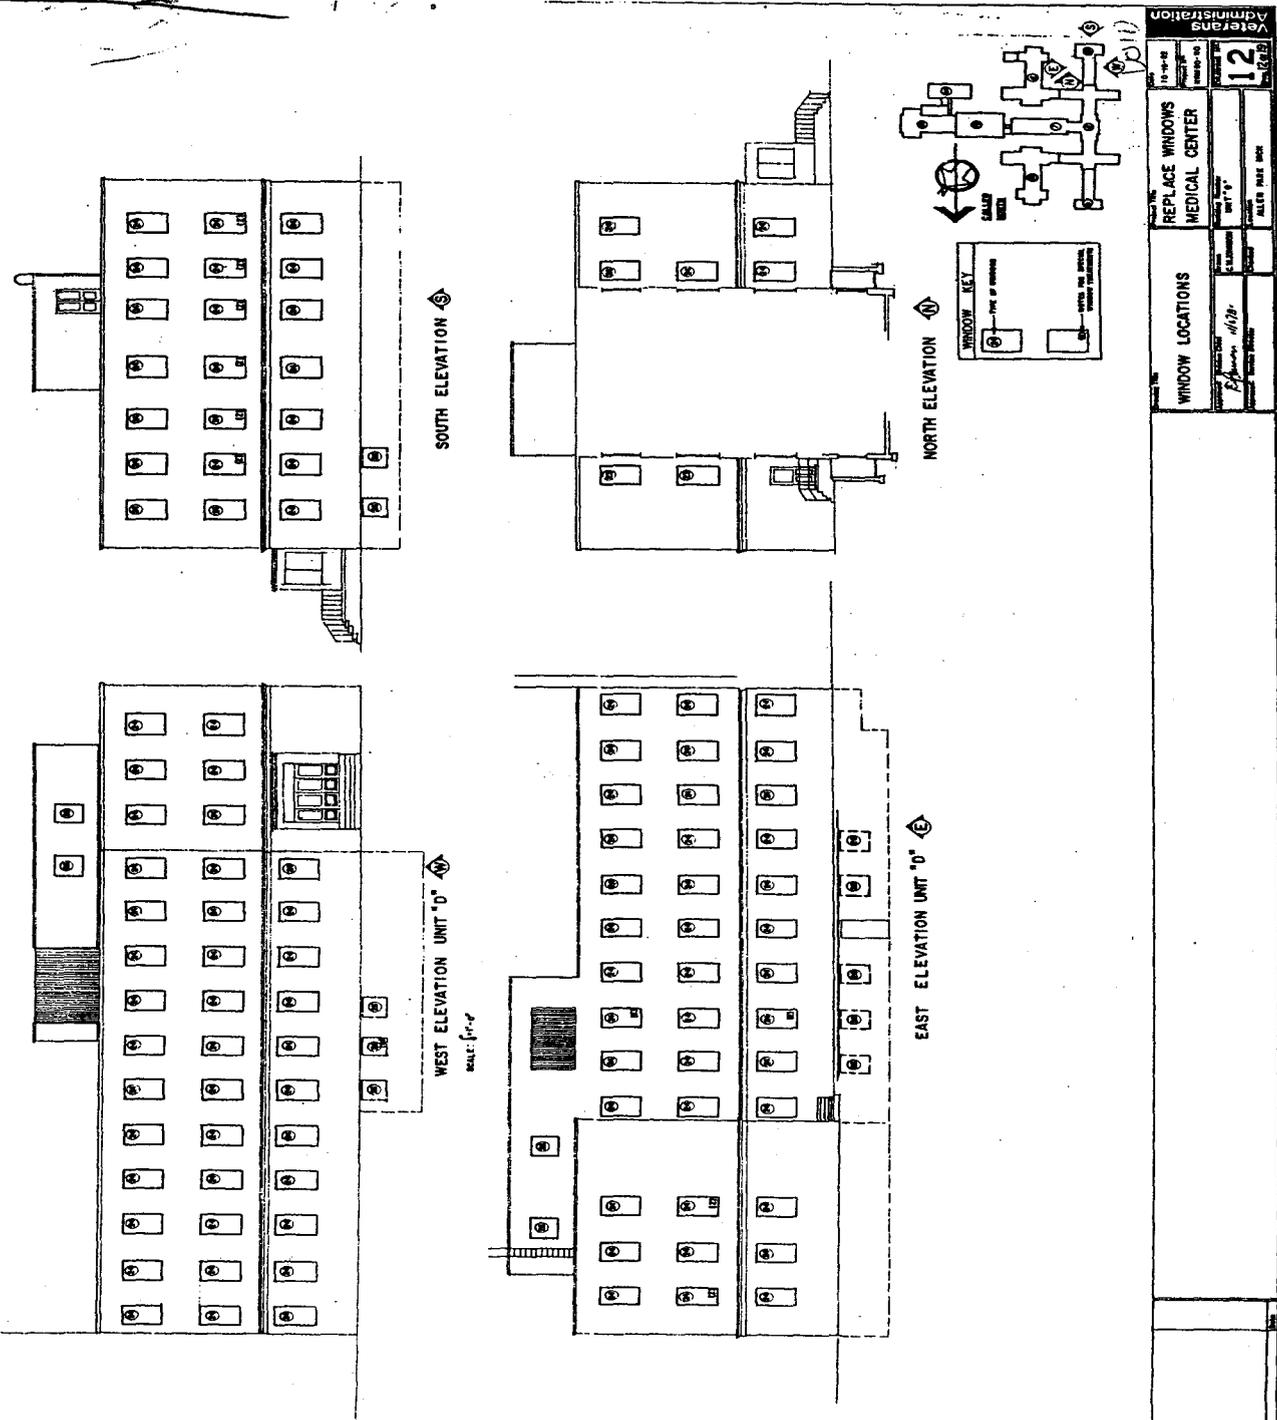
Reduced Copy of Current Elevation, February 2002
 Unit D

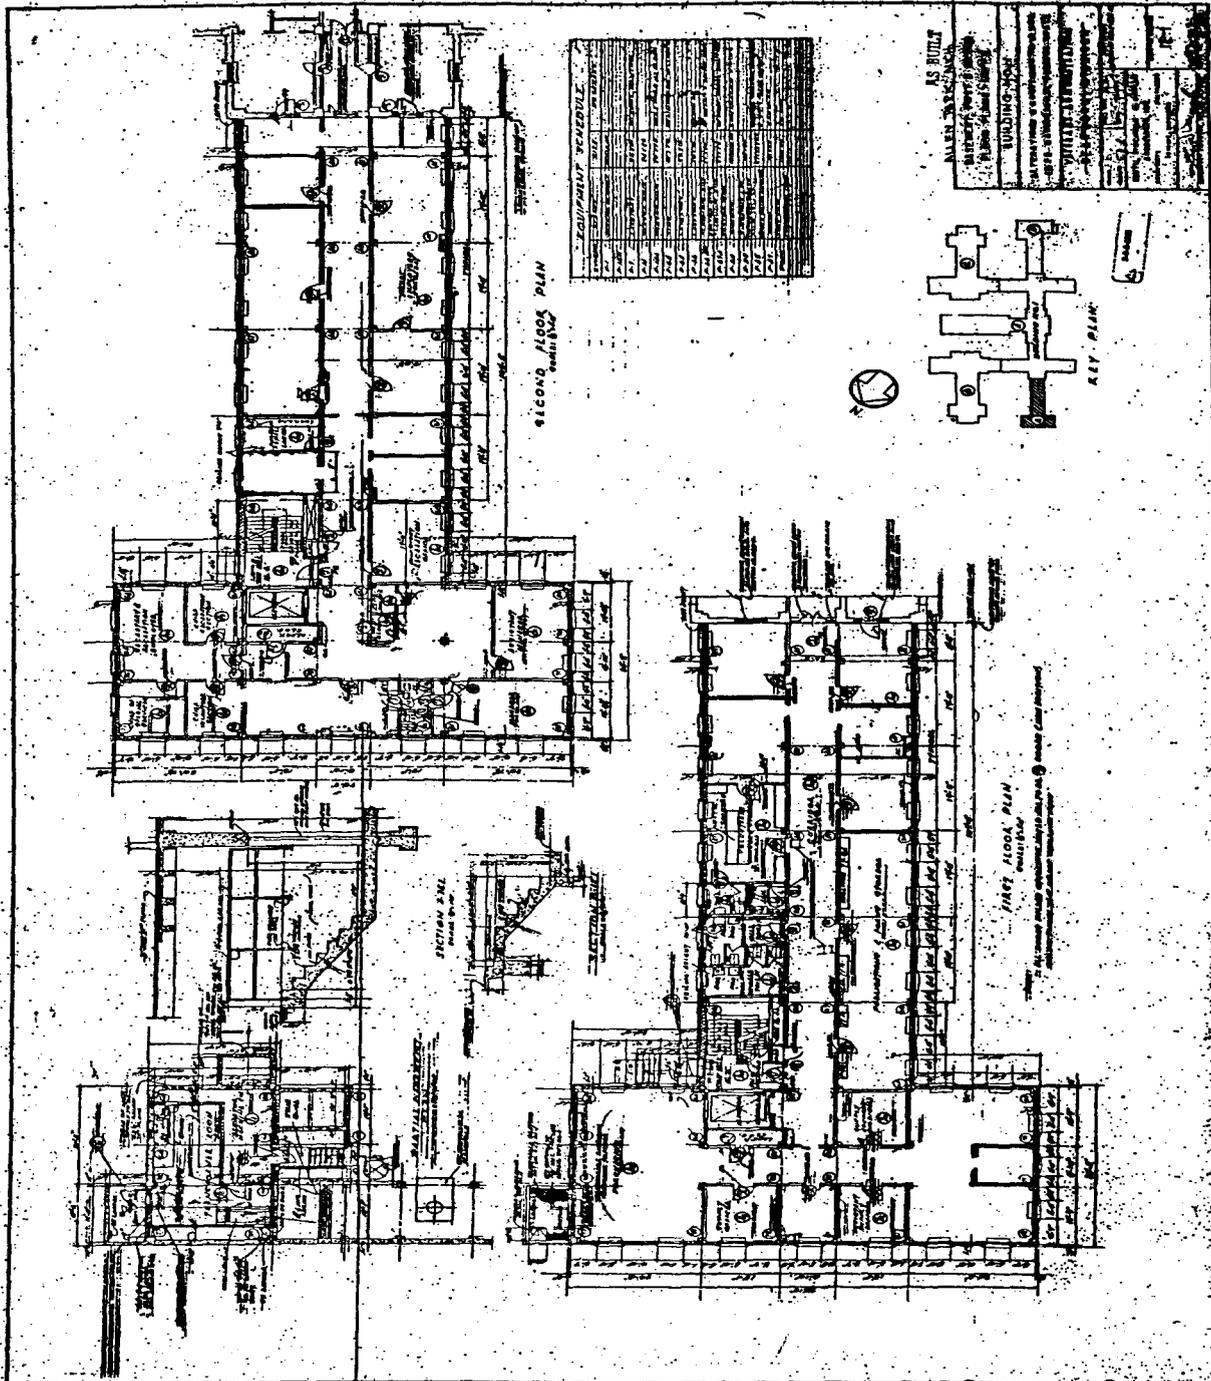
Reduced Copy of Current Plan, February 2002
 Unit E, Basement, First and Second Floors

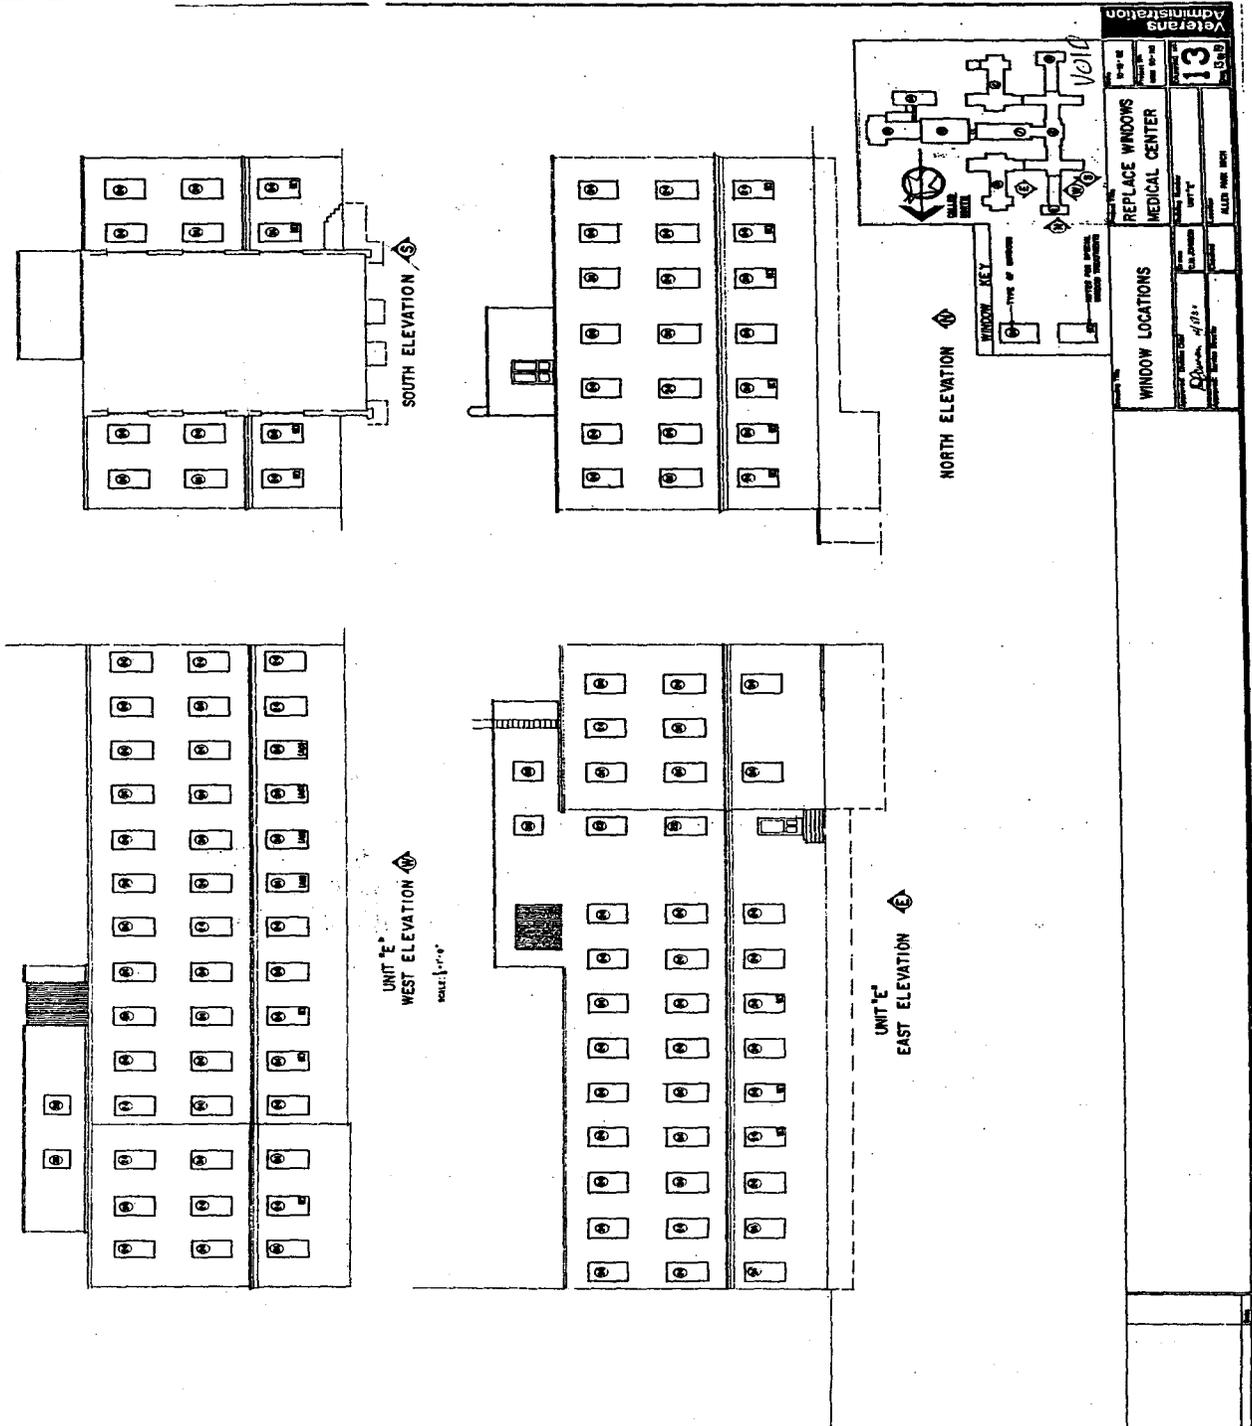
Reduced Copy of Current Elevation, February 2002
 Unit E
