ALLEN PARK VETERANS ADMINISTRATION HOSPITAL, BUILDING NO. 1
(Allen Park Veterans Administration Hospital, Hospital)
Southfield Expressway & Outer Drive
Allen Park
Wayne County
Michigan

HABS No. MI-427-A

ALLEN PARK VETERANS ADMINISTRATION HOSPITAL BUILDING 1 (Hospital Building)

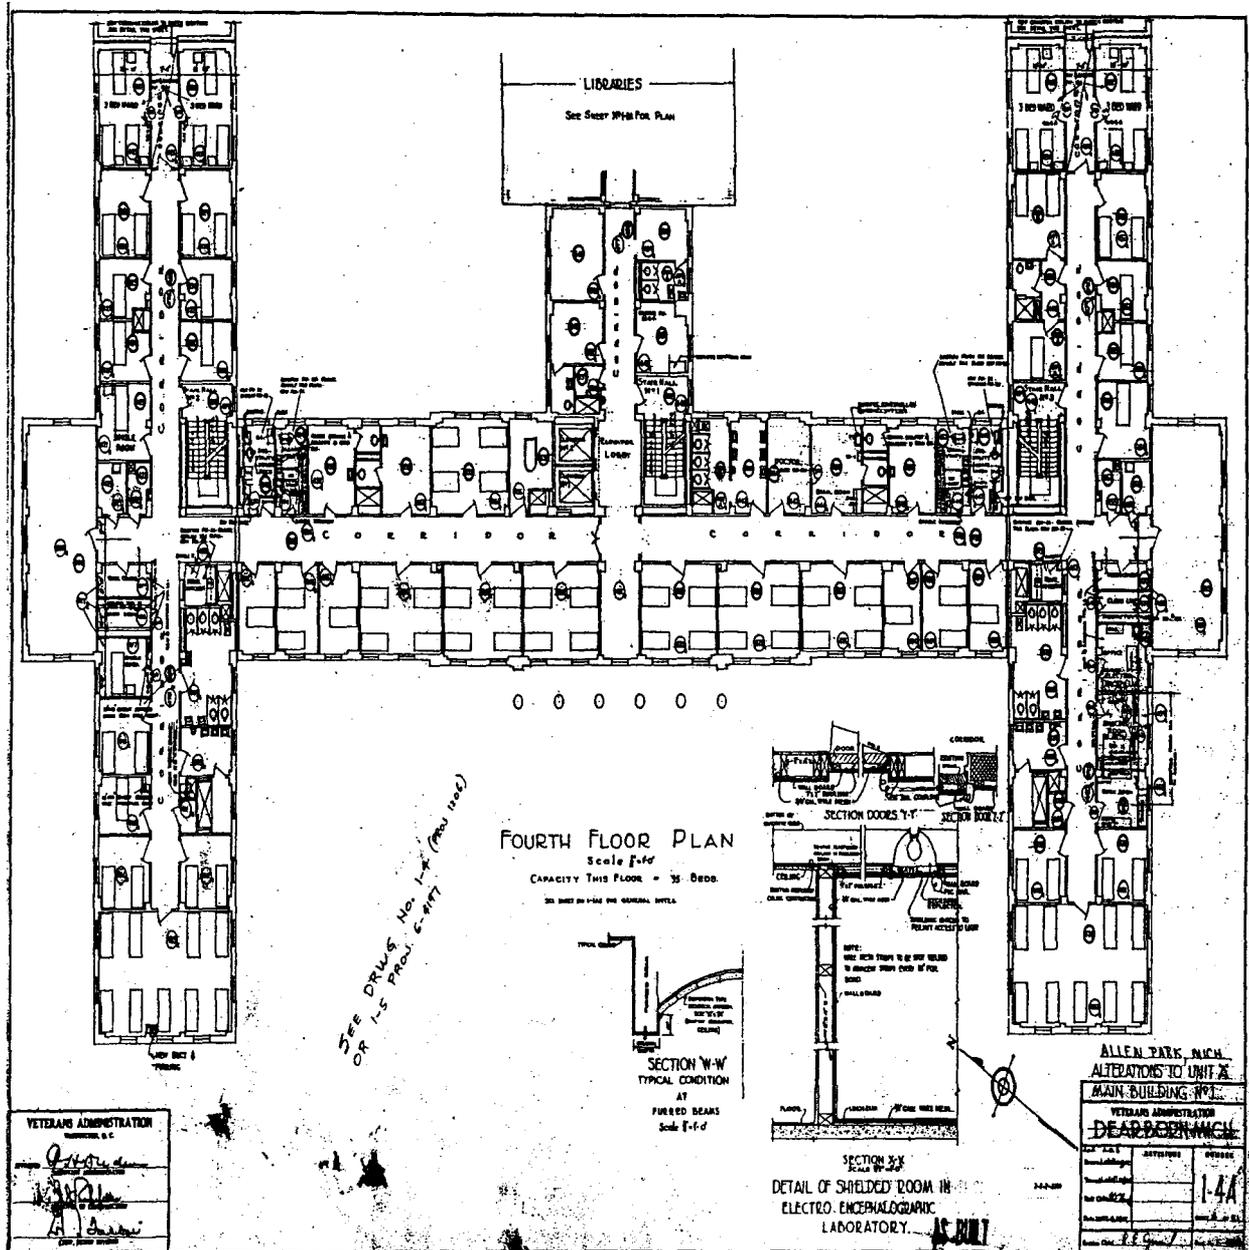
Reduced Copy of Historic Plan, dated September 9, 1947
 Unit A, Fourth Floor
 On file at the John D. Dingell Department of Veterans Affairs Medical Center, Detroit,
 Michigan

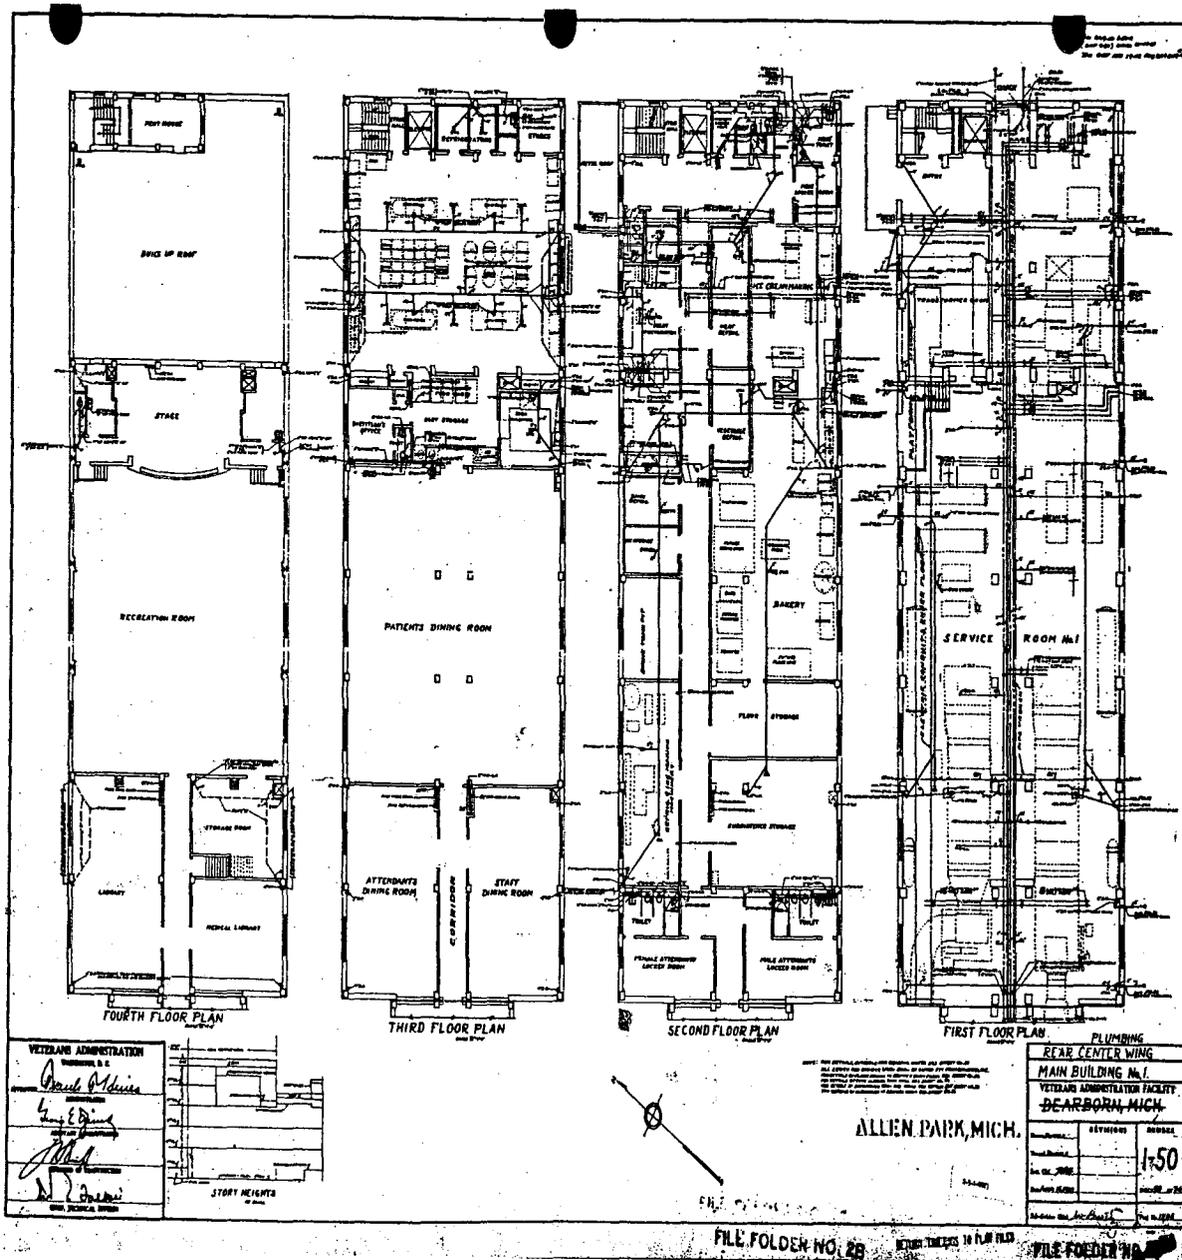
Reduced Copy of Historic Plan, dated April 15, 1937
 Rear Center Wing, First, Second, Third, and Fourth Floors
 On file at the John D. Dingell Department of Veterans Affairs Medical Center, Detroit,
 Michigan

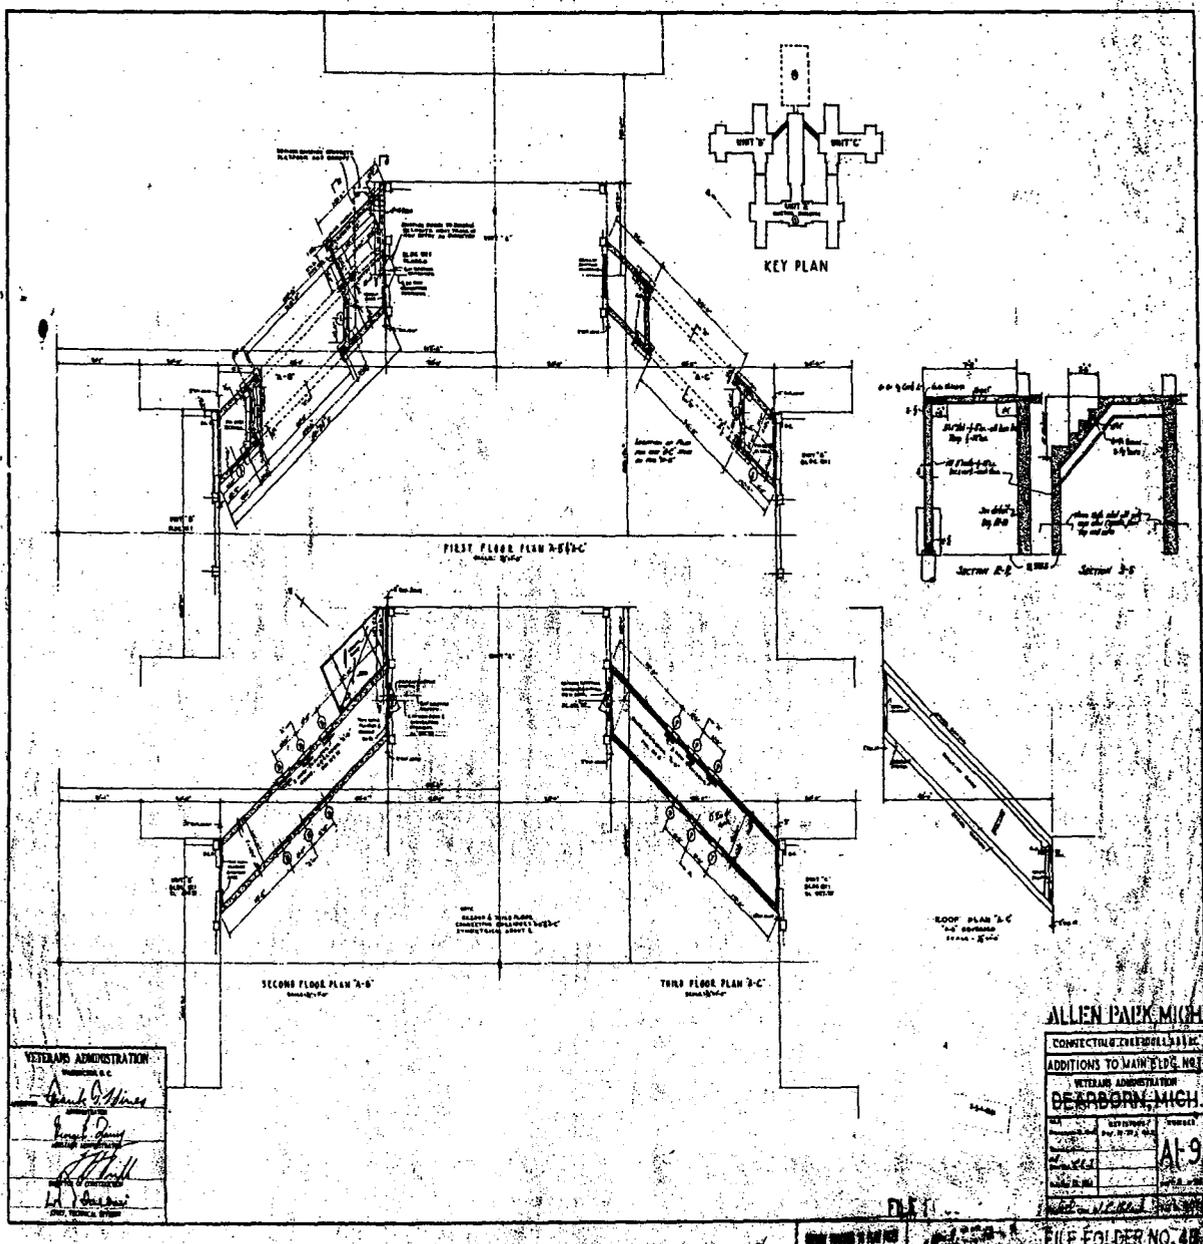
Reduced Copy of Historic Plan, dated November 28, 1944
Connecting Corridors, First, Second, and Third Floors
On file at the John D. Dingell Department of Veterans Affairs Medical Center, Detroit,
Michigan

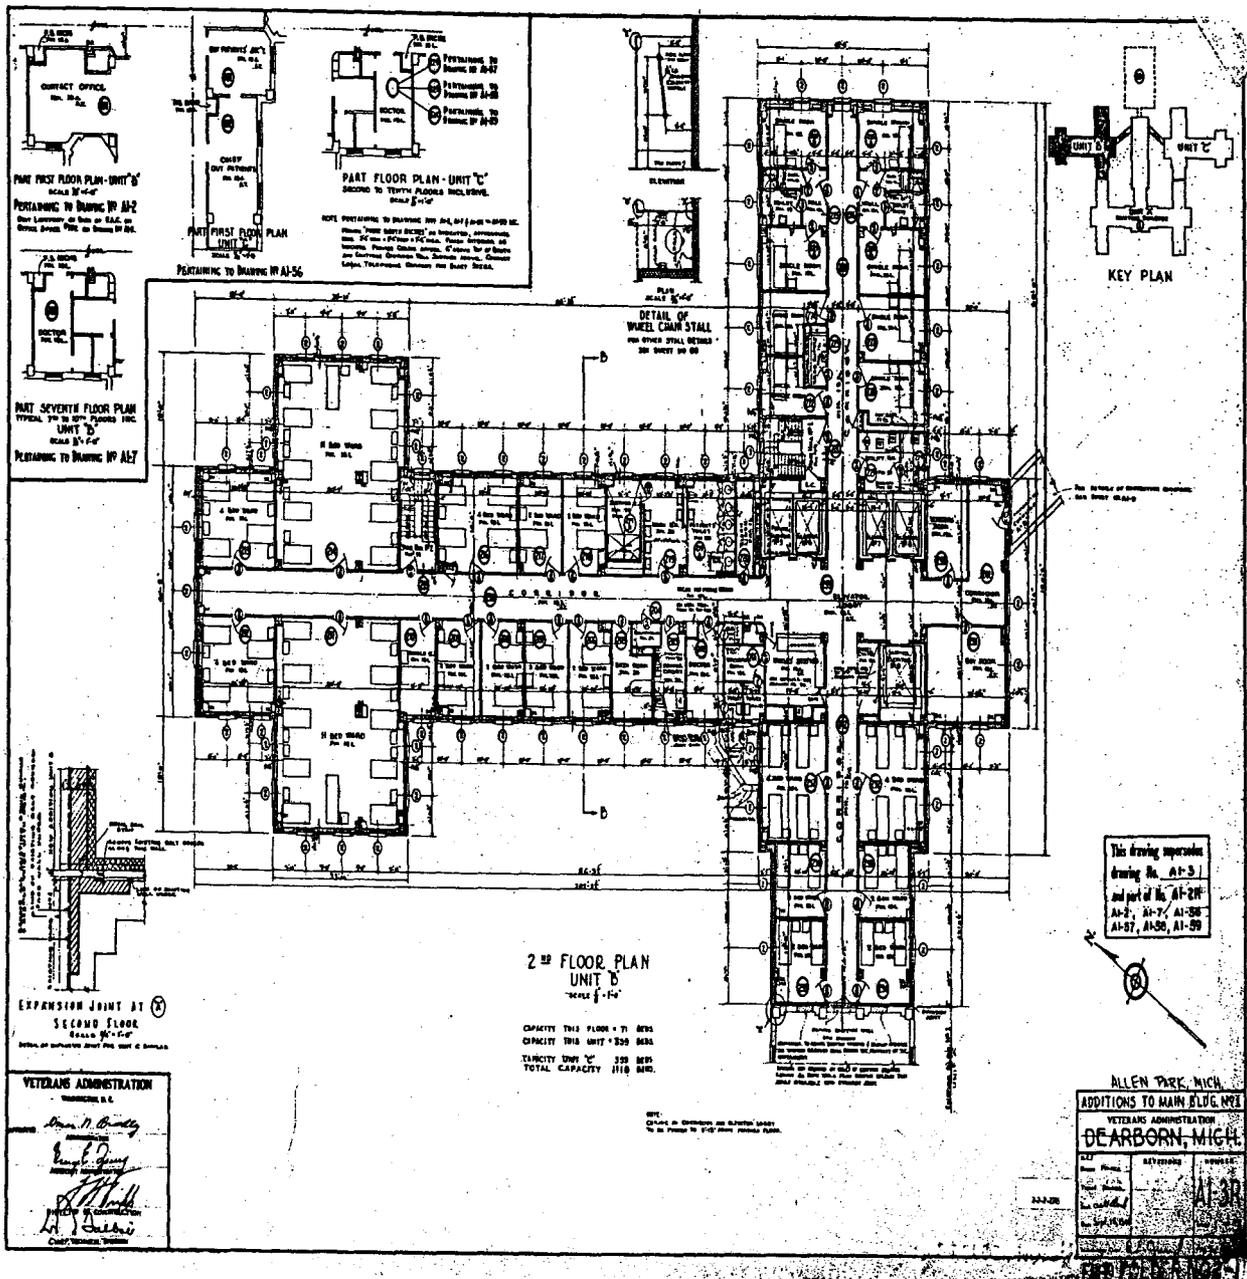
Reduced Copy of Historic Plan, dated September 15, 1945
 Unit B, Second Floor
 On file at the John D. Dingell Department of Veterans Affairs Medical Center, Detroit,
 Michigan

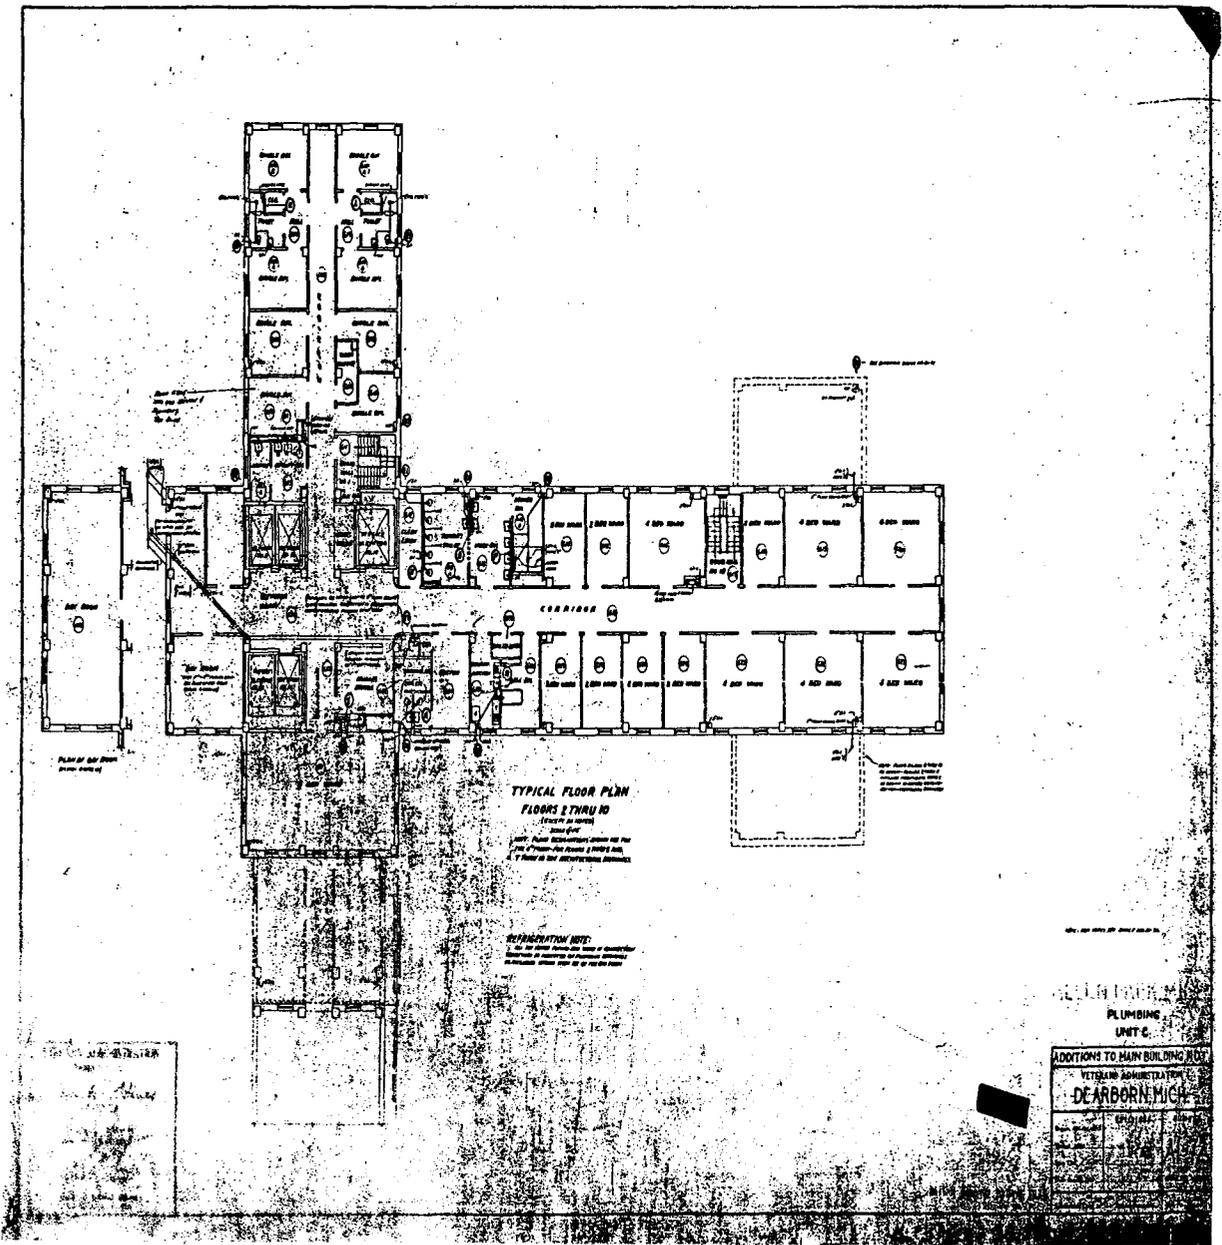
Reduced Copy of Historic Plan, dated November 28, 1944
Unit C, Typical Floor Plan for Floors Two through Ten
On file at the John D. Dingell Department of Veterans Affairs Medical Center, Detroit,
Michigan

- (4) Third through Tenth Floors:** The plan of these floors is reversed, but otherwise identical to those in Unit B. As on the second floor, the large wards at the southern end were broken into smaller spaces on the third floor. While interior partitions were changed somewhat to accommodate new uses, the room configuration largely remains intact on these floors. Exceptions include dividing the two eleven-bed wards into four four-bed wards on the fourth and fifth floors, and opening up space on the ninth floor at the south end of the main corridor into one large dining room.

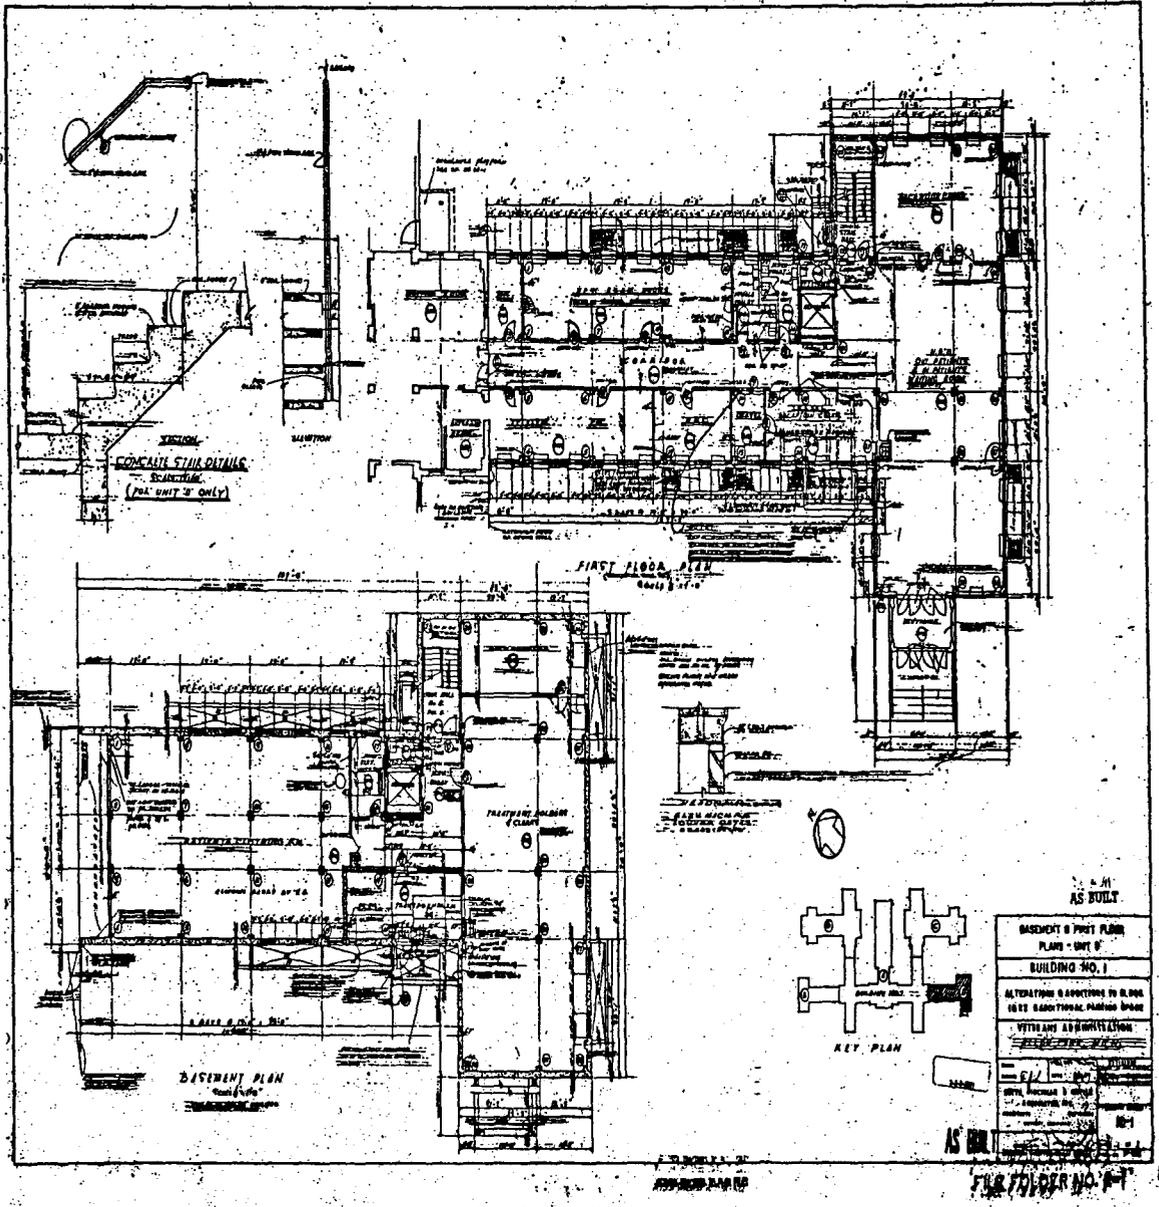
Reduced Copy of Historic Plan, dated March 10, 1959
 Unit D, Basement and First Floor
 On file at the John D. Dingell Department of Veterans Affairs Medical Center, Detroit,
 Michigan
