LAKE CHAMPLAIN BRIDGE
New York Route 185/Vermont Route 17 spanning Lake Champlain
Crown Point
Essex County
New York

HAER NY-541
HAER NY-541

LAKE CHAMPLAIN BRIDGE

Structural Type: Steel continuous through and deck truss span

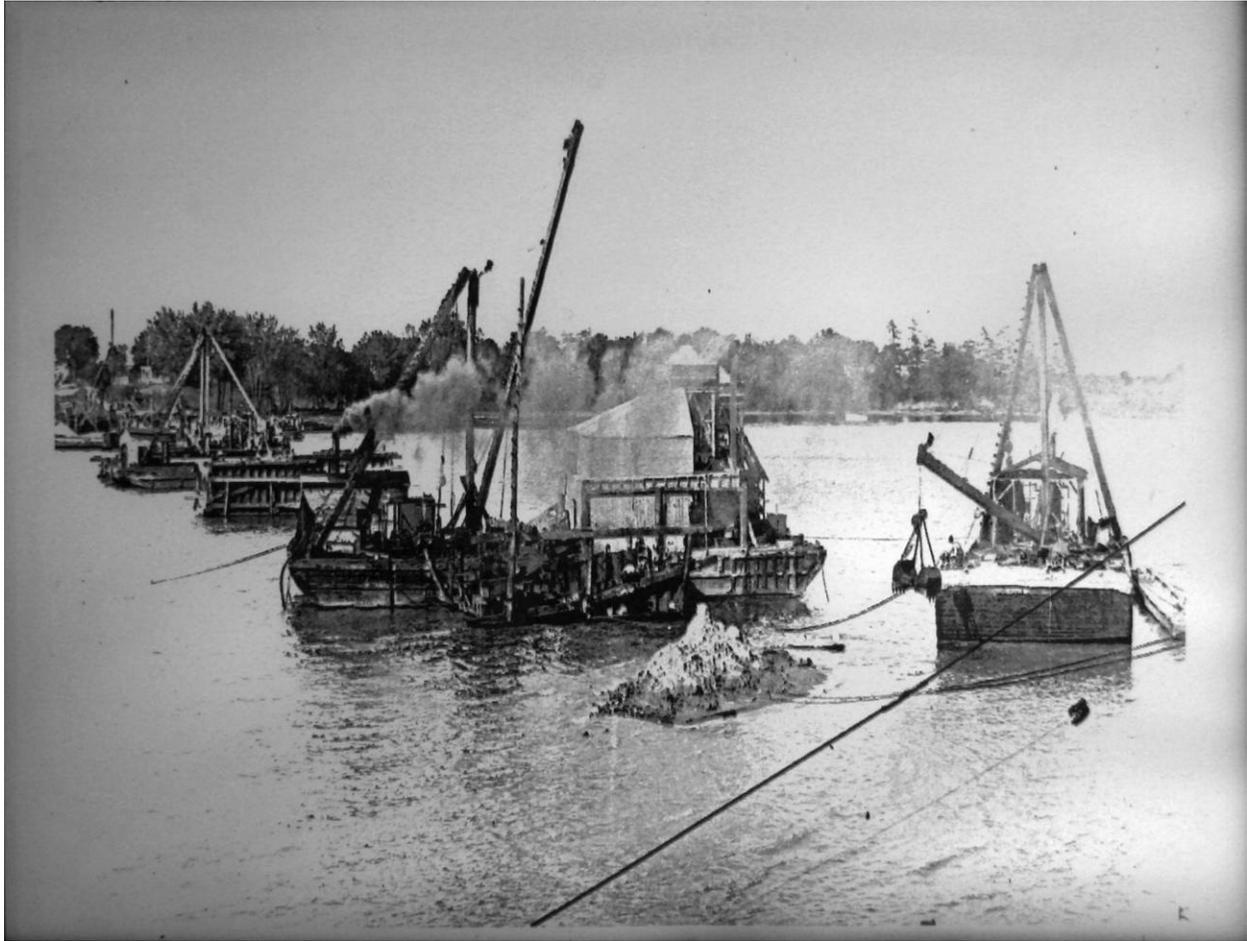
Figure 15. Pier construction by the Merritt-Chapman and Scott Corporation, summer 1928. Shows a derrick clamshell excavator and a floating cement plant on the nearest barges. Image courtesy Bill Bodette, Crown Point, New York.

were built in the water, pier nine was dry-laid, and all except piers six and seven (the channel piers), were originally designed for construction with open coffer dams. Bids for piers six and seven were solicited for both the open coffer-dam process and the pneumatic caisson process, but the former proved substantially less costly and was selected. Site conditions, namely a soft lake bed overlying bed rock at a depth of 100', a fresh water lake without rapid changes in water level, and comparatively little current, made reliance on the unusually deep coffer-dam method possible. In addition, the surfaces of bed-rock had been scored by glacial action and contained potholes, as well, ensuring a good bond between concrete pier and bed-rock. Piling for the coffer dams was driven to bed-rock with a steam hammer, and a system of horizontal bracing was constructed between interior steel sheet piling and exterior wooden piles. Struts in the form of I-beams also extended across the full width of the coffer dam, and segments of that bracing were left in place in those parts of the piers in which concrete was laid beneath water level.

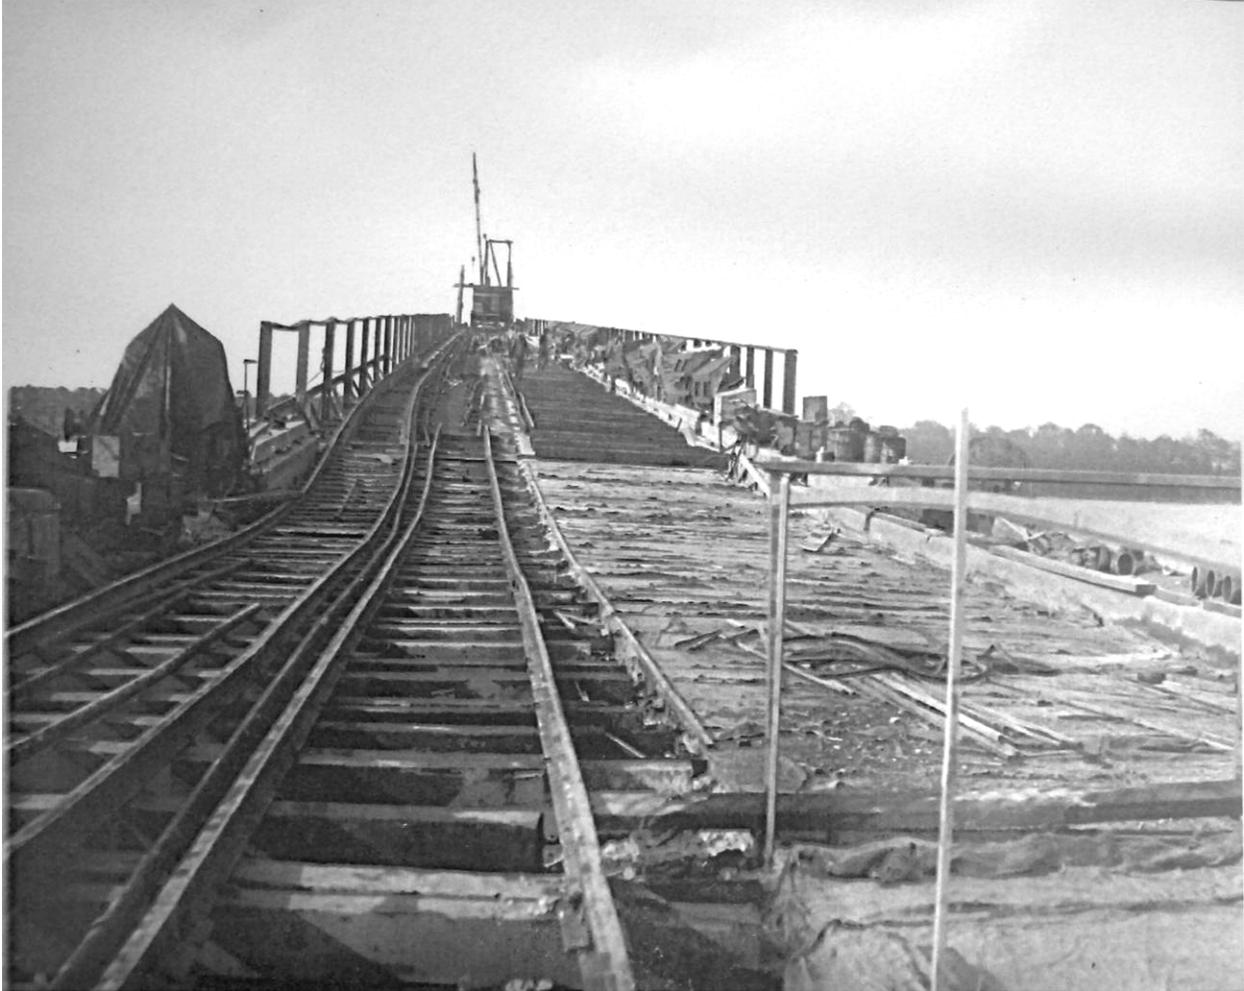
Figure 32. Concrete deck under construction on the New York end of the bridge, late April, 1929. The two sets of rails on the left side of the deck were used by Scott Brothers for their equipment and by American Bridge for their traveling derrick, which was still in use building Span 7. Image courtesy Bill Bodette.

As originally designed, the deck systems for the viaduct and truss spans differed. For the viaducts, plate girders supported transverse 24" I-beams employed as floor beams but without intermediate stringers. For the truss spans, floor beams carried longitudinal I-beam stringers set slightly more than 6' apart. The deck beams carried a reinforced-concrete slab strengthened with unit trusses to counteract shear stresses in the slab. Initially, a patented, two-course, plain-concrete, wearing surface - 1- $\frac{1}{2}$ " in depth - was poured above the reinforced concrete slab.

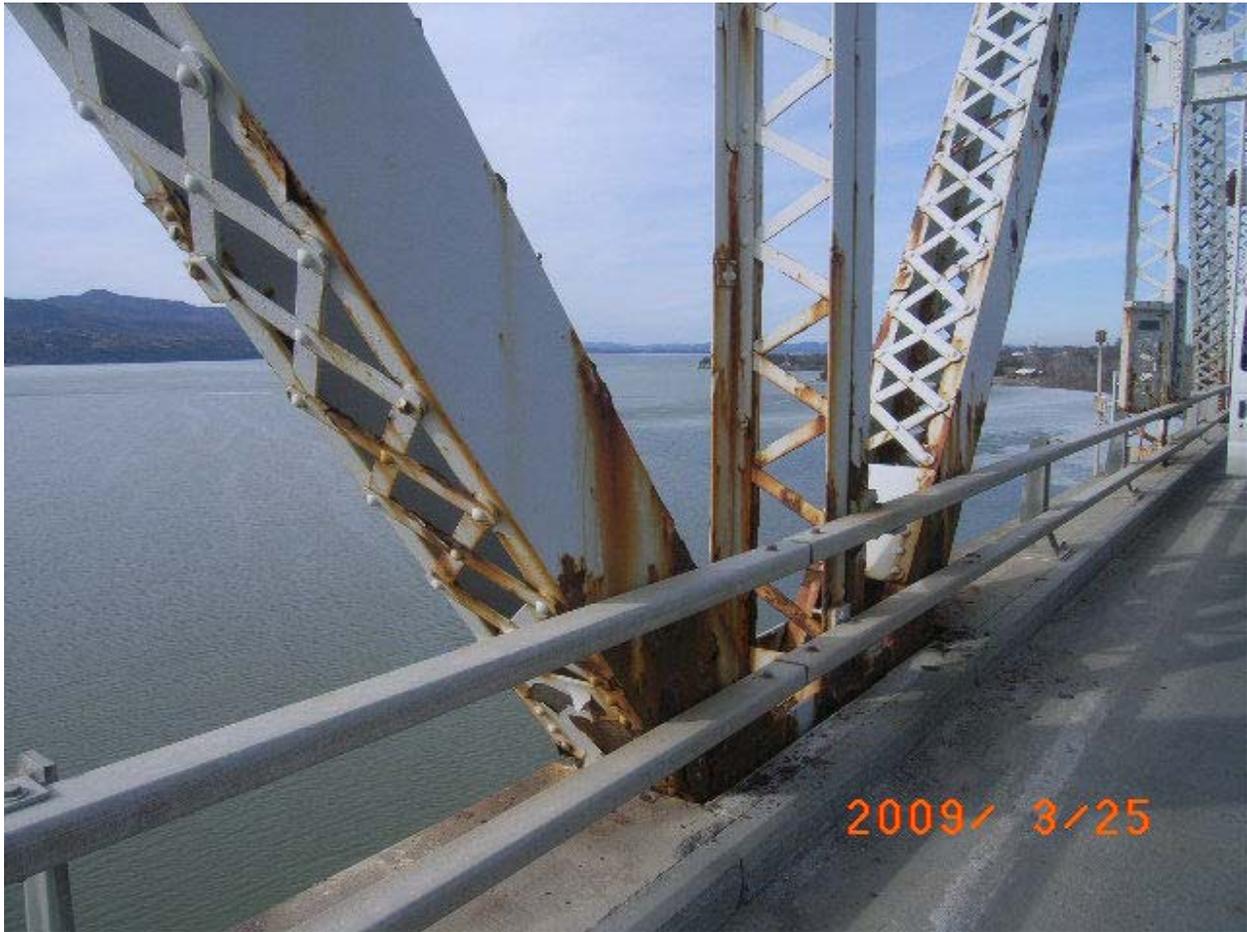
Figure 112. Span 7 deck at connection L16.

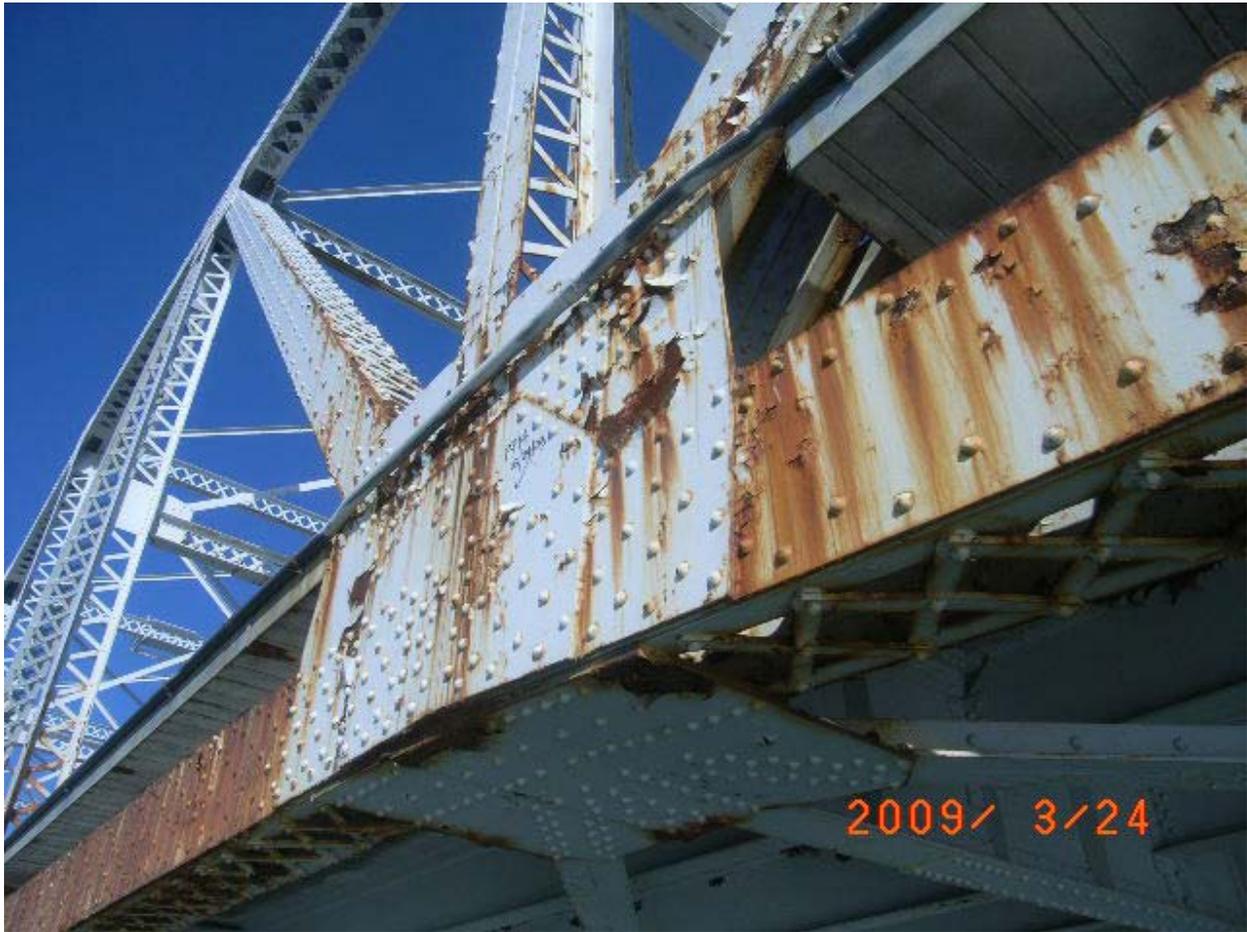
Figure 113. Span 7 lower chord connection at L14.

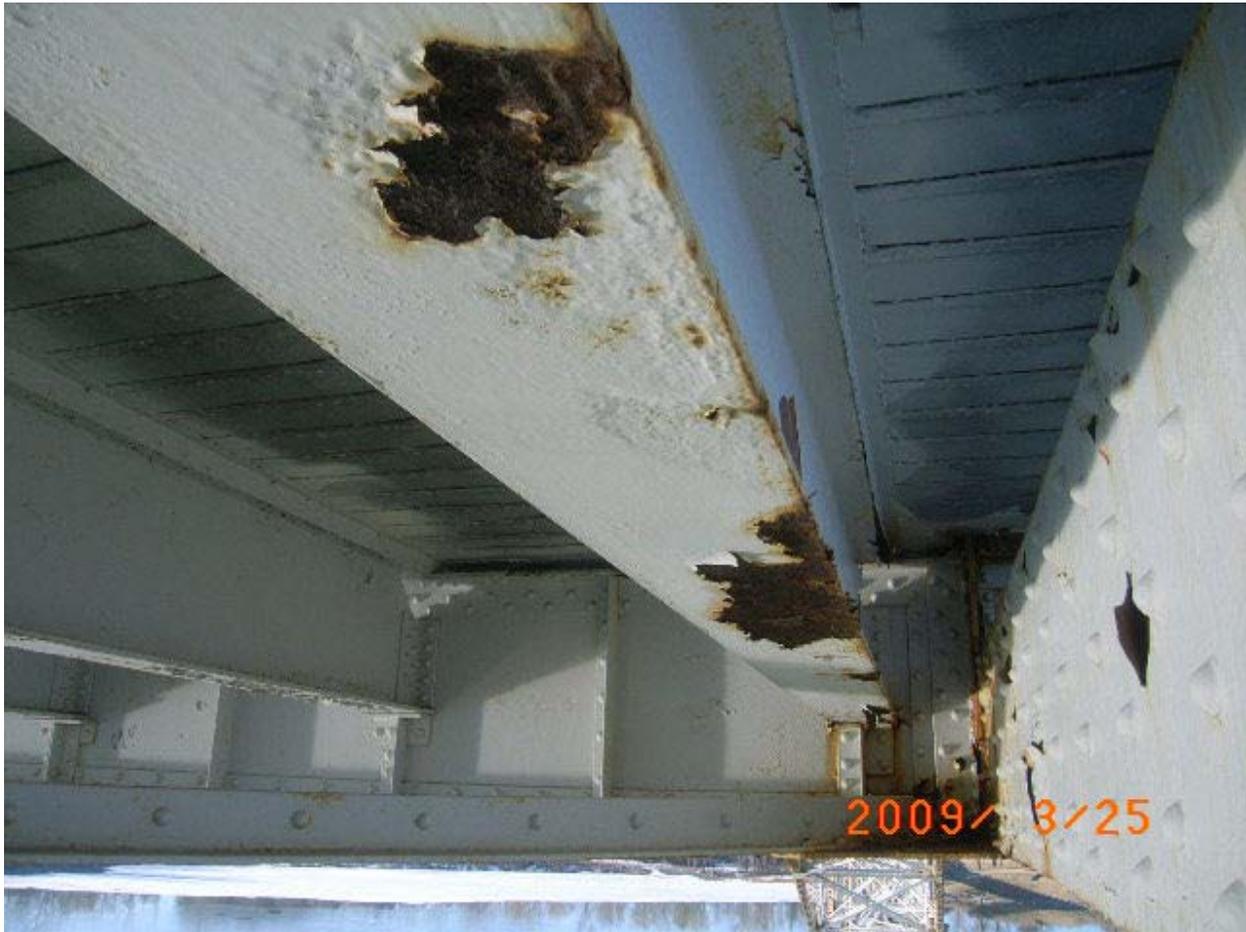
Figure 118. Span 7 Panel 20 stringer.

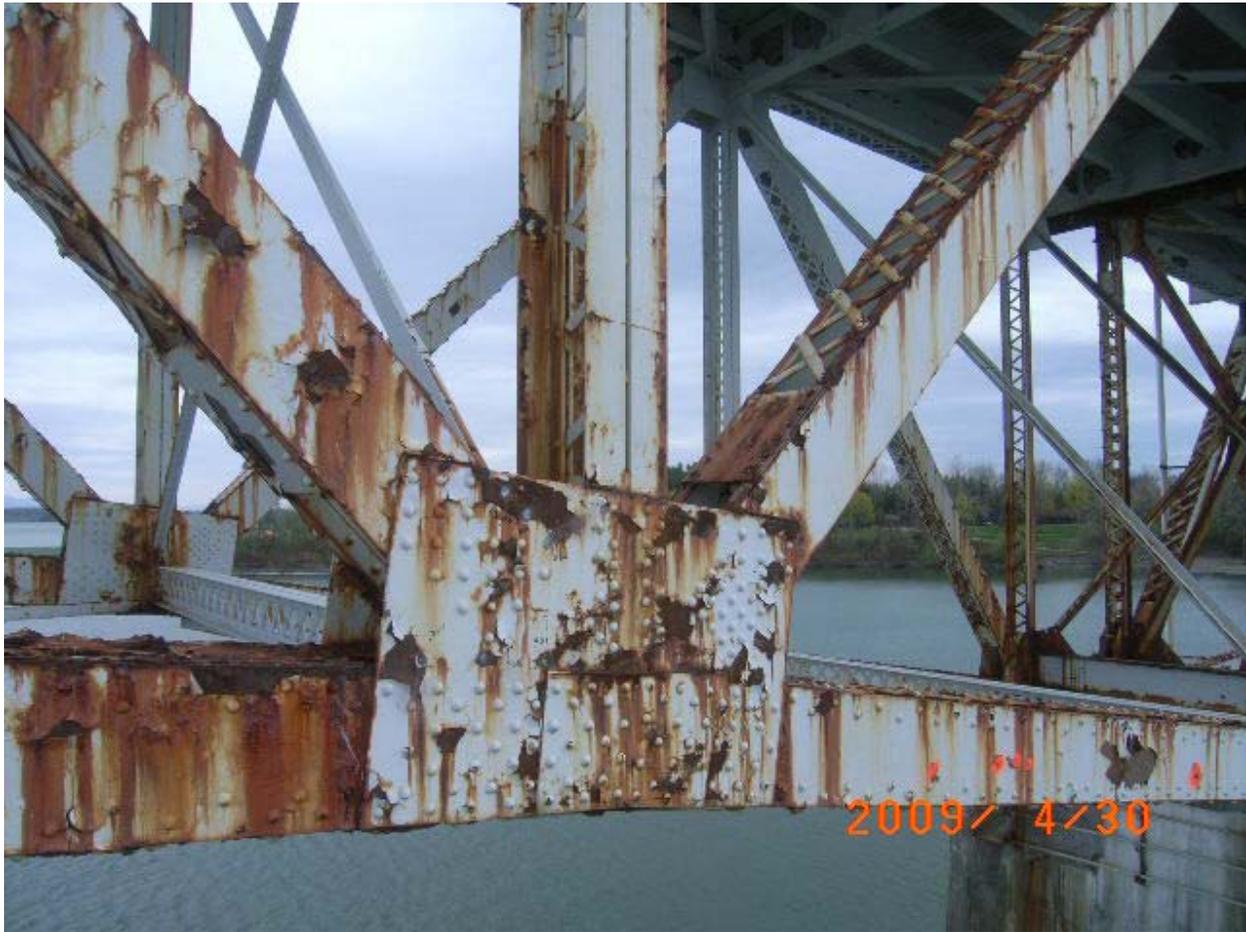
Figure 122. Span 6 lower chord connection at L02.

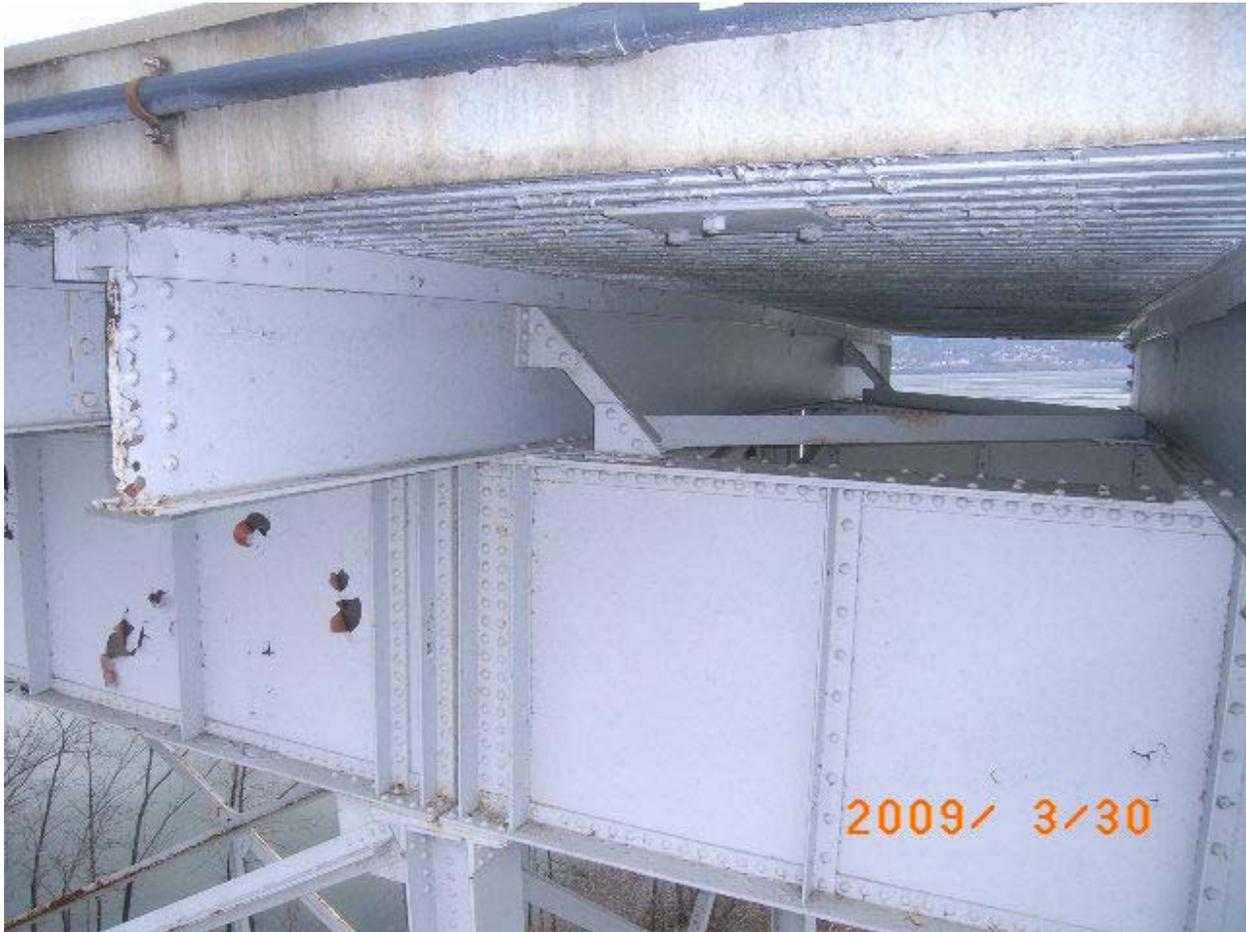
Figure 124. Span 11 Floor Beam at G2 (All girder spans are similar).

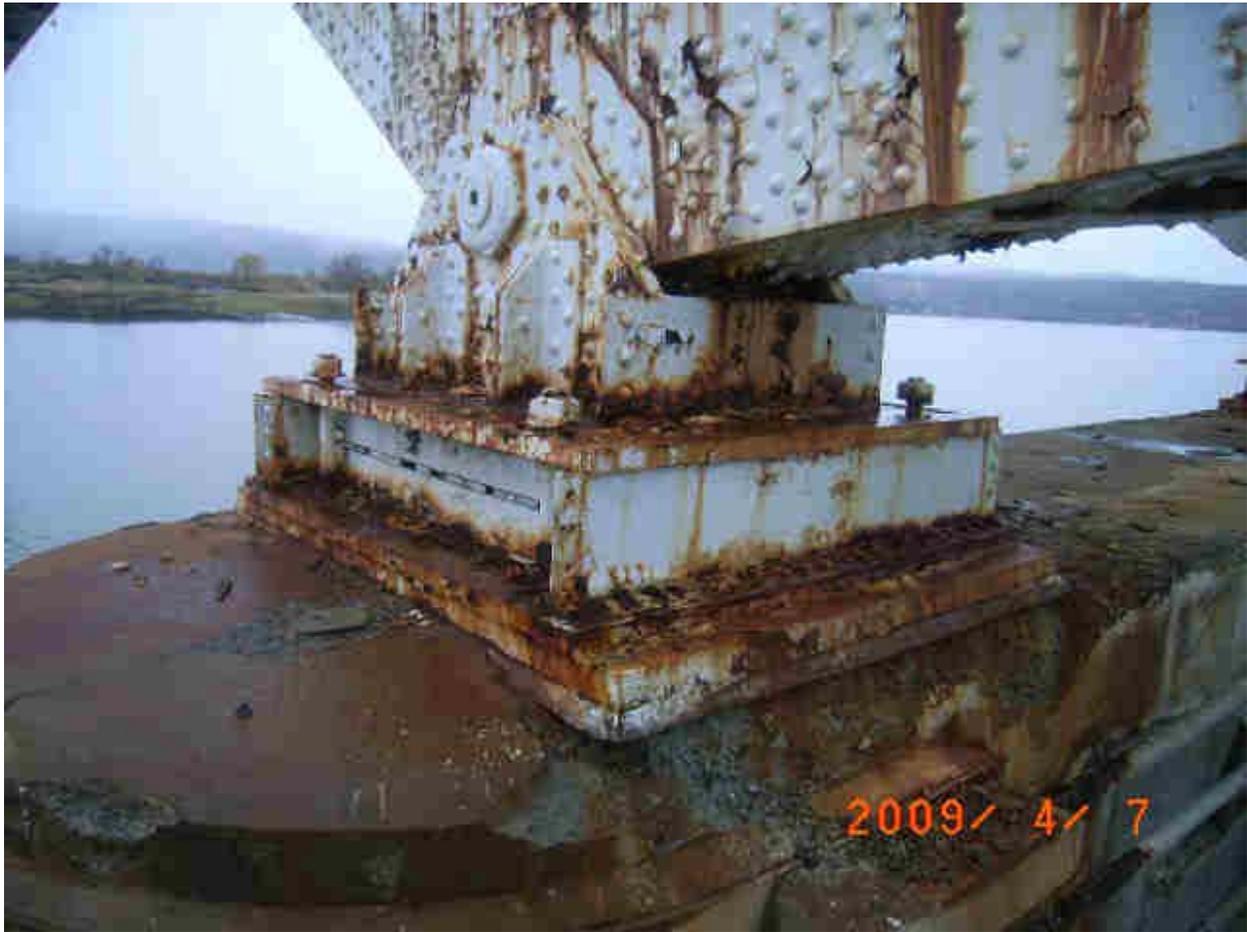
Figure 128. Spans 7/8 at Pier 7, right truss rocker bearing.

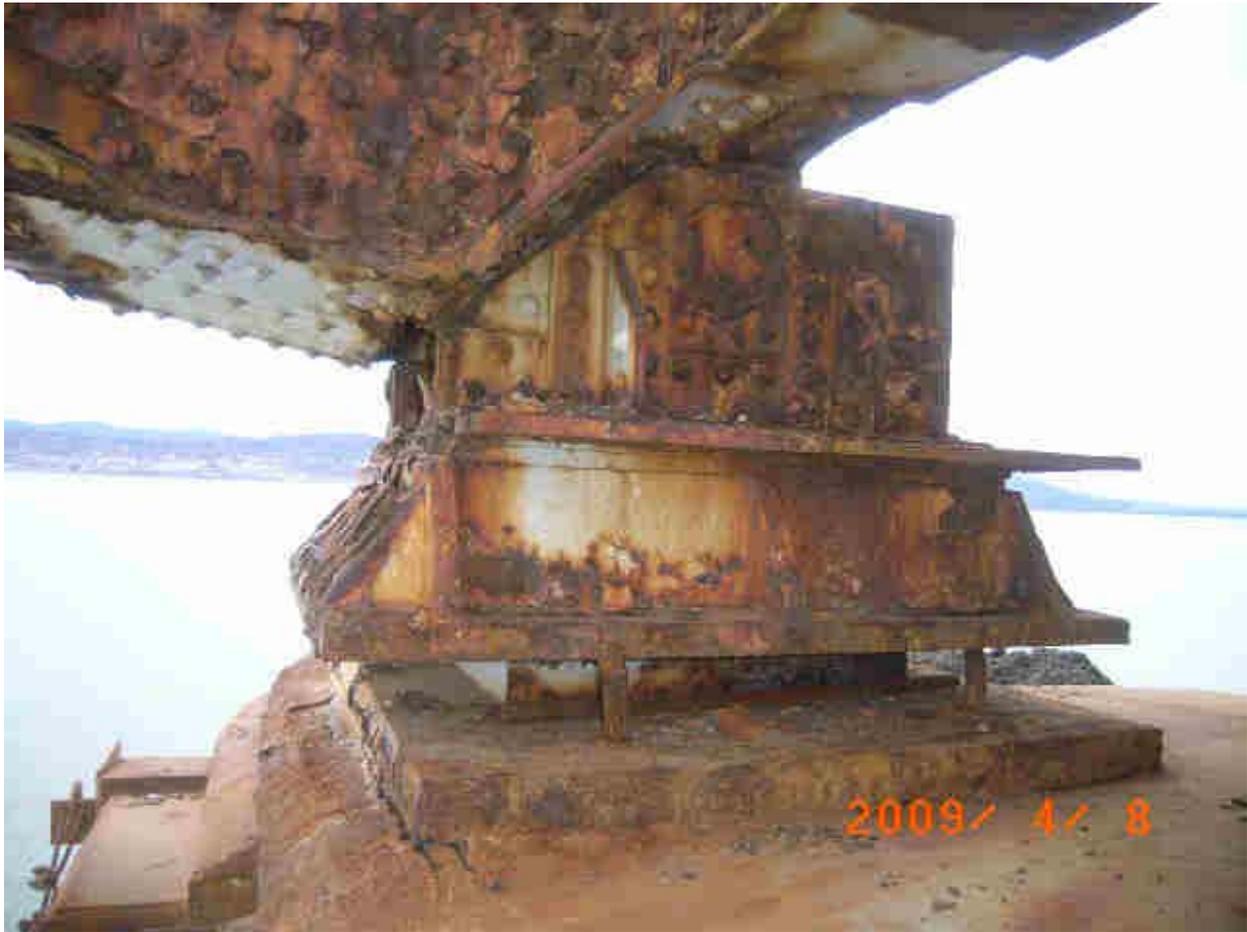
Figure 129. Span 8 at Pier 8, left truss roller bearing.

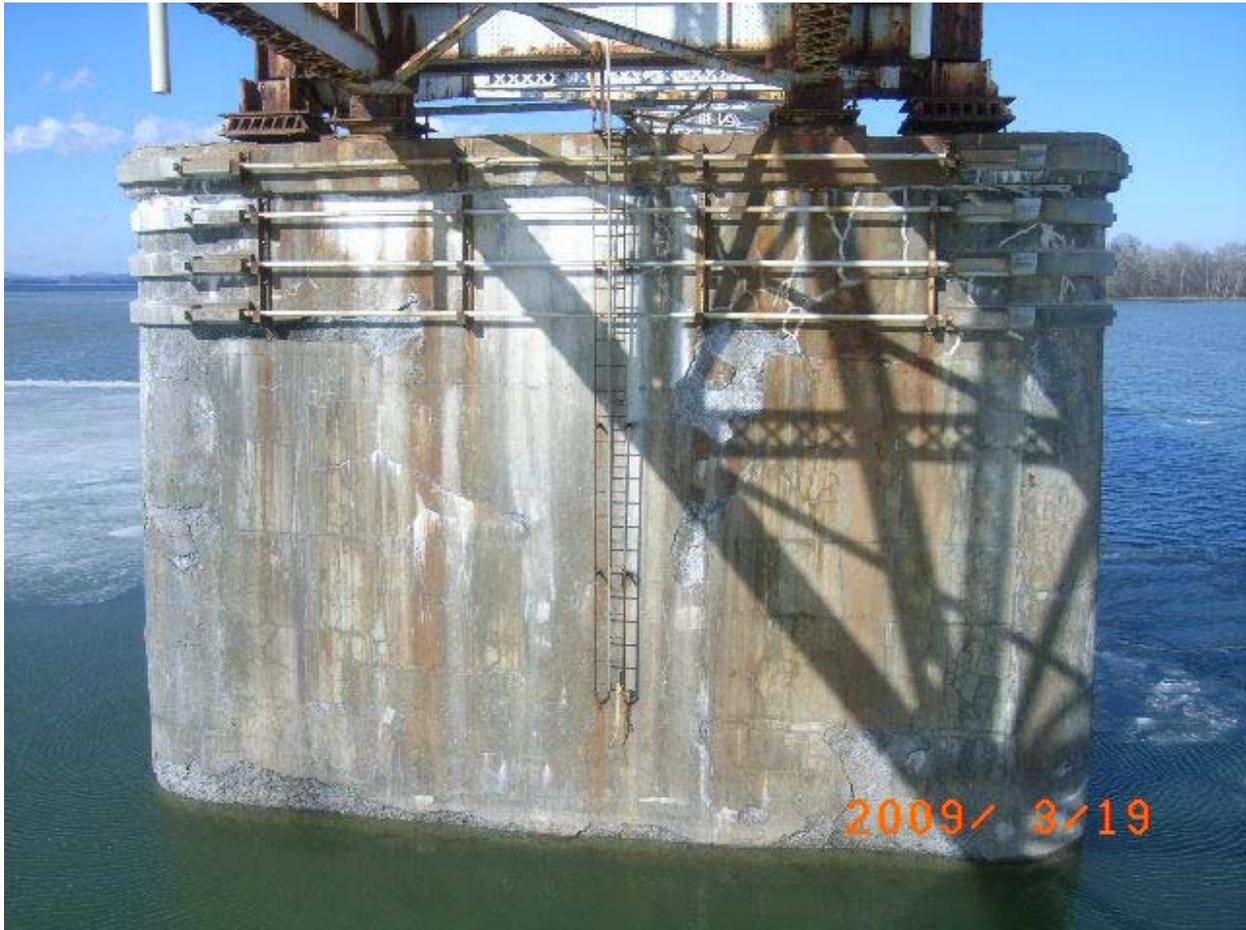
Figure 130. Pier 5, south side of stem. The potential failure of this pier resulted in the permanent closure of the Lake Champlain Bridge.

The future of the bridge was decided suddenly in 2009. Following an emergency repair of the floor system and a partial closure in July, the bridge was closed to all traffic on October 16 due to the potential failure of one of the piers. A final structural inspection by NYSDOT determined that due to extensive deterioration of the substructure and the possibility of a catastrophic failure, the bridge was unsafe for rehabilitation and would not reopen. On November 9, 2009, Governor Paterson of New York officially announced that the bridge would be replaced.

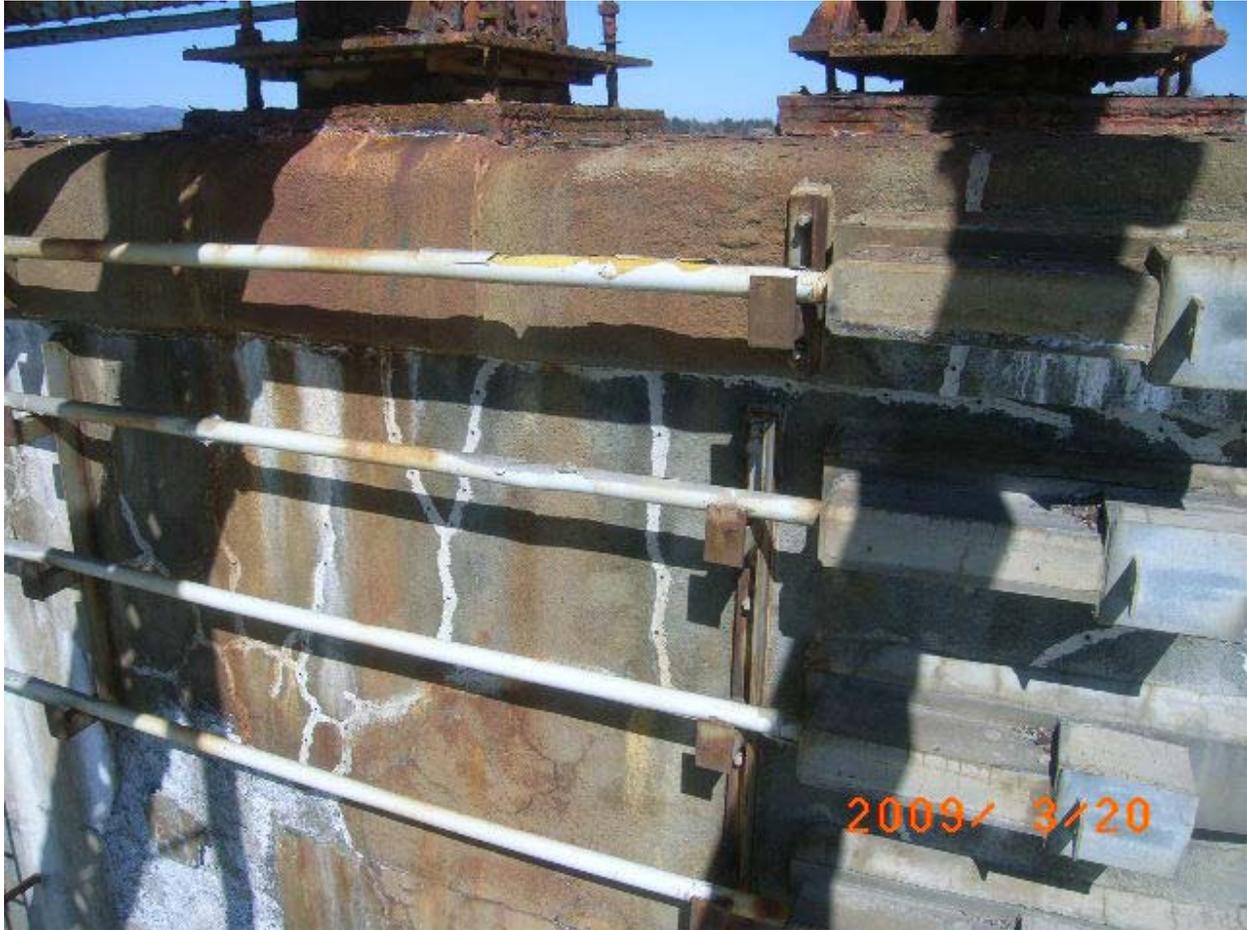
Figure 131. Pier 5 upper south side of stem, cap and tensioners.
