THE HORSE RANCH, WOOD SHED-WASH HOUSE
Wallowa-Whitman National Forest
Joseph vicinity *Eagle Cap Wilderness Area*
Wallowa County
Oregon

HABS No. OR-165-M

HISTORIC AMERICAN BUILDINGS SURVEY
THE HORSE RANCH (Red's Horse Ranch), Wood Shed/Wash House

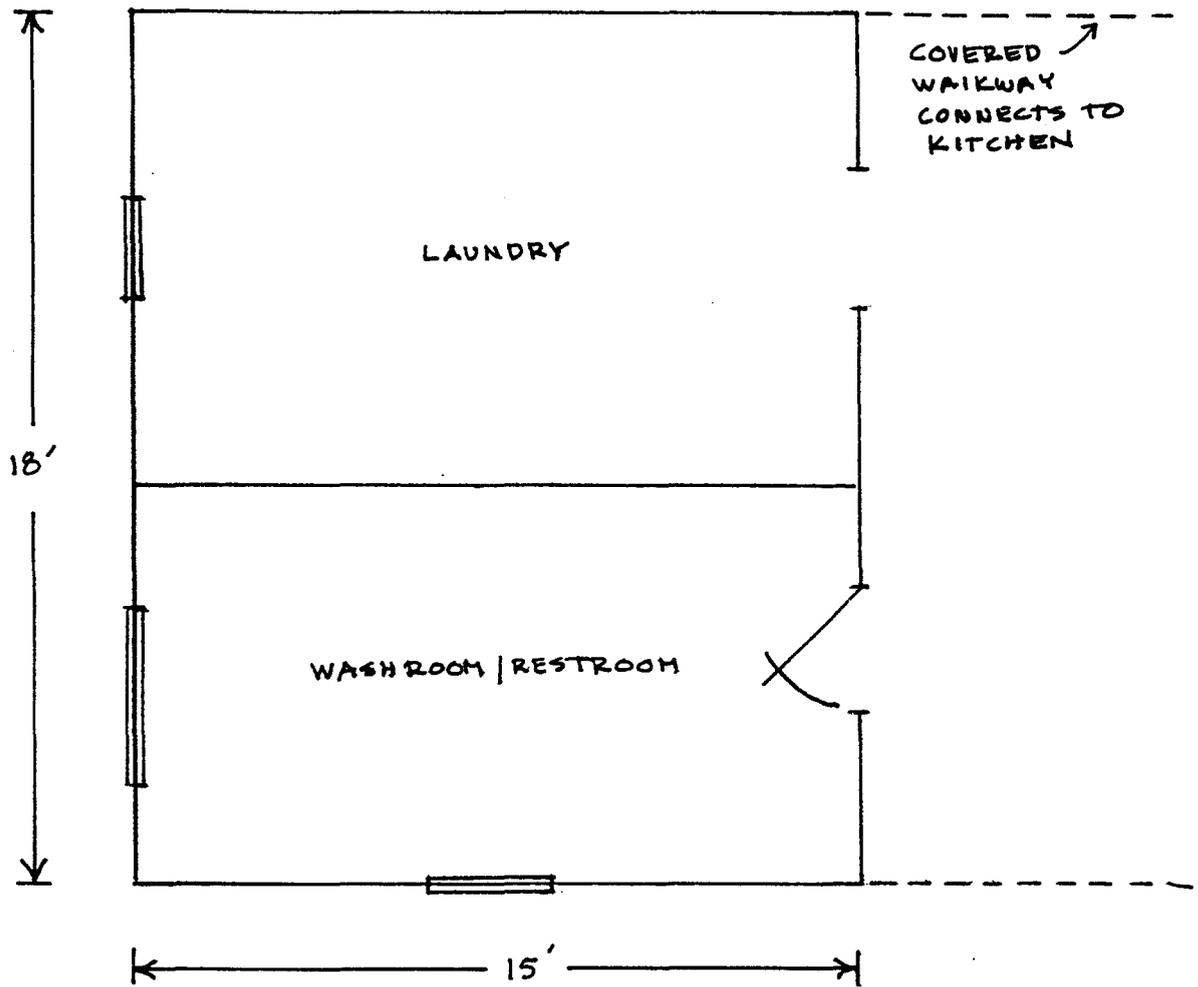
WOOD SHED/WASH HOUSE

The interior of the wood shed/wash house is composed of two room. The space is divided in half east-west. The southern room is used as a restroom and contains a shower stall (concrete in stall says 1974), toilet, and sink. Wood paneling and wood planks cover the interior walls. The floor in the restroom is

concrete. A plank wall separates the two sections of the wood shed/washroom. The northern half of the building is used as a washroom. It contains sinks, freezer, washers, and miscellaneous equipment. The floors are constructed of wood planks. Both rooms are wired for electricity. The wood shed/wash house is very similar in construction methods and size to the adjacent cook's cabin. The building is in good-excellent condition.
