BLAIR HEIGHTS, BUILDING 8
Maple Avenue
Clairton
Allegheny County
Pennsylvania

HABS No. PA-6642-B

BLAIR HEIGHTS, BUILDING 8

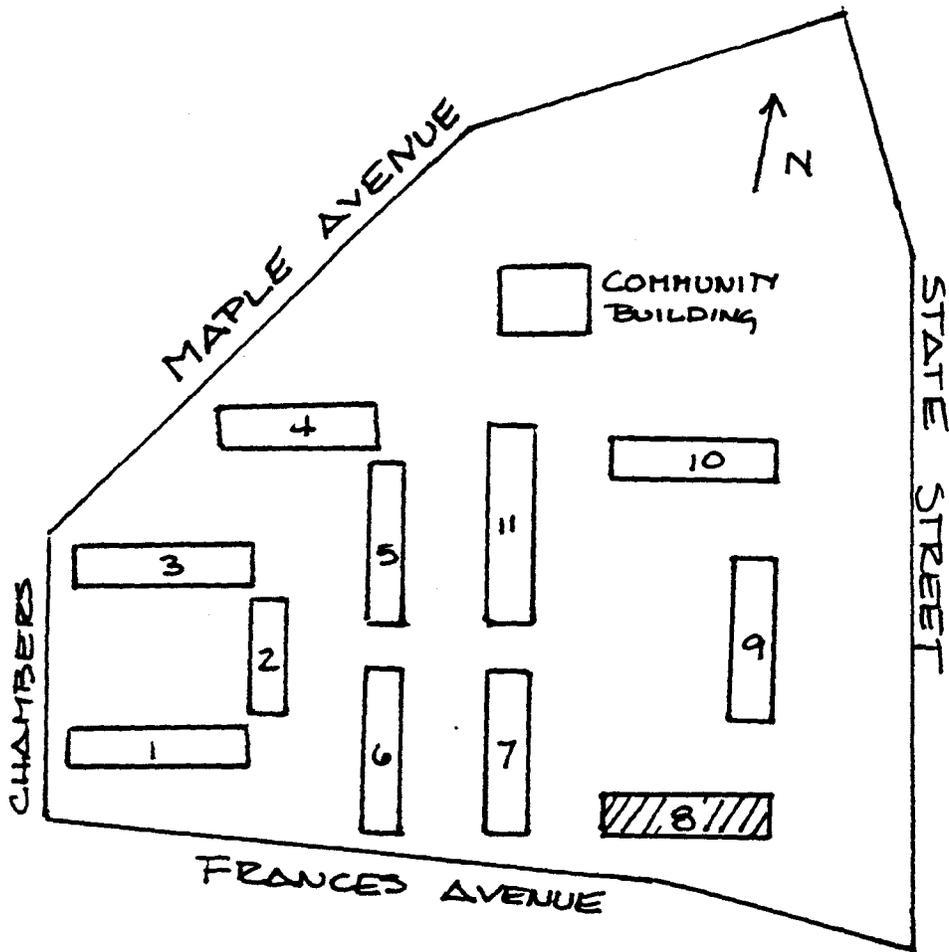
Site Plan Noting Location of Building 8, 1999
