MOUNTAIN HOME, DUPLEX/QUARTERS  
(Mountain Home VA Medical Center, Building No. 40)  
Lamont & Veterans Way  
Johnson City  
Washington County  
Tennessee

ADDENDUM TO:  
NATIONAL HOME FOR DISABLED VOLUNTEER SOLDIERS,  
MOUNTAIN BRANCH, DUPLEX QUARTERS  
(Mountain Home Veterans Affairs Medical Center, Building No. 40)  
(James H. Quillen Veterans Affairs Medical Center, Building No. 40)  
Lamont & Veterans Way  
Johnson City  
Washington County  
Tennessee

NATIONAL HOME FOR DISABLED VOLUNTEER SOLDIERS – MOUNTAIN BRANCH,  
DUPLEX QUARTERS

HABS No. TN-254-N

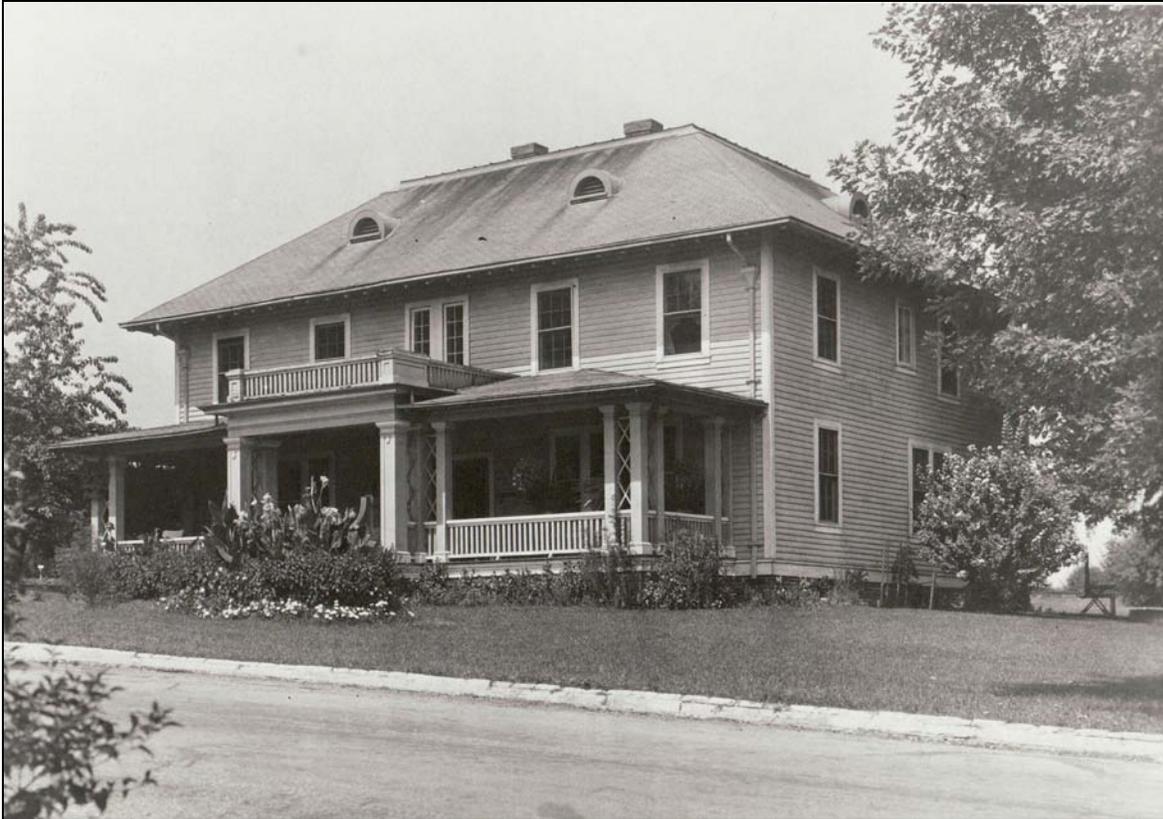
Figure 1: View of Duplex Quarters, c. 1930  
Source: Museum at Mountain Home

To accommodate the new members of the enlarged medical staff, five Colonial Revival duplex houses for Assistant Surgeons were constructed beginning in early 1921, including Building No. 40.<sup>11</sup> These wood frame Duplex Quarters (Buildings No. 39 through 43) were constructed along two roads to the north of the greenhouses between the main gate and the hospital. This new contingent of doctors was given private, up-to-date housing on the campus close to the hospital (Figure 1). Nurses' lived communally in a wood frame building behind the hospital.

- A. Architectural drawings: Design and construction drawings have not been located for Building No. 40 or the other Duplex Quarters. Later plans showing existing conditions in 1946 and 1953 are located in the drawing files of the Planning and Design Office, Quillen VAMC, Johnson City, TN.
- B. Early Views: The Museum at Mountain Home photograph collection has a few early exterior photographs of various duplex quarters. One that appears to depict Building No. 40 is reproduced below.
- C. Selected Bibliography:
