EDGEWOOD FARM, ANIMAL SHED
West side of State Route 600,
.8 mile north of State Route 778
Clover Vicinity
Halifax County
Virginia

HABS No. VA-1290-E

WRITTEN HISTORICAL AND DESCRIPTIVE DATA

EDGEWOOD FARM, Animal Shed

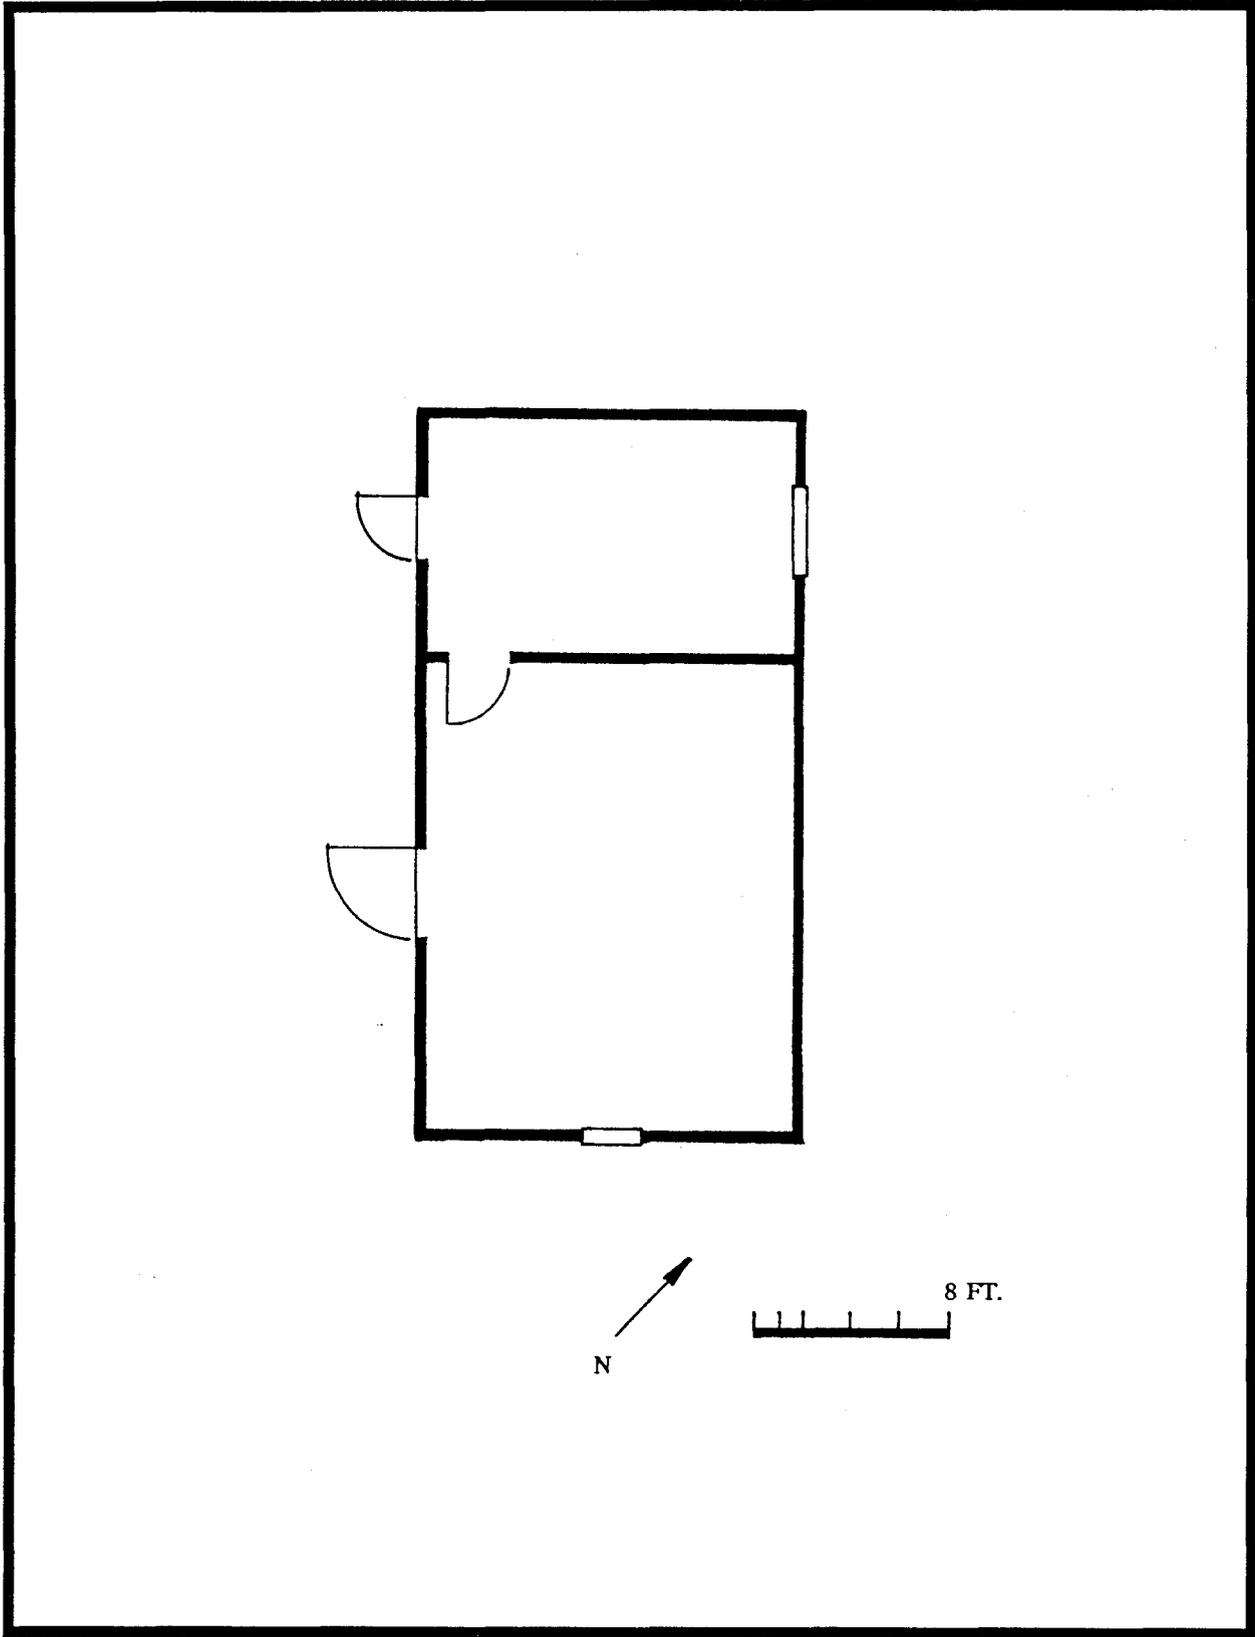
EDGEWOOD FARM, ANIMAL SHED
HABS NO. VA.-1290-E (PAGE 2)

DESCRIPTION: This 16' X 20' animal shed is constructed of rough-hewn, diamond-notched logs, the walls chinked with wood and daubed with mud. It is sheathed with board-and-batten siding, with weatherboard at the gable peaks. The gable roof has pole rafters and is covered with seamed metal. A log-walled lean-to with vertical plank siding and seamed metal roof is located across the northwest end of the shed.
