EDGEWOOD FARM, LOG ANIMAL SHED  
West side of State Route 600,  
.8 mile north of State Route 778  
Clover Vicinity  
Halifax County  
Virginia

HABS No. VA-1290-I

HISTORIC AMERICAN BUILDINGS SURVEY

EDGEWOOD FARM, Log Animal Shed

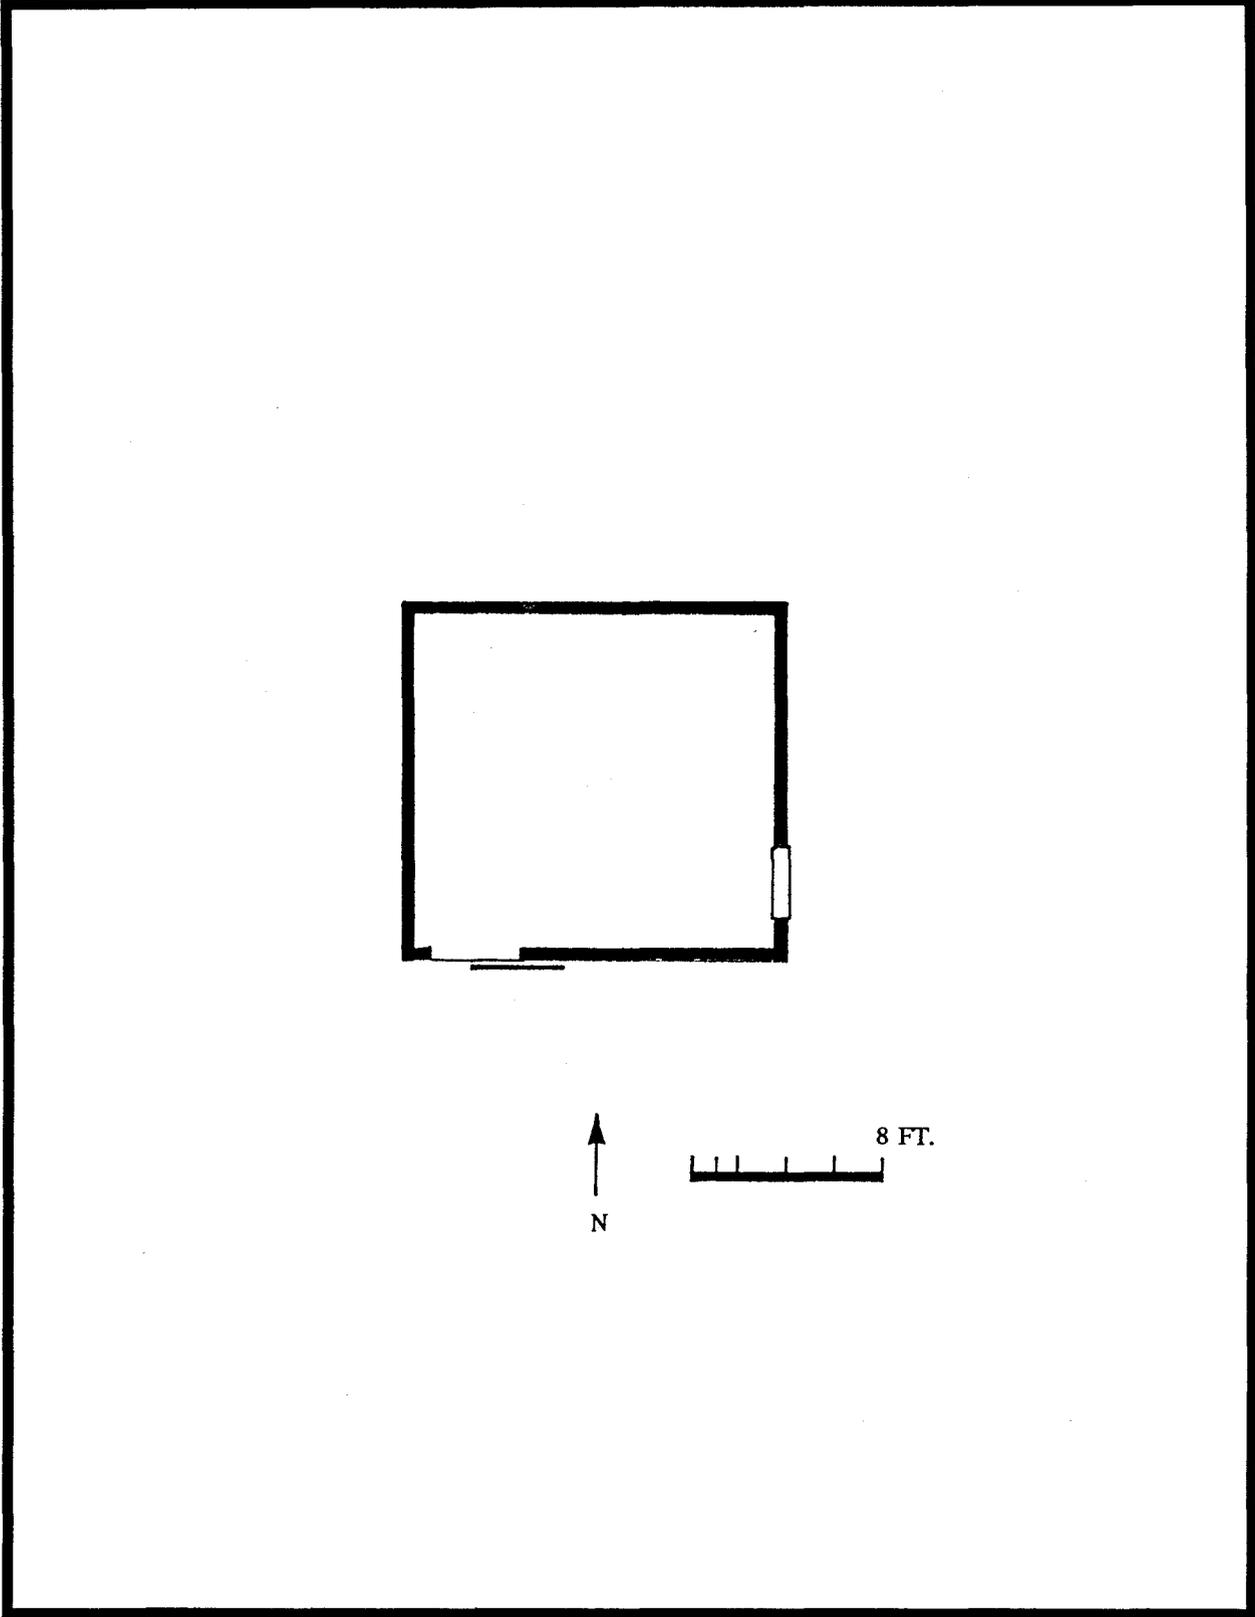
EDGEWOOD FARM, LOG ANIMAL SHED  
HABS NO. VA.-1290-I (PAGE 2 )

DESCRIPTION: This 16' x 17' animal shed is constructed of rough-hewn logs with diamond corner notching. The spaces between the logs are devoid of either daubing or chinking. The exterior walls were originally sheathed with vertical planking, much of which is now missing. The gable ends, framed with pole "studs", are sheathed with weatherboard. Five thick poles, laid north to south at the level of the eaves, may originally have formed a loft. The lower portions of the interior walls are "sealed" with horizontal planking. The shed is roofed with asphalt roll sheeting. An entrance is located in the eastern end of the north wall and a sashless window is located in the southern end of the east wall.
